Contract No. : DC/2007/06
**River Improvement Works in Upper Lam Tsuen, She
Shan River and Upper Tai Po River**

MONTHLY EM&A REPORT of

UPPER TAI PO RIVER

for May 2010

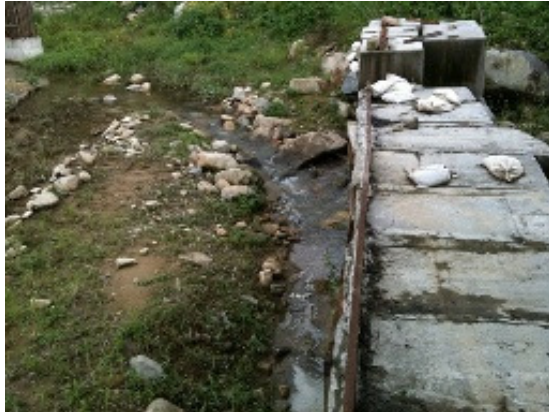
3. During the investigation river water was observed to be slightly turbid (Fig.3.1~3.3). Major construction activities were ceased as river-based excavation works were restricted according to contractual requirements. Only site clearance activities of removal of noise barriers were being carried out during the investigation and no generation of muddy effluent was observed from such activities. As reported by Contractor, immediate follow up action was taken on the same day to minimize surface runoff from causing water quality impact.

Fig.3.1 – Water discharged from approximate ch.200

5. Contractor was advised to pay serious attention to the weather condition and provide necessary protective measures to prevent erosion and runoff from deteriorating the river water quality. Bared soil surface and earthy stockpiles on site should be properly covered. Excavated pit should be backfilled as far as practicable.

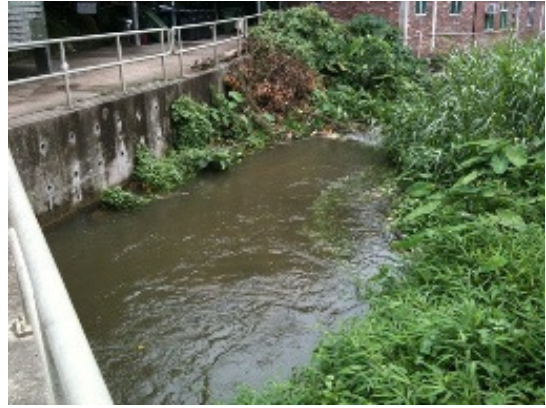
4. The condition of turbid river water was believed to be attributed by adverse weather condition in the morning on 7th May 2010 (i.e.: amber rainstorm warning signal was hoisted in the morning), which caused soil runoff and disturbance of sediment along the UTPR.

Fig.3.2 – River water at down stream area

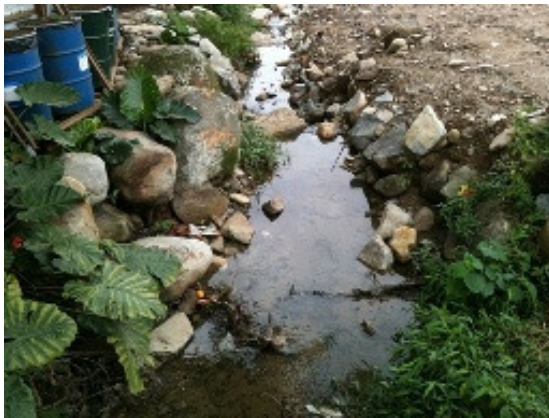
Fig.3.3 – River channel near site ch.400

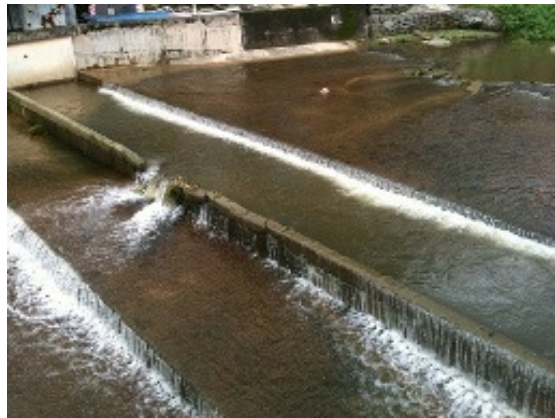
Fig.3.4 – River water at down stream area

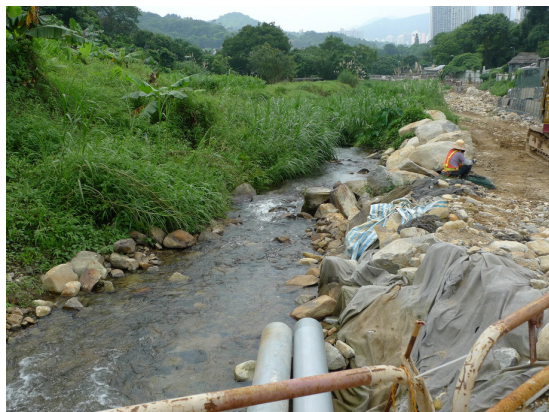
6. As a follow up investigation, inspection was carried out by ET on 12th May 2010 to check the conditions of project site as well as water quality of UTPR. River water was observed to be clear (Fig.6.1 to 6.3) and no major construction activities were being carried out during investigation.

Fig.6.1 – River water at approximate ch.50

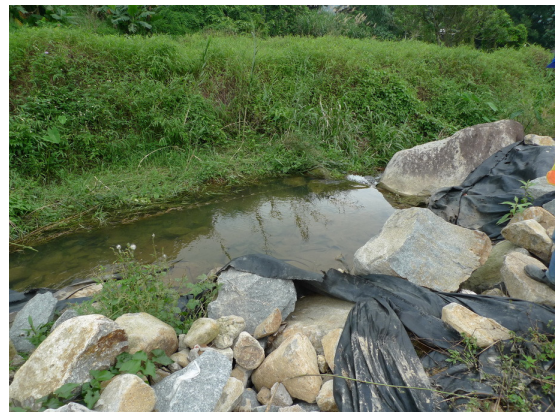
Fig.6.2 – River water at approximate ch.150

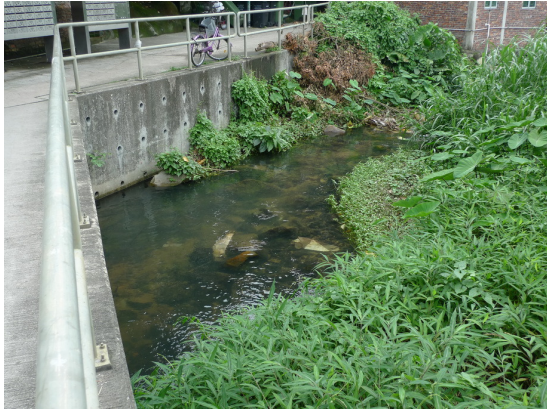
Fig.6.3 – River water at downstream area

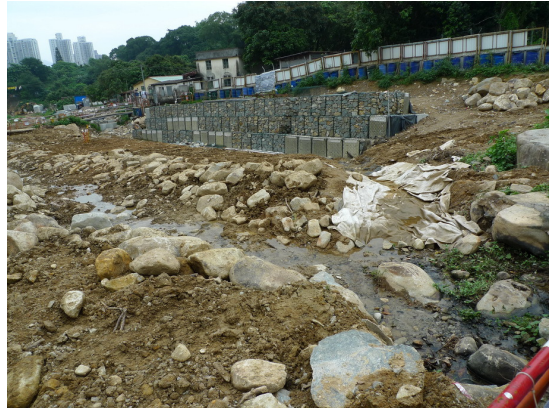
Fig.7.1 – reformed haul access at approximate ch.300

8. As reported by Contractor, compaction by roller to the loosed earth surface of the haul access is scheduled in the forthcoming week to upgrade the protective measures to the water stream at UTPR. Hydro-seeding would be also considered as an alternative measure to site area where roller cannot be reached.

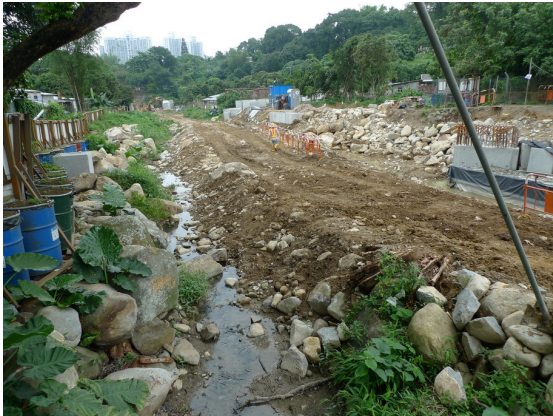
Fig.7.2 – reformed haul access at approximate ch.450

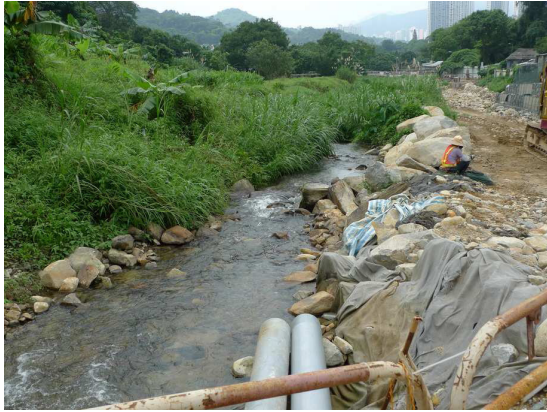
3. During the investigation, river water was observed to be clear (Fig.3.1 to 3.4). Major construction activities were ceased as river-based excavation works were restricted during wet season according to contractual requirements. According to the observation and reporting of Contractor, activities of site clearance, removal of noise barriers and reformation of partial haul access had been carried out as measures to prevent surrounding area from flooding during wet season.

Fig.3.1 – Water Quality at approximate ch.50

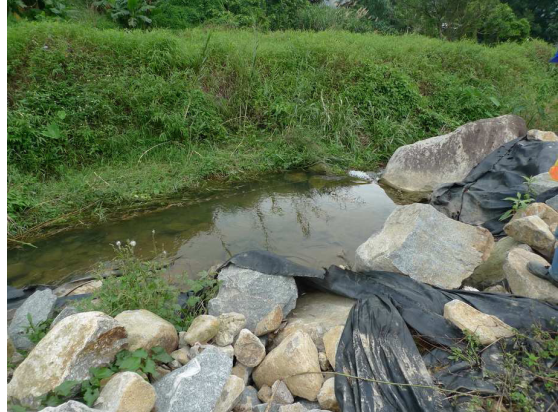
Fig.3.2 – Water Quality at approximate ch.100

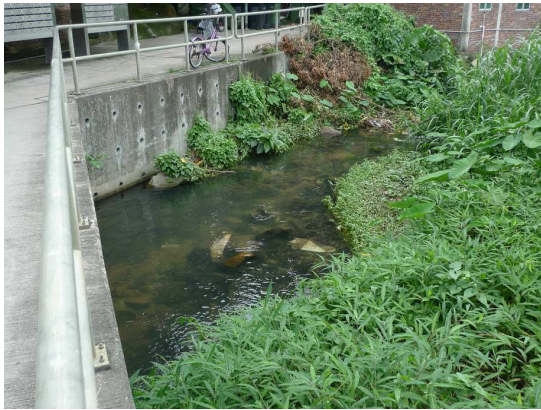
Fig.3.3 – Water Quality at downstream area of the site

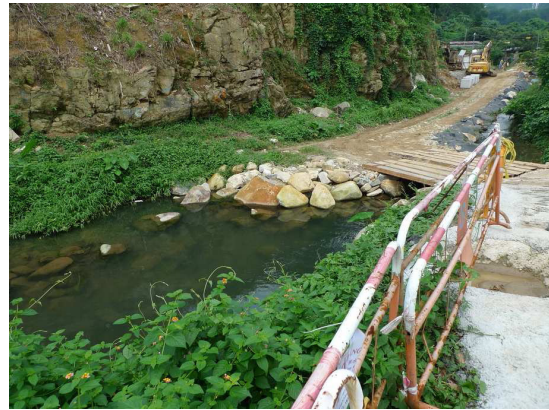
Fig.3.4 – Water Quality at approximate ch.600

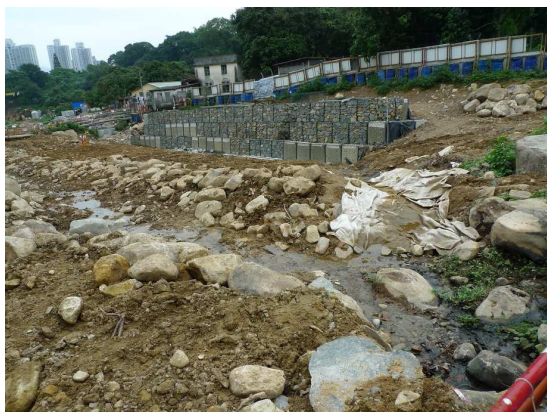
4. Contractor was reminded to pay serious attention to the site condition and provide necessary protective measures to prevent erosion and runoff from deteriorating the river water quality. Loosed earth surface of the reformed haul access at ch.300 to 450 should be protected (Fig.4.1 & 4.2). As major construction activities were ceased, temporary stockpiling of earth material should be prevented on site.

Fig.4.1 – Reformed haul access at approximate ch.300

5. Contractor took the advice given by ET and scheduled to upgrade the protective measures to the water stream at UTPR. Compaction by roller to the loosed earth surface of haul access at ch.300 to 450 was scheduled to be carried out in the forthcoming week. Hydro-seeding would be also considered as an alternative measure to site area where roller cannot be reached.

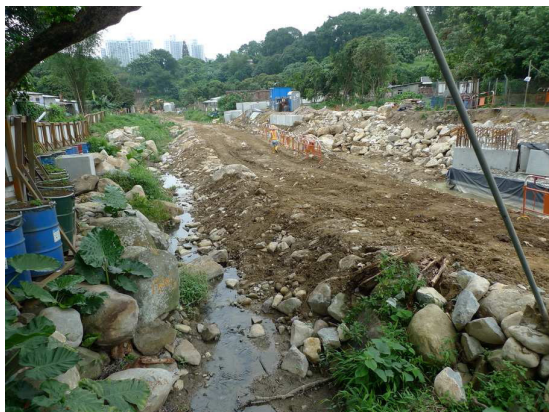
Fig.4.2 – Reformed haul access at approximate ch.450
