Contract No. : DC/2007/06
**River Improvement Works in Upper Lam Tsuen,
She Shan River and Upper Tai Po River**

ENVIRONMENTAL MONITORING AND AUDIT

MONTHLY EM&A REPORT of

for February 2011

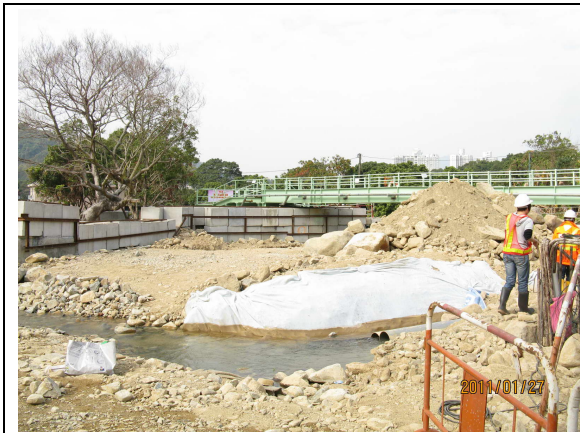
Photo 1: General view of the works area

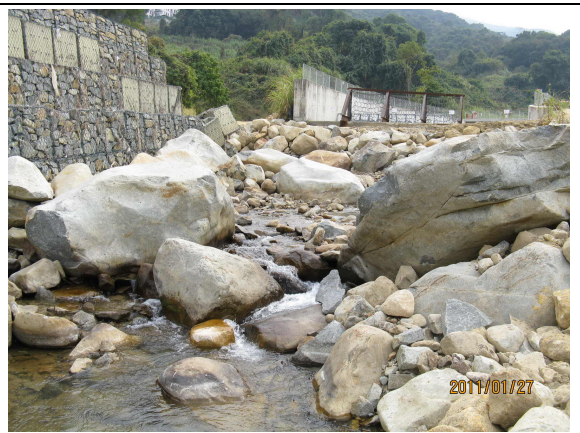
Photo 2: General view of the works area
