Contract No. : DC/2007/06
**River Improvement Works in Upper Lam Tsuen,
She Shan River and Upper Tai Po River**

ENVIRONMENTAL MONITORING AND AUDIT

MONTHLY EM&A REPORT of

for March 2011

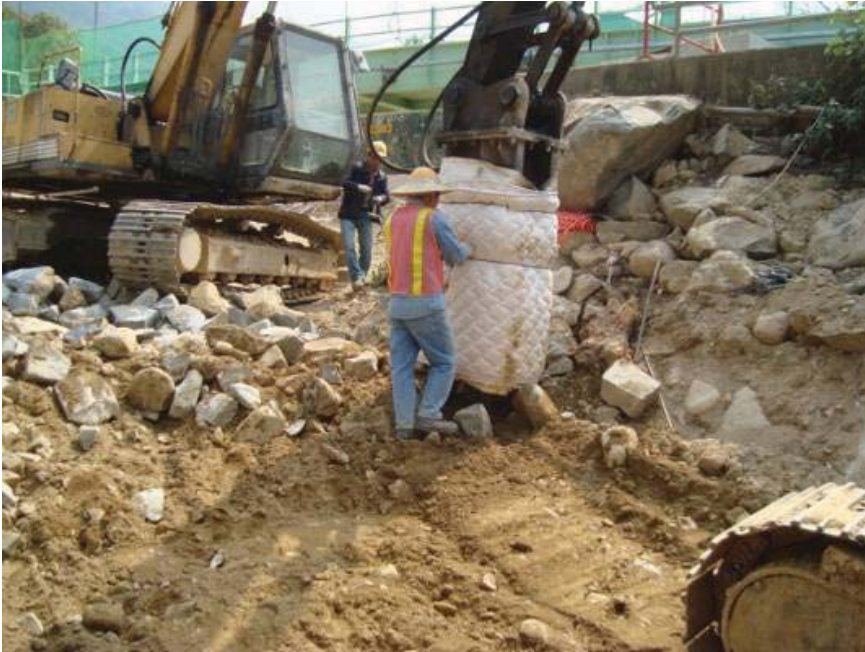
3. Findings from the investigation showed major noise source was generated from boulder breaking activities being carried out at approximate ch.250. Due to size of boulders to be broken and difficulty of transportation, as reported by Contractor boulder breaking activities were confined within the abovementioned location.

Fig.1 – Breaker Tips of Hydraulic Breaker was warped up with noise insulation material

5. To minimize noise generation from the concerned activities, Contractor was recommended to further enhance mitigation measures immediately, which should at least include:

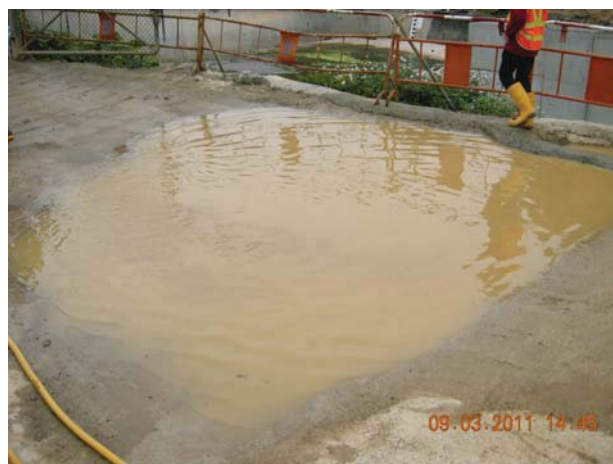
4. Accumulation of used water was found in the wheel washing bay at ch.600 (Fig.4). As such, Contractor was recommended to clean and maintain the wheel washing area regularly to maintain good condition as to avoid site vehicles from bringing muddy water to public area.

Fig.4 – Condition of Wheel Washing Bay at site entrance located at ch.600

5. Contractor was also recommended to pay serious attention on their site practices and implement necessary mitigation measures to avoid dust emission, which should at least include:

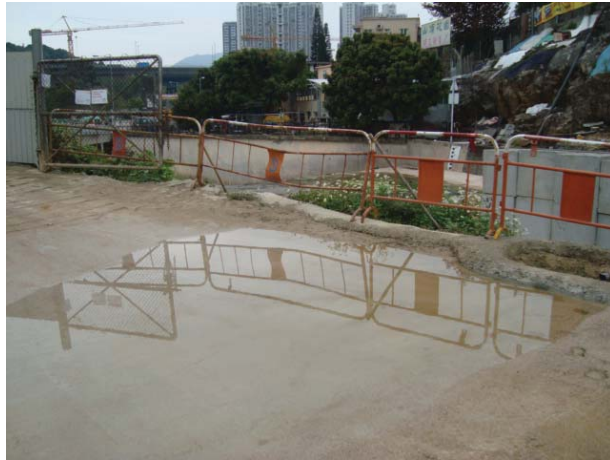
Fig.6.1 – Wheel Washing Bay is cleaned before and after works everyday

6. Contractor considered recommendations given by ET and implement rectification works on 10th March 2011 including:
- Briefing to frontline staffs about prevention of dust generation, especially of issue of vehicles washing, has been made during morning assembly (Fig.6.1 & 6.2).
 - Wheel washing bay has been checked and cleaned at every morning as well as after works. Immediate cleaning would be conducted should condition of wheel washing bay be unsatisfactory (e.g.: full of mud and used water).
7. ET has reminded the contractor to pay serious attention on not arising possible environmental impacts in the future.

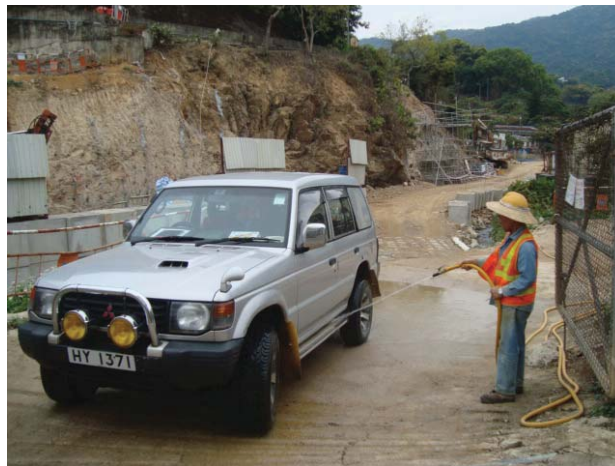
Fig.6.2 – Briefing has been given to staff to remind importance of vehicle washing before leaving site

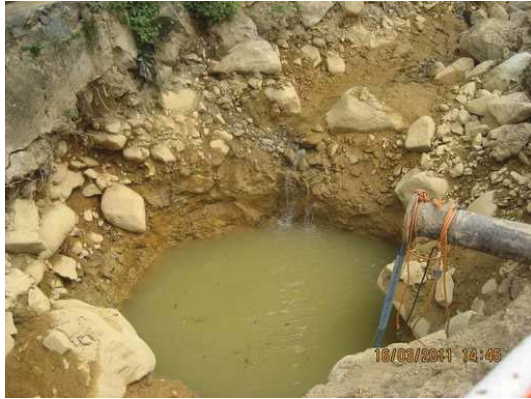
2. A Routine site inspection covering site area at UTPR was carried out on 16th March 2011 with representatives from RE, ET, Contractor and Independent Environmental Checker. During the inspection improper effluent discharge causing water quality impact to the downstream area was observed at excavated site at approximate ch.200 (Fig.2.1 to 2.3). As such, Contractor was requested to implement immediate corrective actions to stop further deterioration of water quality.

Fig.2.1 – Muddy water arisen from excavation at ch.200

6. Contractor was seriously recommended to review their site conditions and implement necessary water quality mitigation measures to avoid further deterioration of river water quality, which should at least include:

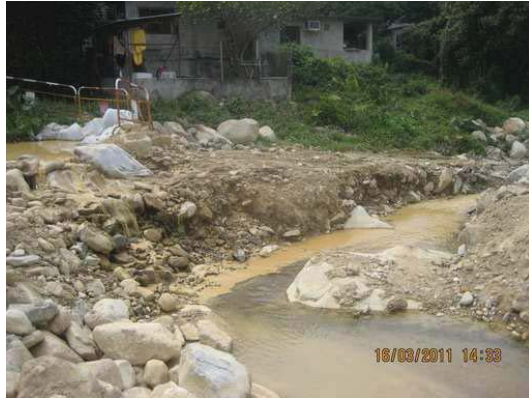
Fig.2.1 – Effluent discharge from ch.200 on 16/03/11

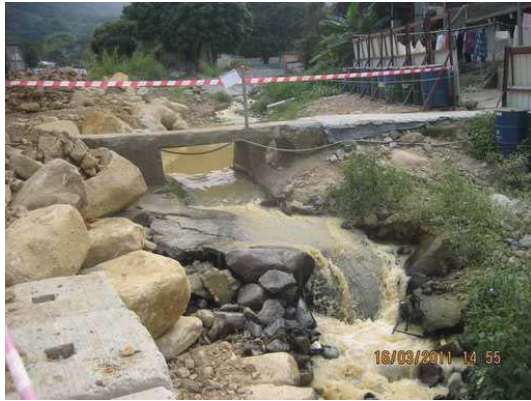
Fig.2.3 – River water at approximate ch.500 on 16/03/11

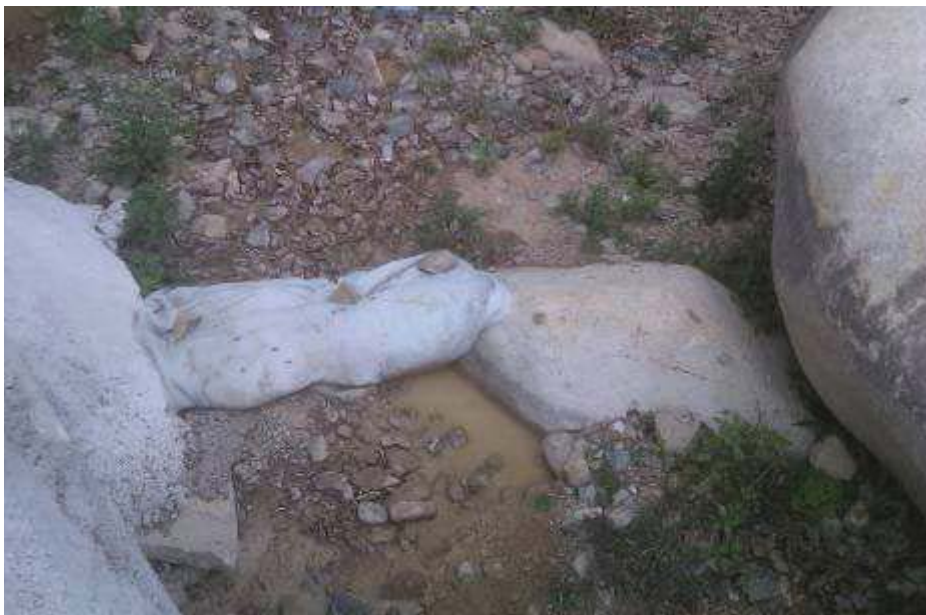
Fig.3.1 – Sandbags barriers was formed to form enclosed environment for construction activities carrying out at ch.400

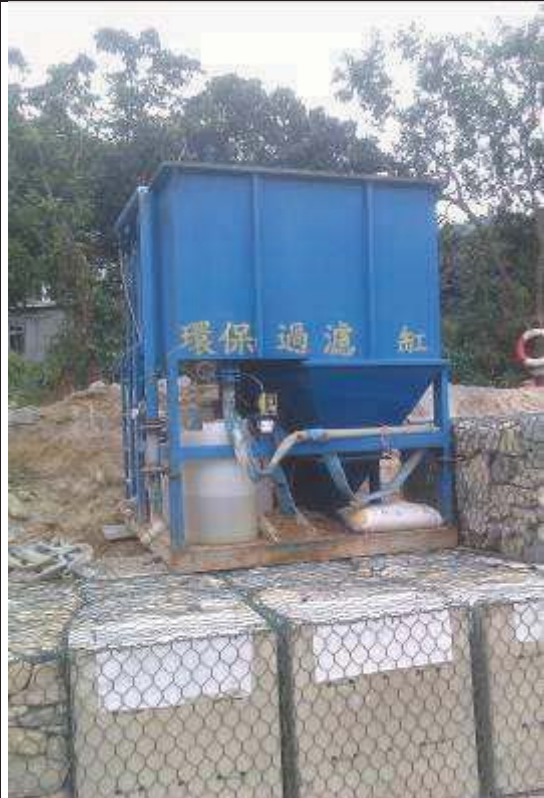
Fig.3.2 – Site water from construction activities at ch.400 was diverted to sedimentation tank (photo taken by Contractor)

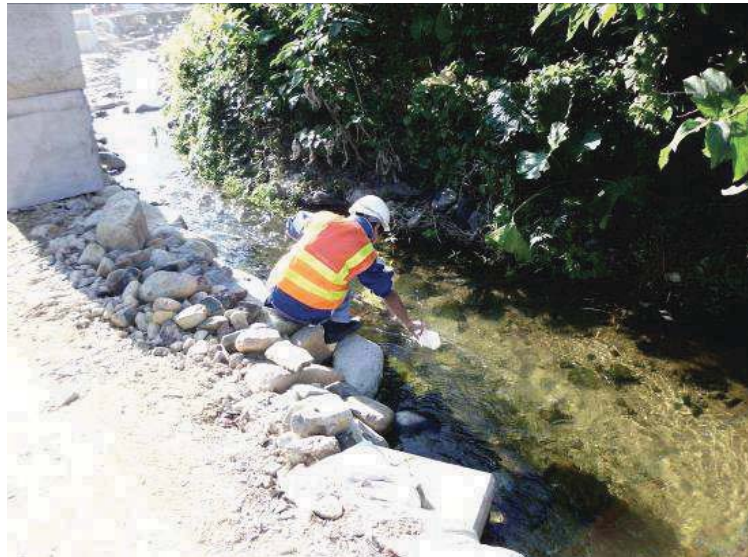
Fig.4 – Technician from third party laboratory for water quality monitoring (photo taken by Contractor)

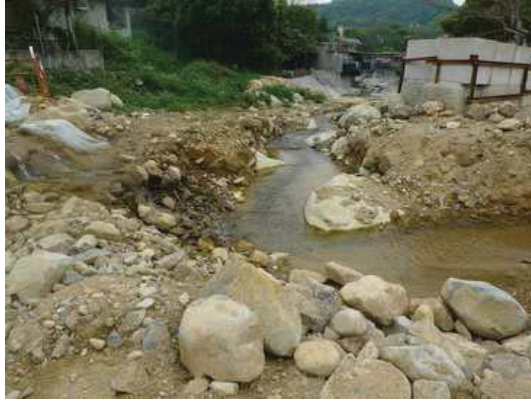
5. As a follow up investigation, second site inspection was carried out on 23rd March 2011 to check if proper follow up actions and mitigation measures were implemented for the spots of ch.200 and 400. During the investigation no improper discharge was observed (Fig.5.1 & 5.2). However, it was observed that no further action was

observed to protect the exposed riverbanks along site and to enhance effectiveness of site water treatment system at ch.200.

Fig.5.1 – Water quality at ch.200 on 23/03/11

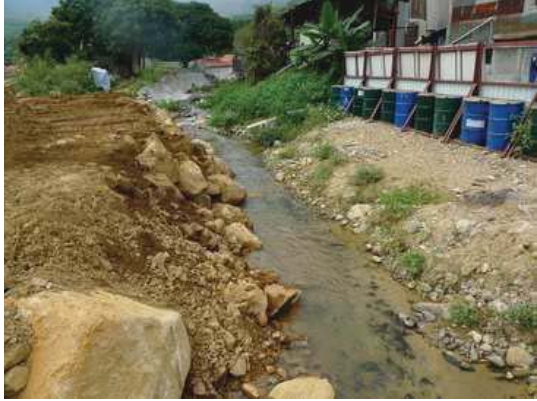
Fig.5.2 – Water quality at ch.600 on 23/03/11
