Contract No. : DC/2007/06
**River Improvement Works in Upper Lam Tsuen,
She Shan River and Upper Tai Po River**

ENVIRONMENTAL MONITORING AND AUDIT

MONTHLY EM&A REPORT of

UPPER TAI PO RIVER

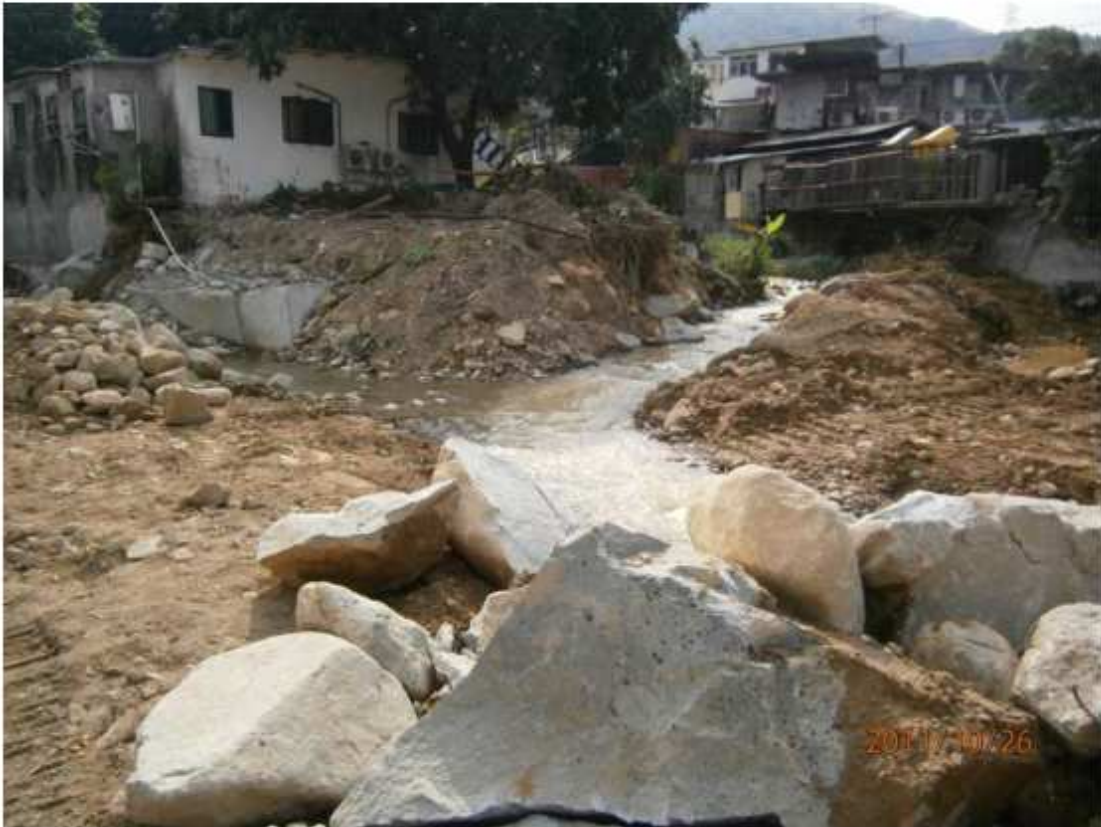
Fig.2.1 –The river banks were barely exposed which caused soil erosion.

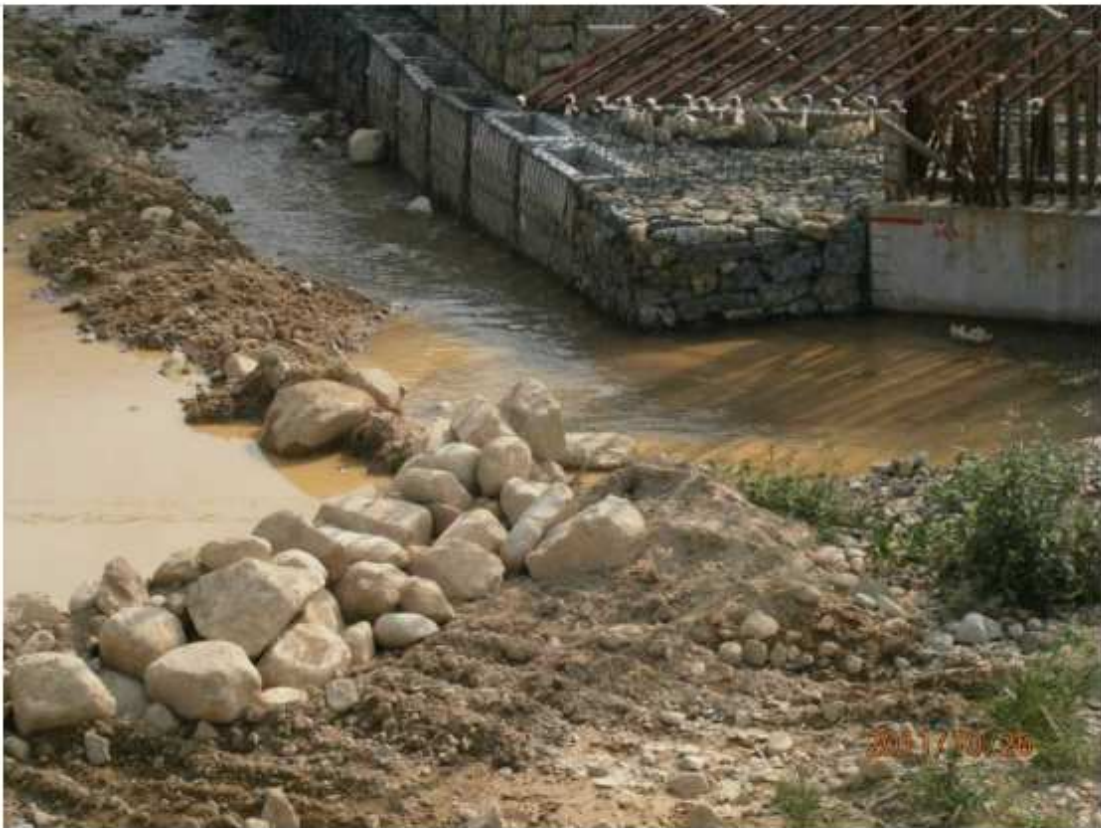
Fig.2.2 –Seepage of untreated site water directly into the river.

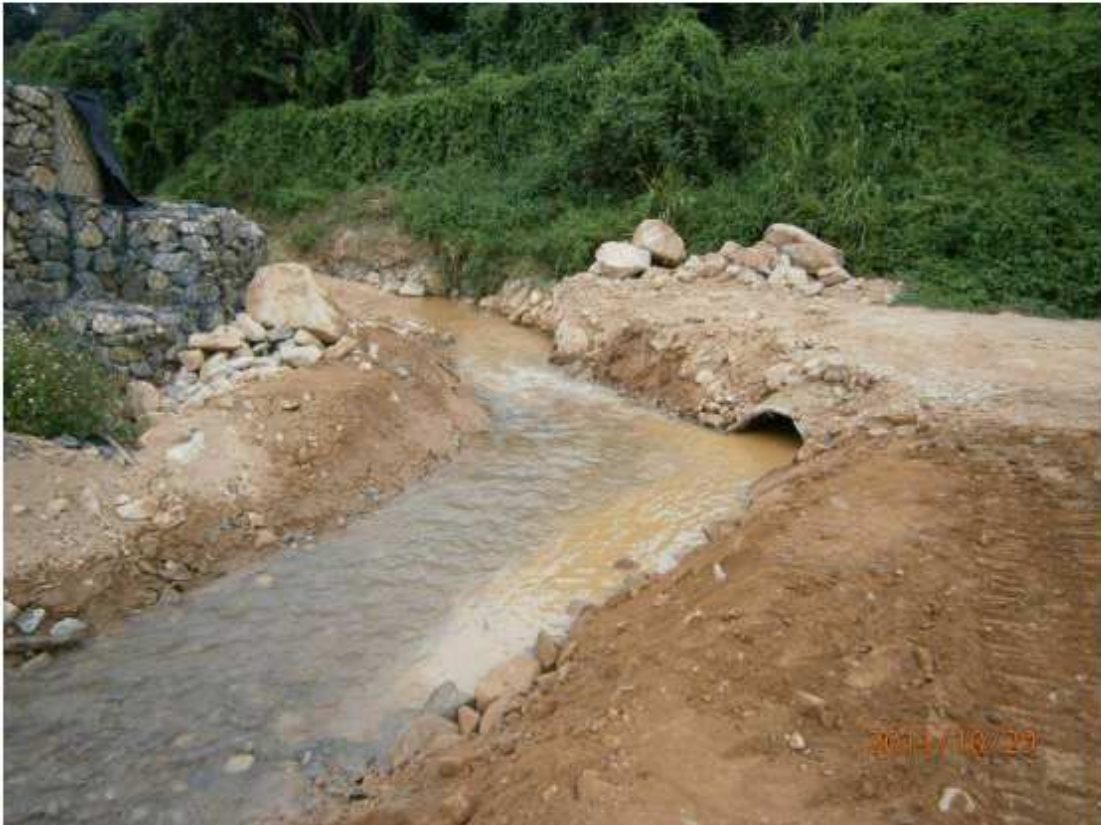
Fig.4.1 – River bank was barely exposed without proper protective measures.

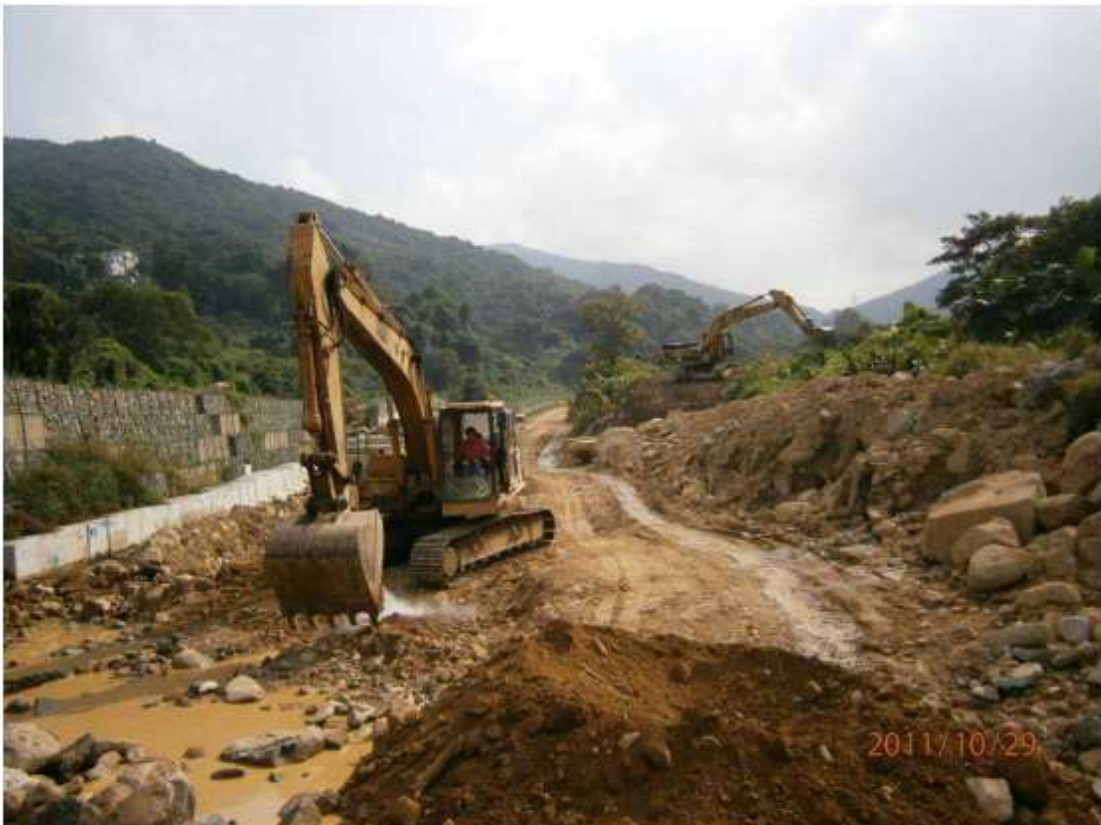
4. ET has conducted a site investigation on 29th October 2011 with representatives from Contractor to resolve the concern. During the investigation, it was observed that diversion of the river channel was being carried out at ch.50 – ch300. Muddy water was generated from construction activities and soil erosion of the exposed riverbanks which caused adverse impact to the downstream area (Fig.4.1 to 4.2). As reported by Contractor, the purpose of the aforesaid works was to avoid the direct contamination of the river from the construction activities. Contractor was seriously requested to implement immediate corrective measures including covering the exposed

Fig.4.2 – Muddy water was generated from river diversion work.

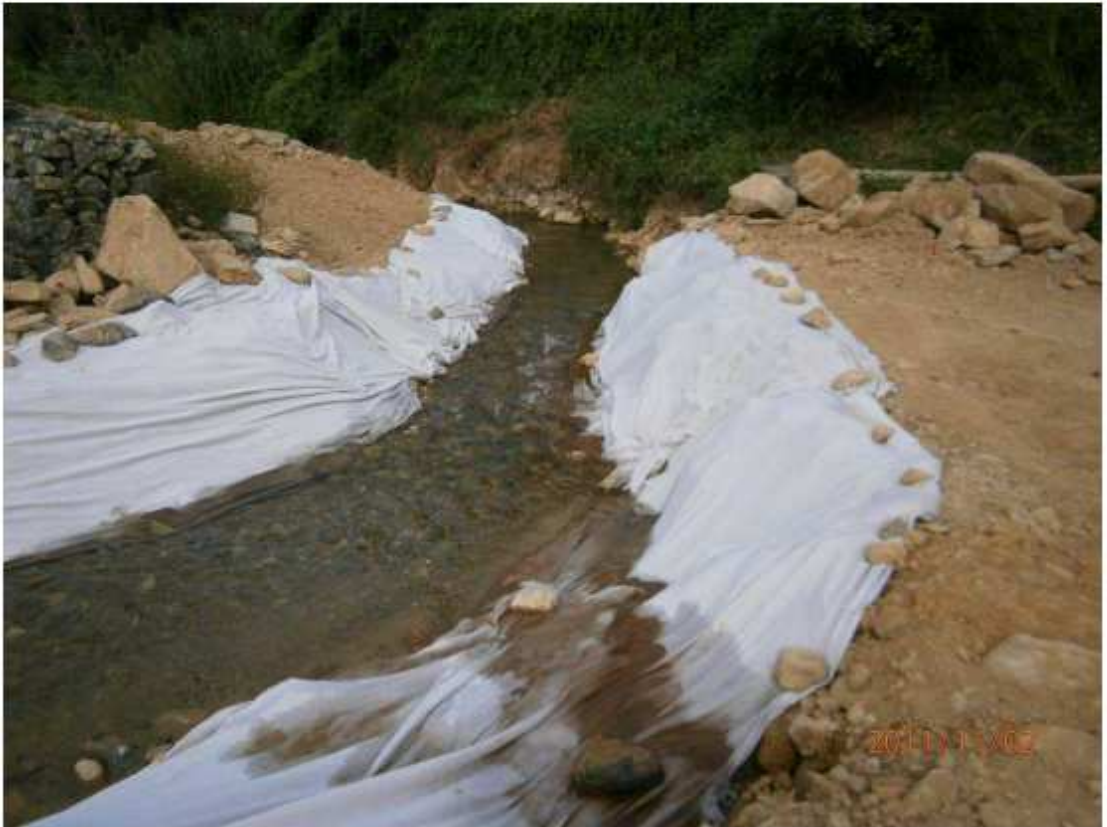
5. As a follow up investigation, second site inspection was carried out on 2nd November 2011 to check if proper follow up mitigation measures were implemented. During the investigation, geo-textile coving was provided at ch.50 to avoid soil erosion. However, muddy water was still observed from ch.500 which caused by surface runoff generated from overflowing of wheel washing bay at ch.600 and seepage of underground water and domestic waste water (Fig.5.1 to 5.3). Contractor was requested to implement immediate corrective actions to stop further deterioration of water quality.

Fig.5.1 – Geo-textile covering was provided to prevent soil erosion.

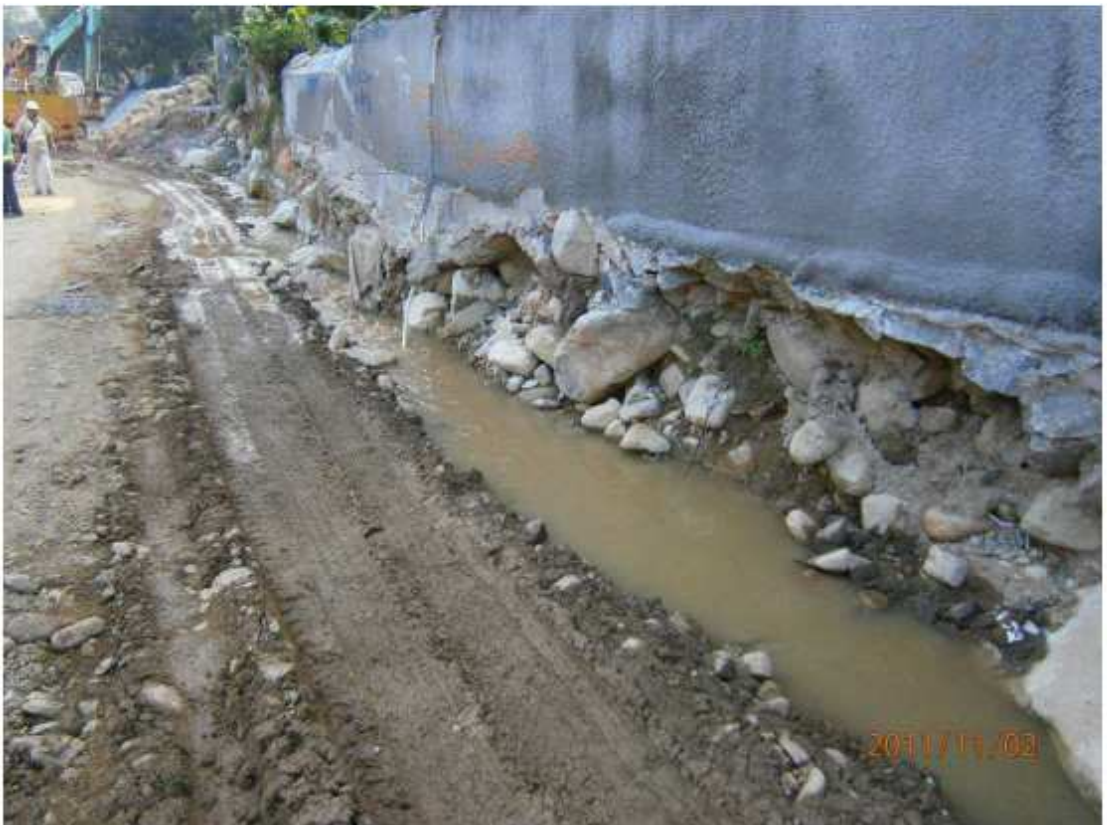
Fig.5.2 – Muddy surface runoff caused by seeping of underground water and domestic waste water.

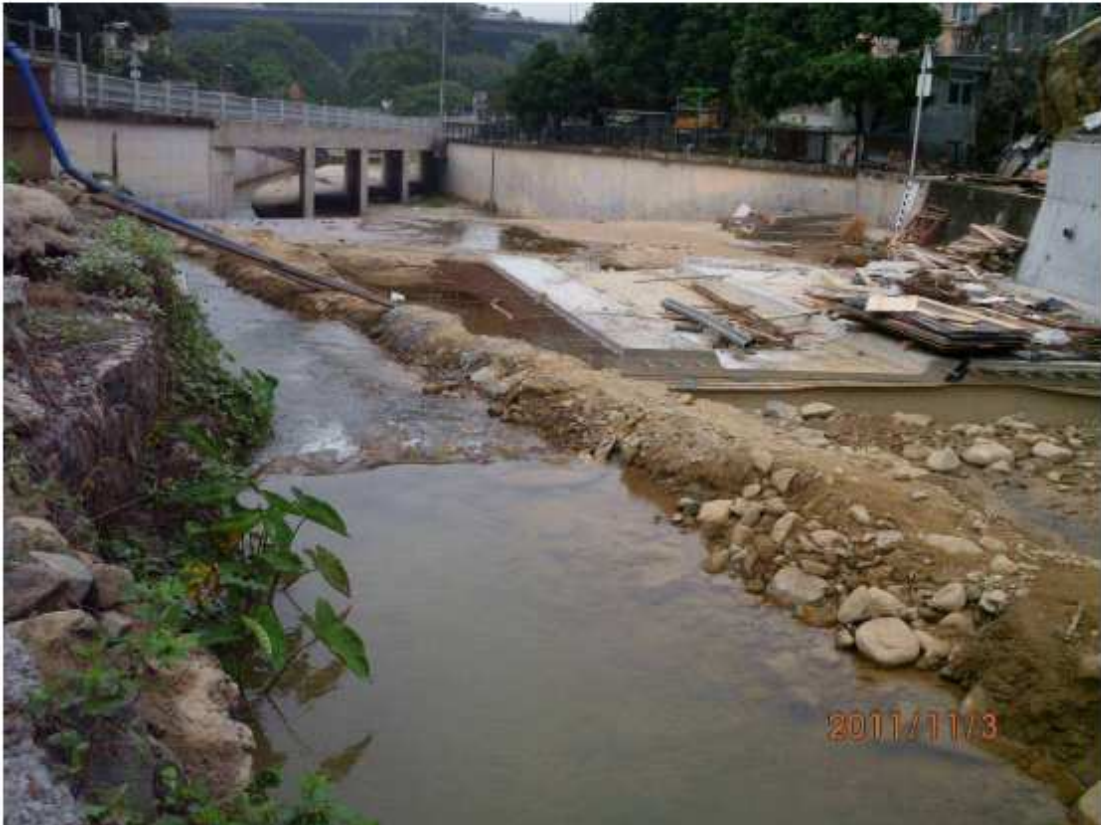
Fig.6.2 – The river quality was acceptable with no muddy water observed (photo provided by Contractor).

<p>washing bay at ch.600</p> <p>After the mitigation measures implemented by Contractor, no further contaminated water discharged into the river and the river quality was acceptable (Fig.6.1 & 6.2).</p> <p>7. Contractor was seriously recommended to review their site conditions and implement necessary water quality mitigation measures to avoid further deterioration of river water quality, which should at least include:</p> <ul style="list-style-type: none"> vi. Proper temporary drainage system should be provided on site for site water diversion as to avoid surface runoff and site water seepage from entering into river channel. vii. Haul access and excavated area should be enclosed with proper bund walls. viii. Riverbanks, soil slopes and earth bunds should be covered with geo-textile materials to avoid erosion by water. ix. Any site water, wastewater, underground water and runoff arisen from construction activities should be diverted to proper site water treatment system before discharge; sedimentation tank using chemicals to enhance its treatment effectiveness should be adopted for silty water whenever it is necessary. x. Site water treatment facilities should be regularly checked and maintained as to ensure those are in good condition and functional. xi. Excessive storage of earth materials should be prevented on site; earthy materials should not be stockpiled next to the river channel as to avoid soil runoff. <p>8. To meet relevant environmental ordinance such as Environmental Impact Assessment Ordinance (EIAO) and Water Pollution Control Ordinance</p>

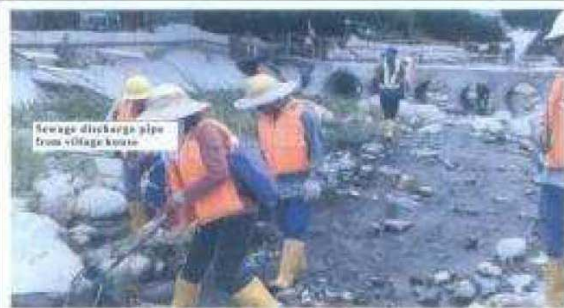
Generally, the water quality was found polluted at lower stream section mainly due to the domestic sewage discharge (Photo 5) from villages. Concentration of Ammonia (0.20 mg/L) in lower stream section was comparatively higher than that measured at upper stream section. Fish with less tolerance to toxic ammonia would be eliminated from stream water. Currently, the level of ammonia concentration is considered low and it was likely due to dilution of the running water in the stream. Salinity was low, and it was indicated that the stream was not affected by tidal effect. The detailed abiotic information was shown in Table 4-7.

Photo 5: Sewage discharge pipe
