**Contract No. : DC/2007/06**  
**River Improvement Works in Upper Lam Tsuen,**  
**She Shan River and Upper Tai Po River**

**MONTHLY EM&A REPORT of**

**UPPER TAI PO RIVER**

**for May 2012**

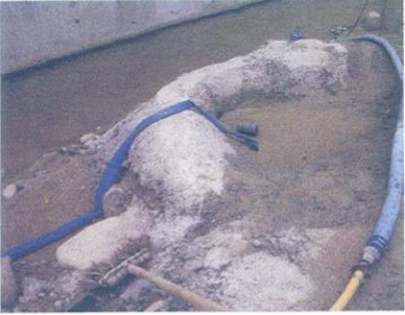
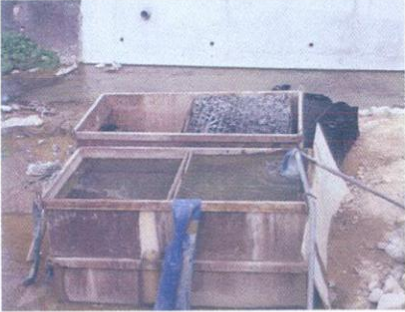
1.3 (b)	Upper Tai Po River, Area N

<p>Muddy water overflowed from the wheel washing bay was observed</p>	<p>A sedimentation tank has been provided to treat the muddy water from ahead washing bay prior to the discharge into the river. The sedimentation tank will be cleaned and de-sludge regularly</p>

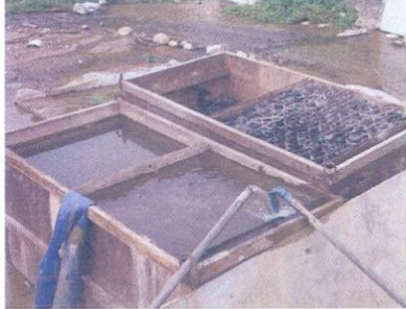
1.3 (c)	Upper Tai Po River, Area N

The capacity of sedimentation tank near Ch.600 was insufficient.	Two proper sedimentation tanks which have sufficient capacity have been provided to treat the muddy water before discharge to the river.
