**Contract No. : DC/2007/06**  
**River Improvement Works in Upper Lam Tsuen,**  
**She Shan River and Upper Tai Po River**

**MONTHLY EM&A REPORT of**

**UPPER TAI PO RIVER**

**for May 2012**

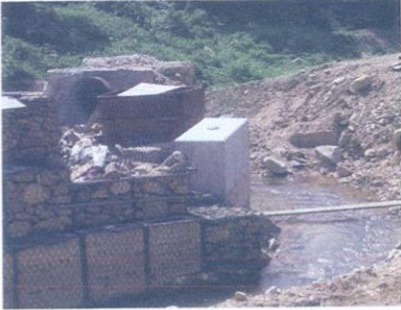
Action Items	Location	Record Photos	Non-compliance Defects	Rectification Method	Rectify Photos	Inspection Date	Inspection by
1.3 (a)	Upper Tai Po River, Area N

<p>Muddy water was observed being directly discharged into river from sump pit near Ch. 250.</p>	<p>A sedimentation tank has been provided to treat the muddy water prior to the discharge into the west branch of the river. The sedimentation tank will be cleaned and de-sludge regularly. During the inspection, no muddy water was generated from the sump pit.</p>

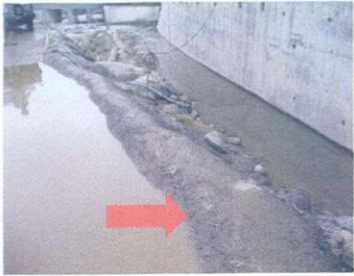
1.3 (b)	Upper Tai Po River, Area N

<p>Muddy water overflowed from the wheel washing bay was observed</p>	<p>A sedimentation tank has been provided to treat the muddy water from ahead washing bay prior to the discharge into the river. The sedimentation tank will be cleaned and de-sludge regularly</p>
