Contract No. : DC/2007/06
**River Improvement Works in Upper Lam Tsuen,
She Shan River and Upper Tai Po River**

ENVIRONMENTAL MONITORING AND AUDIT

MONTHLY EM&A REPORT of

for October 2011

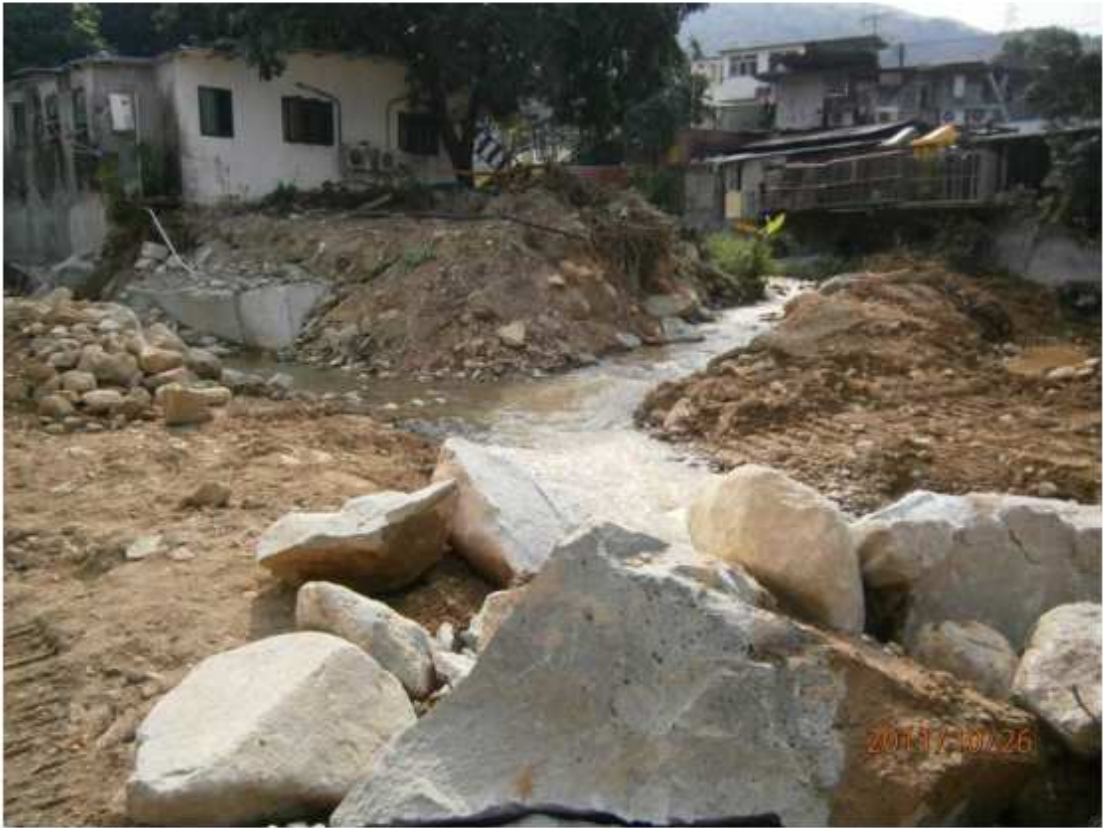
2. A routine site inspection covering site area at UTPR was carried out on 26th October 2011 with representatives from RE, ET, Contractor and Independent Environmental Checker. During the inspection, muddy surface runoff, site water seepage and soil erosion were observed to be causing water quality impact to the downstream area at excavated site at approximate ch.200 & 500 (Fig.2.1 & 2.2). As such, Contractor was requested to implement immediate corrective actions to stop further deterioration of water quality.

Fig.2.1 –The river banks were barely exposed which caused soil erosion.

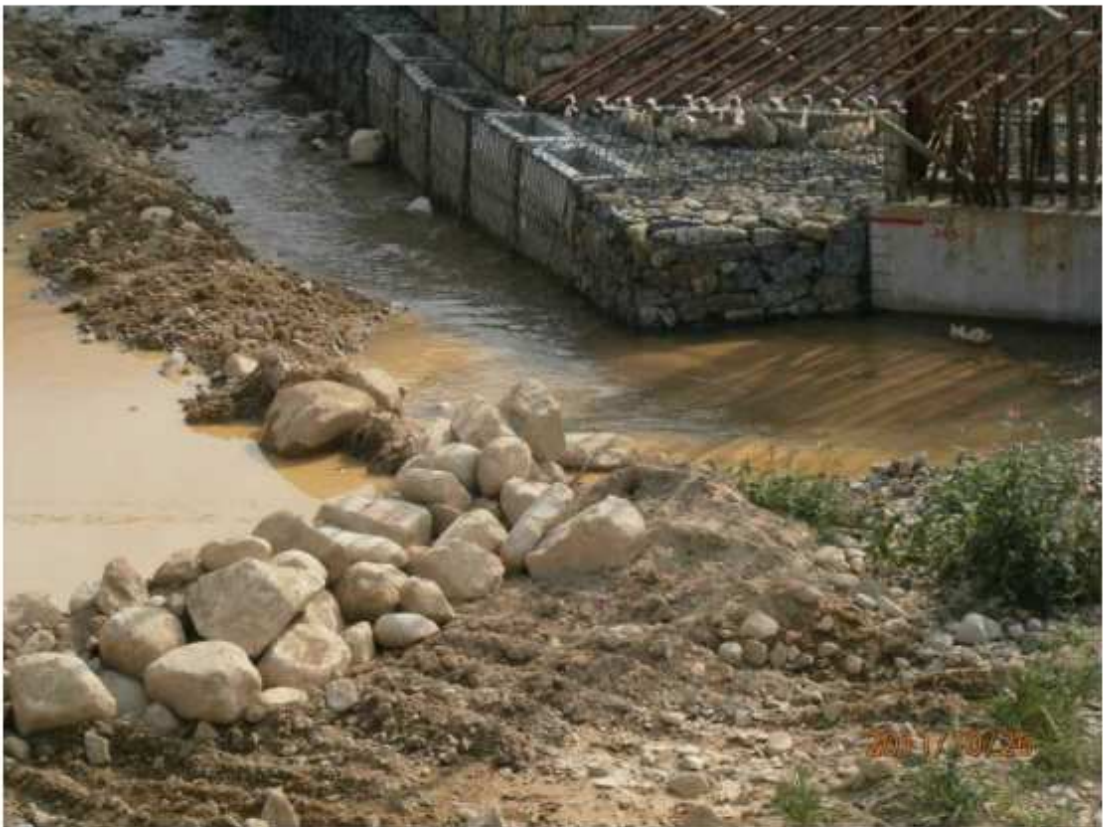
Fig.2.2 –Seepage of untreated site water directly into the river.

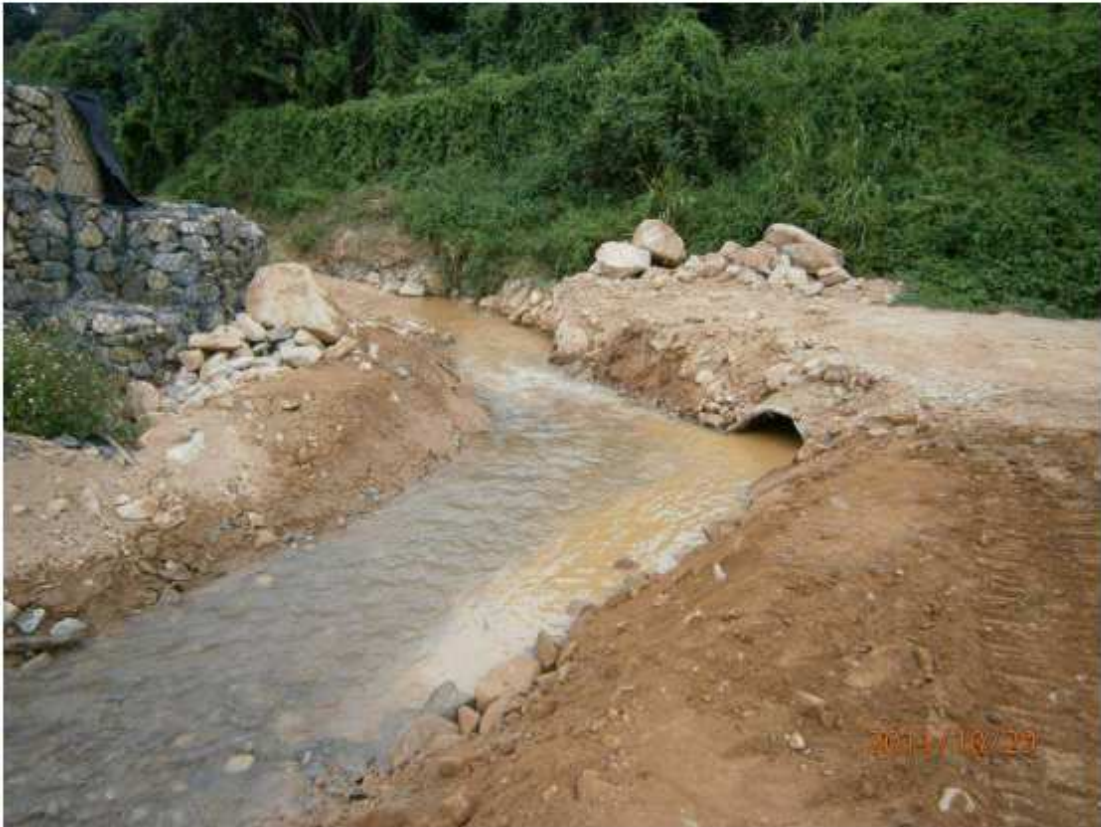
4. ET has conducted a site investigation on 29th October 2011 with representatives from Contractor to resolve the concern. During the investigation, it was observed that diversion of the river channel was being carried out at ch.50 – ch300. Muddy water was generated from construction activities and soil erosion of the exposed riverbanks which caused adverse impact to the downstream area (Fig.4.1 to 4.2). As reported by Contractor, the purpose of the aforesaid works was to avoid the direct contamination of the river from the construction activities. Contractor was seriously requested to implement immediate corrective measures including covering the exposed

Fig.4.1 – River bank was barely exposed without proper protective measures.

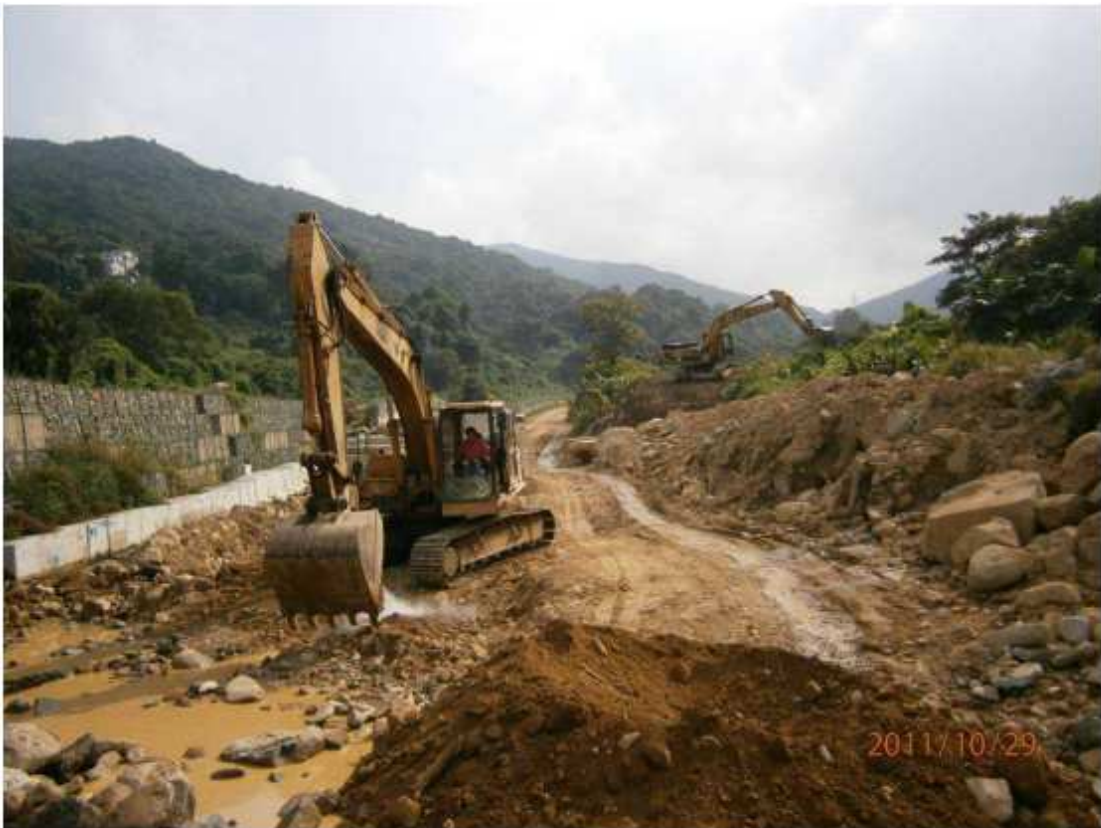
Fig.4.2 – Muddy water was generated from river diversion work.

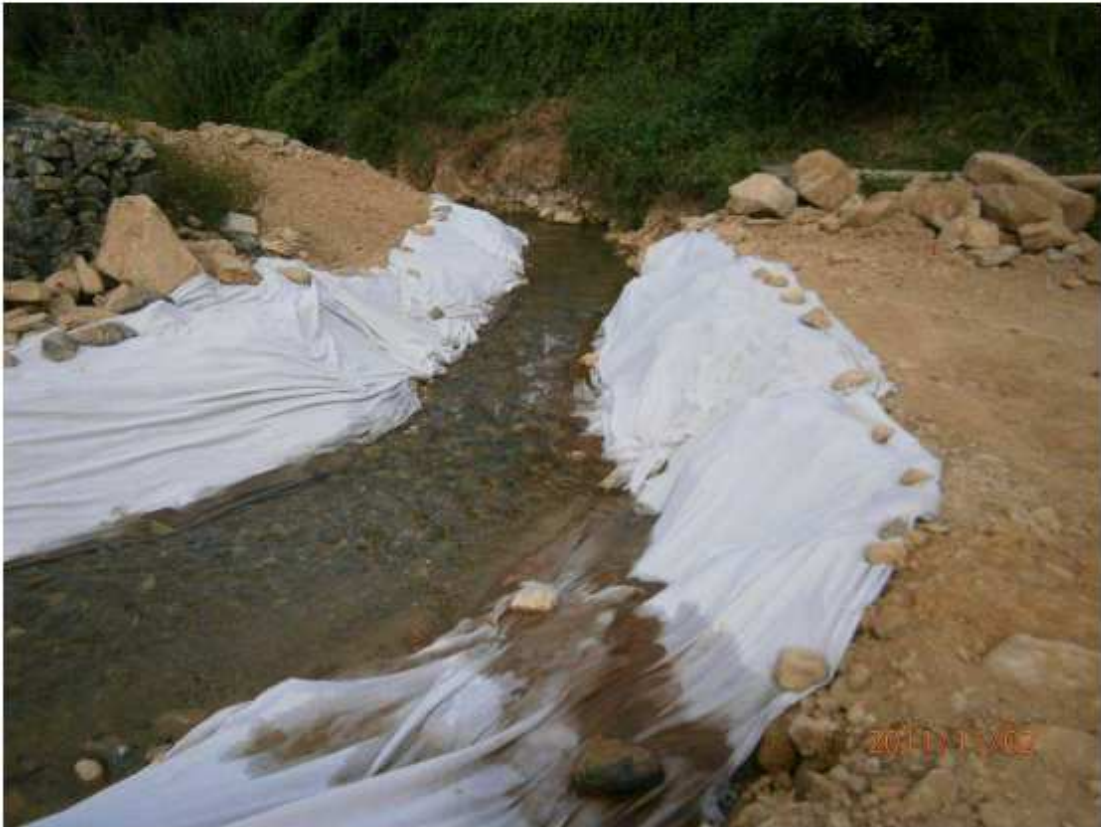
5. As a follow up investigation, second site inspection was carried out on 2nd November 2011 to check if proper follow up mitigation measures were implemented. During the investigation, geo-textile coving was provided at ch.50 to avoid soil erosion. However, muddy water was still observed from ch.500 which caused by surface runoff generated from overflowing of wheel washing bay at ch.600 and seepage of underground water and domestic waste water (Fig.5.1 to 5.3). Contractor was requested to implement immediate corrective actions to stop further deterioration of water quality.

Fig.5.1 – Geo-textile covering was provided to prevent soil erosion.

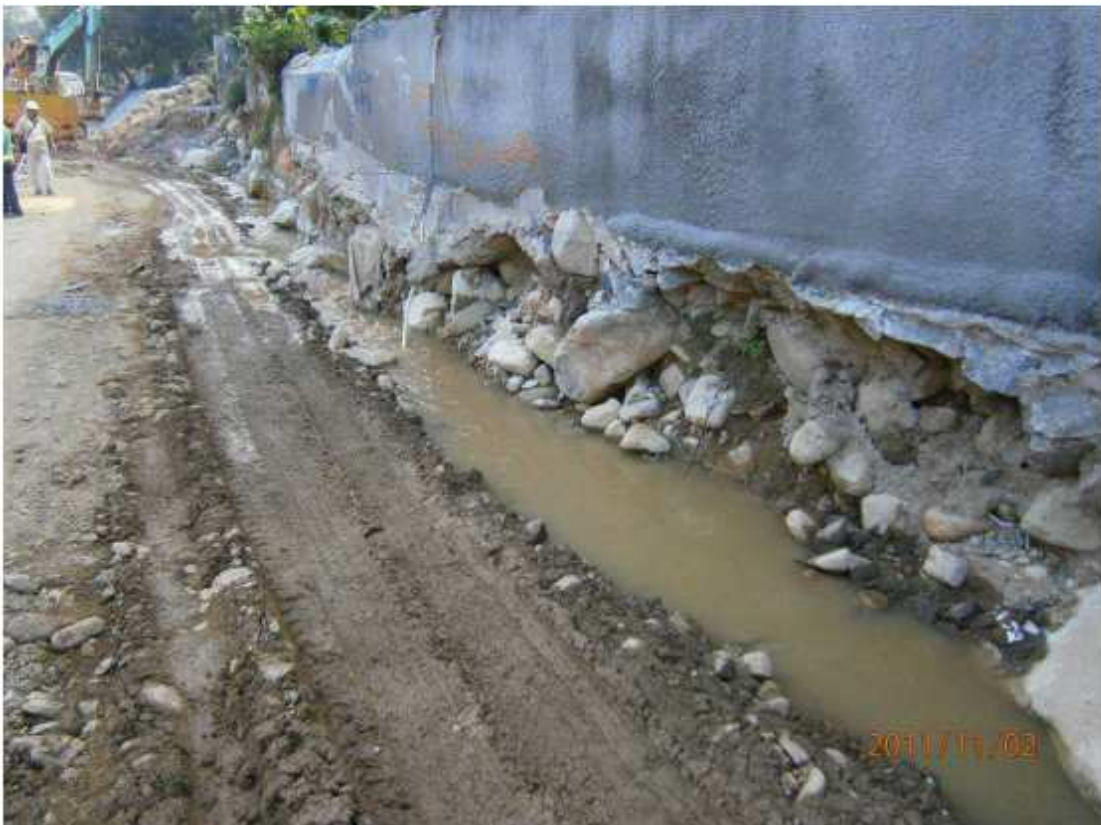
Fig.5.2 – Muddy surface runoff caused by seeping of underground water and domestic waste water.

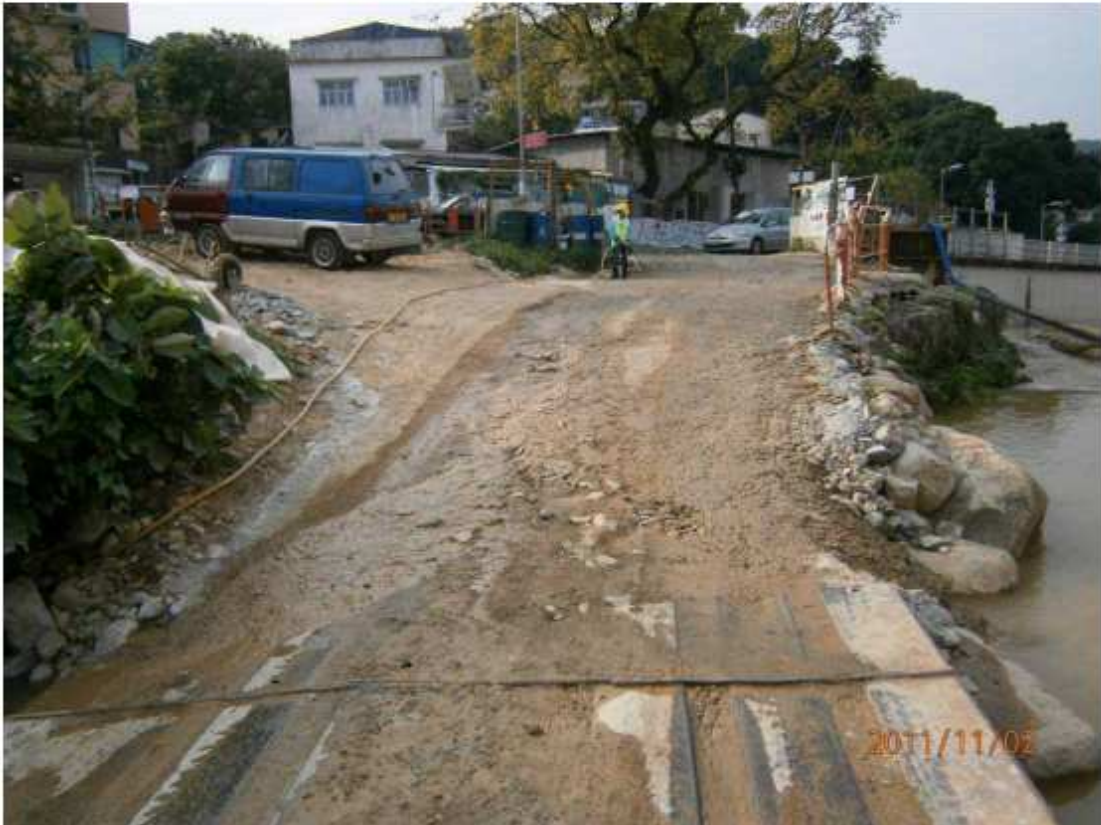
Fig.5.3 – Leakage of contaminated water from the overflowed wheel washing bay.

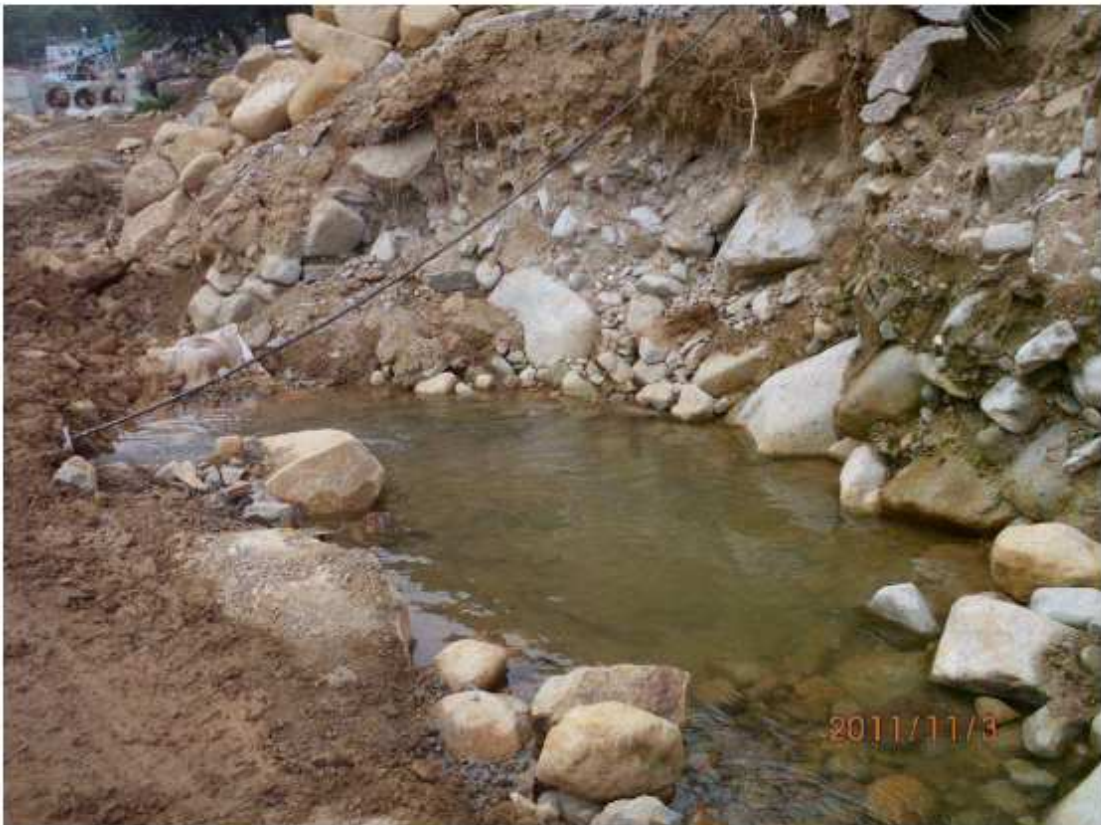
Fig.6.1 – Earth bunds was provided to avoid leakage of muddy runoff entering into the river (photo provided by Contractor).

6. As reported by Contractor on 3rd November 2011, immediate corrective actions were implemented to stop muddy water generation, including:
 - Provision of earth bunds to avoid leakage of muddy runoff entering into the river at ch.500.

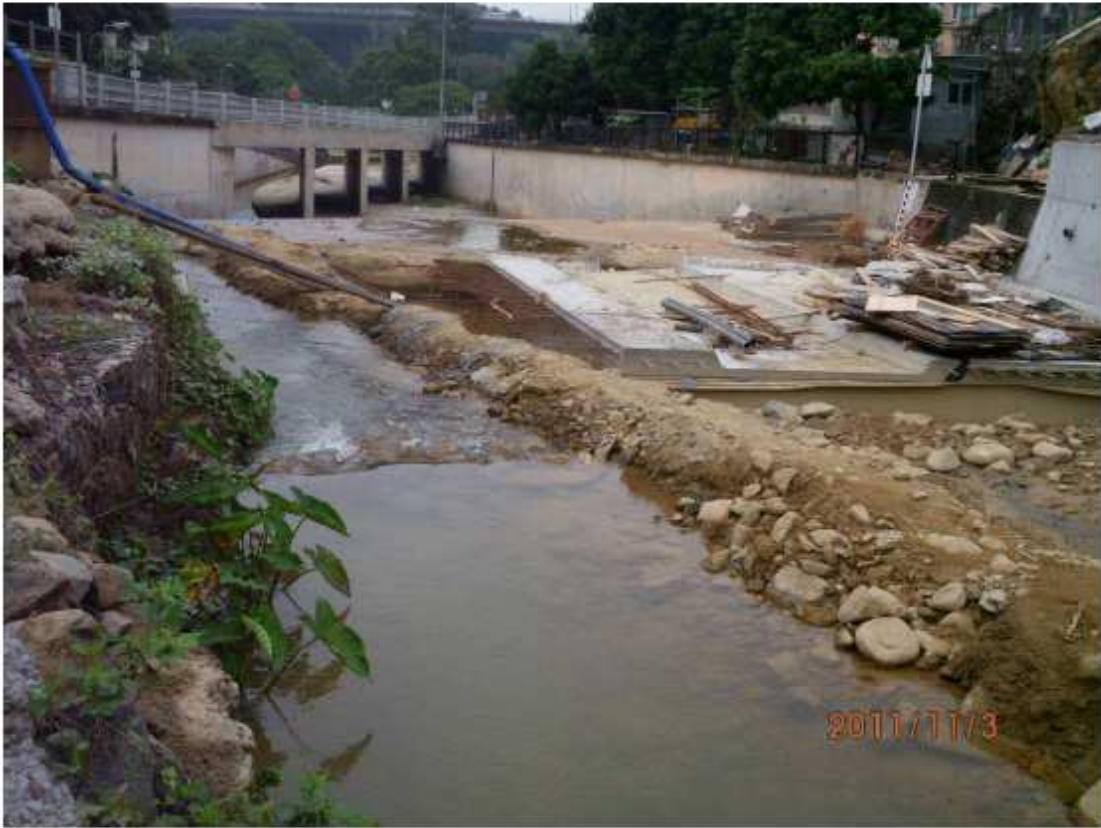
Fig.6.2 – The river quality was acceptable with no muddy water observed (photo provided by Contractor).

<p>washing bay at ch.600</p> <p>After the mitigation measures implemented by Contractor, no further contaminated water discharged into the river and the river quality was acceptable (Fig.6.1 & 6.2).</p> <p>7. Contractor was seriously recommended to review their site conditions and implement necessary water quality mitigation measures to avoid further deterioration of river water quality, which should at least include:</p> <ul style="list-style-type: none"> vi. Proper temporary drainage system should be provided on site for site water diversion as to avoid surface runoff and site water seepage from entering into river channel. vii. Haul access and excavated area should be enclosed with proper bund walls. viii. Riverbanks, soil slopes and earth bunds should be covered with geo-textile materials to avoid erosion by water. ix. Any site water, wastewater, underground water and runoff arisen from construction activities should be diverted to proper site water treatment system before discharge; sedimentation tank using chemicals to enhance its treatment effectiveness should be adopted for silty water whenever it is necessary. x. Site water treatment facilities should be regularly checked and maintained as to ensure those are in good condition and functional. xi. Excessive storage of earth materials should be prevented on site; earthy materials should not be stockpiled next to the river channel as to avoid soil runoff. <p>8. To meet relevant environmental ordinance such as Environmental Impact Assessment Ordinance (EIAO) and Water Pollution Control Ordinance</p>

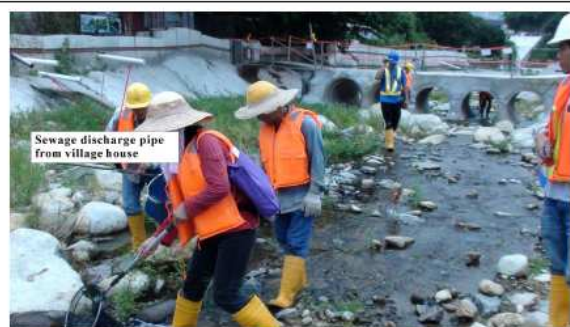
Generally, the water quality was found polluted at lower stream section mainly due to the domestic sewage discharge (Photo 5) from villages. Concentration of Ammonia (0.20 mg/L) in lower stream section was comparatively higher than that measured at upper stream section. Fish with less tolerance to toxic ammonia would be eliminated from stream water. Currently, the level of ammonia concentration is considered low and it was likely due to dilution of the running water in the stream. Salinity was low, and it was indicated that the stream was not affected by tidal effect. The detailed abiotic information was shown in Table 4-7.

Photo 5: Sewage discharge pipe
