Kwun Tong Line Extension (KTE)

Reconnaissance Site Visit Report
for the Kerosene Store at Chung Hau Street

**MTRC Contract No. 1001
Kwun Tong Line Extension:
Yau Ma Tei to Whampoa Tunnels
and Ho Man Tin Station**

**Reconnaissance Site Visit Report
For the Kerosene Store at Chung Hau Street**

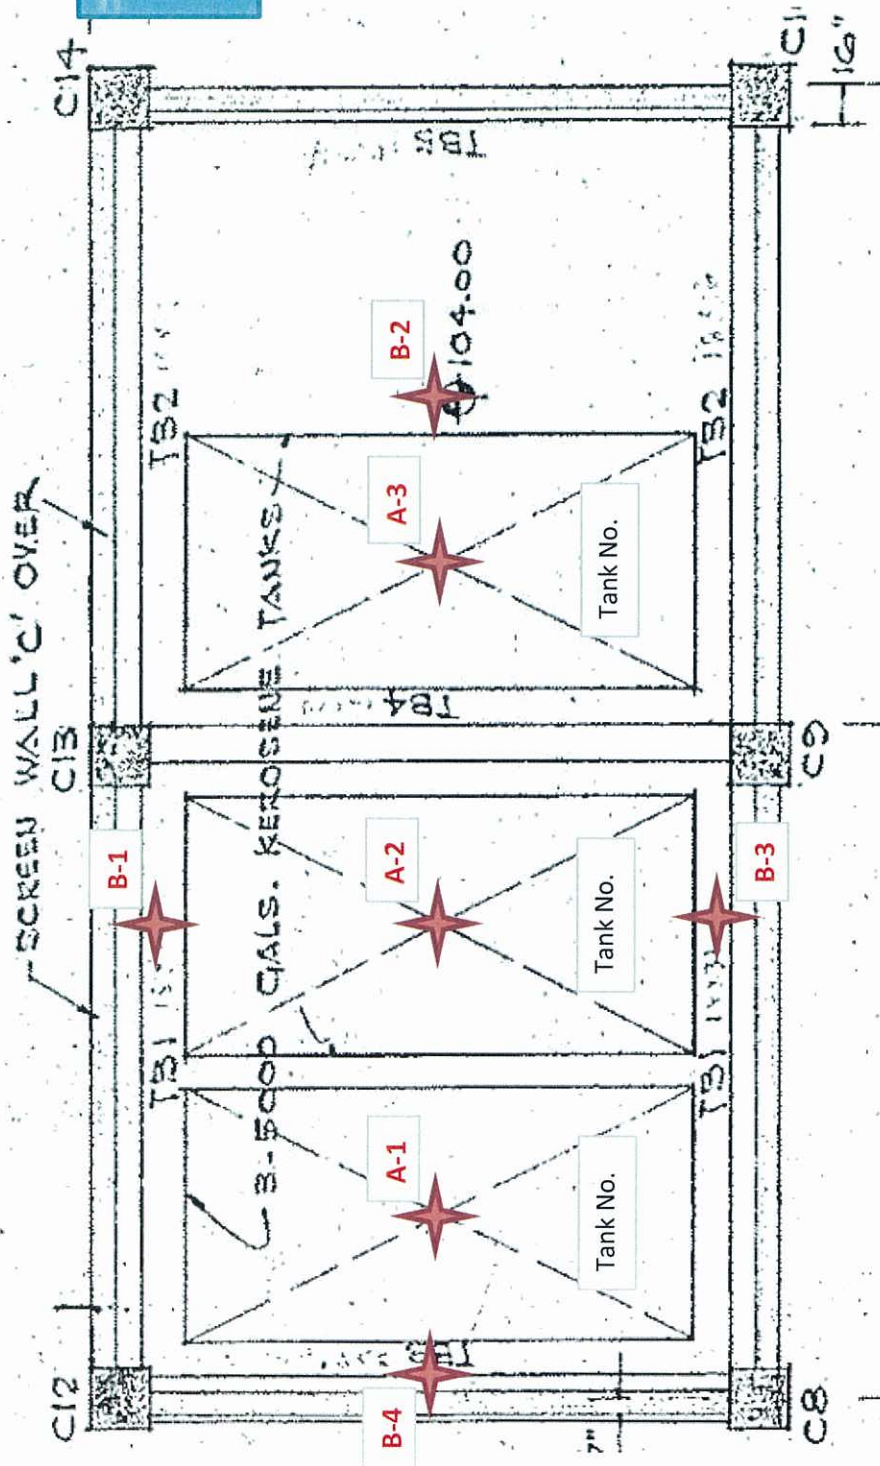
Project Title Reconnaissance Site Visit Report for the Kerosene Store at Chung Hau Street	Scale	N.T.S.	Project No	LC10079
	Figure Title Proposed Confirmatory Sampling Location on the Existing Slope	Date	JUL11	Figure

- 5.1 Total 8 sampling locations (A-1 to A-3, B-1 to B-4 and C-1) are proposed for soil sampling. The sampling level of the proposed sampling locations is on the existing slope (about 29.4 mPD) under the layer of filled rocks and the concrete box containment. A-1 to A-3 are directly below the middle point of each tank. B-1 to B-4 are immediately adjacent to the tanks to determine whether any leakage through the bottom edge of the concrete box containment. The above 7 samples are needed if crack was found in the concrete box containment and soil was found in the existing slope. C-1 is under the concrete floor slab for the three pumps. This sample shall be taken after removal of the pumps and concrete slab if soil is found under the concrete slab. All the samples will be taken on the surface of the existing slope under the concrete box containment. One sample will be taken in each location as shown in **Figure 1**.

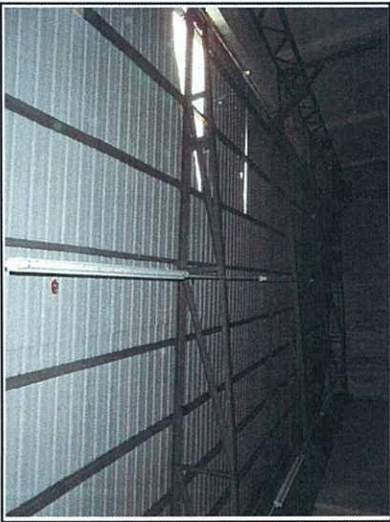
- 3.2 At Roof Floor, the floor slab was concrete paved with no crack and the ceiling was made of iron sheets. The floor area of this floor was about 360 m². This area seems to be used as a store and there was no evidence of significant contamination source or visual evidence of spillage observed through the site visit in Roof Floor. [Photo 1, 2]

Photo 1: The ceiling of the Roof Floor was made of iron sheets.

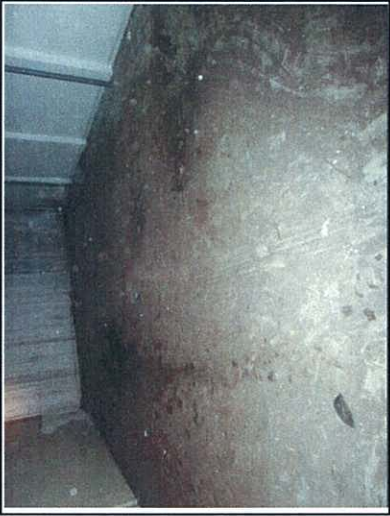
Photo 2: The floor slab of the Roof Floor was concrete paved. No visual evidence of spillage/staining was observed.

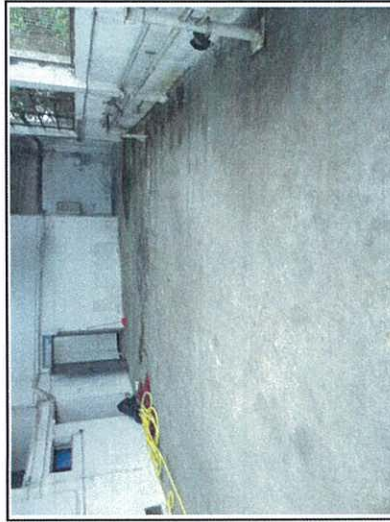
- 3.3 At Ground Floor, the floor slab and the ceiling were concrete paved with no crack. The floor area of this floor was about 360 m². This area seems to be used as a store and with road access to Chung Hau Street. The filling points and filling area of kerosene are also on this floor [Photo 14]. A DG store was found near the entrance with concrete paved and no crack. No LPG container or stain was found within the store. [Photo 13] An oil layer (about 1m x 1m) was found on the ground in the eastern corner of this floor. This area seems to be used for filling of the retail kerosene containers. It was believed that kerosene was dropped on the area during filling process. Apart from the above oil stain area, no other stain or leakage was found at the Ground Floor. The oil layer was a localized spot on the concrete of the floor slab. The concrete floor slab with oil stain will be disposed of by means of chemical waste in accordance with Waste Disposal Ordinance. However, it was not identified as contamination hotspot. [Photo 3, 4]

Photo 4: The floor slab of the Ground Floor was concrete paved with no crack. An oil layer (about 1m x 1m) was found in eastern corner but it was a localized spot. The concrete floor slab with oil stain will be disposed of as chemical waste.

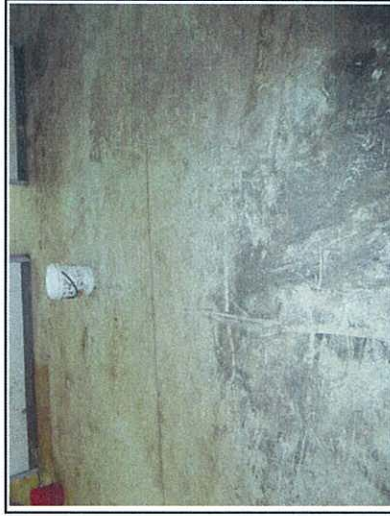
- 3.4 At Lower Ground Floor, the floor slab and the ceiling were concrete paved with no crack. The floor area of this floor was about 320 m². This area seems to be used as office and there was no evidence of significant contamination source or contaminated area found. [Photo 5]

Photo 5: The floor slab of the Lower Ground Floor was concrete paved. No visual evidence of spillage/staining was observed.

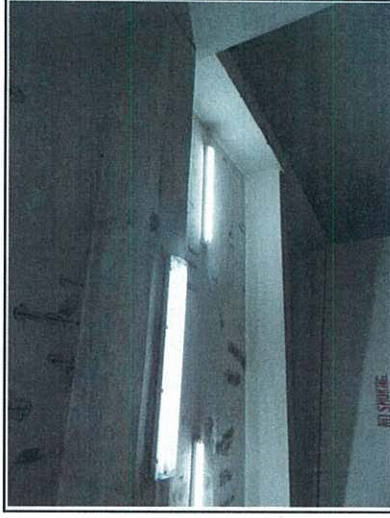
- 3.5 At Sub-Lower Ground Floor, the floor slab and the ceiling were concrete paved with no crack. [Photo 6, 7] The floor area of this floor was about 300 m². This area seems to be used as a store. Three kerosene tanks at the Underground Tank Level were accessible through three metal covers on the floor slab of this Sub-Lower Ground Floor. These tanks are contained within walls of about 9-inch thick concrete forming a “box containment” and in addition, the containment is filled with sand which covers a large portion of three tanks inside. The tops of the three tanks were disclosed and smell of kerosene was noticeable after removal of the three metal covers. No leakage was found in the observable pipes connecting to the top of the tanks. The observable pipes are in good condition and no potential leakage was identified. No abnormal colour was found in the sand under the observable pipes. [Photo 8] The tanks were connected through the filling points at Ground Floor via the pipes which run outside external wall of the building. No evidence of pipe leakage was observed.

Photo 6: The ceiling of the Sub-Lower Ground Floor was concrete paved.

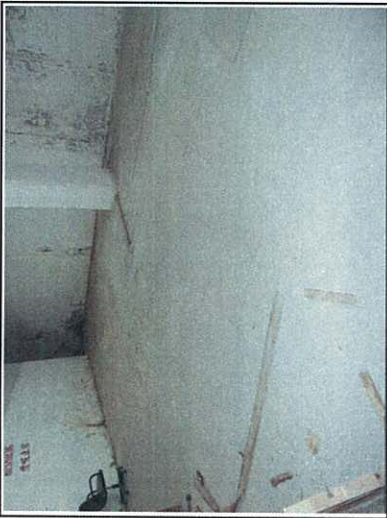
Photo 7: The floor slab of the Sub-Lower Ground Floor. No visual evidence of spillage/staining was observed.

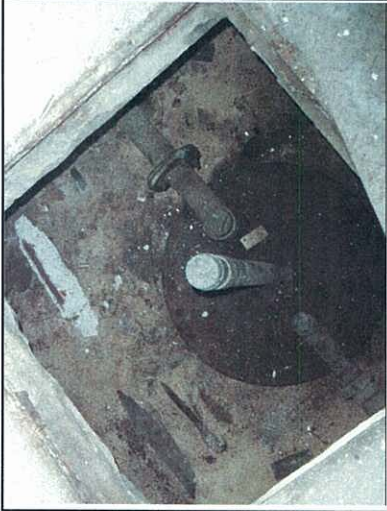
Photo 8: The top of the three kerosene tanks can be found after removal of three metal covers in the floor slab of Sub-Lower Ground Floor. No leakage found in the pipes connecting the tanks. No visual evidence of spillage/staining was observed.

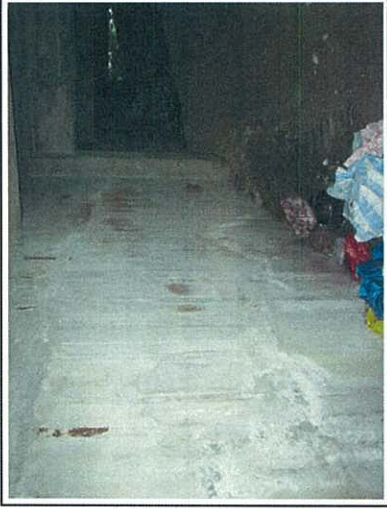
Photo 9: The wall of concrete box containment on Underground Tank Level was exposed to air. The concrete box is used to hold the three tanks inside.

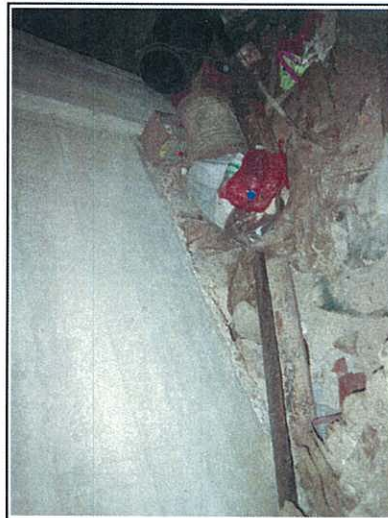
Photo 10: The concrete box containment was placed on a layer of filled rocks.

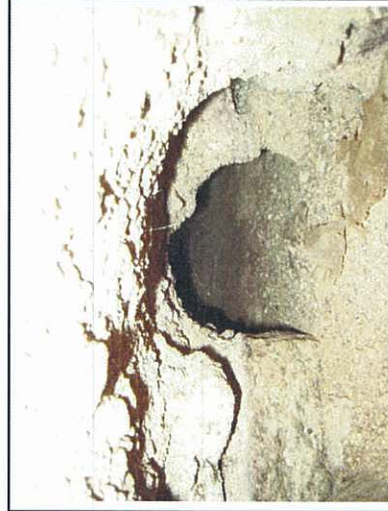
Photo 11: Some of the filled rocks under the concrete box containment was removed during site visit. No soil was found on the inspected area under the concrete box and no visual evidence of spillage was observed.

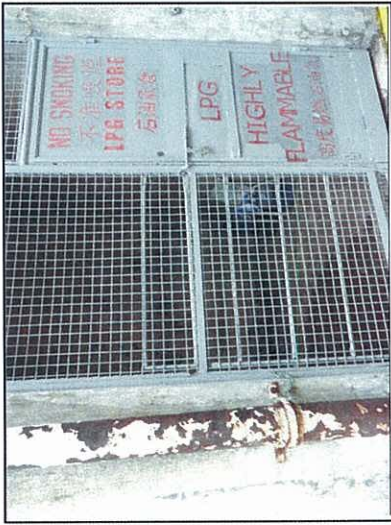
Photo 13: A DG store was found near the entrance of Ground Floor. The store was concrete paved with no crack. No LPG container or stain was found within the store.

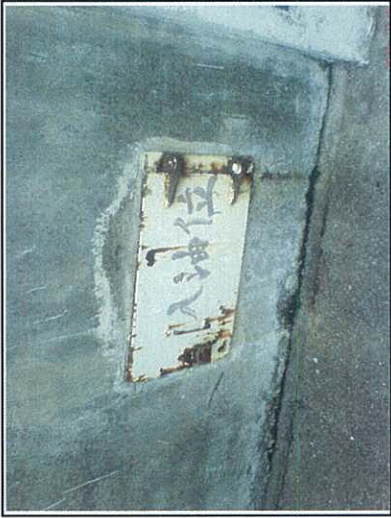
Photo 14: The filling point of kerosene was found near the entrance of Ground Floor.
