Contract No. HY/2010/02

Hong Kong – Zhuhai – Macao Bridge Hong Kong Boundary Crossing Facilities – Reclamation Works

Monthly EM&A Report for October 2013

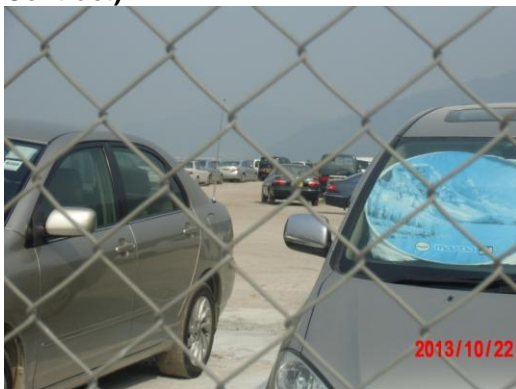
View A (Traffic on dusty surface observed at nearby construction site which do not belongs to this Contract)

- 2.7.5.3 Photo records shows that vehicle would travel on exposed soil surfaces at those construction sites of nearby private development project which are close to the monitoring station AMS3A but beyond the site boundary of Works Area WA2. (Please also see photo and layout map attached for reference of site conditions (View A.)

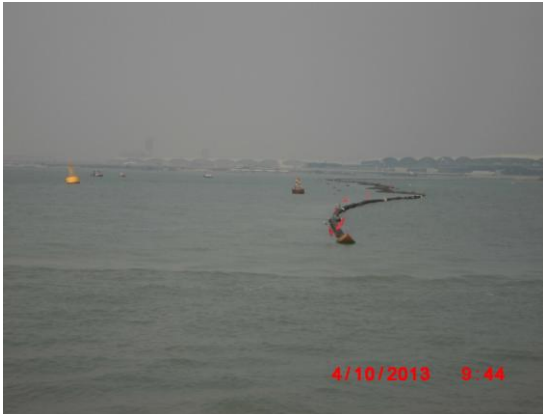
Photo record shows that no defect was observed on the perimeter silt curtain nearby IS(Mf)9.

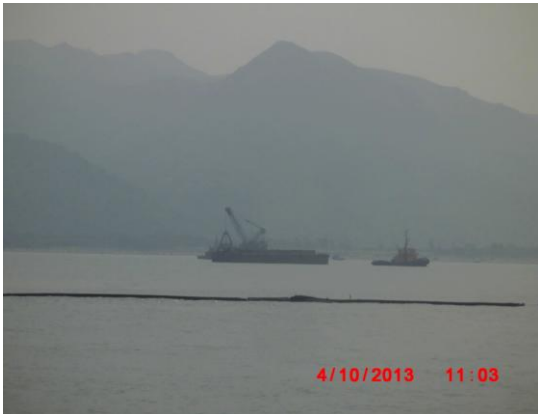
Photo record shows that no defect was observed on the perimeter silt curtain nearby IS(Mf)16.

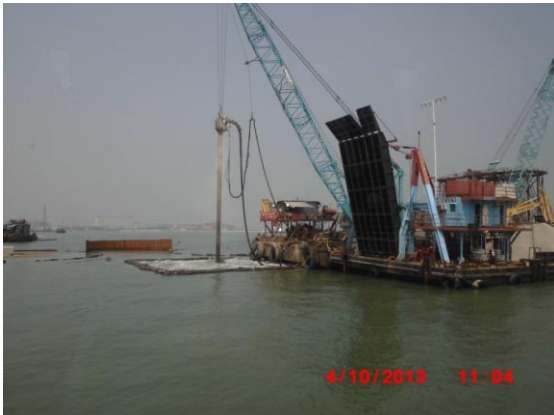
Photo record shows that localised silt curtain was implemented during stone column installation.

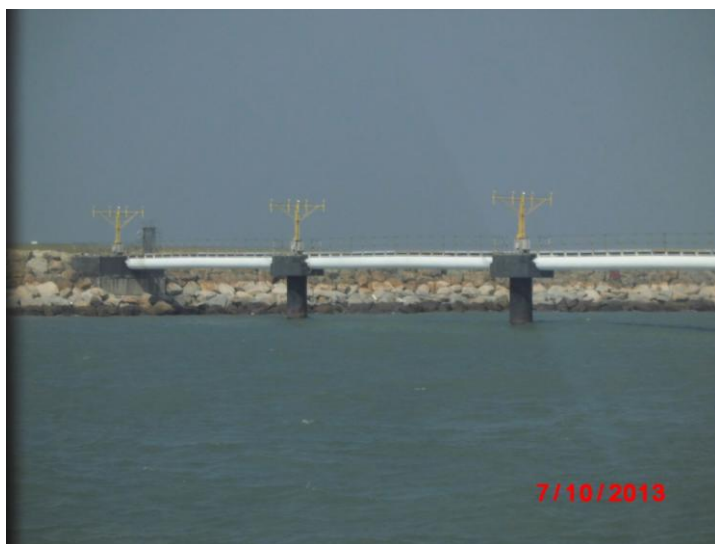
4.7.6.5 Turbidity level (NTU) result recorded at IS10 and SR5 is 11.7 NTU and 12.6 NTU respectively during flood tide on 7 Oct 13 which was below the Action and Limit Level which indicates turbidity level was not adversely affected. (Please see attached photo record of the sea condition taken on 7 Oct 13)

4.7.6.7 Strong wind and rough sea condition were experienced during impact water quality monitoring conducted during mid flood tide at monitoring. (Please see photo record which shows the sea condition recorded on 7 Oct 13.)

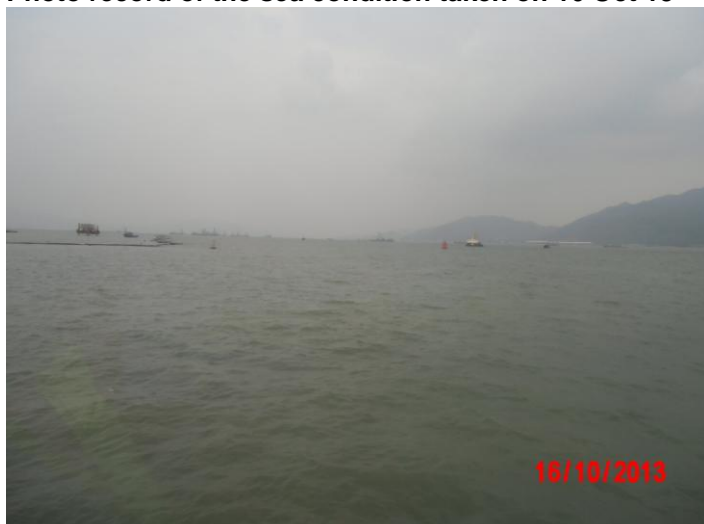
Photo record of the sea condition taken on 16 Oct 13

4.7.7.4 Turbidity level (NTU) result recorded on 16 Oct 13 at IS(Mf)16 is 20.5 NTU during flood tide which were below the Action and Limit Level, this indicates turbidity level was not adversely affected. (Please see below photo record of the sea condition taken on 16 Oct 13.)

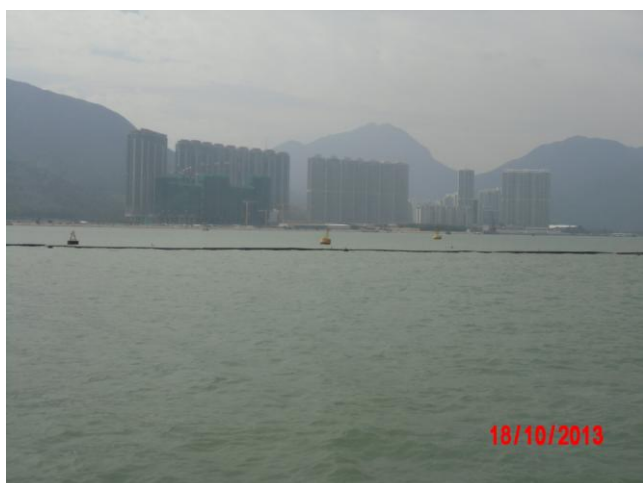
4.7.8.5 Photo record shows that no defect was observed on the perimeter silt curtain nearby IS7 on 18 Oct 13. (Please see below photo record)

4.7.8.8 Nevertheless, the Contractor was reminded to ensure provision of ongoing maintenance to the silt curtains and to carry out maintenance work once defects were found.
