**TUEN MUN - CHEK LAP KOK LINK
CONTRACT NO. HY/2013/12 –
NORTHERN CONNECTION TOLL PLAZA AND
ASSOCIATED WORKS**

BASELINE MONITORING REPORT (REV.03)

PREPARED FOR
CRBC AND KADEN JOINT VENTURE

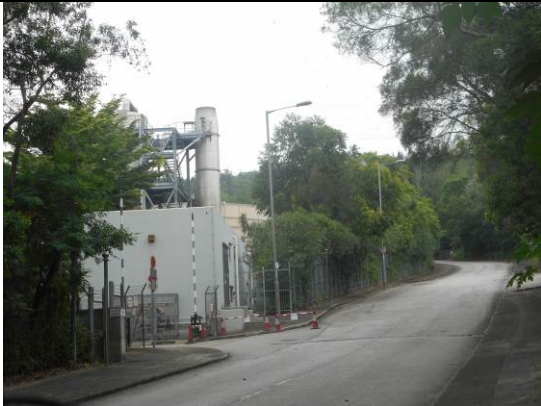
Temporary River Trade Golf (LR03)

4.2.1.1 Baseline walkover for the exiting landscape condition was conducted on 22 September 2014. During the baseline monitoring, apart from the temporary river trade golf at LR03 was demolished and abandoned, LR01 to LR07 were identified as same as the EIA study.

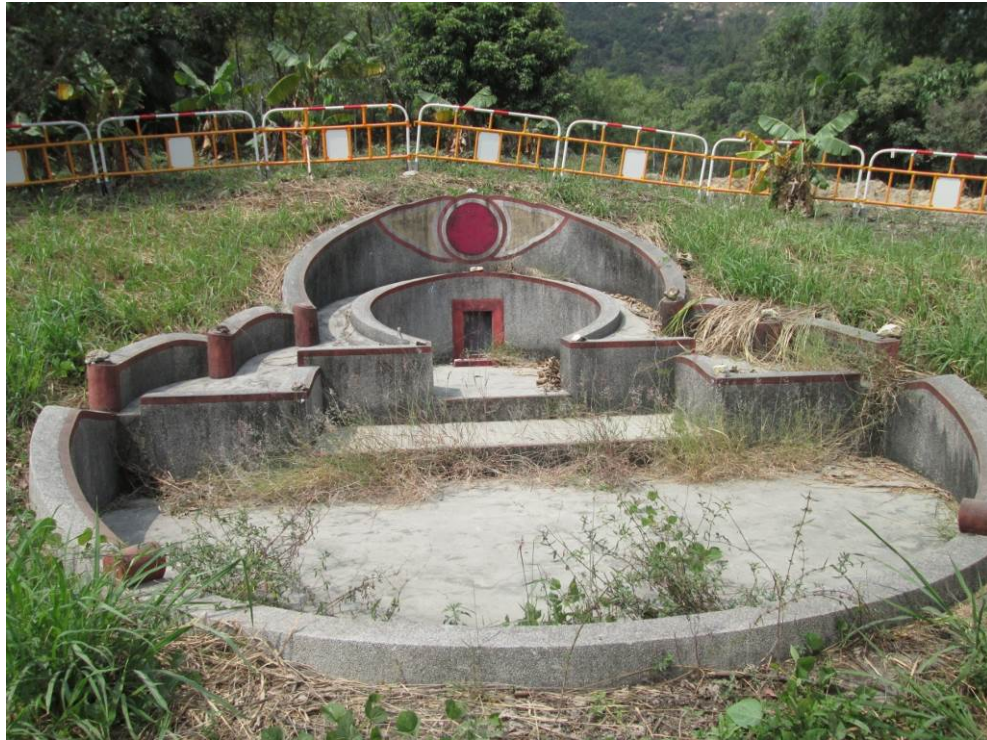
Figure 5.2 General View of the Grave G1

5.3.1.2 The historical grave was identified during the EIA stage of the project and the location of the grave (G1) was shown in **Figure 5.1**. It was observed that plenty of bushes was grown around the grave. The general view of the grave was shown in **Figure 5.2**.

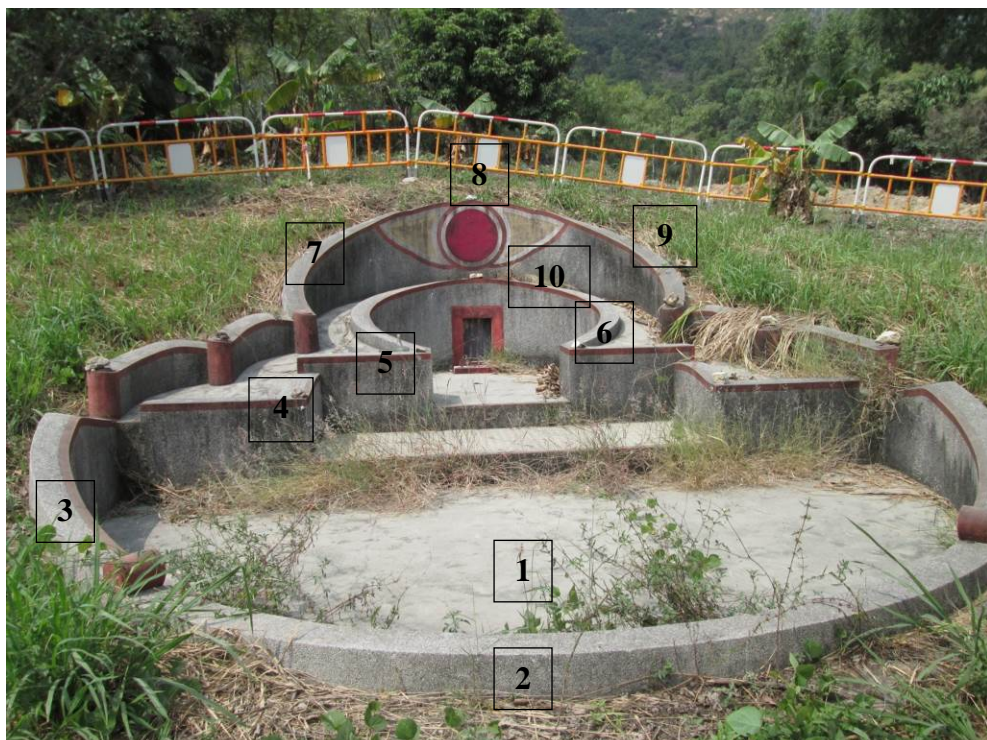
Figure 5.3 Existing Cracks of the Grave G1

5.4.1.1 The Grave G1 is generally in good condition. However, a total of 10 cracks ranged from hairline to 2.8mm were identified in the cement rendering and mortar of bricks of the grave. The location of the cracks are shown in *Figure 5.3*. Detailed information such as crack width and photographic record of the grave are summarized in *Table 5.1*.

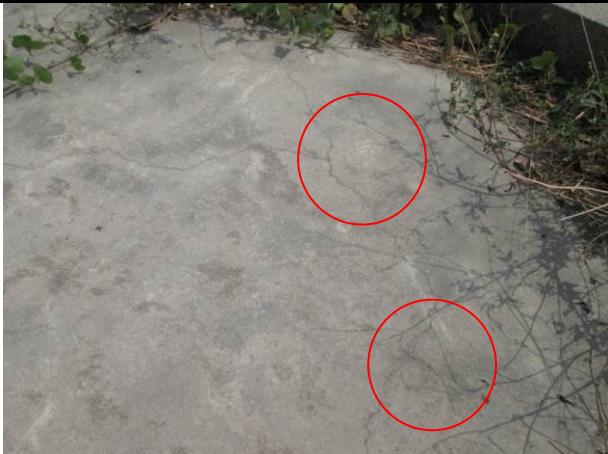
Crack No.	Crack Width (mm)	Photographic Record
1	Hairline

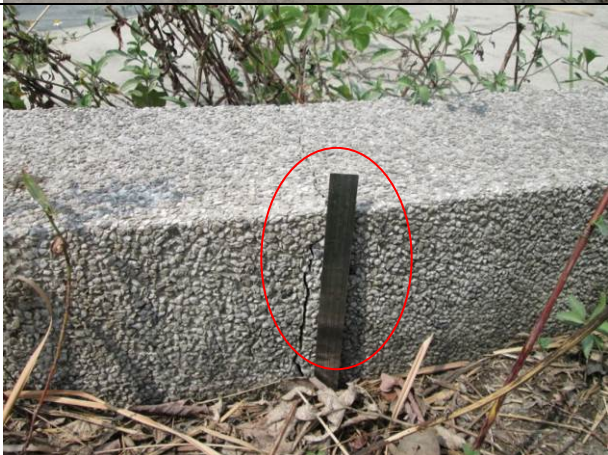
2	1.2

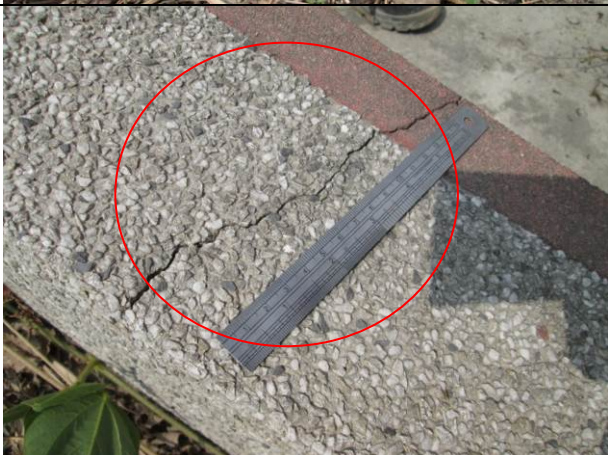
3	1.5

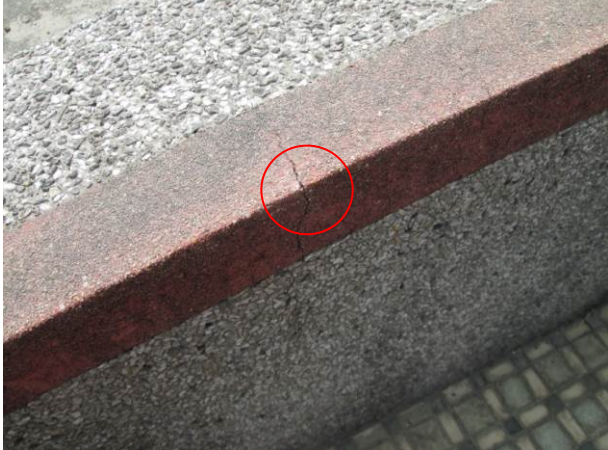
Crack No.	Crack Width (mm)	Photographic Record
4	1.0

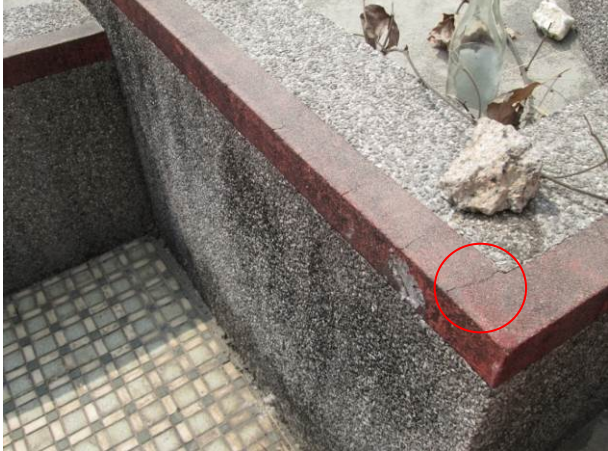
5	Hairline

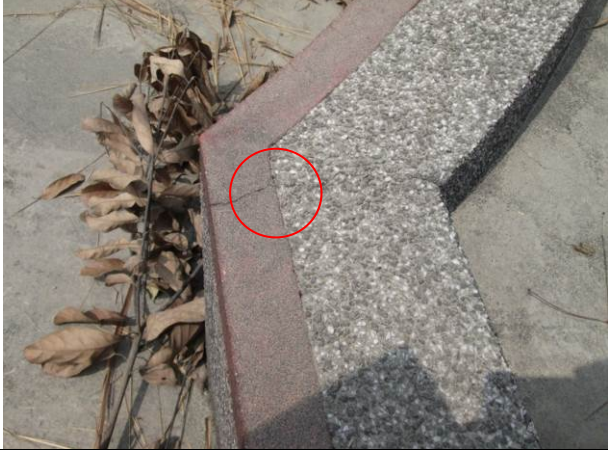
6	1.0

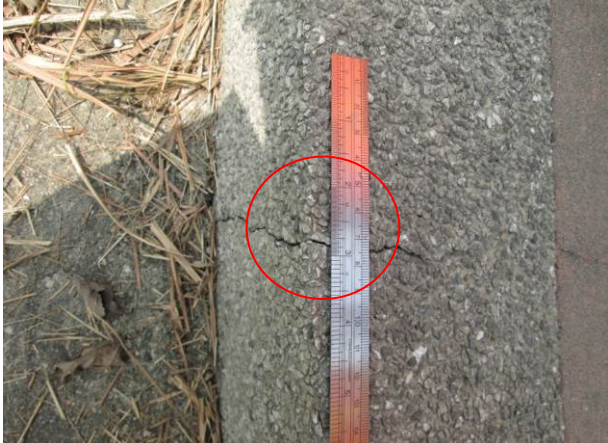
7	1.6

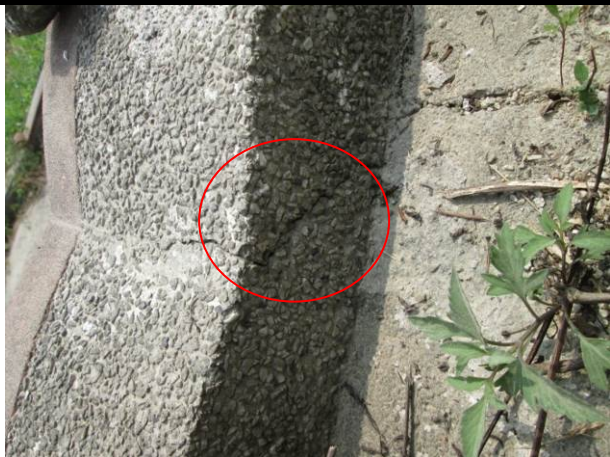
Crack No.	Crack Width (mm)	Photographic Record
8	1.3-4.0

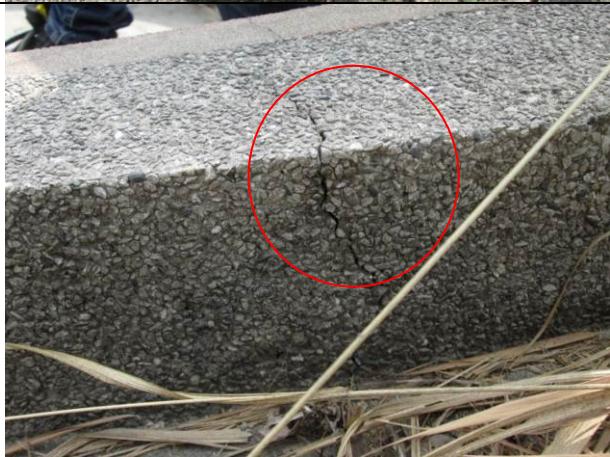
9	2.5-2.8
