**Appendix H
Investigation Report**

Report No. 001
Monitoring Date 28 January 2022

Report No. 002
Monitoring Date 28 January 2022

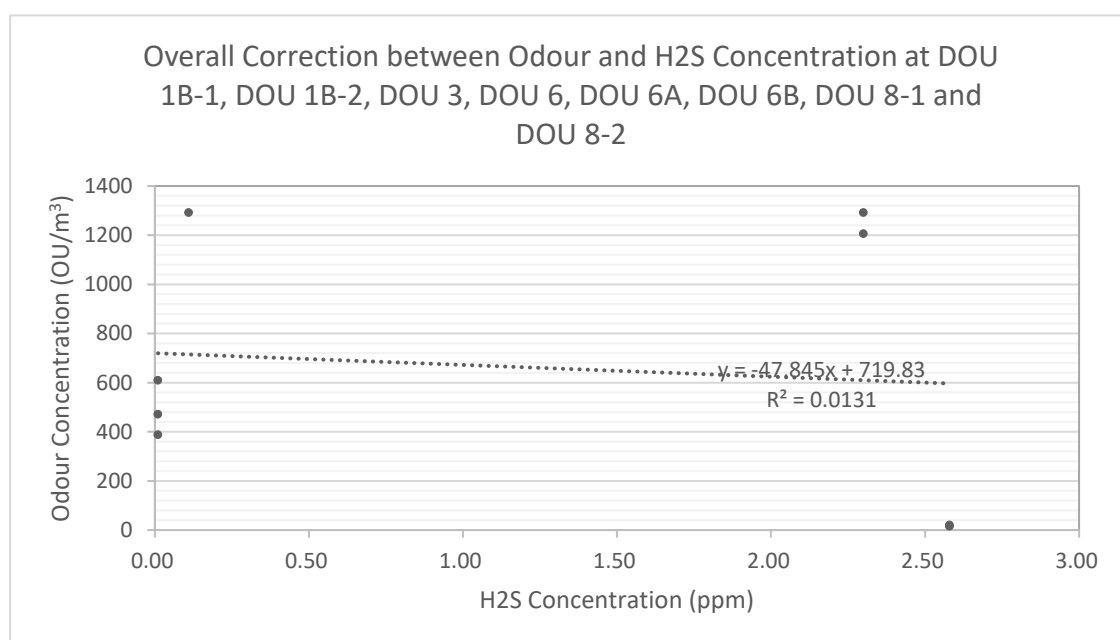
- The difference in foul air source of each DOU may lead to large variation in odour concentration and flow rate. Also, it can affect the gas or odour emission composition of each DOU. To understand the gas composition from the existing data for providing more information on investigating the exceedance, the overall correlation between H₂S concentrations and odour units of available DOUs was listed and plotted below:

- With limited past operation data, no correlation can be established and thus no further information can be obtained for concluding the reasons of exceedance. To provide more information for future investigation, the correlations between H2S concentrations and odour units of individual deodourization units are suggested to be established to understand if there are any difference in gas emission composition if available.
- To further confirm the performance of deodorization device, it is recommended to counter check the H2S reading of the in-house sensors and portable equipment in order to provide more information on determination of odour exceedance reason in the next monitoring.

- The reason of exceedance is unable to be identified based on the discrepancy of the odour measurement result and the odour concentration measured by the in-house H₂S sensor. The correlations between H₂S concentrations and odour units of individual deodorization units are suggested to be established if available.
- To further confirm the performance of deodorization device, it is recommended to

counter check the H₂S reading of the in-house sensors and portable equipment in order to provide more information on determination of odour exceedance reason in the next monitoring.
