Hong Kong- Zhuhai- Macao Bridge

Hong Kong Link Road Section between Scenic Hill and Hong Kong Boundary Crossing Facilities

Notifications of Environmental Quality Limits Exceedances

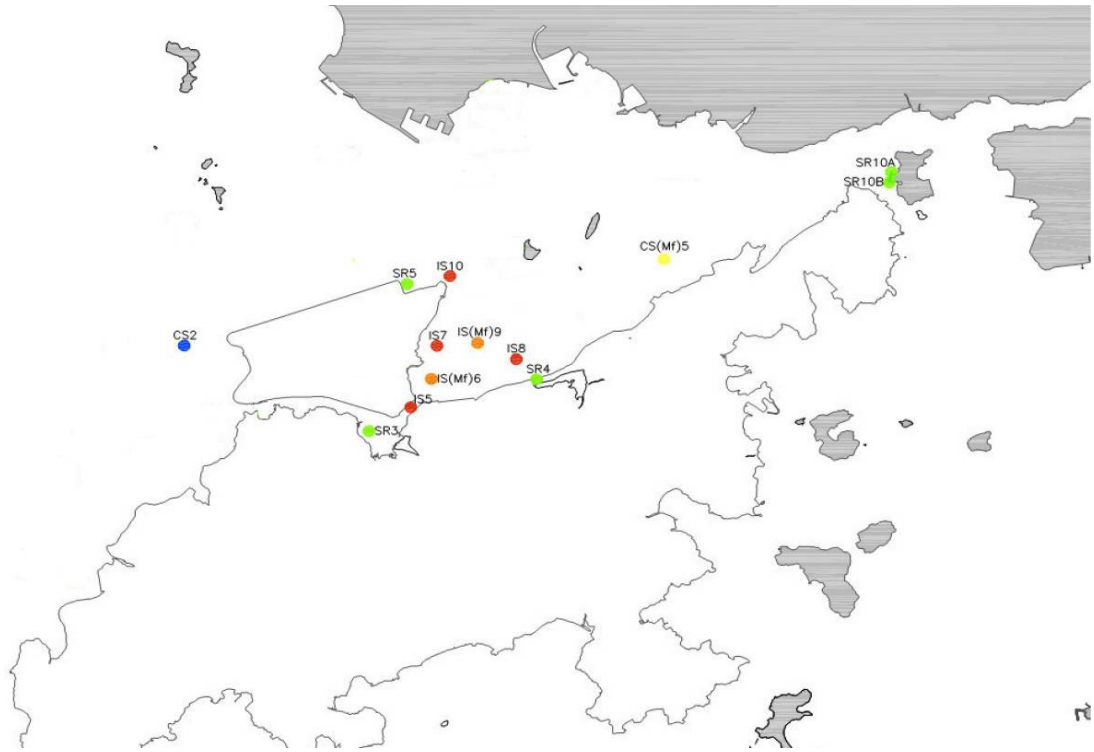
Location Plan:

On 5 December 2014, a LL exceedance of suspended solid at station IS(Mf)9 was recorded during the mid-ebb tide. The exceedance have been investigated and are considered unlikely to be related to contract works due to the following reasons:

The measured value at station IS(Mf)9 was above the range of suspended solid during baseline monitoring for the mid-ebb tide. However, there were no specific activities recorded during the monitoring period that would cause any significant impacts on the monitoring results.

As the suspended solid levels recorded beyond the water quality criteria were not related to contract works, no immediate actions are considered necessary.

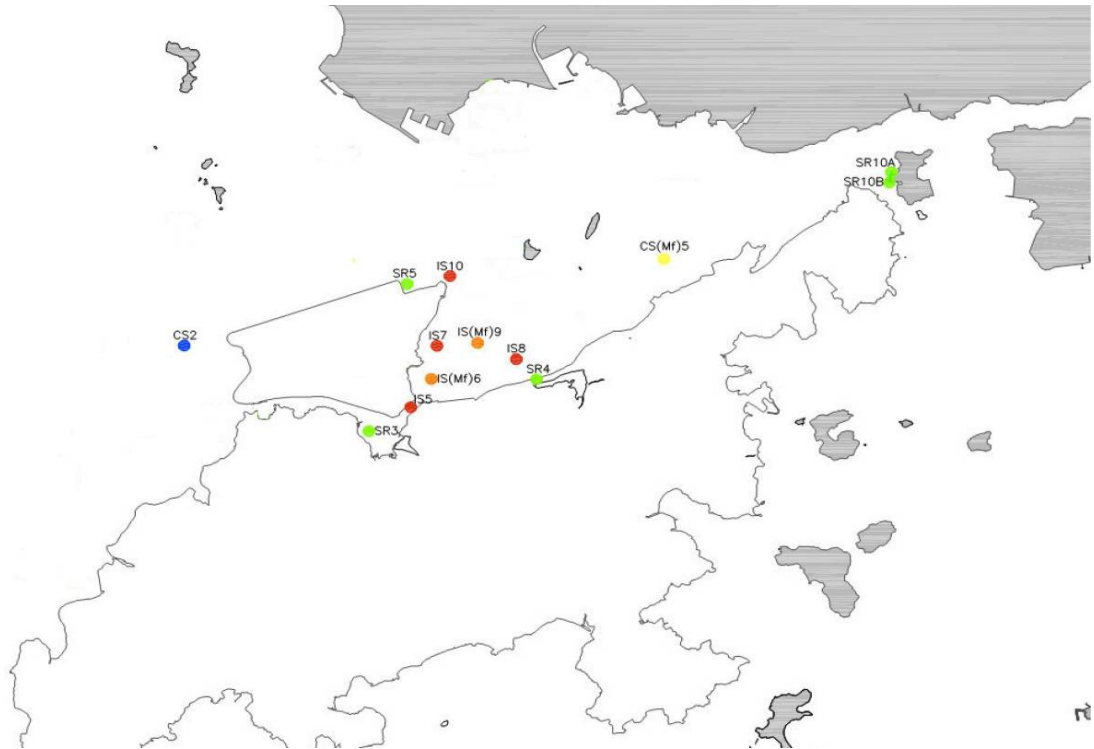
Location Plan:

On 12 January 2015, an AL exceedance of suspended solid at station IS(Mf)9 was recorded during the mid-flood tide. The exceedance have been investigated and are considered unlikely to be related to contract works due to the following reasons:

The measured value at station IS(Mf)9 was below the range of suspended solid during baseline monitoring for the mid-flood tide. There was no specific activities recorded during the monitoring period that would cause any significant impacts on the monitoring results.

As the suspended solid levels recorded beyond the water quality criteria were not related to contract works, no immediate actions are considered necessary.

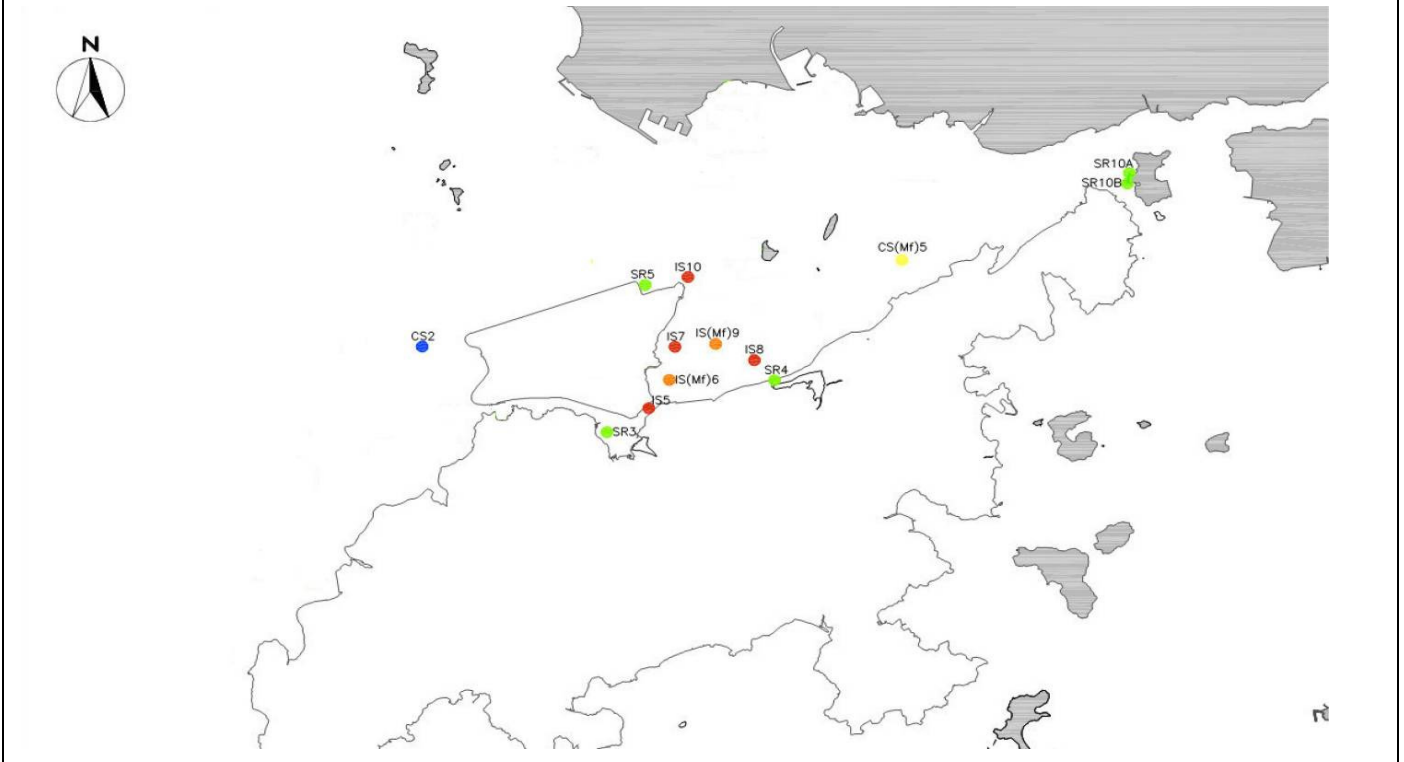
Location Plan:

On 21 January 2015, AL exceedances of suspended solid at stations SR5 and IS10 were recorded during the mid-flood tide. The exceedances have been investigated and are considered unlikely to be related to contract works due to the following reasons:

The measured value at station SR5 was below the range of suspended solid during baseline monitoring for the mid-flood tide. The measured value at station IS10 was above the range of suspended solid during baseline monitoring for the mid-flood tide. However, there were no specific activities recorded during the monitoring period that would cause any significant impacts on the monitoring results.

As the suspended solid levels recorded beyond the water quality criteria were not related to contract works, no immediate actions are considered necessary.

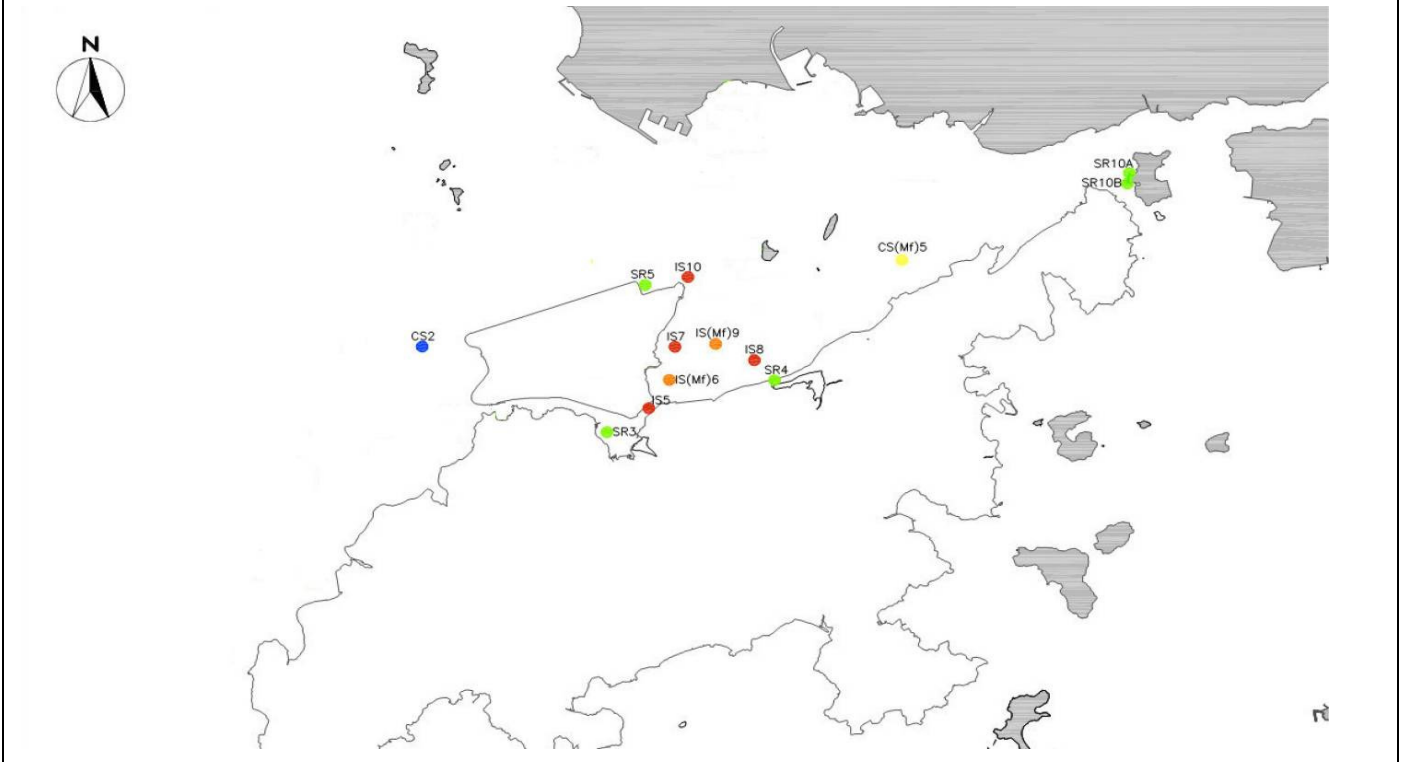
Location Plan:

On 23 January 2015, an AL exceedance of suspended solid at station SR5 and a LL exceedance of suspended solid at station SR10A were recorded during the mid-flood tide. The exceedances have been investigated and are considered unlikely to be related to contract works due to the following reasons:

The measured value at station SR5 was below the range of suspended solid during baseline monitoring for the mid-flood tide. The measured value at station SR10A was above the range of suspended solid during baseline monitoring for the mid-flood tide. However, there was no specific activities recorded during the monitoring period that would cause any significant impacts on the monitoring results.

As the suspended solid levels recorded beyond the water quality criteria were not related to contract works, no immediate actions are considered necessary.

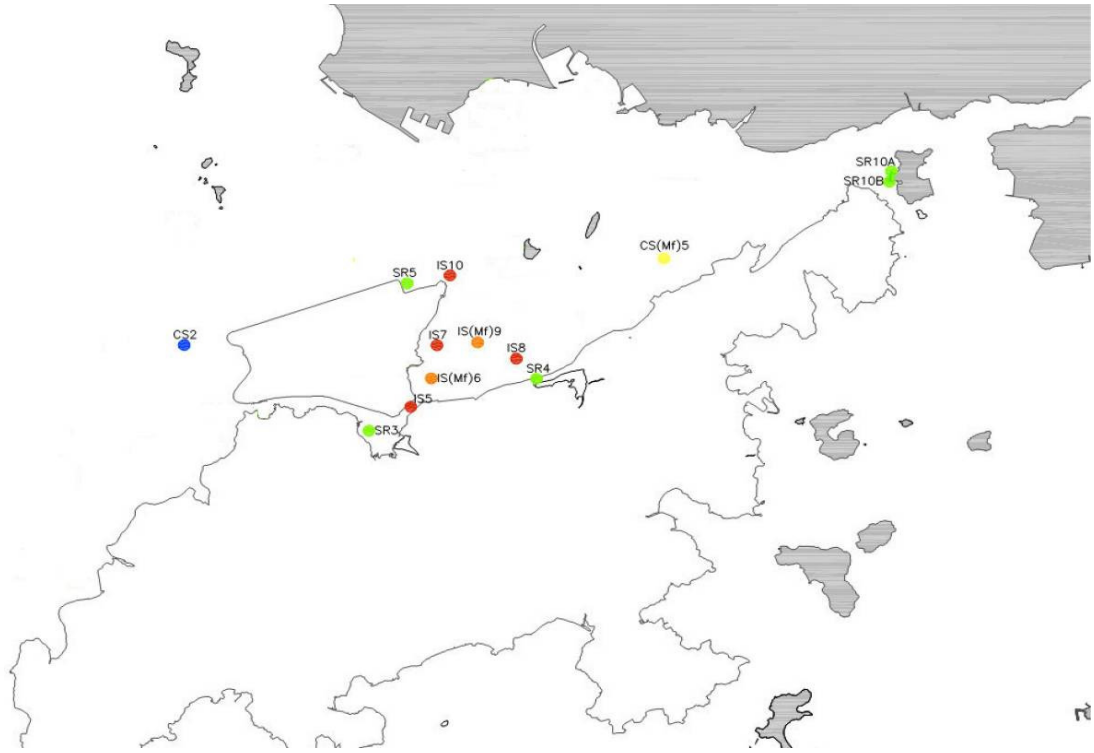
Location Plan:

On 26 January 2015, an AL exceedance of suspended solid at station IS5 was recorded during the mid-ebb tide. The exceedance has been investigated and is considered unlikely to be related to contract works due to the following reasons:

The measured value at station IS5 was slightly above the range of suspended solid during baseline monitoring for the mid-ebb tide. However, there was no specific activities recorded during the monitoring period that would cause any significant impacts on the monitoring results.

As the suspended solid levels recorded beyond the water quality criteria were not related to contract works, no immediate actions are considered necessary.
