Contract No. HY/2010/02

Hong Kong – Zhuhai – Macao Bridge Hong Kong Boundary Crossing Facilities – Reclamation Works

**Quarterly EM&A Report for
September 2014- November 2014**

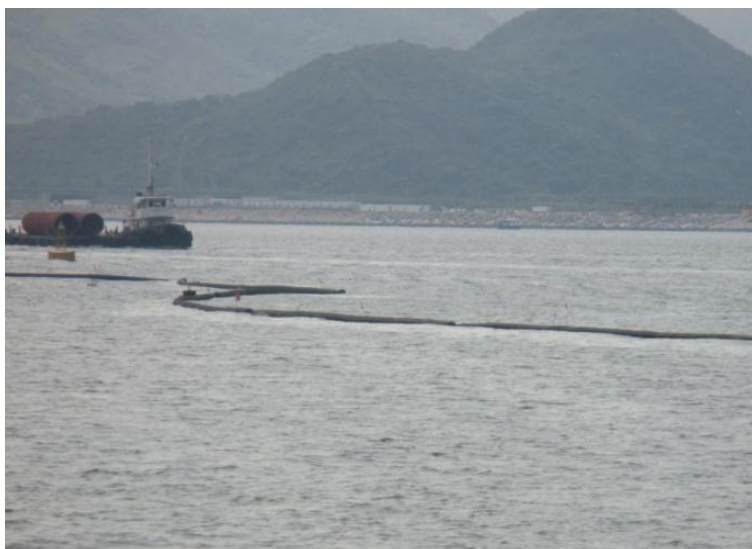
3.3.4.3 As informed by the Contractor, filling was conducted on 3, 5 and 8 September 2014 at Portion E2, but with referred to monitoring record and photo record attached, no sediment plume has been observed to flow from the inside of the perimeter silt curtain to the outside of the perimeter silt curtain and no discoloration of sea water has been observed.

3.3.4.4 Photo record of sea condition taken during flood tide at the North of HKBCF Reclamation Works near IS8 on 5 September 2014.

- 3.3.4.12 Nevertheless, the Contractor was reminded to ensure provision of ongoing maintenance to the silt curtains and to carry out maintenance work once defects were found.

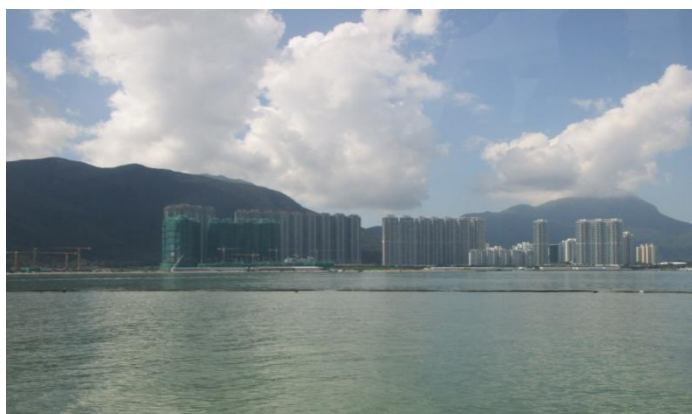
3.3.5.3 As informed by the Contractor, filling was conducted on 8, 10 and 12 September 2014 at Portion E2, but with referred to monitoring record and photo record attached, no sediment plume has been observed to flow from the inside of the perimeter silt curtain to the outside of the perimeter silt curtain and no discoloration of sea water has been observed.

3.3.5.4 Photo record of sea condition taken at South of HKBCF Reclamation Works near IS5 and SR3 on 10 September 2014.

- 3.3.5.10 Nevertheless, the Contractor was reminded to ensure provision of ongoing maintenance to the silt curtains and to carry out maintenance work once defects were found.

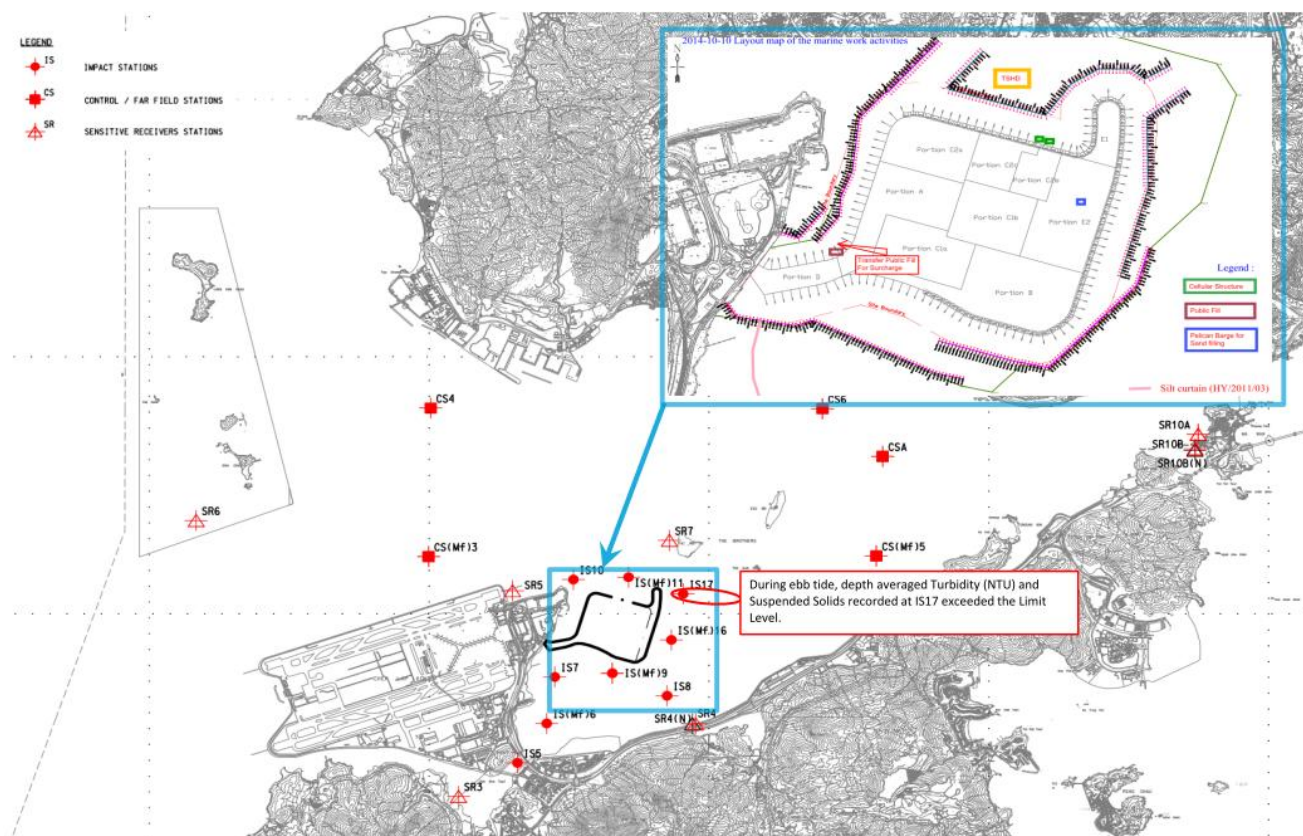
- 3.3.7.3 As informed by the Contractor, sand filling was carried out at Portion E2 on 8, 10 and 13 Oct 14 at almost the same location but no exceedance was recorded at monitoring station IS17 on 8 and 13 Oct 14 during mid ebb tide. This indicates filling works were unlikely to cause the exceedance in turbidity at monitoring station IS17.

- 3.3.7.4 The source of impact is likely due pelican barge's propeller movement at shallow water during ebb tide when the position of the barge was adjusted at portion E. In addition, with refer to the silt curtain condition on 10 Oct 14, defects of the perimeter silt curtain was observed at northwest of the construction site. The dispersion of turbid water from the inside of the perimeter silt curtain to the outside of the perimeter silt curtain is potentially due to defects of northwest part of the perimeter silt curtain.
- 3.3.7.5 Action taken under the event and action plan
1. In situ measurement was repeated to confirm findings of the exceedance of turbidity. Repeat in situ measurement is not applicable to suspended solid as SS was not measured in situ;
 2. Source of impact refer to Section 4.7.3.3

3.3.7.6 ET's conclusions and recommendations for mitigation: Exceedances recorded at IS17 are likely to be related to vessel movement at shallow water during ebb tide. The Contractor was further reminded to control the vessel traffic at this area and ensure swift provision of maintenance to the silt curtains once defect was found.

3.3.7.8 With refer to the maintenance record provided by the Contractor, maintenance work for the defects of the northwest part of the perimeter silt curtain was conducted on 28 October 2014.

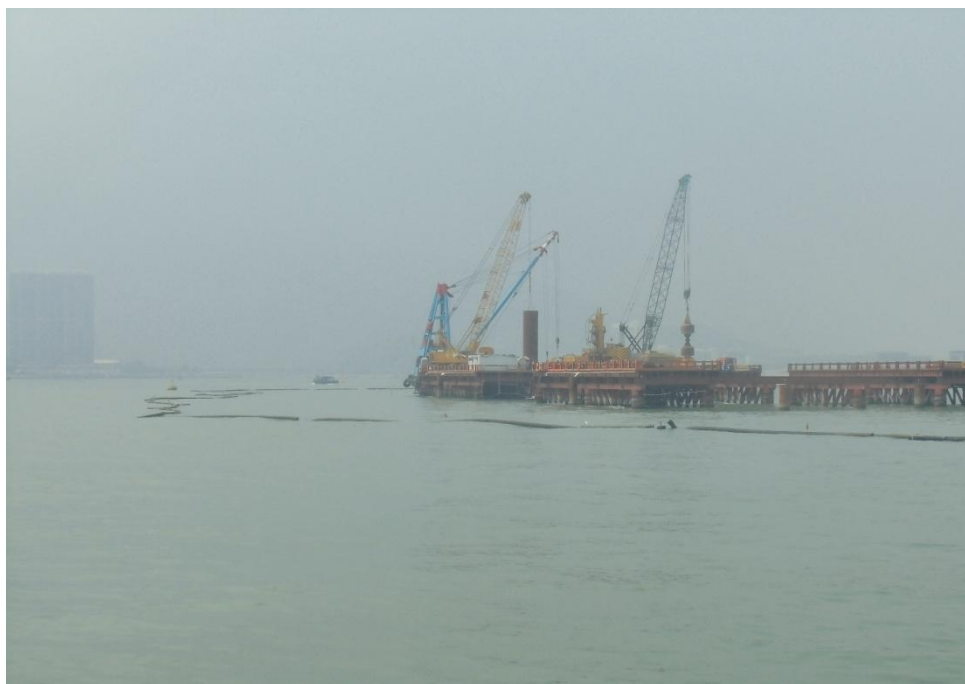
3.3.9.5 In accordance with the silt curtain integrity checking record of 3 October 2014, disconnection of the perimeter silt curtain was observed at the southeast part of HKBCF Reclamation Works, but with referred to monitoring record and photo record below, no sediment plume has been observed to flow from the inside of the perimeter silt curtain to the outside of the perimeter silt curtain and no discoloration of sea water has been observed. (Please refer to below photo). In accordance with the silt curtain integrity checking record, the observed disconnection was rectified on 6 October 2014.

- 3.3.9.6 Photo record above shows the sea condition taken during flood tide at HKBCF Reclamation Works near IS8 on 3 October 2014.
- 3.3.9.7 Turbidity level recorded at IS8, IS(Mf)9 and IS(Mf)16 were below the action and limit level. This indicates the turbidity level at area near IS8 was not adversely affected.

- 3.3.9.11 ET's conclusions and recommendations for mitigation: Nevertheless, the Contractor was reminded to ensure provision of ongoing maintenance to the silt curtains and to carry out maintenance work once defects were found.

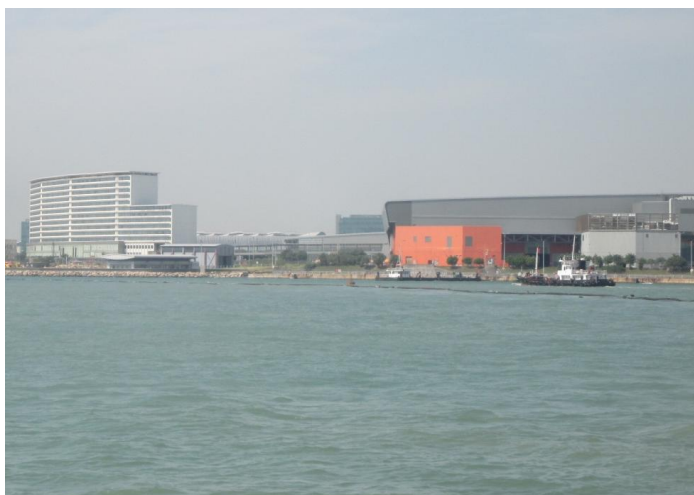
- 3.3.10.19 Photo shows sea condition at northwest part of HKBCF reclamation works on 6 Oct 2014 during ebb tide.

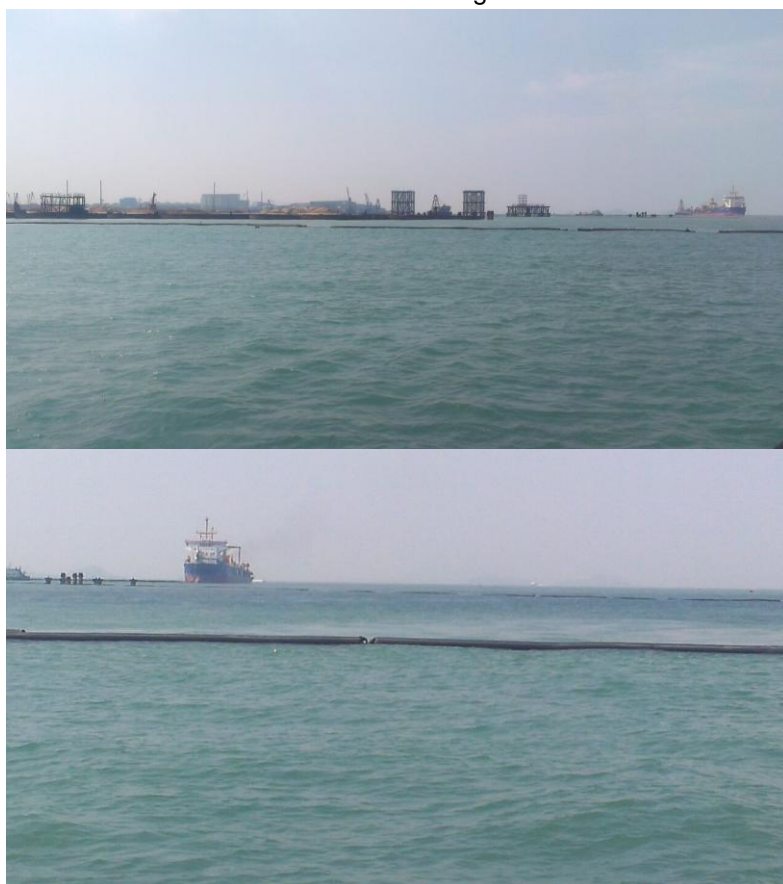
- Subsequently, a rock placement trial was conducted by the Contractor on 28 October 2014. Silt plume was observed during the process but Figure 3.8 of the investigation report shows that spreading to the outside of the silt curtain was prevented by the silt curtain.
- Photo records taken on 31 October 2014 shows the sea condition at sea area near the northeast side of the HKBCF Reclamation Works and no silt plume was observed spreading out from Portion E1 of the construction site through the silt curtain:

- 5.1.7.6 As informed by the Contractor, rockfill materials would be placed more slowly by the derrick as well as the lowest dropping point to minimize the generation of silt plume. Daily site inspection in the area would be conducted so that any damaged parts of silt curtain can be observed and repaired promptly.

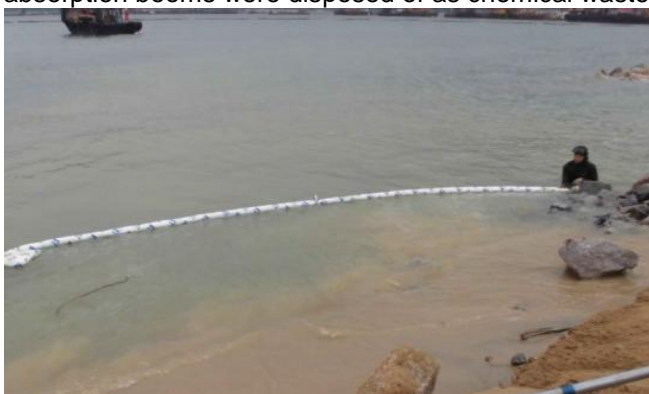
5.1.9.3 The Contractor used absorption booms to enclose and remove the floating oil from water and absorption booms used was collected using disposal bags as part of the spill kits item. The used absorption booms were disposed of as chemical waste (Also refer to photo record below).

5.1.9.6 The contractor was reminded to continue to follow the spill response plan in the event of accidental oil spillage.

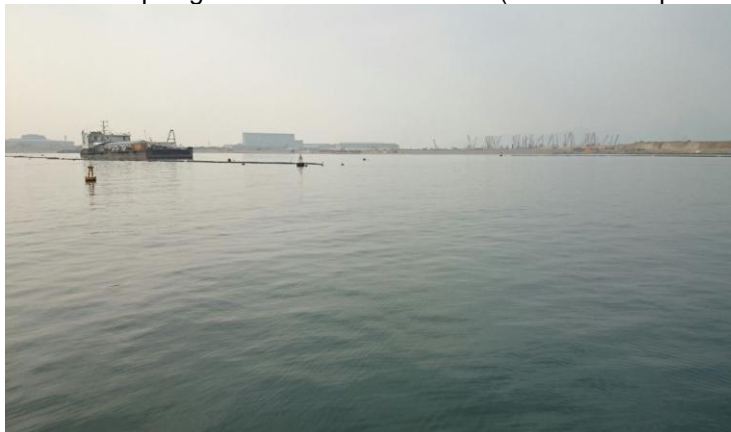
5.1.10.5 The oil stain observed was limited at nearby eastern sea area within the silt curtain.

5.1.10.7 Impact water quality monitoring record of 14 and 17 November 2014 of IS(Mf)16 which is the closest location to location of observed oil spill have been reviewed. There is no water quality exceedance recorded at IS(Mf) 16 on 14 and 17 November 2014.

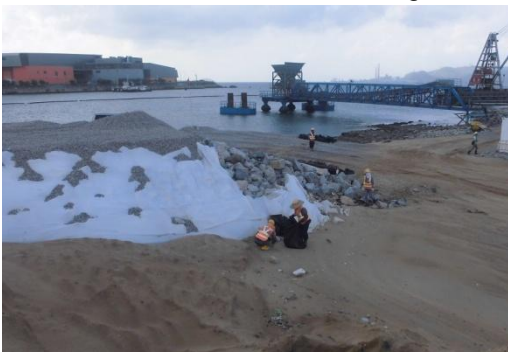
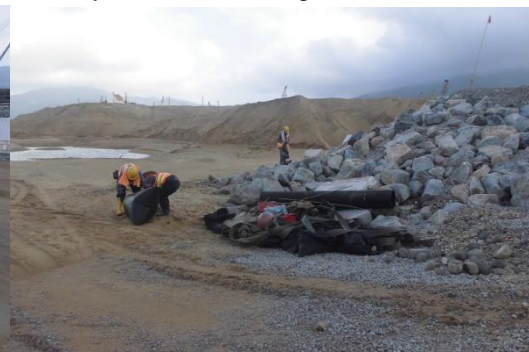
- Photo records shows collection of general refuse by workers on a regular basis:

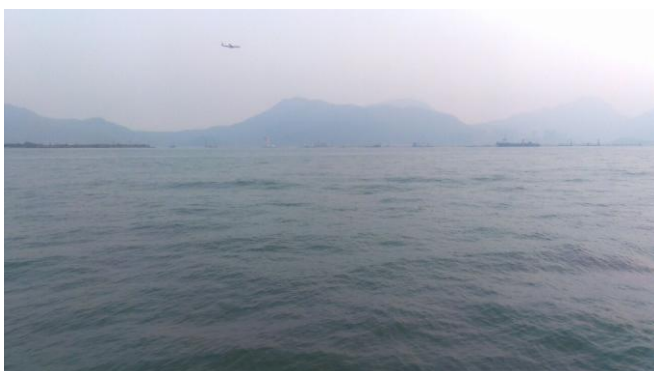
7.1.4.4 Below photo shows condition of the sea area facing HKBCF Reclamation Works on 22 September 14.

- 7.1.4.5 After investigation, there is no adequate information to conclude the observed impact is related to this Contract.
- 7.1.4.6 The Contractor was advised to ensure to continue the provision of waste mitigation measures to barges on reclamation land and vessels.
- 7.1.4.7 The Contractor was recommended that the site and surroundings shall be kept tidy and litter free. General refuse generated on-site should be stored in enclosed bins or compaction units separately from construction and chemical wastes.
