Contract No. CV/2013/08
Liantang / Heung Yuen Wai Boundary Control Point
Site Formation and Infrastructure Works – Contract 6

Environmental Permit No. EP-404/2011/C
Condition 2.16 – Photographic and Cartographic Survey Report

Contract No. CV/2013/08
Liantang/Heung Yuen Wai
Boundary Control Point Site
Formation and Infrastructure
Works – Contract 6
*Cartographic and Photographic
Survey Report*

December 2015

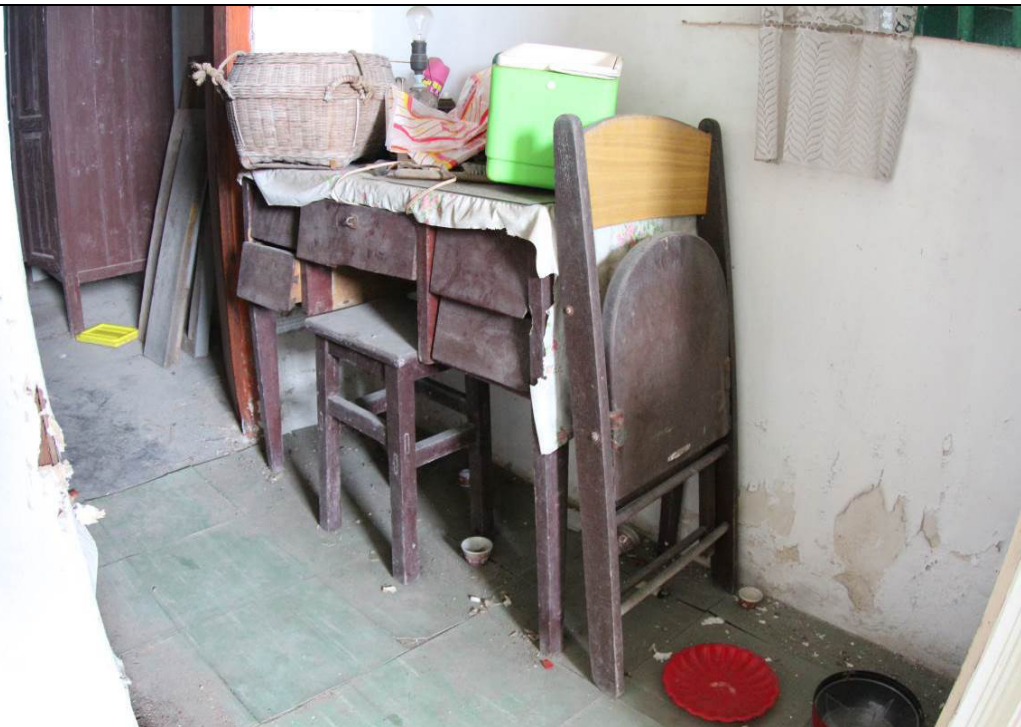
| Site Code | Photo No. | Content | Categories |
|---|---|---|---|
| | BS64-1-P36 | Deteriorated wooden floor (above toilet) 霉爛的地板 (廁所上方) | Interior (b) |

Deteriorated wooden floor (above toilet) 霉爛的地板 (廁所上方)

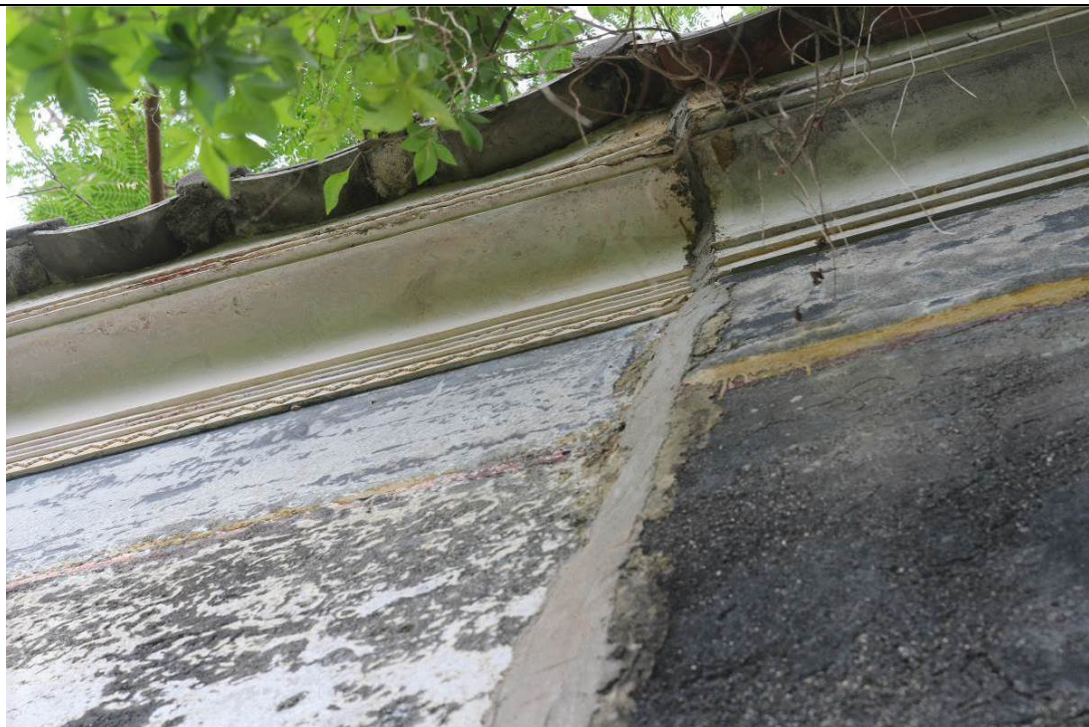
| Site Code | Photo No. | Content | Categories |
|---|---|--|---|
| | BS65-overall-P21 | Joint of BS65-3 and BS65-4 observed on back wall BS65-3及BS65-4後壁的接縫 | Exterior (b) |

Joint of BS65-3 and BS65-4 observed on back wall BS65-3及BS65-4後壁的接縫

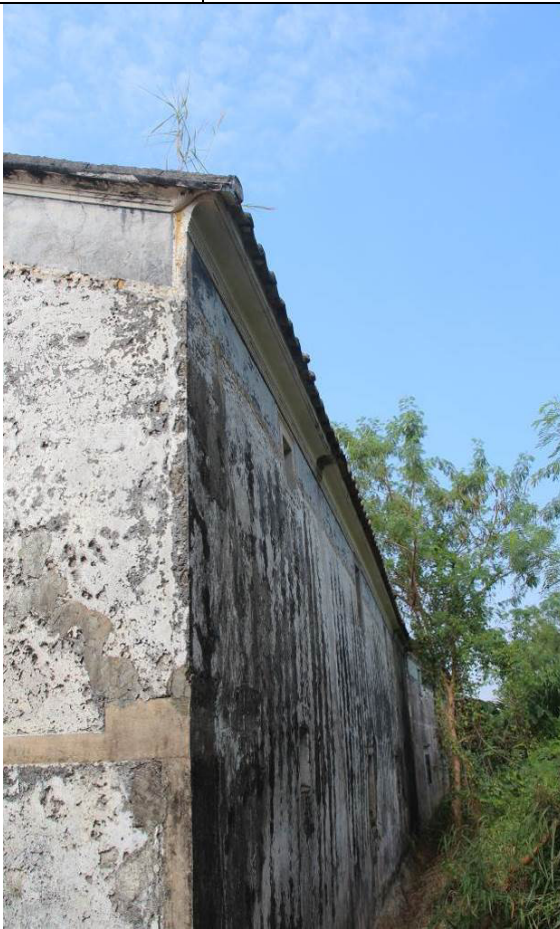
| Site Code | Photo No. | Content | Categories |
|---|---|--|---|
| | BS65-overall-P22 | Joint of BS65-3 and BS65-4 observed at eave of back wall BS65-3及BS65-4後壁檐口的接縫 | Exterior (b) |

Joint of BS65-3 and BS65-4 observed at eave of back wall BS65-3及BS65-4後壁檐口的接縫

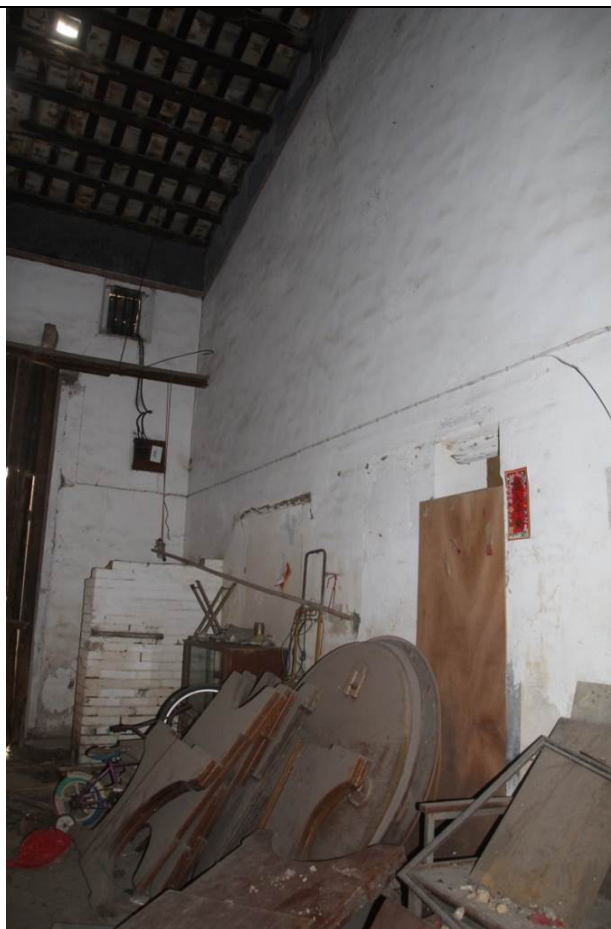
| Site Code | Photo No. | Content | Categories |
|---|---|---|---|
| | BS65-2-P10 | A blocked door way linking to BS65-1 is observed behind the water tank and stove. The cupboard is embedded within the door way. Therefore the tank, stove and cupboard are constructed after the door way is blocked. 水缸及灶後見通往BS65-1的門洞。門洞已封，碗櫃置於門洞中，可知水缸及灶均建於門洞被封後。 | Interior (b) |

A blocked door way linking to BS65-1 is observed behind the water tank and stove. The cupboard is imbedded within the door way. Therefore the tank, stove and cupboard are constructed after the door way is blocked. 水缸及灶後見通往BS65-1的門洞。門洞已封，碗櫃置於門洞中，可知水缸及灶均建於門洞被封後。

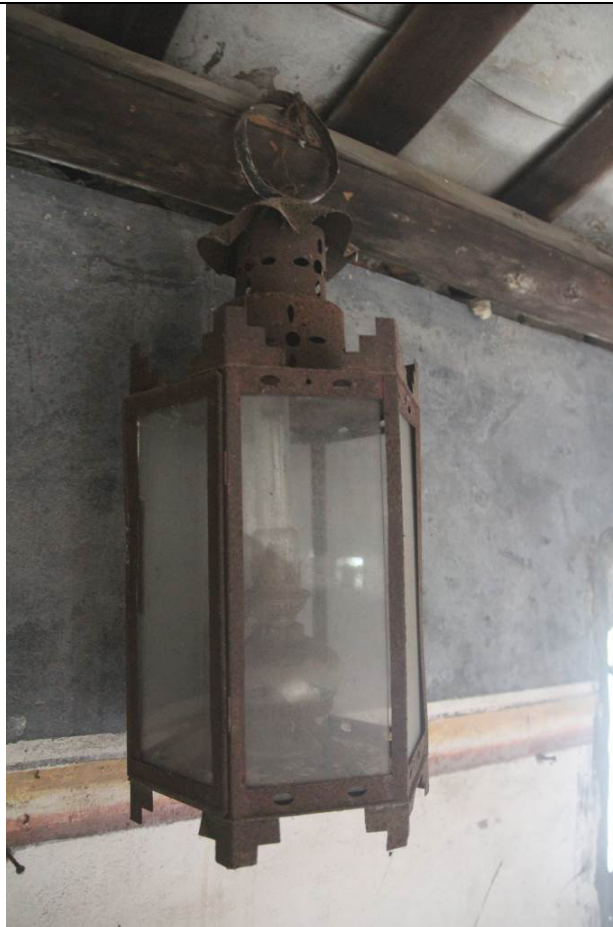
| Site Code | Photo No. | Content | Categories |
|---|---|--|---|
| | BS65-2-P16 | Back wall of the cockloft is decorated with character “壽” and a colour ban on the top edge of the wall. Both decorations are damaged when constructing the window. The character “壽” is also damaged by the floor of the cockloft. Therefore the current window and the cockloft should be part of the later alternations. 木閣樓後壁中部飾有“壽”字裝飾，壁頂飾有彩條。但“壽”字及壁頂裝飾均在開置窗戶時被破壞，另“壽”字亦被閣樓地板破壞，因此後壁窗戶及閣樓皆曾在後期加建/改造。 | Interior (b) |

Back wall of the cockloft is decorated with character "壽" and a colour band on the top edge of the wall. Both decorations are damaged when constructing the window. The character "壽" is also damaged by the floor of the cockloft. Therefore the current window and the cockloft should be part of the later alternations. 木閣樓後壁中部飾有"壽"字裝飾，壁頂飾有彩條。但"壽"字及壁頂裝飾均在開置窗戶時被破壞，另"壽"字亦被閣樓地板破壞，因此後壁窗戶及閣樓皆曾在後期加建/改造。

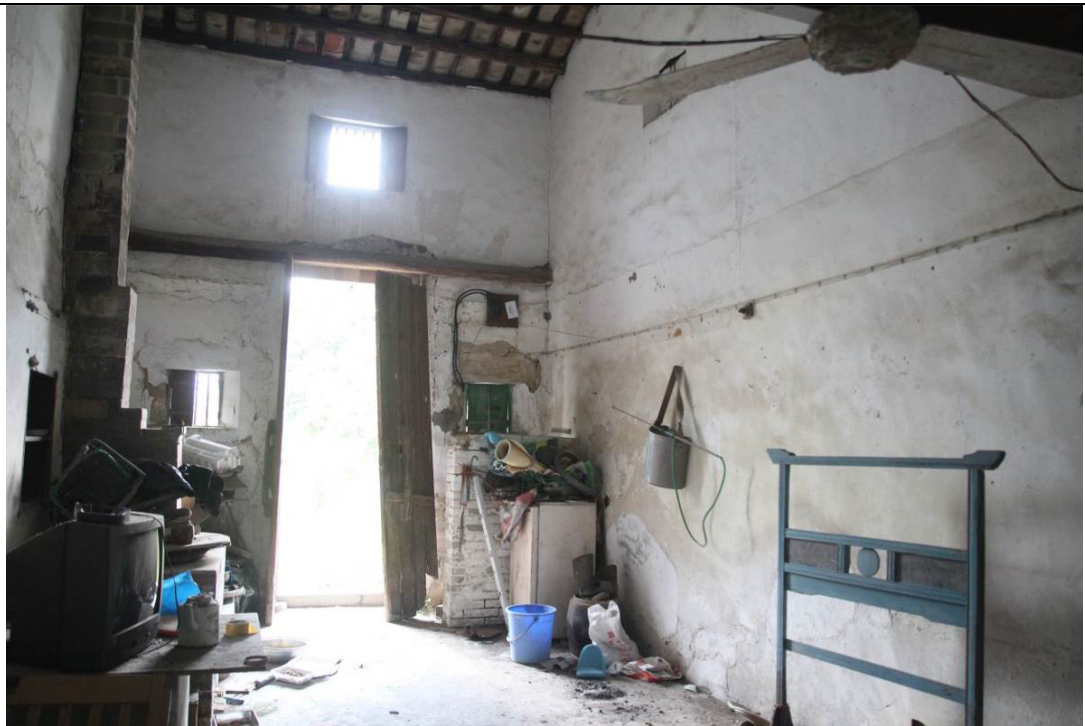
| Site Code | Photo No. | Content | Categories |
|---|---|---|---|
| | BS65-3-P8 | A door way linking to BS65-2 is observed behind the water tank and stove. The cupboard is embedded within the door way. Therefore the tank, stove and cupboard are constructed after the door way is blocked. 水缸及灶後見連接至BS65-2的門洞，碗櫃亦於門洞位置，可知水缸及灶建於門洞被封後。 | Interior (b) |

A door way linking to BS65-2 is observed behind the water tank and stove. The cupboard is imbedded within the door way. Therefore the tank, stove and cupboard are constructed after the door way is blocked. 水缸及灶後見連接至BS65-2的門洞，碗櫃亦於門洞位置，可知水缸及灶建於門洞被封後。

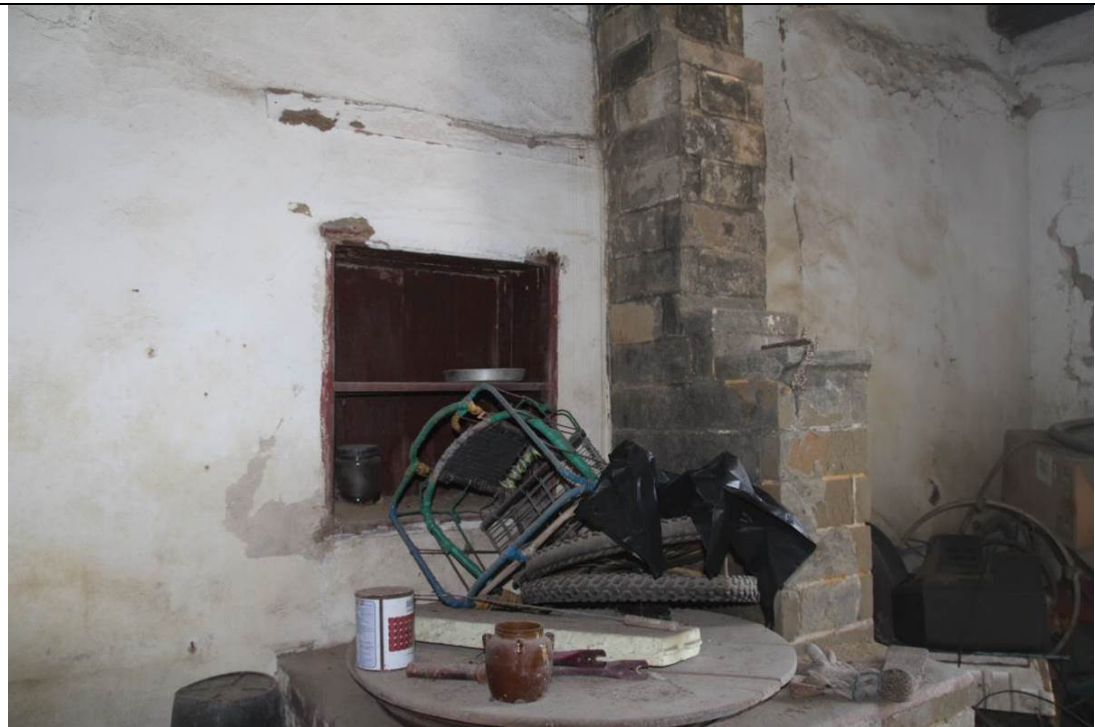
| Site Code | Photo No. | Content | Categories |
|---|---|---|---|
| | BS65-3-P29 | General view of the stove. Trace of the chimney could be observed on the wall which suggests the stove had been displaced in the past. 灶概貌，煙囪的痕跡見於牆上，這代表灶的位置在過去曾被移動。 | Interior (b) |

General view of the stove. Trace of the chimney could be observed on the wall which suggests the stove had been displaced in the past. 灶概貌，煙囪的痕跡見於牆上，這代表灶的位置在過去曾被移動。

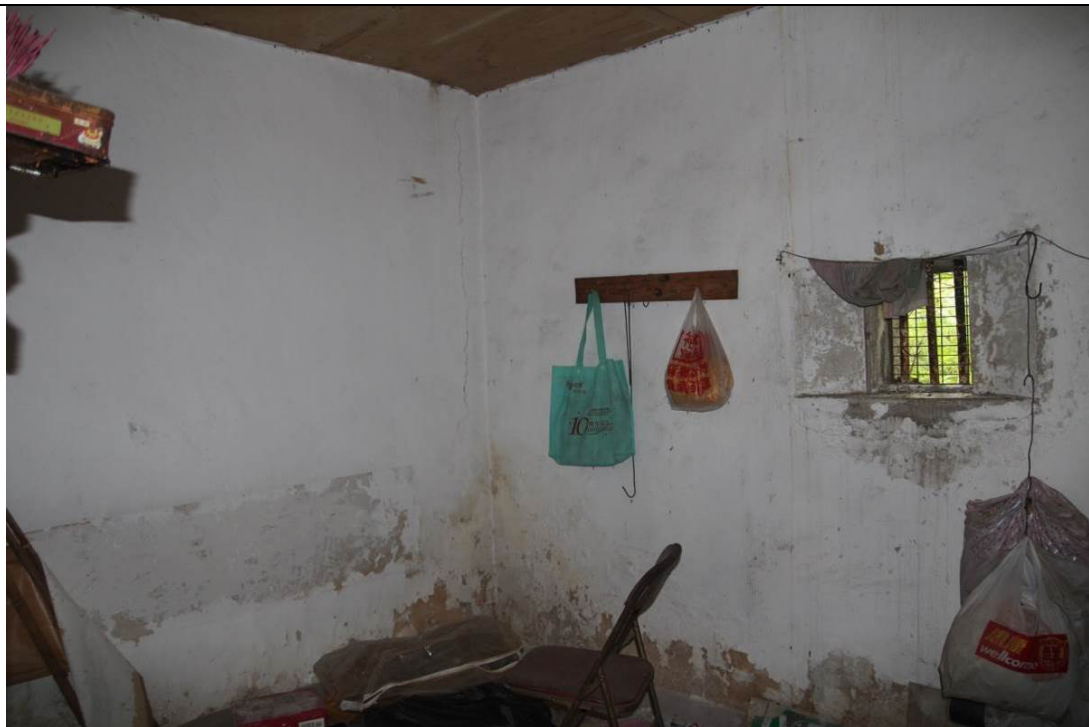
| Site Code | Photo No. | Content | Categories |
|---|---|---|---|
| | BS65-4-P20 | Brick wall of the room under the cockloft, no purlin for supporting the cockloft is observed 閣樓下房間的磚牆，未見支撐閣樓的桁樑。 | Interior (b) |

Brick wall of the room under the cockloft, no purlin for supporting the cockloft is observed 閣樓下房間的磚牆，未見支撐閣樓的桁樑。
