Contract No. HY/2010/02

Hong Kong – Zhuhai – Macao Bridge Hong Kong Boundary Crossing Facilities – Reclamation Works

Annual Review Report for March 2014- February 2015

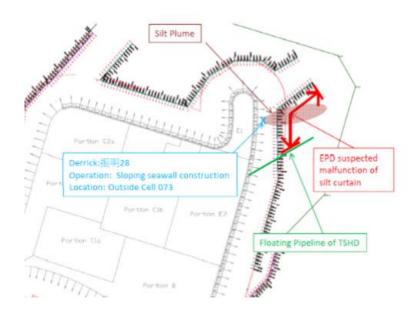
- The Contractor arranged diver to check the integrity of the concerned silt curtain. Minor damaged found on the concerned silt curtain and rectification works had been carried out by the Contractor.

- Diver checking and rectification record for integrity of silt curtain has been checked and it shows that the part of the silt curtain which was suspected to be malfunction (showed by red arrow in the diagram below) has been rectified by the Contractor.

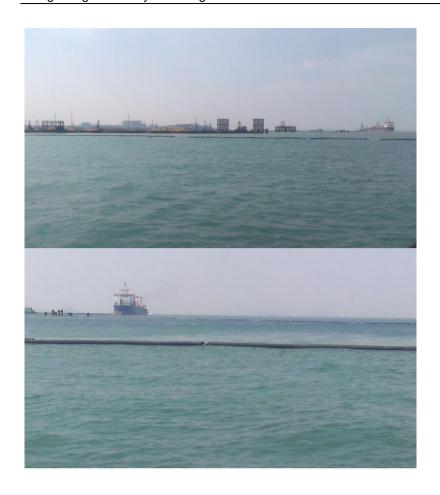
- Subsequently, a rock placement trial was conducted by the Contractor on 28 October 2014. Silt
 plume was observed during the process but Figure 3.8 of the investigation report shows that
 spreading to the outside of the silt curtain was prevented by the silt curtain.
- Photo records taken on 31 October 2014 shows the sea condition at sea area near the northeast side of the HKBCF Reclamation Works and no silt plume was observed spreading out from Portion E1 of the construction site through the silt curtain:

- 6.1.8.6 As informed by the Contractor, rockfill materials would be placed more slowly by the derrick as well as the lowest dropping point to minimize the generation of silt plume. Daily site inspection in the area would be conducted so that any damaged parts of silt curtain can be observed and repaired promptly.

- 6.1.8.7 The Contractor was further reminded to ensure swift provision of maintenance to the perimeter silt curtains once defects of the perimeter silt curtain were observed and continue the preventive measures during rock filling and keep the site inspected at least daily to ensure compliance with respect to the recommendations in the EIA Report and EM&A Manual in particular on EIA Ref. Section 9.11.1.1
