TUEN MUN - CHEK LAP KOK LINK  
CONTRACT NO. HY/2013/12 –  
NORTHERN CONNECTION TOLL PLAZA AND  
ASSOCIATED WORKS

12<sup>TH</sup> MONTHLY ENVIRONMENTAL MONITORING AND  
AUDIT (EM&A) REPORT – OCTOBER 2015

PREPARED FOR  
CRBC AND KADEN JOINT VENTURE

Date	Reference No.	Prepared By	Certified By
12 November 2015	TCS00715/14/600/R00144v2

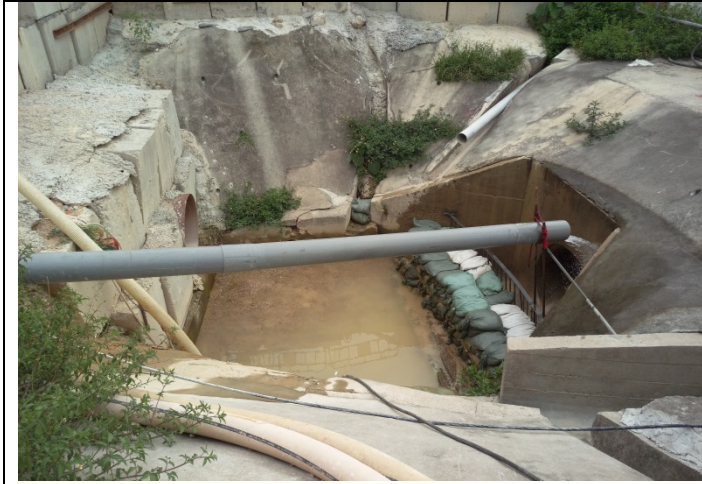
Stream A: In normal condition, and outfall pit should be cleaned.

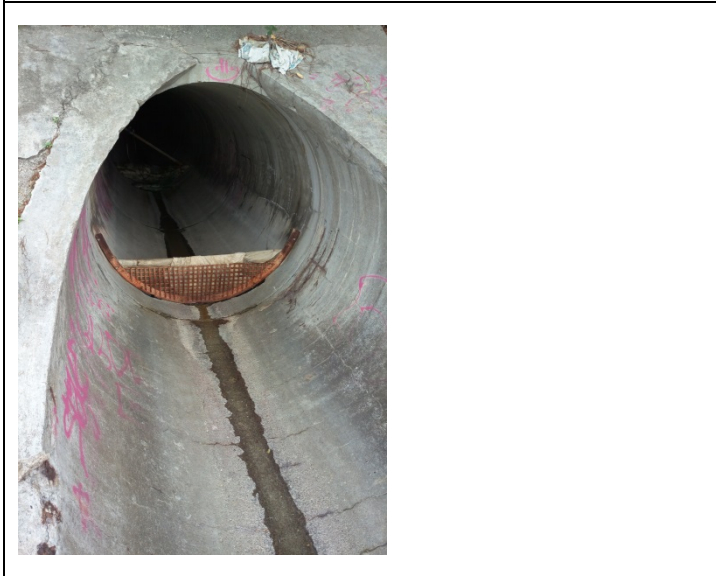
Outfall 1: No muddy water leaking out

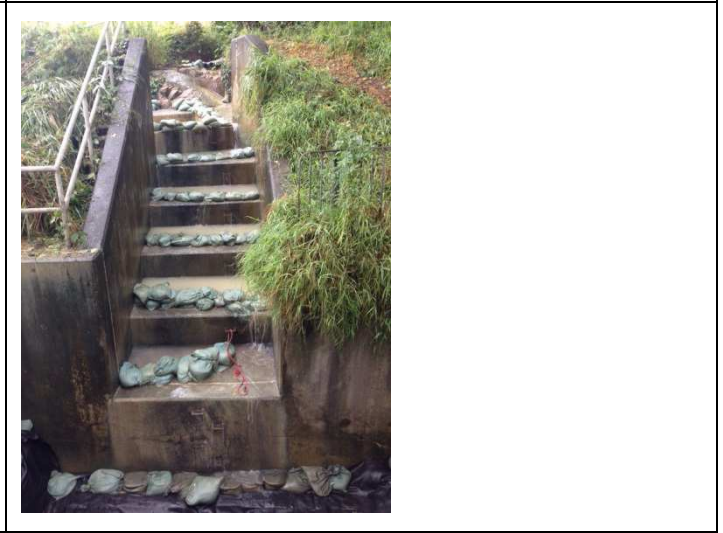
<p>Stream A: Muddy water was pumped to Wetsep and discharging after treatment.</p>	<p>Stream B: Pit 1 in normal condition.</p>

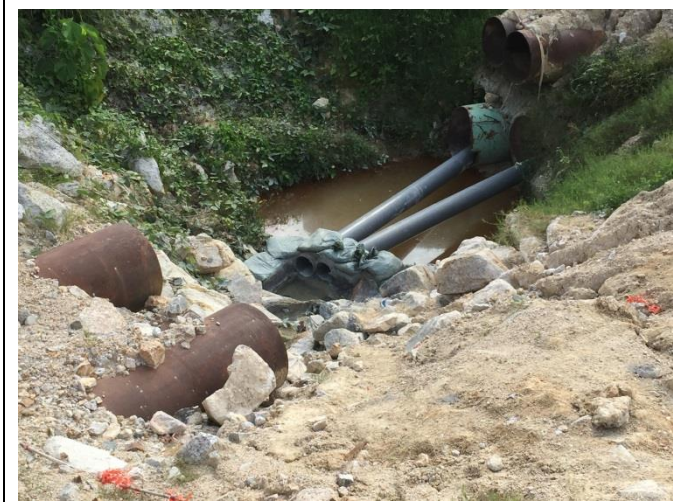
Stream B Pit 2: Treated water was directly discharged to downstream bypass.

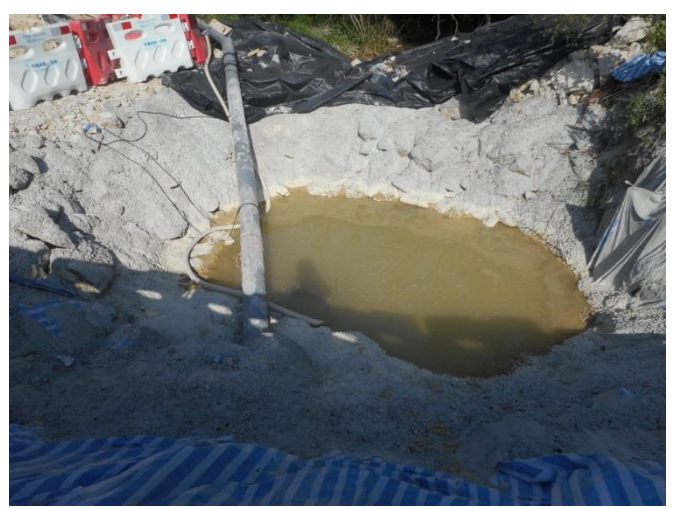
Stream A Outfall: pumped muddy water and discharged after treatment.

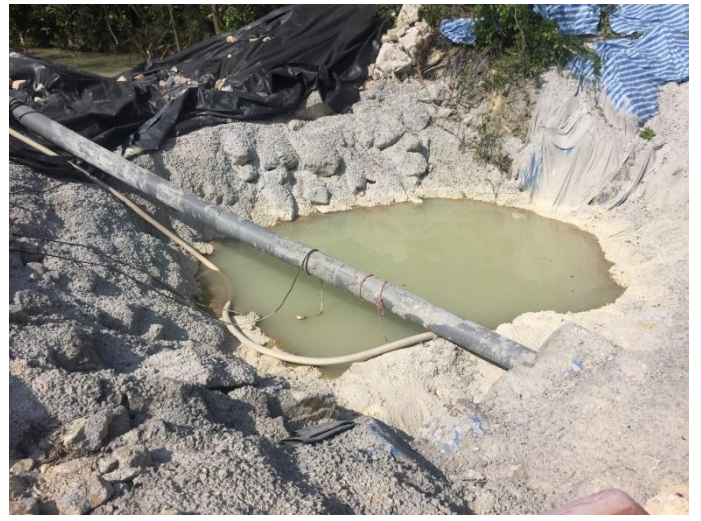
Stream A Outfall: pumped muddy water and discharged after treatment.

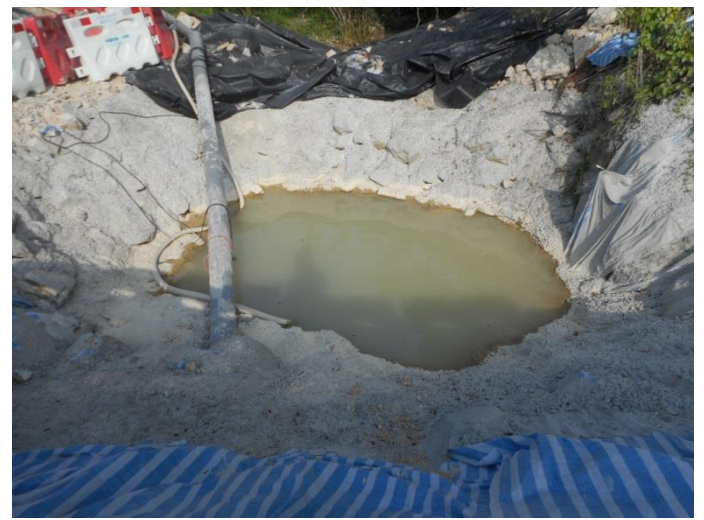
Stream A Outfall: pumped muddy water and discharged after treatment.

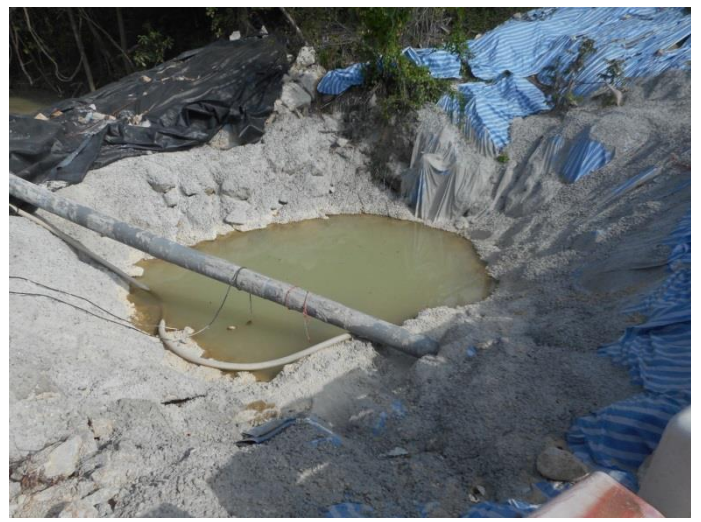
Stream A Outfall: pumped muddy water and discharged after treatment.
