**TUEN MUN - CHEK LAP KOK LINK
CONTRACT NO. HY/2013/12 –
NORTHERN CONNECTION TOLL PLAZA AND
ASSOCIATED WORKS**

**36TH MONTHLY ENVIRONMENTAL MONITORING AND
AUDIT (EM&A) REPORT – OCTOBER 2017**

PREPARED FOR
CRBC AND KADEN JOINT VENTURE

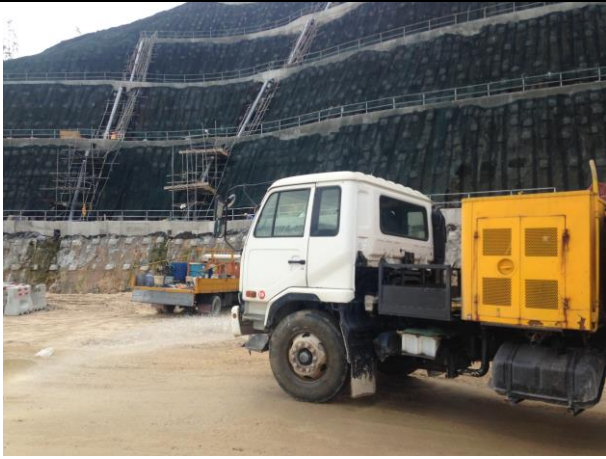
Photo 7 Watering of haul road by water truck to keep road surface wet was observed during the site inspection on 12 September 2017

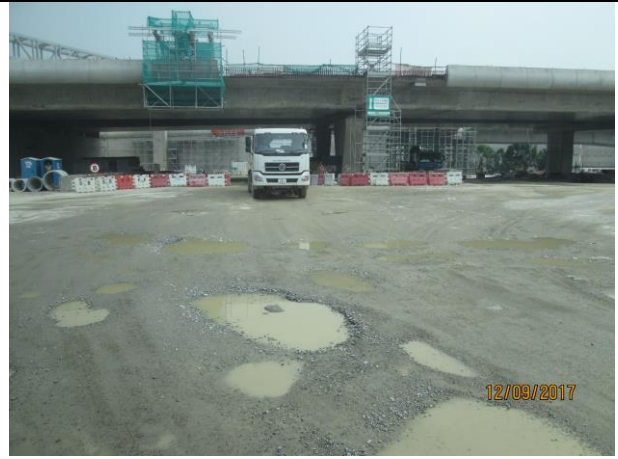
Photo 8 Watering of haul road by water truck to keep road surface wet was observed during the site inspection on 12 September 2017

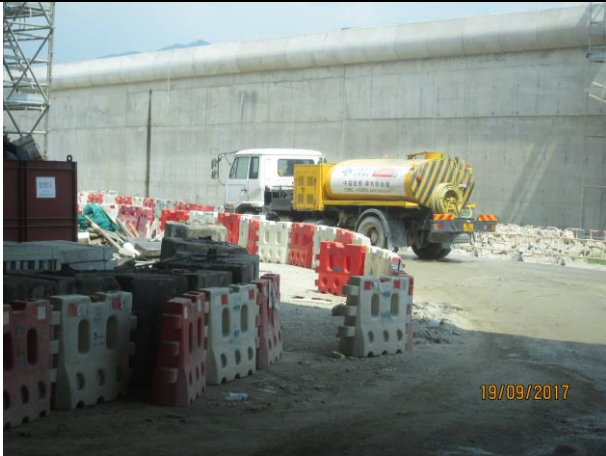
Photo 7 Watering of haul road by water truck to keep road surface wet was observed during the site inspection on 19 September 2017

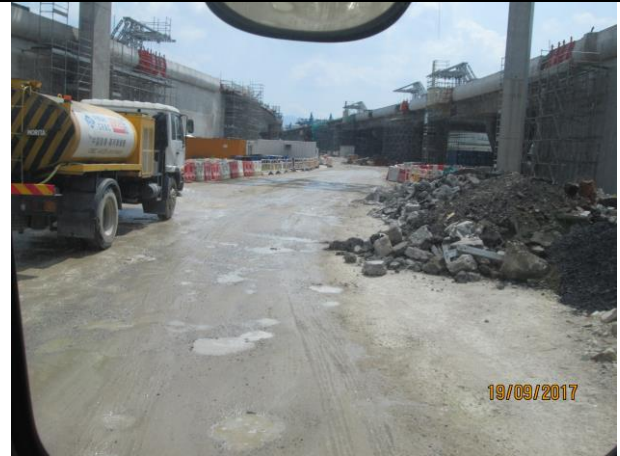
Photo 8 Watering of haul road by water truck to keep road surface wet was observed during the site inspection on 19 September 2017

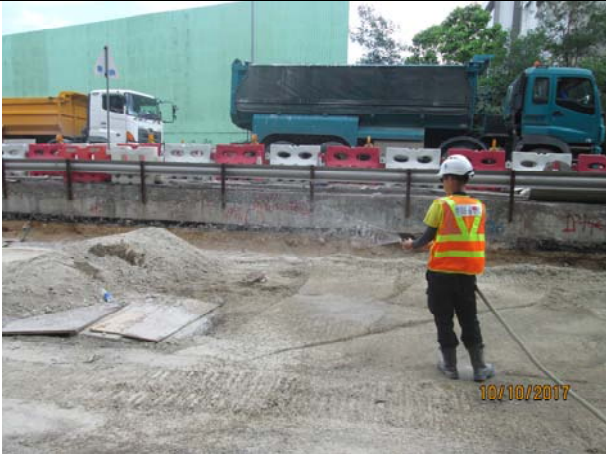
Photo 11
Water spraying was observed during the weekly inspection on 10 October 2017.

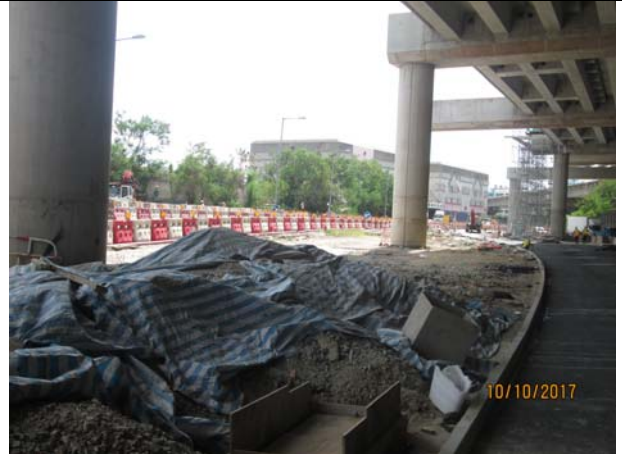
Photo 11
Stockpile covered with tarpaulin was observed during the weekly inspection on 10 October 2017.

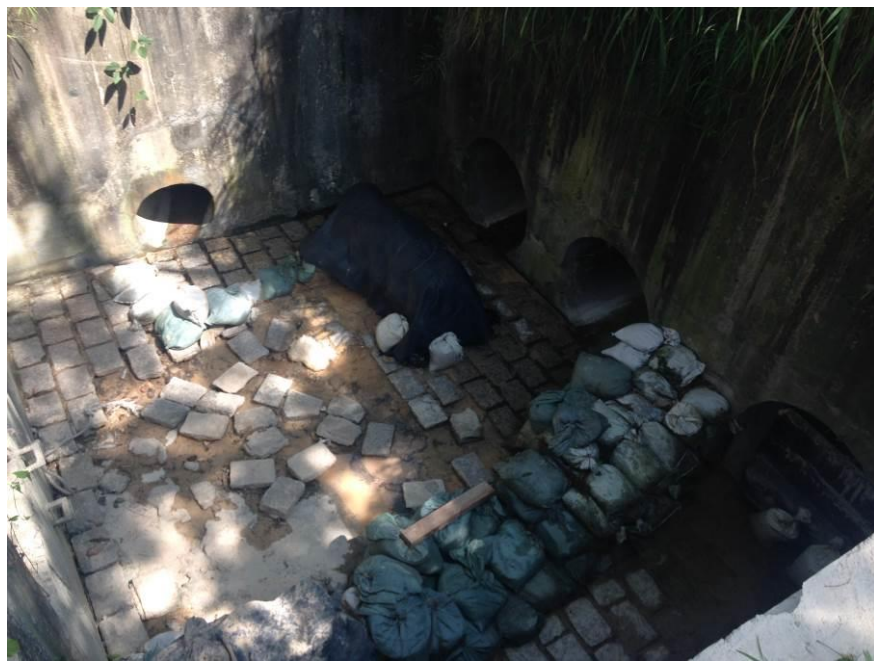
Stream B Outfall: No water is discharging.

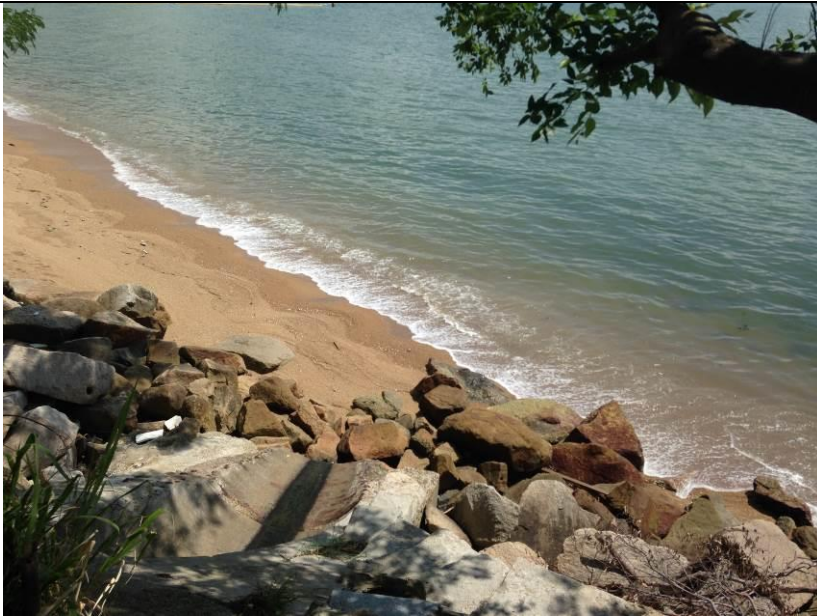
Outfall 1: Clean water is discharging.

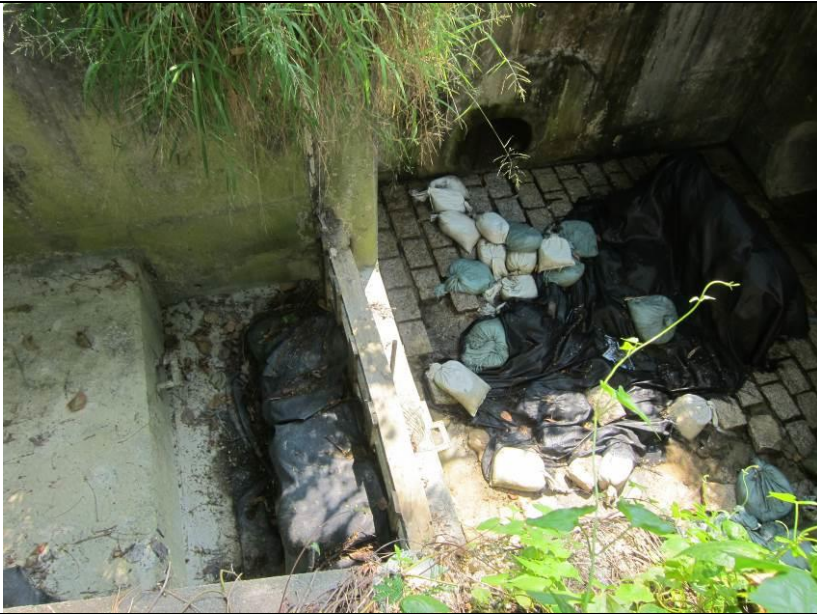
Stream B Outfall: Clean water is discharging.

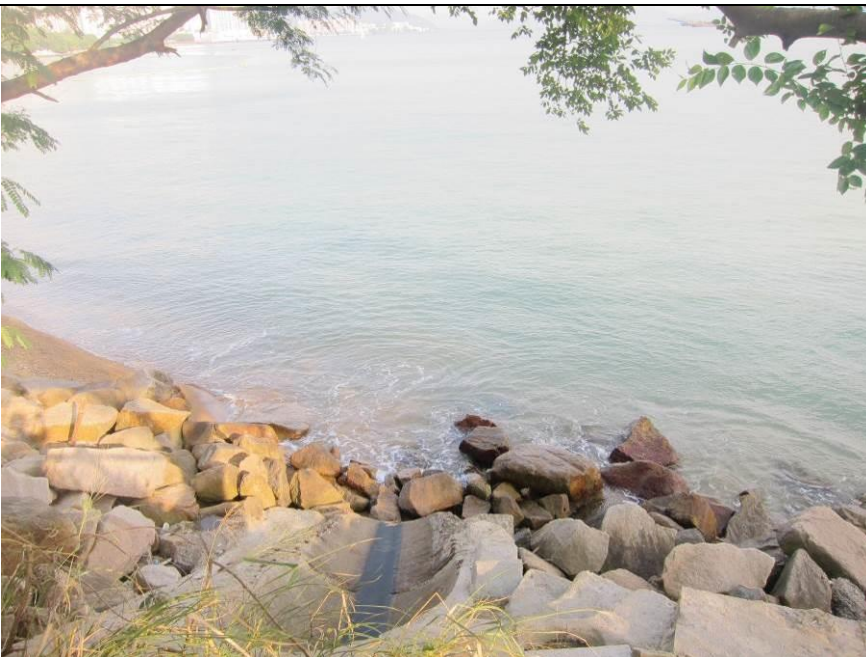
Outfall 1: Clean water is discharging.

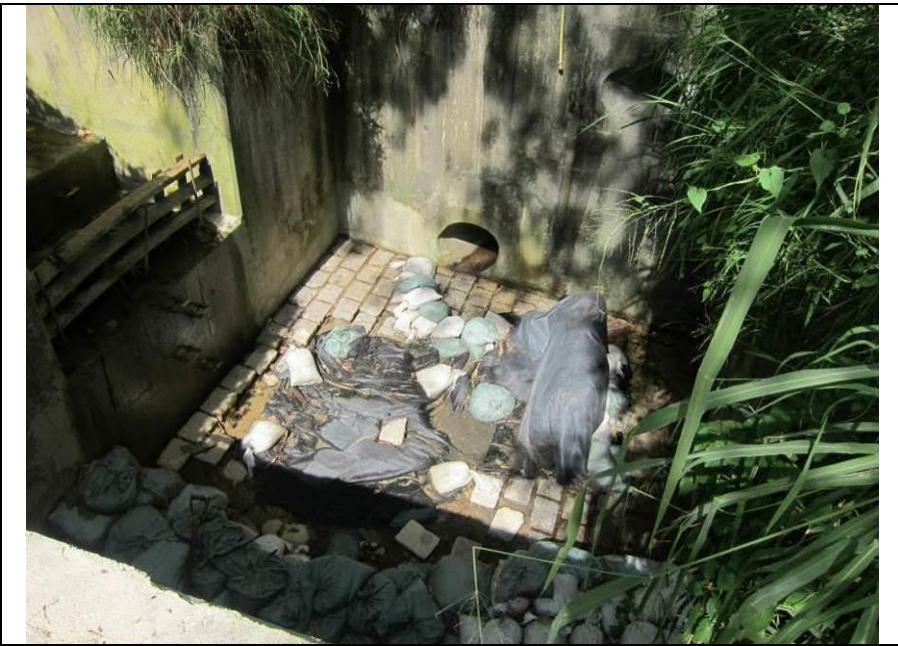
Stream B Outfall: Clean water is discharging.

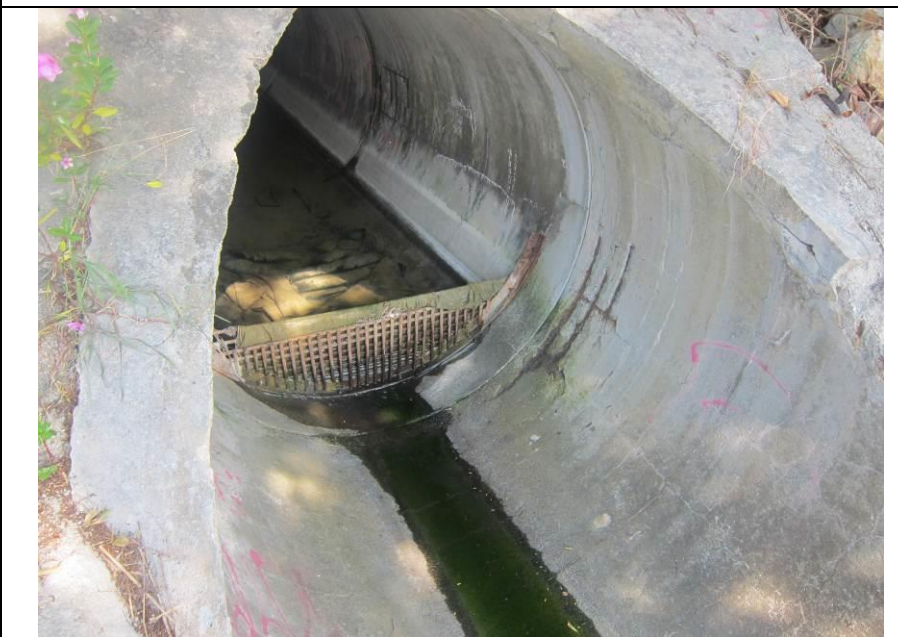
Outfall 1: Clean water is discharging.
