Contract No. HY/2017/10 Tuen Mun – Chek Lap Kok Link – Northern Connection Tunnel Buildings, Electrical and Mechanical Works

Twenty-ninth Monthly EM&A Report

11 November 2020

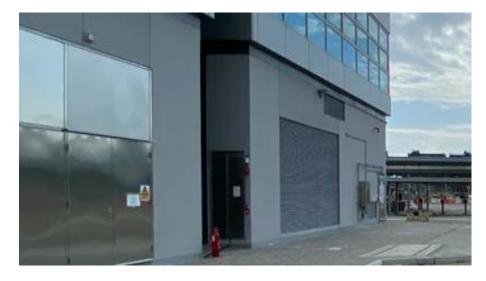
Photo 1 - Northern Landfall

event)	 Indoor defect rectification at Main Control Building 				
Possible Reason for	The exceedance is unlikely to be due to the Contract, in view of the following:				
Action or Limit Level	 With reference to the recorded wind direction (ranged between 322° and 345°), blowing from a 				
Exceedance(s)	north-westerly direction) and wind speed (2.2 m/s) when exceedances recorded, ASR5 and ASR6				
	are located upstream to the work area.				
	 Only minor defect rectification works were conducted which are considered not major dust 				
	generating works, thus result of 1-hour TSP at ASR1 was unlikely impacted by the works under				
	this project.
