INVESTIGATION REPORT

Log Number:	2017/07/001
Date of Enquiry Received	31 July 2017 and 5 August 2017
Location	Project Site
Nature of Enquiry	Landscape and visual
Enquiry from	Ming Pao Newspaper

Photos of Tree 6 from December 2015 to January 2017

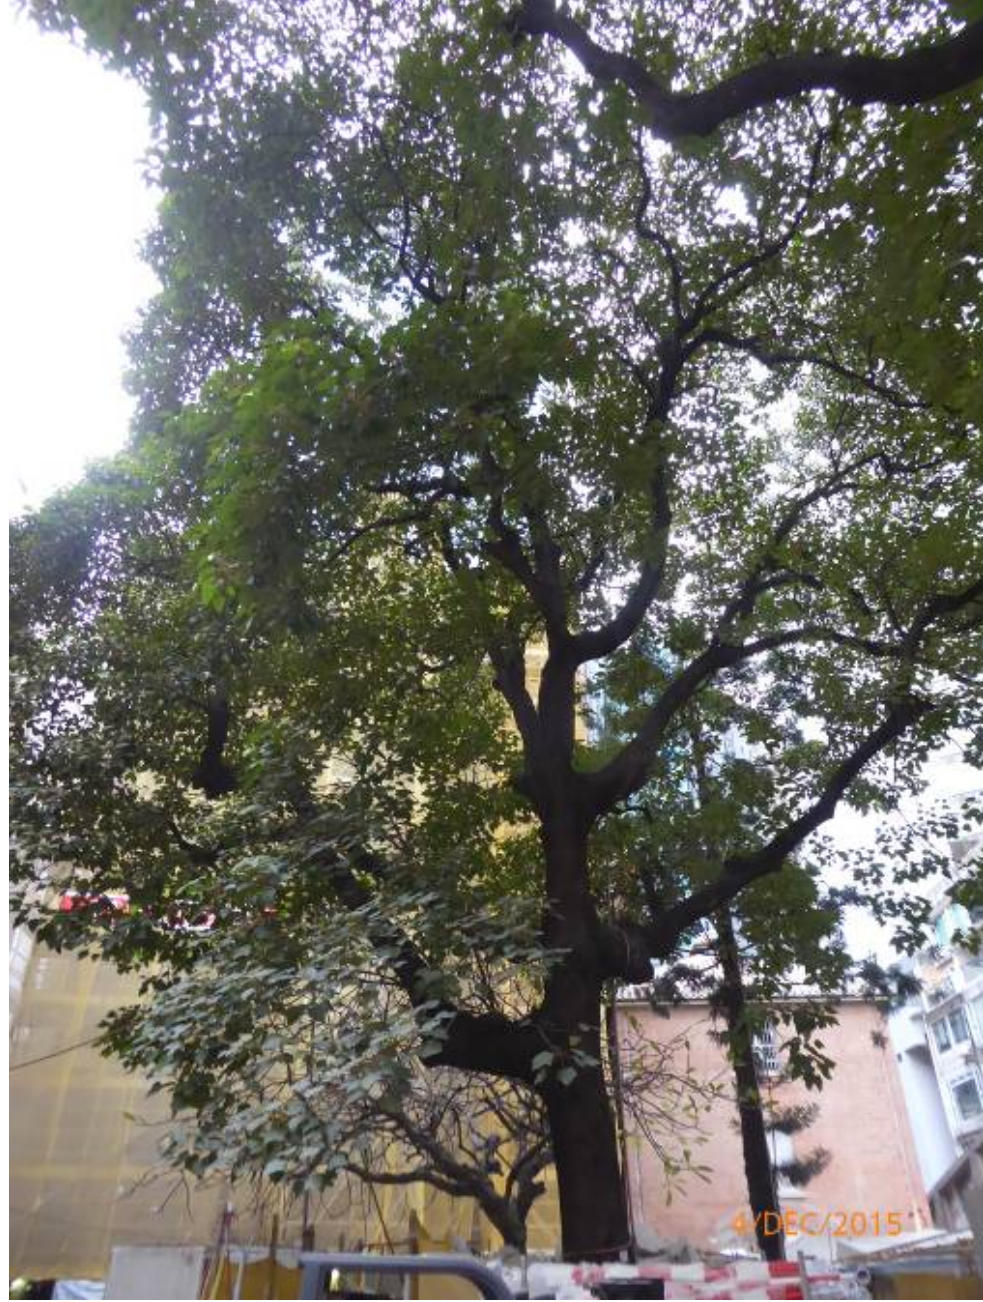
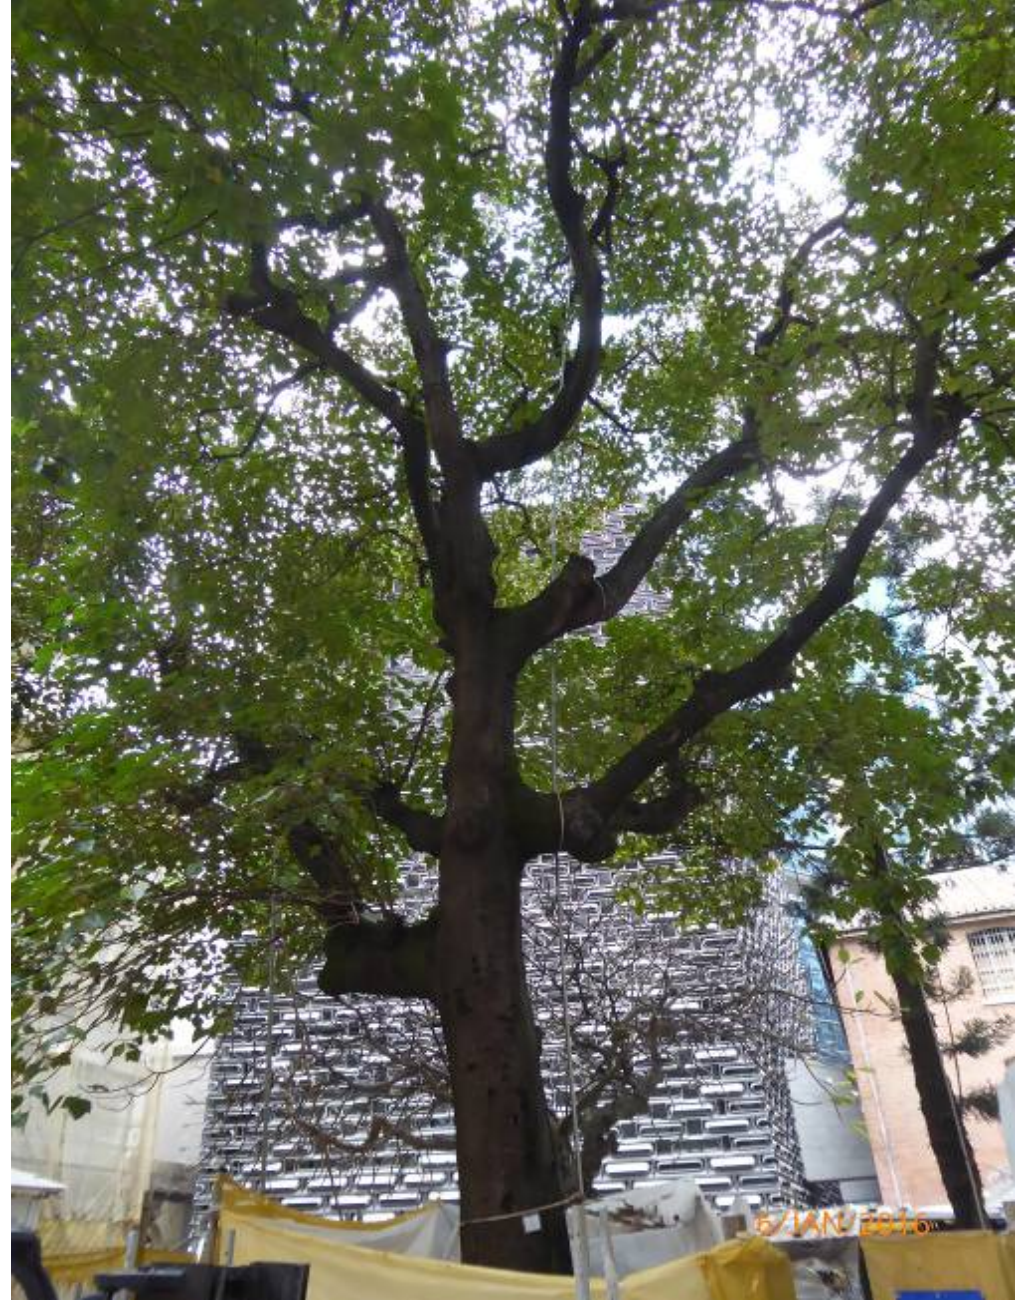
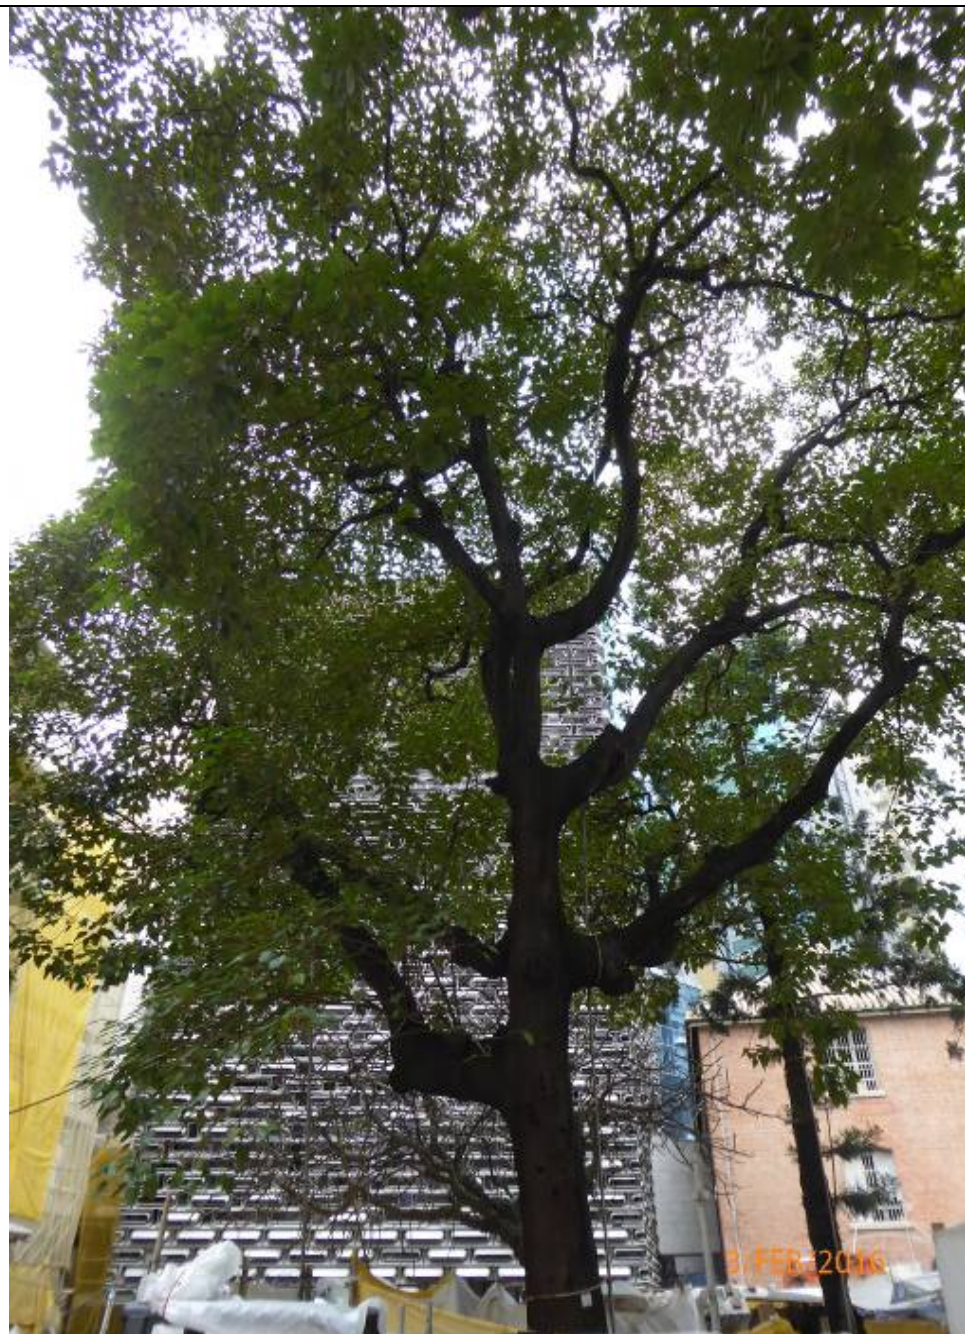
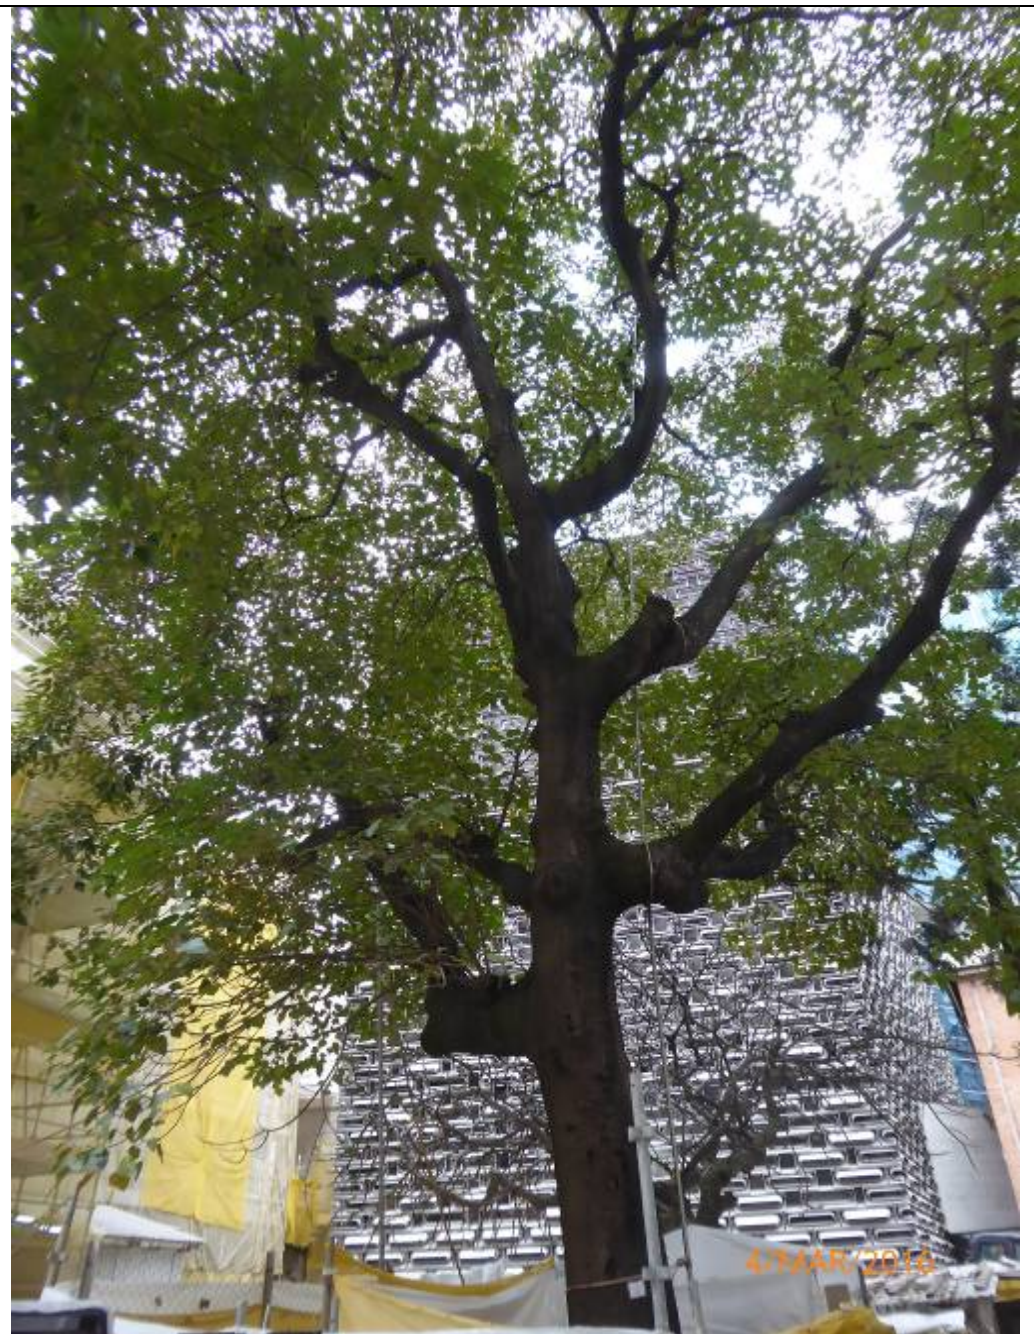
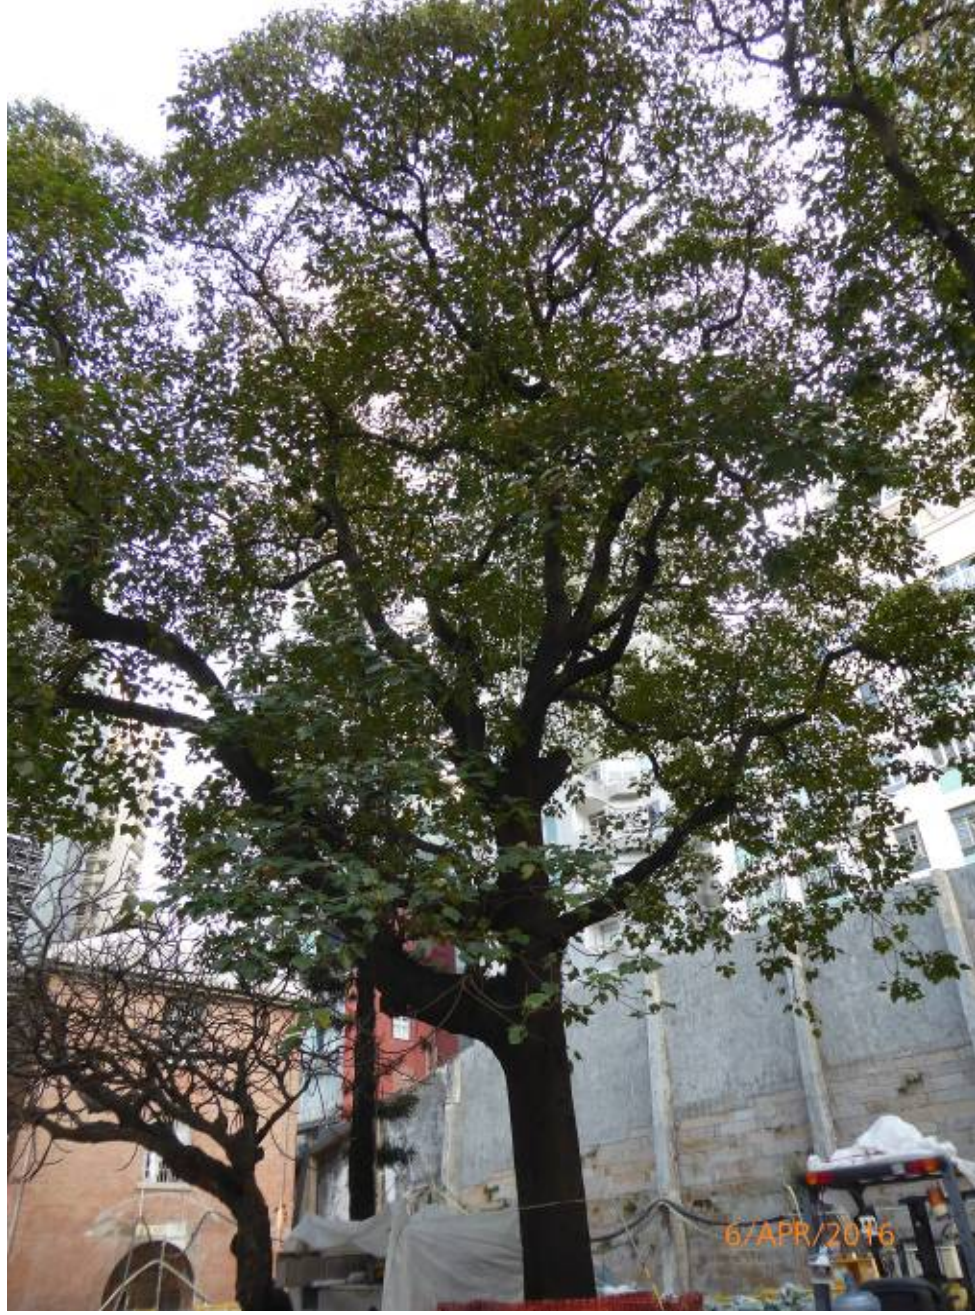
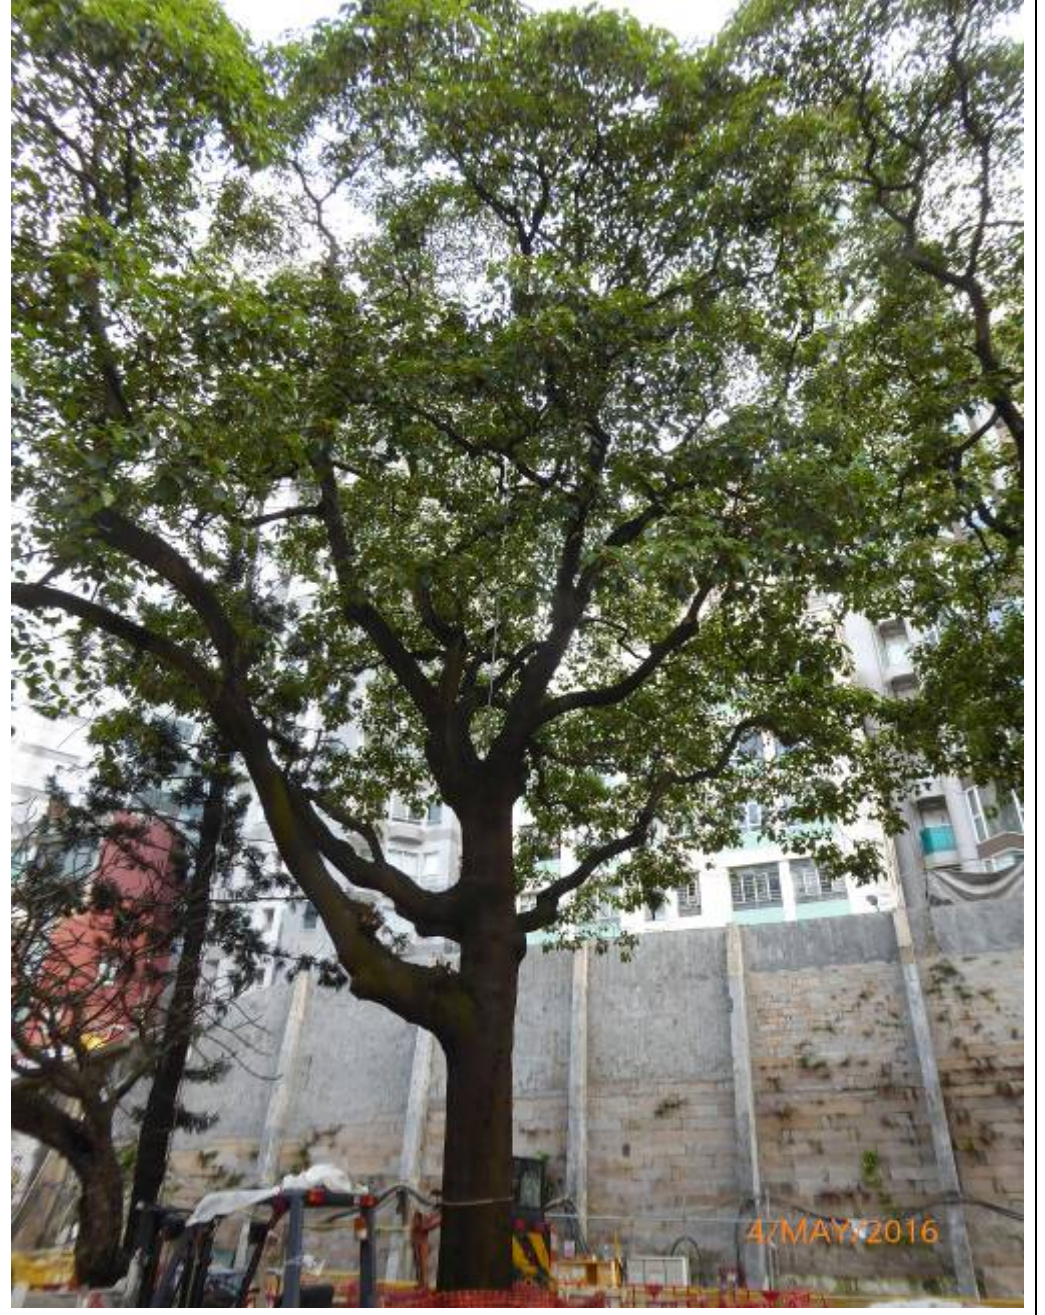
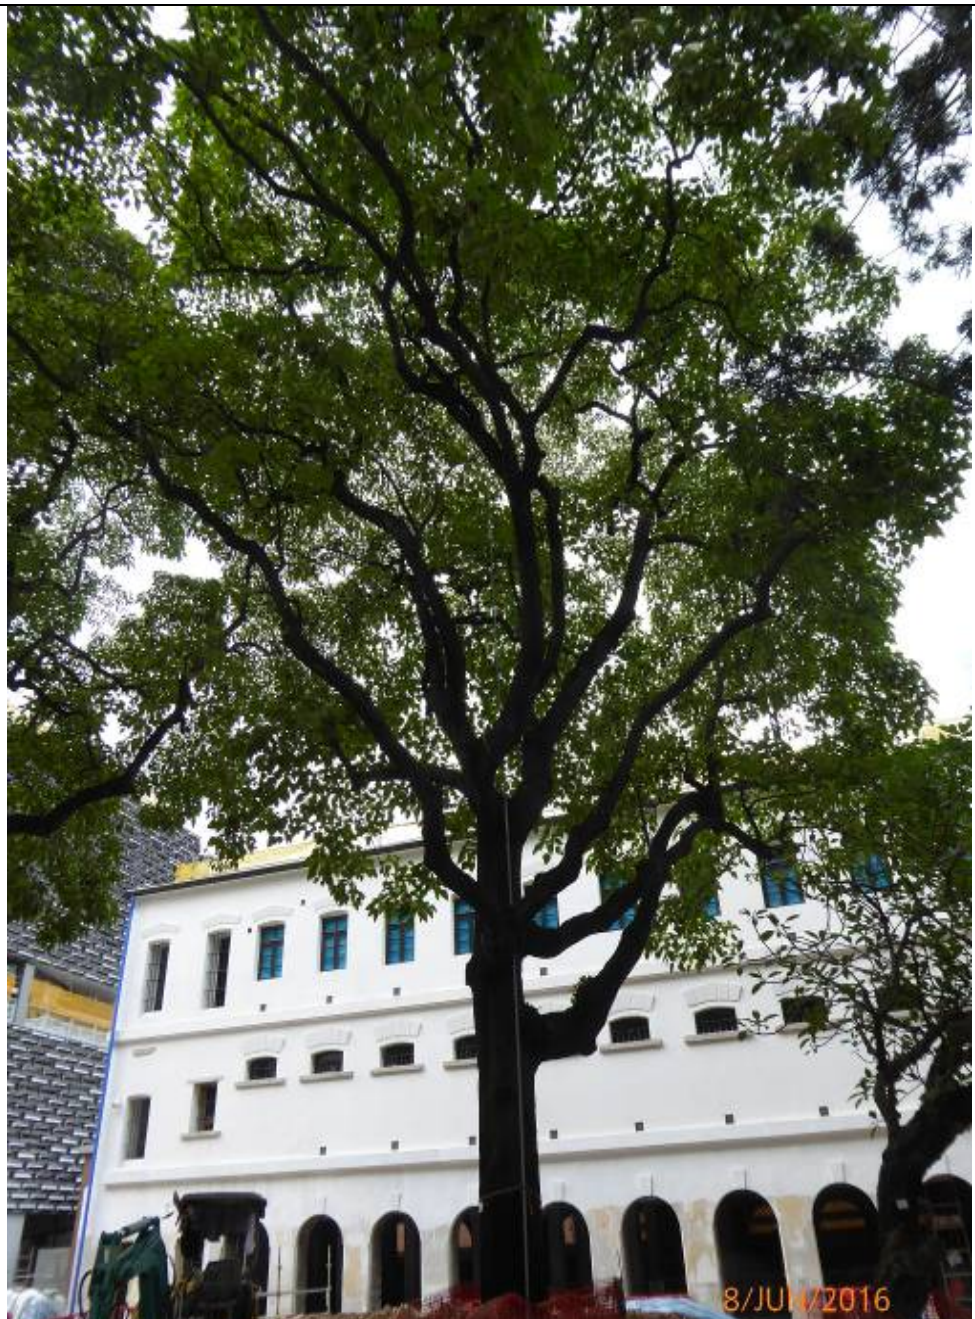
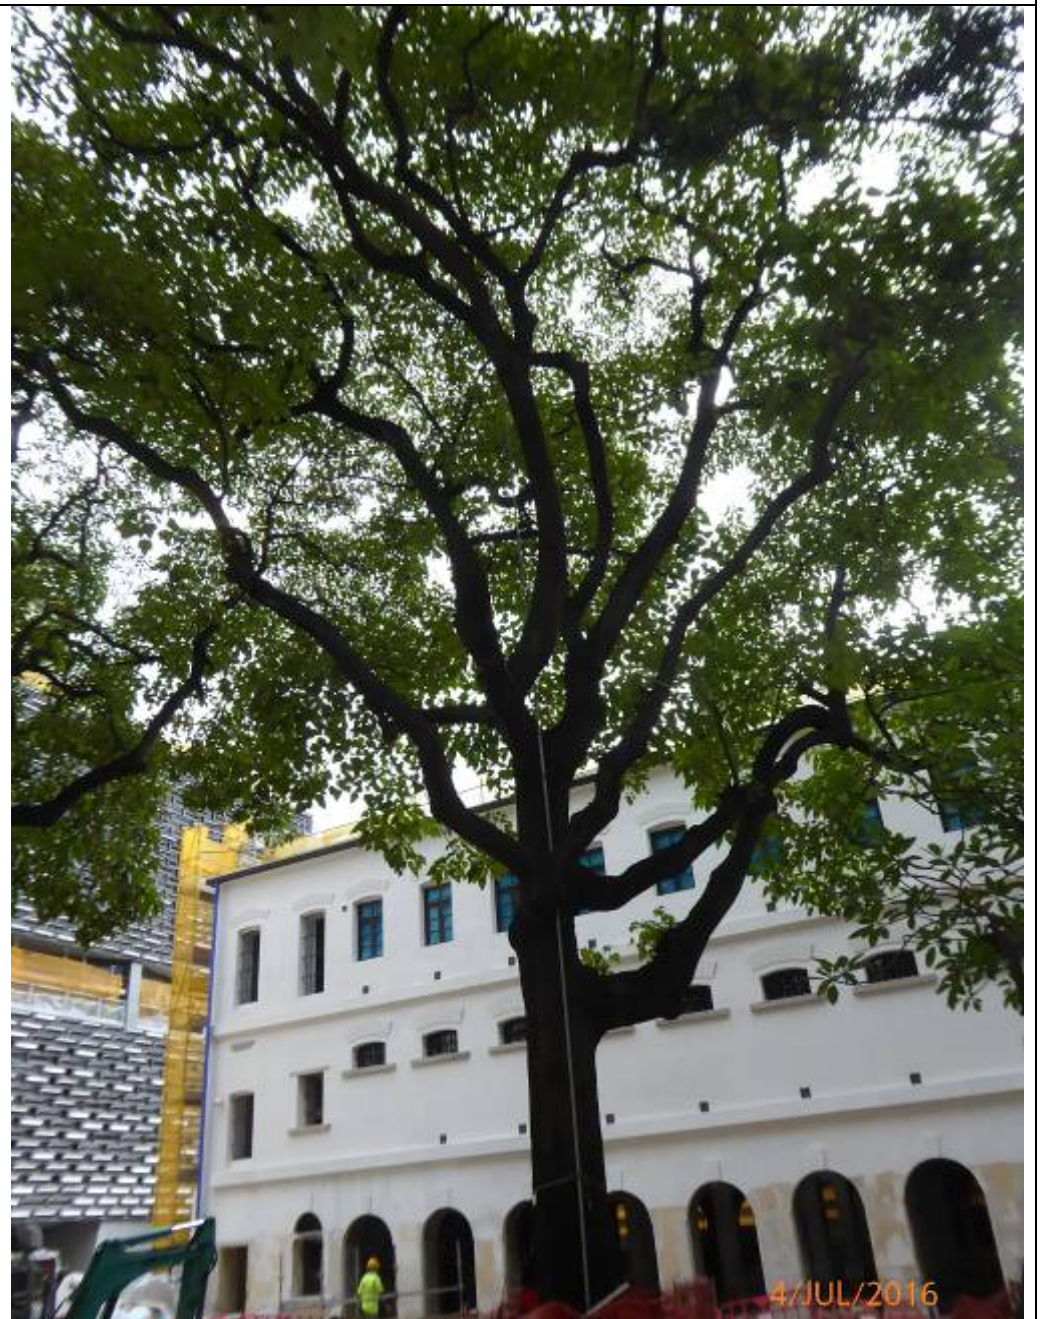
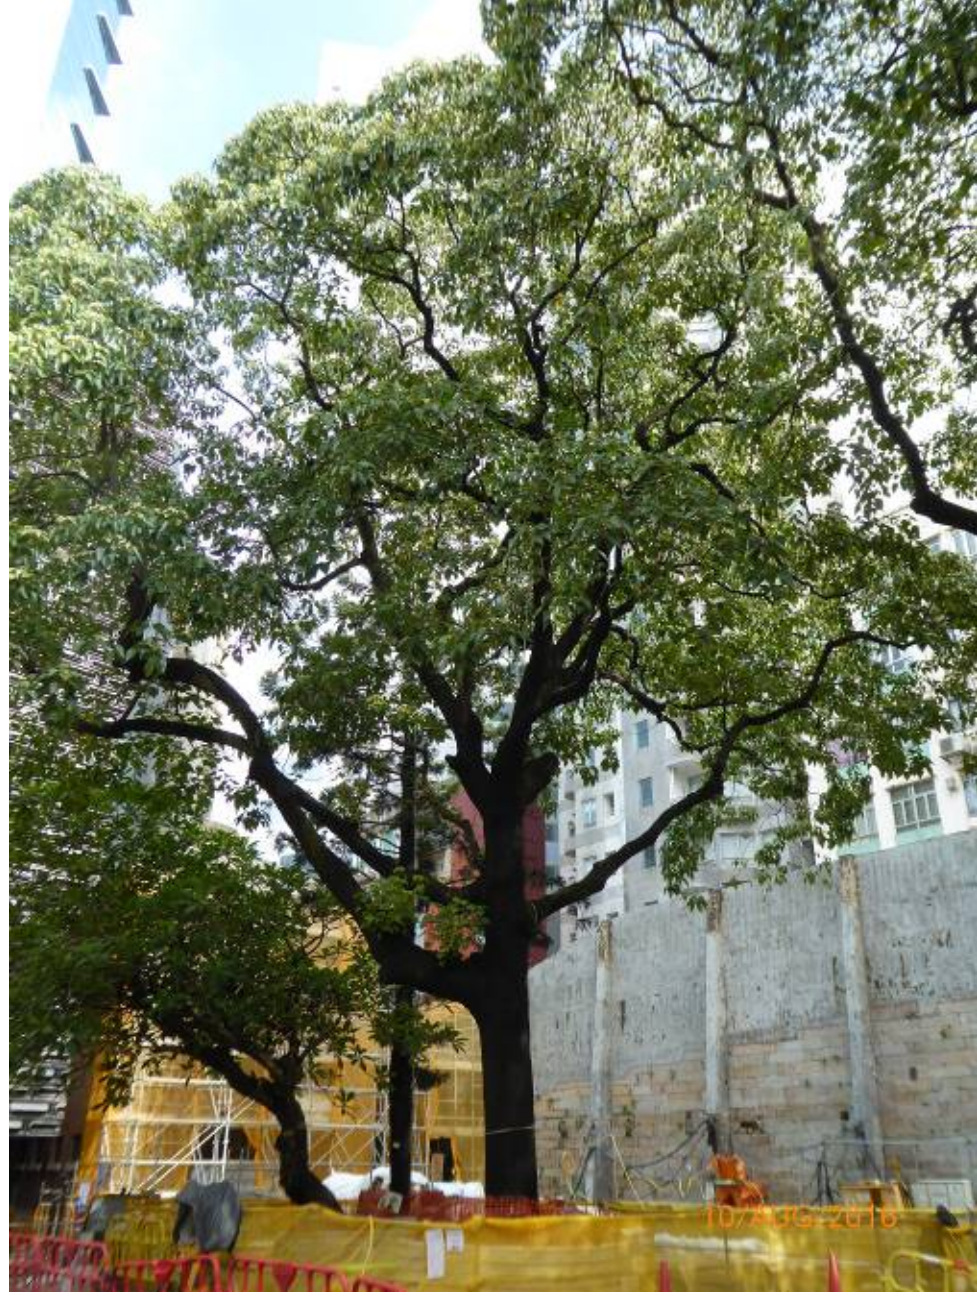
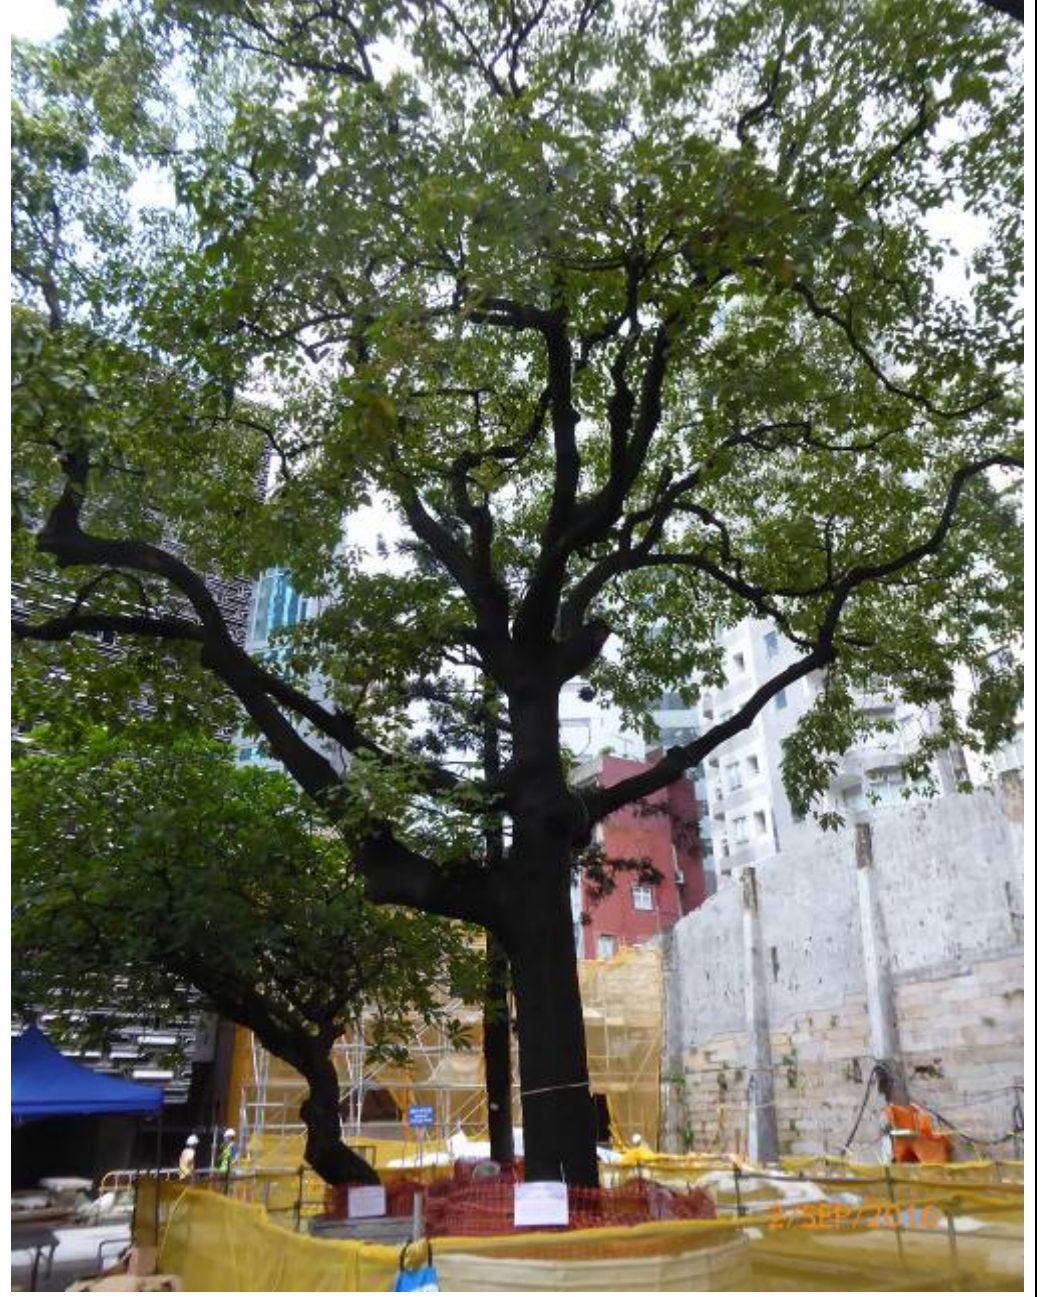
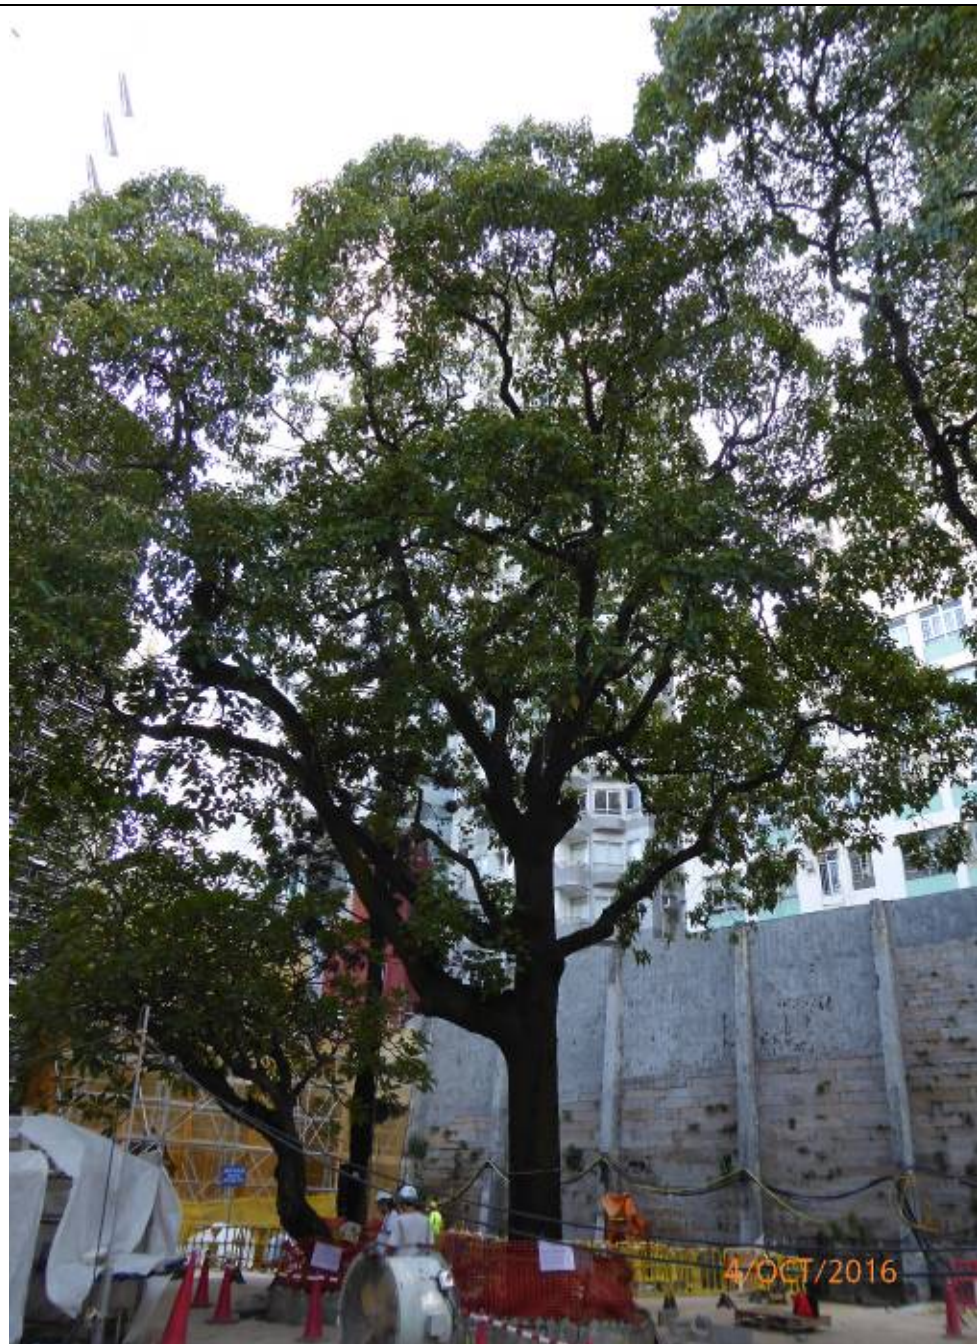
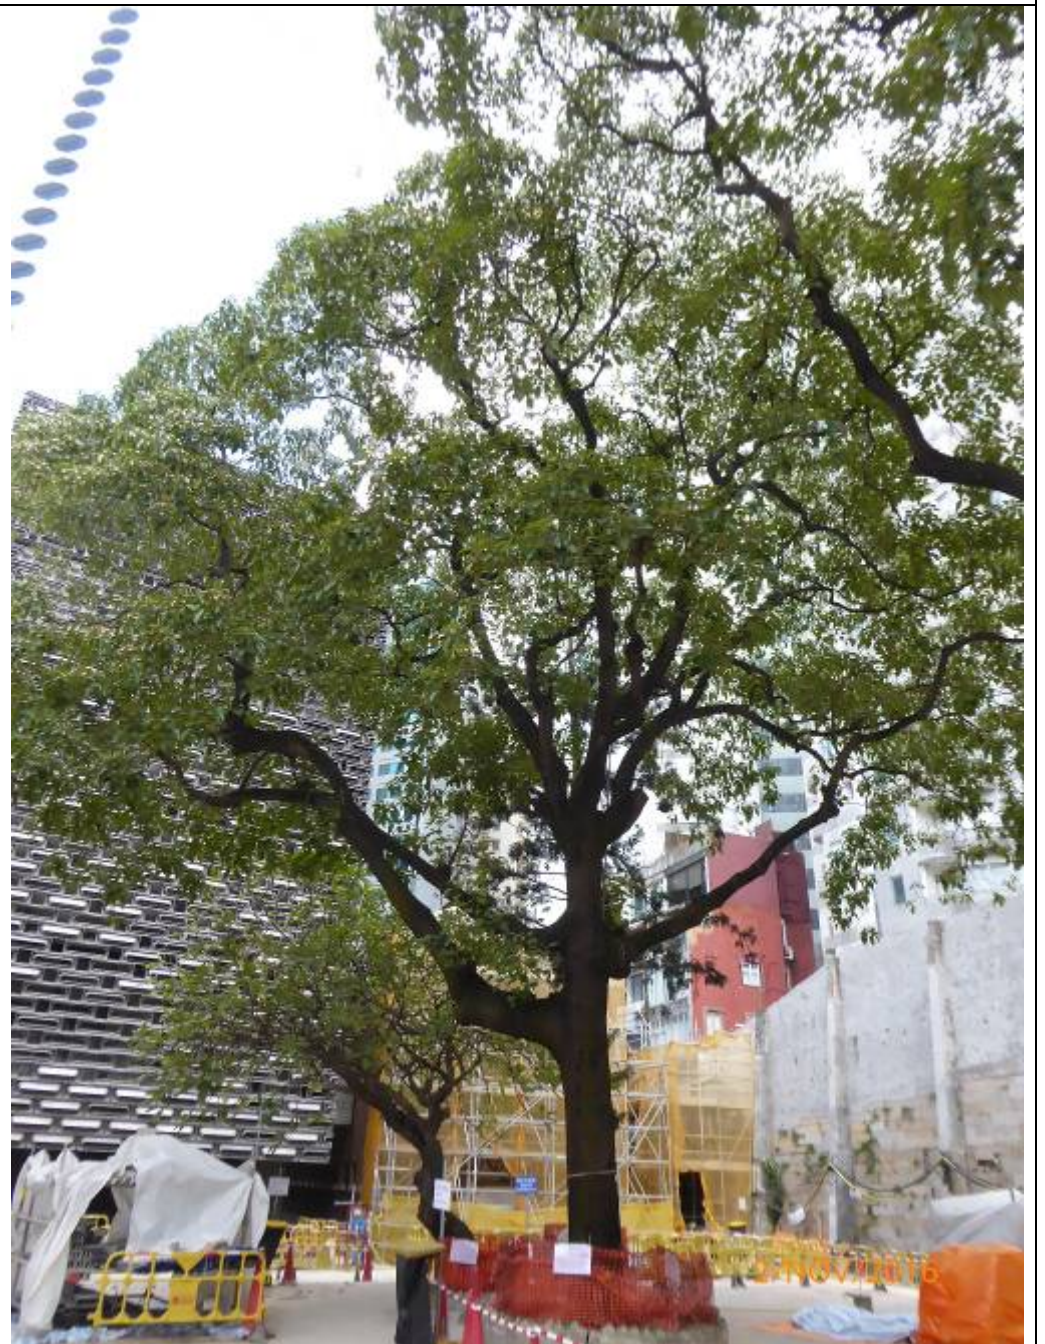
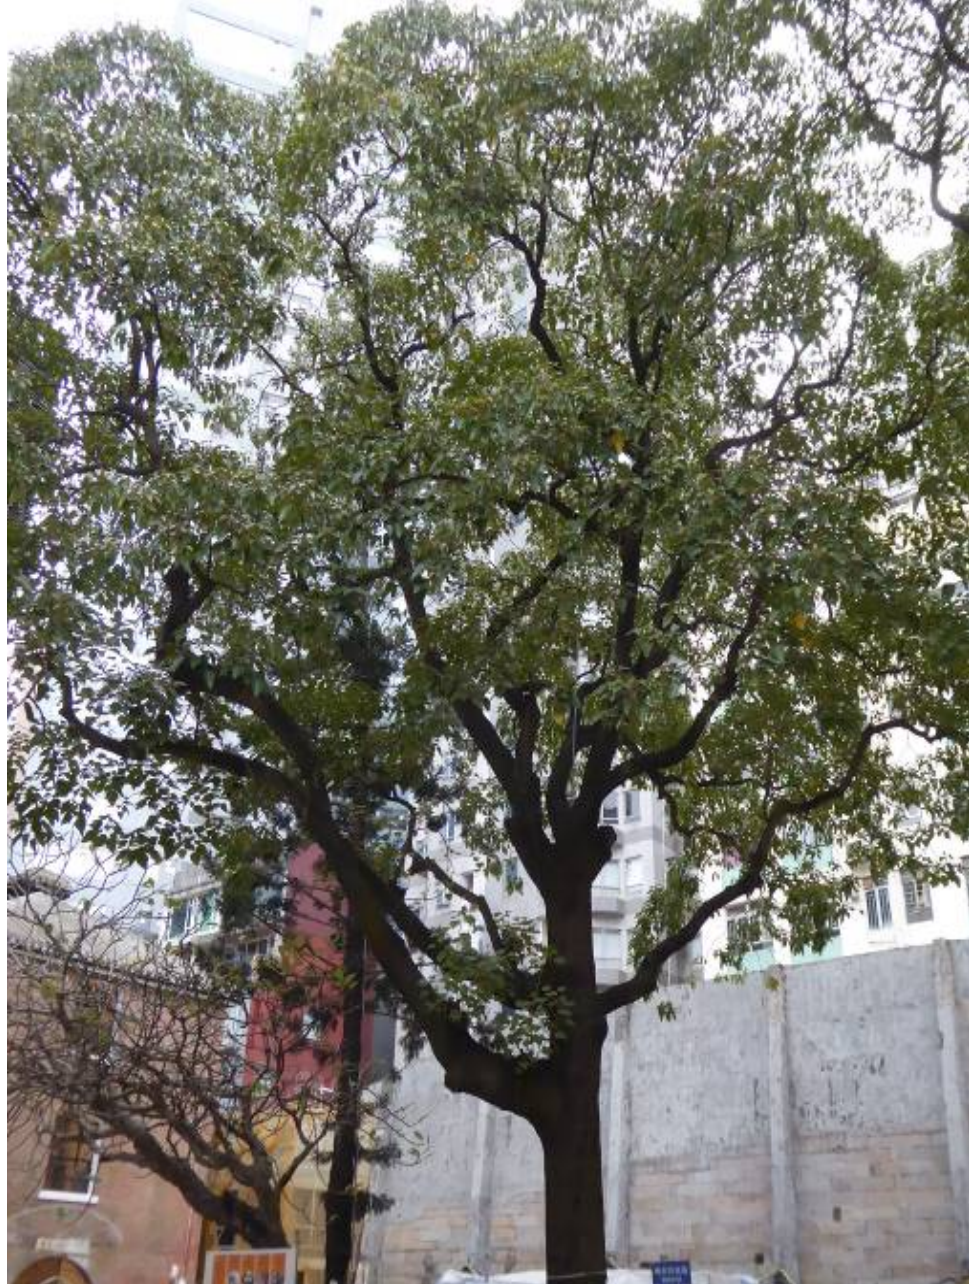
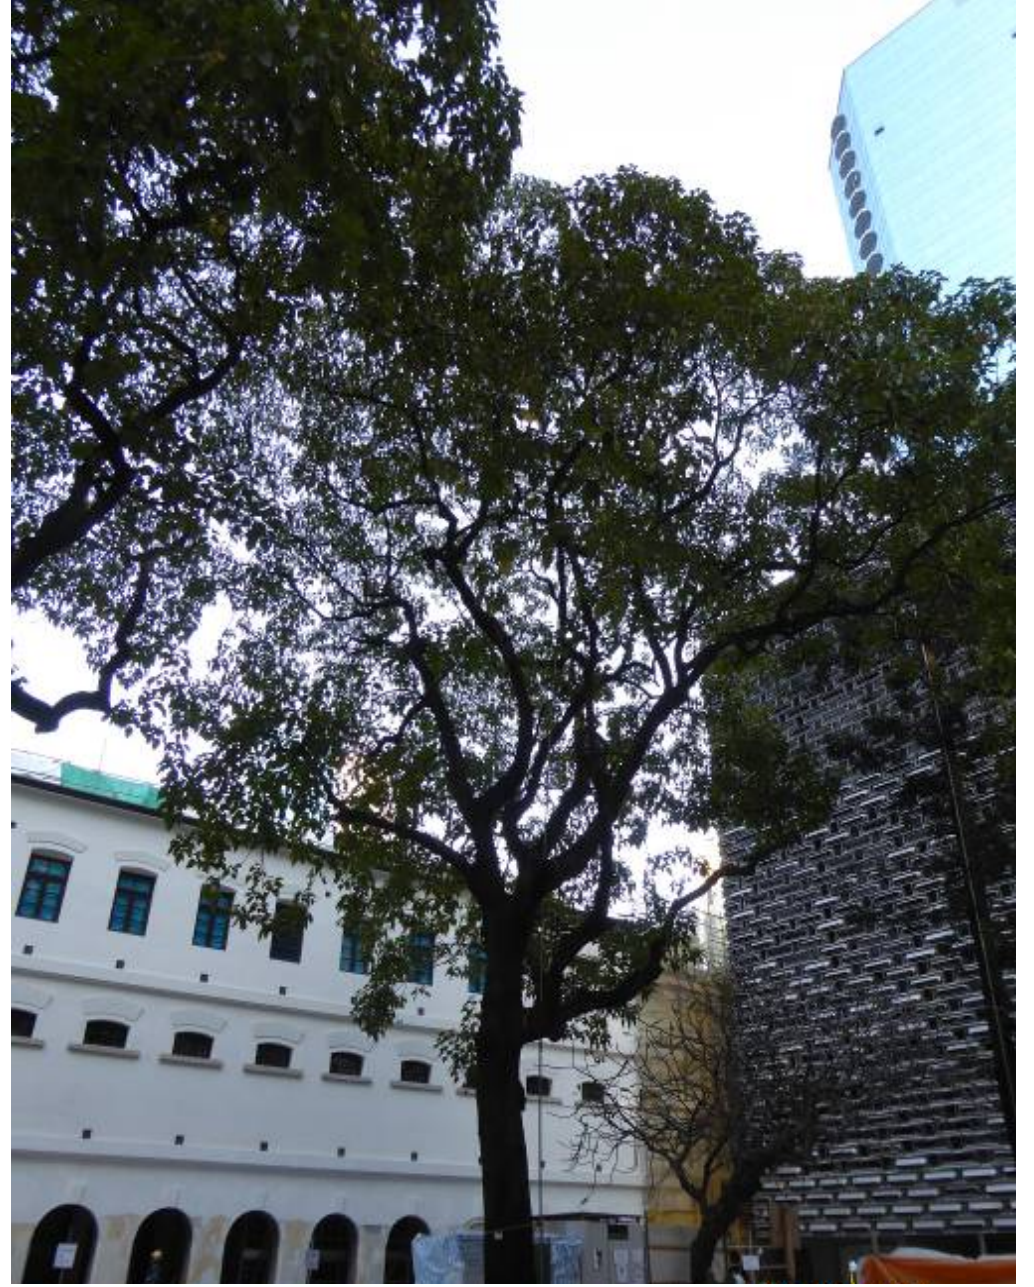
5. Photo records of Tree 6 and Tree 7 taken during the monthly tree inspections from December 2015 to July 2017 were provided below for reference. It can be seen that there is a gradual loss of leaves at Tree 6 and Tree 7 since around May 2016. However, as it is considered there is still reasonable amount of leaves on Tree 6 and Tree 7 with no apparent issues on the health of the trees observed, no actions were recommended or taken by the arborist until pests were observed during the tree inspection on 10 July 2017. The arborist has suggested two possible reasons for the loss of leaves on Tree 6 and Tree 7 since around May 2016:

i) Presence of pests – Besides the pests (*Trialeurodes vaporariorum*) which were recently discovered during the tree inspection on 10 July 2017, Tree 6 and Tree 7 have also been infected with the pest Mealy Bugs in April 2016. Pests present on the leaves take up nutrients from the trees, causing loss of leaves and potential deterioration of the health of the trees. Subsequent application of pesticides and pruning of affected leaves and branches were performed on 25 April 2016 and proved effective with signs of pests apparently reduced and hardly found after the application. Although the trees were clear of pests after the pest application on 25 April 2016, gradual loss of leaves at Tree 6 and Tree 7 can be observed since around May 2016.

ii) Age of the trees – Tree 6 and Tree 7 were planted in 1960s and are currently about 50-60 years of age. According to the arborist responsible for the trees on site and other experienced arborists in Hong Kong, *Aleurites moluccana* (Tree 6 and Tree 7), which is a non-native species, generally has a life expectancy of about 60 to 80 years. The loss of leaves and possible deterioration of health may reflect the natural aging of the tree.

3. After the tree inspection on 10 July 2017, application of pesticides on the tree crown of Tree 6 and Tree 7 and pruning of decayed log on Tree 7 have been arranged and conducted on 3 and 4 August 2017. Residents near the Project Site have been informed of the pesticide application dates in advance. Application of pesticides could not be arranged in July due to presence of frequent rainy days towards the end of July. A Registered Consulting Arborist assessed Tree 6 and Tree 7 on 12 August 2017. He commented that the pests on Tree 6 and Tree 7 appeared to be under control due to the pesticide application on 3 and 4 August 2017. According to the Registered Consulting Arborist, new and healthy branches and roots were observed on the trees. He advised the Contractor to maintain sufficient mulch in the planters and conduct regular watering to the trees. Further application of pesticides is considered not necessary at the moment but the arborist will continue to closely monitor the effectiveness of the pesticide and the health of the trees and apply further measures if required.

All construction works are carried out strictly following the necessary requirements specified in the EP, EIA, and the EM&A Manual of this Project. Application of pesticides and pruning of decayed log have been conducted on Tree 6 and Tree 7 on 3 and 4 August 2017 after the discovery of the presence of pest (*Trialeurodes vaporariorum*) during the tree inspection on 10 July 2017. As observed by the arborist in the inspection on 12 August 2017, the pests on Tree 6 and Tree 7 appeared to be under control. Further application of pesticides is considered not necessary at the moment but the arborist will continue to closely monitor the effectiveness of the pesticide and the health of the trees and apply further measures if required.
