INVESTIGATION REPORT

Log Number:	2017/07/001
Date of Enquiry Received	31 July 2017 and 5 August 2017
Location	Project Site
Nature of Enquiry	Landscape and visual
Enquiry from	Ming Pao Newspaper

Photos of Tree 6 from December 2015 to January 2017

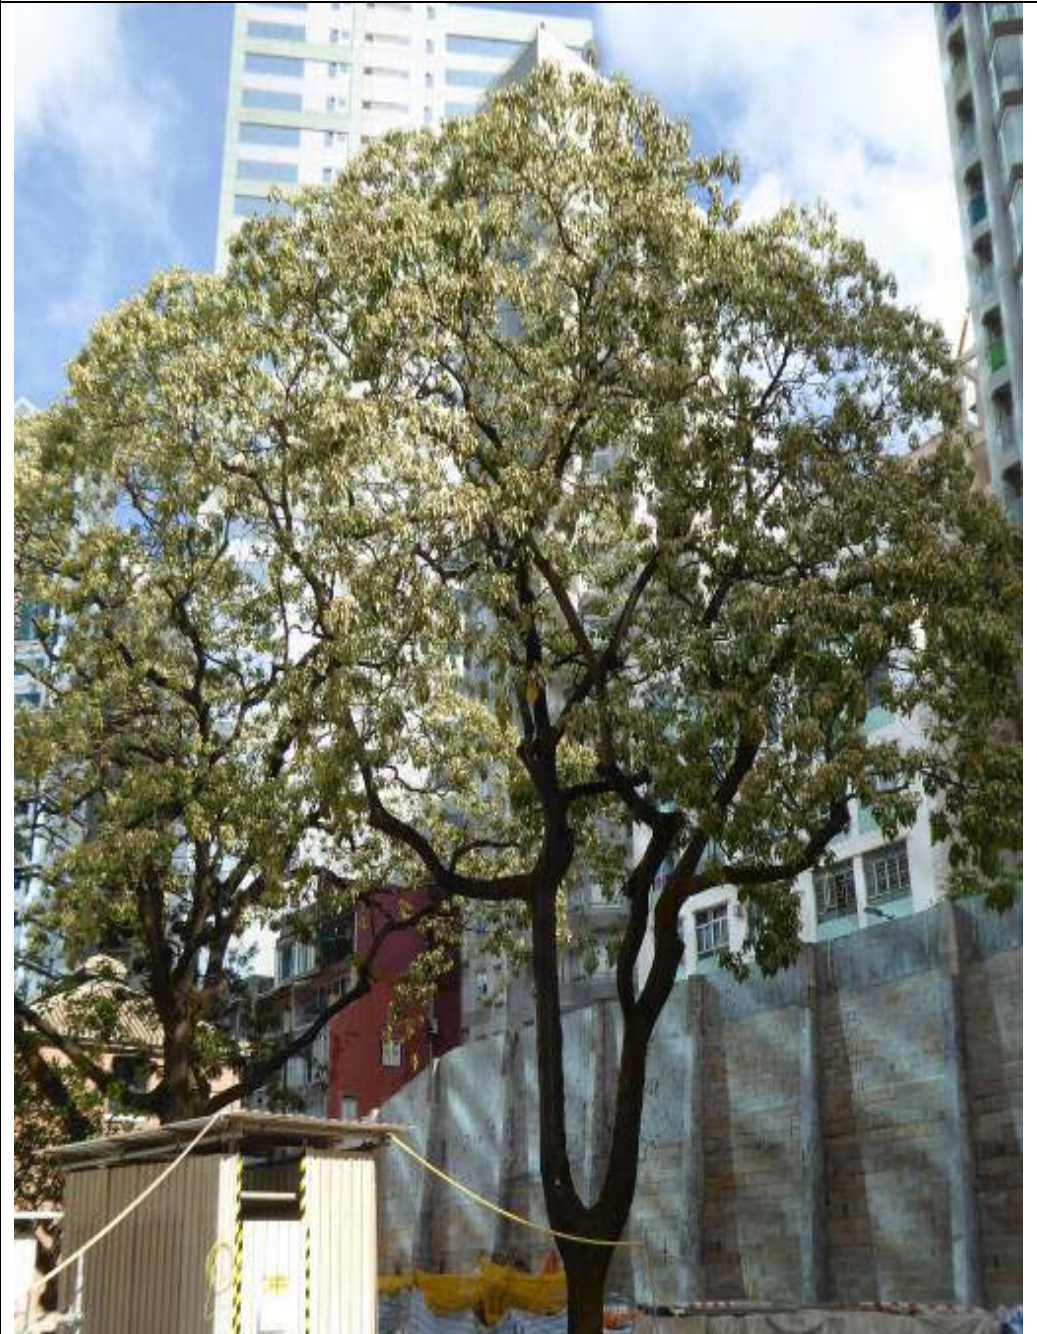
10 July 2017

2. As indicated in the Monthly Tree Inspection Report for July 2017, signs of pests (*Trialeurodes vaporariorum*) have been observed on some faded leaves of Tree 6 and Tree 7 during the tree inspection on 10 July 2017. A decayed log was also found on the upper branches of Tree 7. The arborist has recommended the application of pesticides to Tree 6 and Tree 7 and pruning of the decayed log on Tree 7 to be conducted as soon as possible to control and eliminate the pests. Although there are signs of pests, the health condition of the trunks of Tree 6 and Tree 7 is considered fair by the arborist. Some young and green leaves are growing on Tree 6, but leaves on the crown of Tree 7 are observed to be rather sparse. The tree protection zone around the planters of Tree 6 and Tree 7 are also in good condition and the areas in the vicinity of the trees are clean and tidy.

3. After the tree inspection on 10 July 2017, application of pesticides on the tree crown of Tree 6 and Tree 7 and pruning of decayed log on Tree 7 have been arranged and conducted on 3 and 4 August 2017. Residents near the Project Site have been informed of the pesticide application dates in advance. Application of pesticides could not be arranged in July due to presence of frequent rainy days towards the end of July. A Registered Consulting Arborist assessed Tree 6 and Tree 7 on 12 August 2017. He commented that the pests on Tree 6 and Tree 7 appeared to be under control due to the pesticide application on 3 and 4 August 2017. According to the Registered Consulting Arborist, new and healthy branches and roots were observed on the trees. He advised the Contractor to maintain sufficient mulch in the planters and conduct regular watering to the trees. Further application of pesticides is considered not necessary at the moment but the arborist will continue to closely monitor the effectiveness of the pesticide and the health of the trees and apply further measures if required.
