Annex M1 – Summary of Key Findings and Recommendations during the Monthly Site Audits

Site Memorandum No. 986

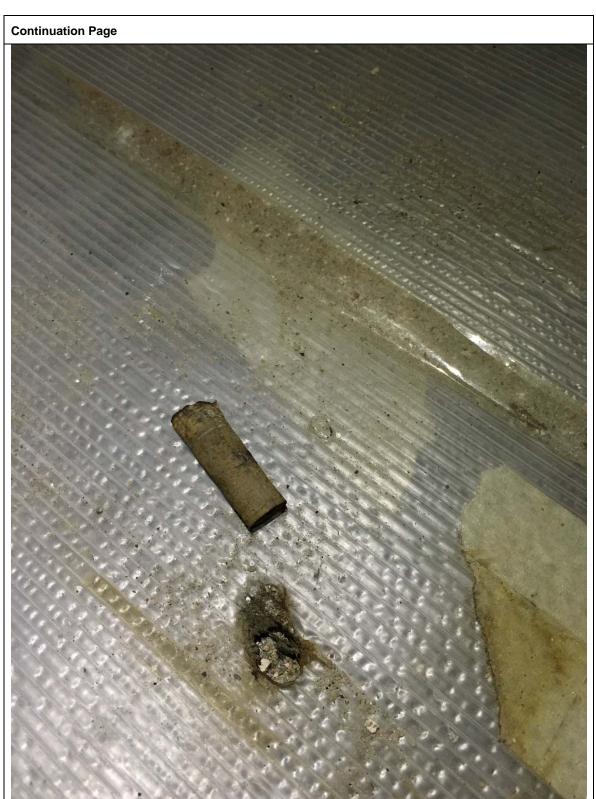
During a site walk on 4th November 2016, we observed signs of urinating and smoking in Block 3 First Floor in rooms where timber floor boards are installed.

Above, photograph taken on 4^{th} November 2016, showing the damage by cigarette to the protection and the timber floorboards in room 03/F/22.

- Remind all site personnel of the site rules. NO SMOKING ON SITE. There is a serious risk of fire if site rules are not followed.
- 2) Ensure site rules are effectively enforced.
- Ensure the site is managed in a safe manner.
- 4) Access and report to the architect any damage caused to the timber floor boards in room 03/F/01 and 03/F/22.
- 5) Rectify any damaged floorboards at neutral cost to the contract.

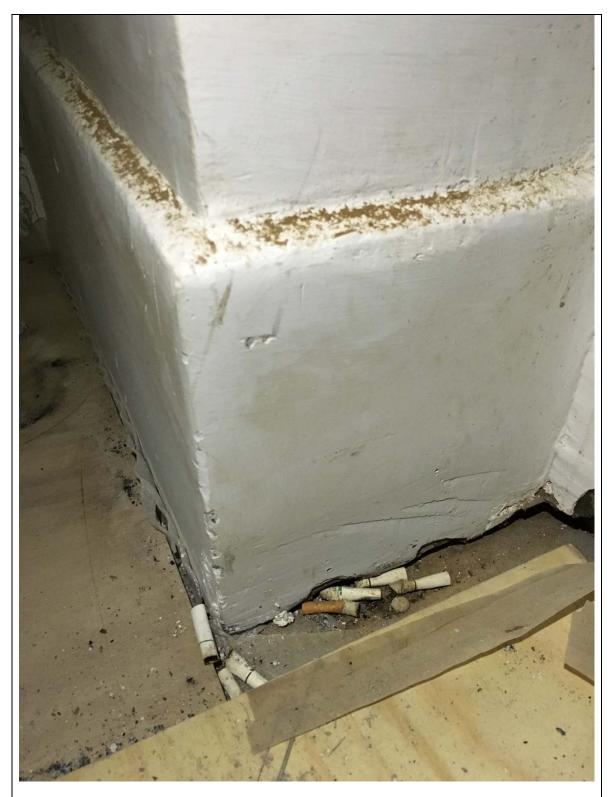
Above, photograph taken on 4^{th} November 2016, showing the plenty of cigarette butts found in room 03/F/22.

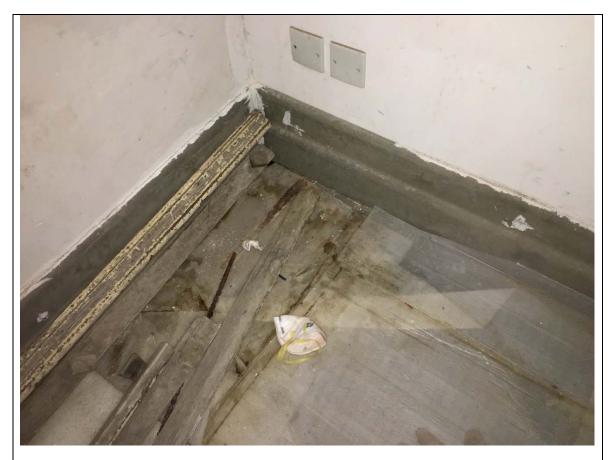
Above, photograph taken on 4th November 2016, showing sign of urinating in room 03/F/01.

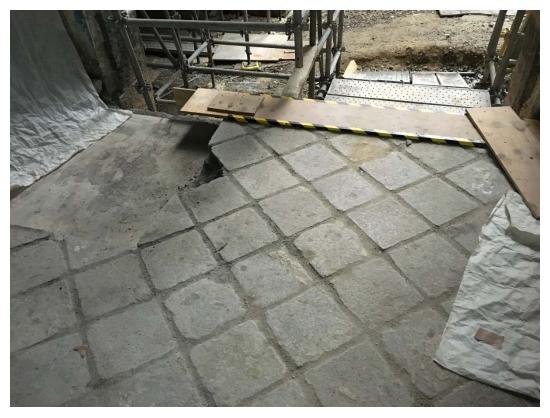
The granite flagstone in Block 10 Passageway was instructed to be labelled, carefully removed and reinstated following the installation of underground services. We have observed that the granite flagstones laid have not been installed to follow the original pattern. For example; The track on the granite flagstone near the east entrance for a former gate has not been reinstated. The solid border at the west archway has not been reinstated. The joint size is incorrect.

Photograph taken on 8th November 2016, showing the incorrect granite laying
