<p>This Site Memorandum confirms a variation of the Works following oral instructions, an inspection of site operations or the issuance of new or revised documents for construction. Unless stated otherwise, it shall be treated as an Instruction to carry out works as authorised by Architects Instruction F-620 dated 12 March 2014. Where applicable, it includes provision for distribution to all relevant members of the client/design/construction team and the Antiquities and Monuments Office.</p>	<p>Site Memorandum No. 987</p> <p>Date: 8th November 2016</p>
--	--

Subject: Non-Compliance, Smoking and Urinating in Block 3 First Floor

Subject: Non-Compliance, Incorrect Laying of Granite Flagstones in Block 10 Passageway	A.I. no: F-620
--	-----------------------

<p>Subject: Non-Compliance, Damage to Hopper from Block 9 West Elevation</p>	<p>A.I. no: F-620</p>
--	-----------------------

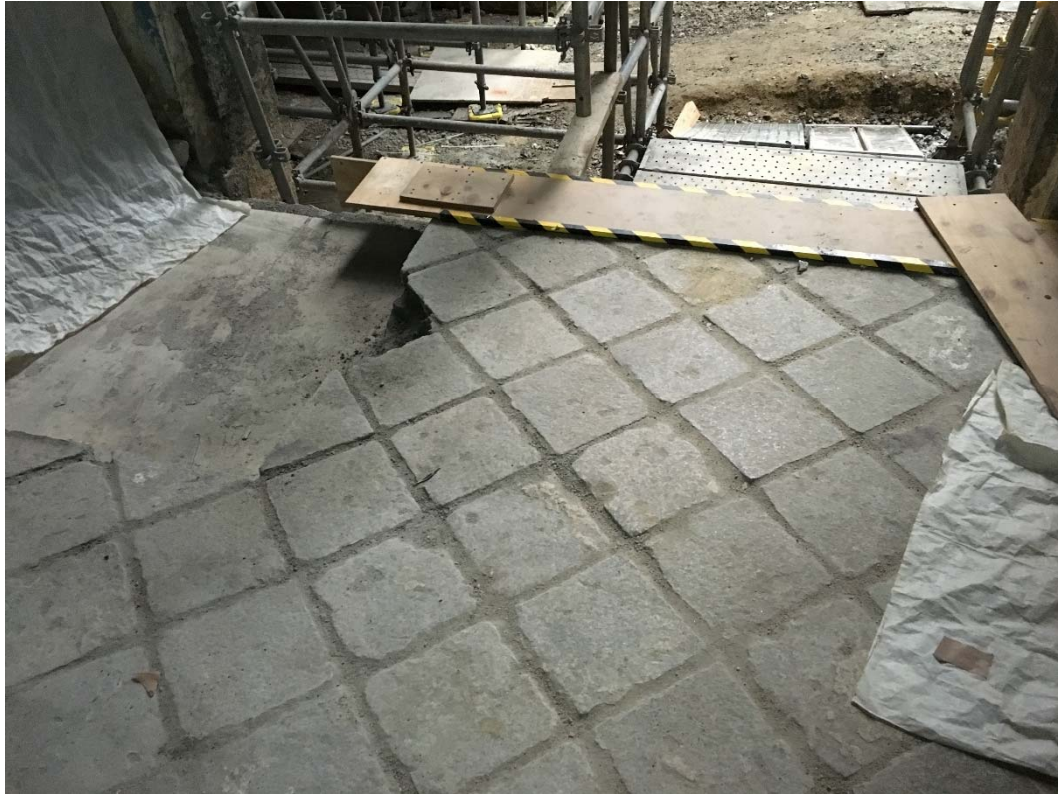
The granite flagstone in Block 10 Passageway was instructed to be labelled, carefully removed and reinstated following the installation of underground services. We have observed that the granite flagstones laid have not been installed to follow the original pattern. For example; The track on the granite flagstone near the east entrance for a former gate has not been reinstated. The solid border at the west archway has not been reinstated. The joint size is incorrect.

Photograph taken on 8th November 2016, showing the incorrect granite laying

1. Exhaust all measures to identify and locate all the granite flagstones from this area, collect the photographic record from the Contractor who lifted up the granite flagstones, lift up the granite flagstones that have been laid incorrectly, carry out a dry lay invite conservation architect for inspection, and finally lay the granite flagstones in accordance with contract documents and specifications. All the above works to be carried out at neutral cost to the contract.
2. Review and revise the work practices of the works package contractors especially the handover process of materials between different works package contractors.
3. Supervise the work operations to ensure compliance with the Contract Documents.

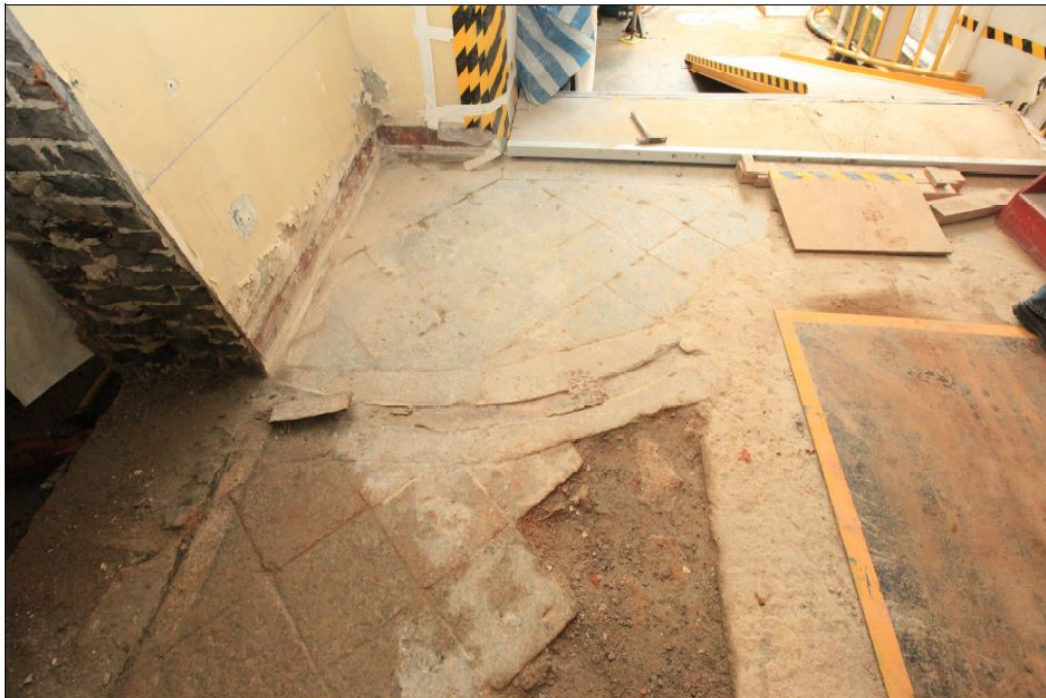
Photograph taken on 22nd August 2013 by the Management Contractor, showing the track on the granite flagstone at the East entrance.

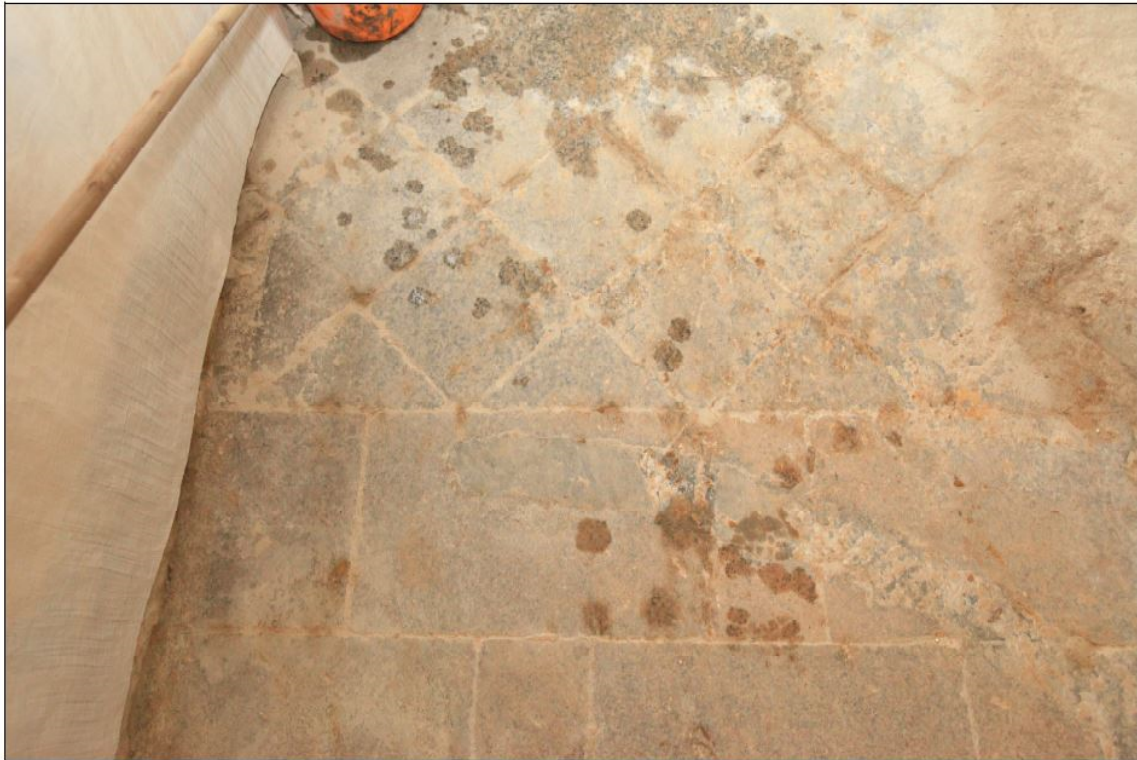
Photograph taken on 22nd August 2013 by the Management Contractor, showing the granite border at the west archway.

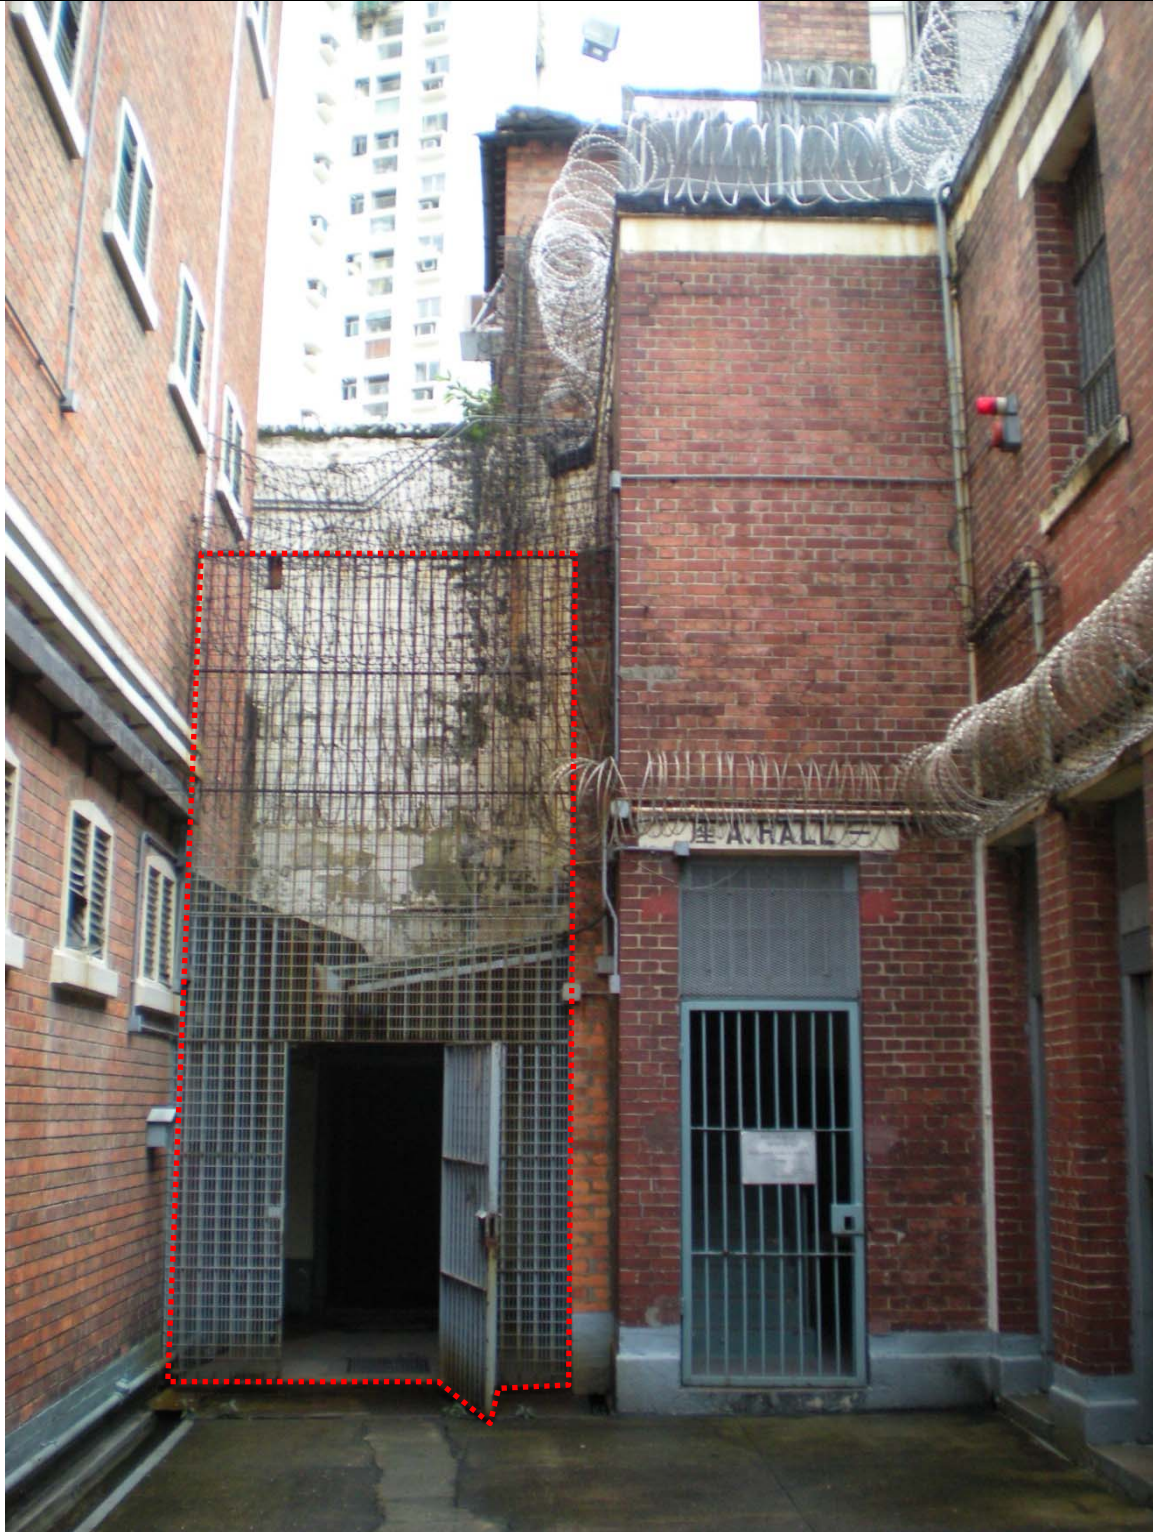
Above, photo taken on 30th July 2009, dotted line showing the Transfer Gate "A" within A Hall Yard.

<p>Heritage Impact: Historic fabric has been lost.</p> <p>Proposed Mitigation Measures: Instruct Contractor to comply with Contract Documents. Fabricate new metal gate to match original.</p> <p>Justification: N/A</p>					
<p>Variation: N</p> <p>Cost implication: N</p>	<p>LB Cost estimate: HKD Initials: Date:</p>	<p>JCCPS approved/rejected Initials: Date:</p>			
<p>Copies to:</p>					
√	Employer JCCPS	√	Structural Eng Arup		
√	Quantity Surveyor RLB	√	Services Eng JRP	√	Environmental Management ERM
√	Contract Administrator RDA	√	Design Consultant HdM	√	Antiquities & Monuments Office AMO
√	Resident Architect RDA			√	For Purcell

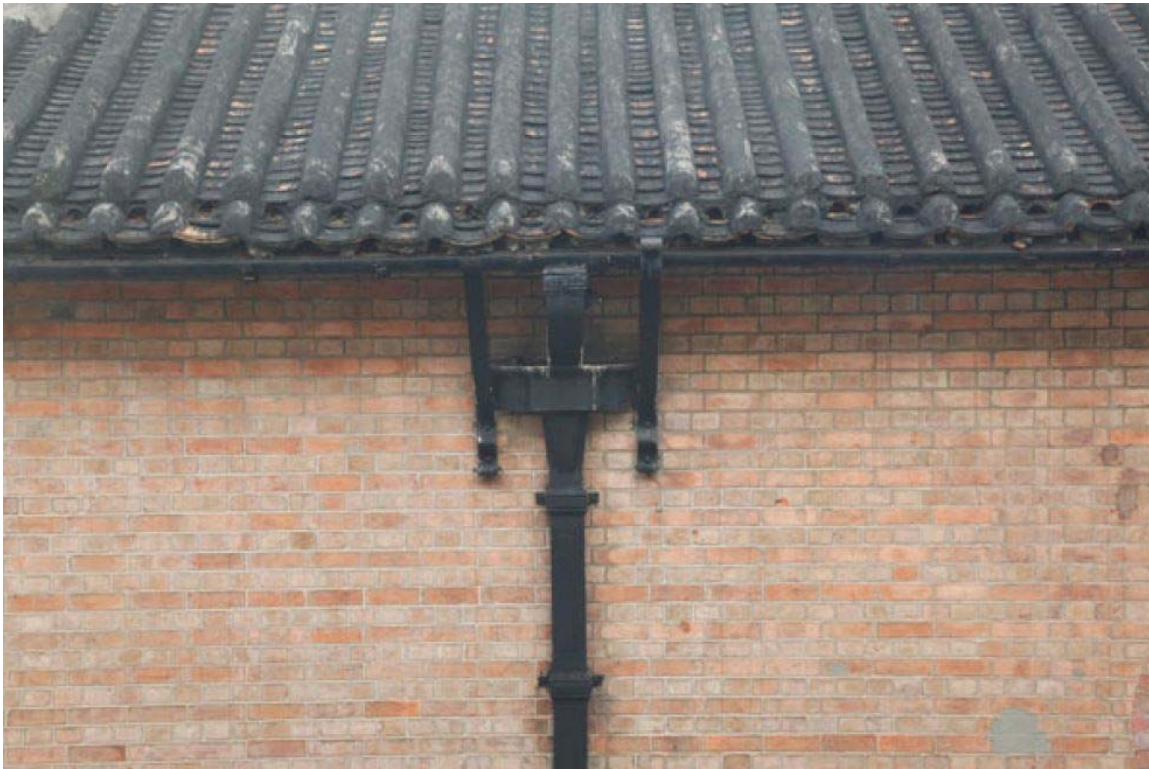
Above, photo taken on 17th August 2011, showing the historic hopper at its location.

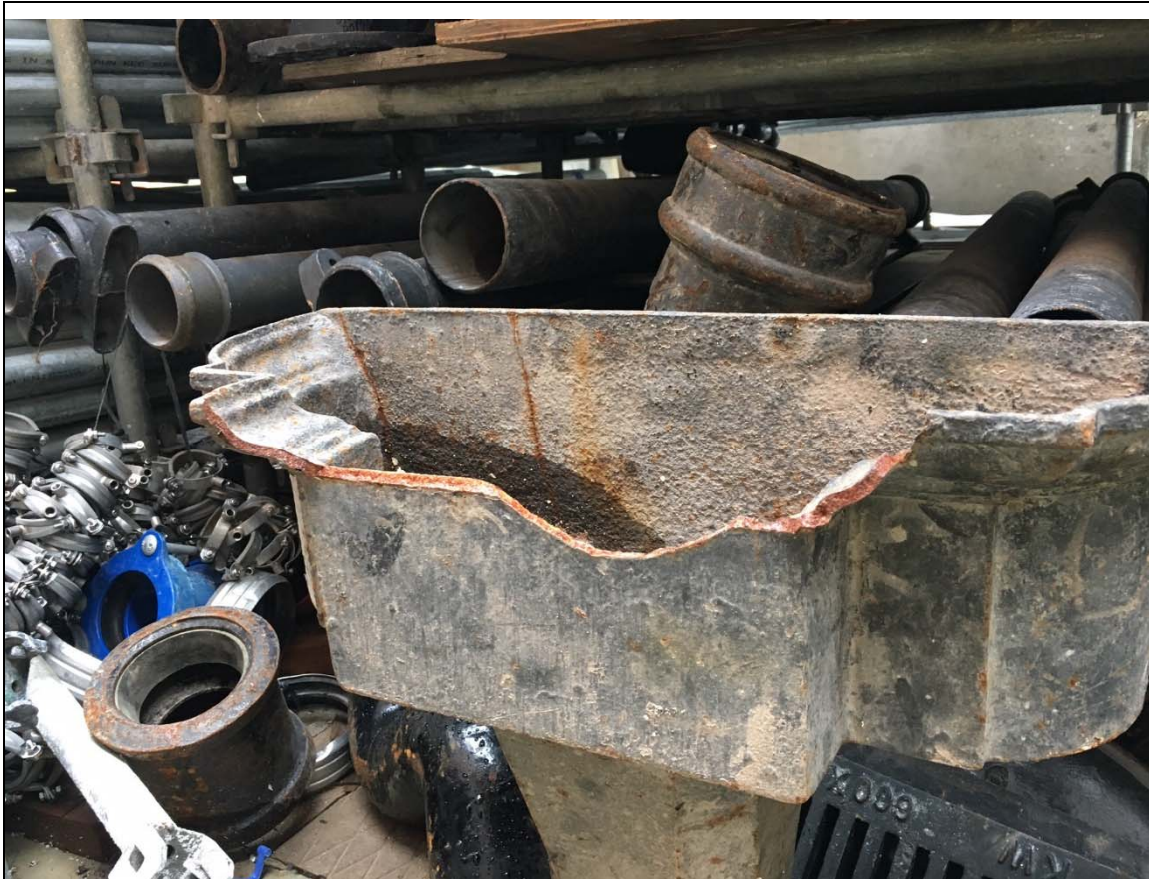
The rainwater hopper from Block 9 west elevation was instructed to be salvaged, redecorated and reinstalled. However, we were notified on 27th April 2017 that the hopper was damaged due to improper storage.

Heritage Impact: Historic fabric is damaged.

Above, photo taken on 27th April 2017, showing the hopper was damaged.

1. Submit proposals to repair the damaged hopper within 14 days of this notice. If repair is not possible, notify the Conservation Architect and fabricate new cast iron rainwater hopper to match existing profile. No work is to be carried out without approval from the Conservation Architect.
2. Review and revise the work practices of the works package contractors especially storage of historic fabric.
3. Supervise the work operations to ensure compliance with the Contract Documents.

Proposed Mitigation Measures: Instruct the Contractor to comply with contract documents. Contractor is to submit proposals to repair the damaged hopper. If repair is not possible, fabricate new cast iron rainwater hopper to match existing profile.
