Investigation Report on Breakdown of Tunnel Ventilation Fan Nos. MVB-TVF-009 and MVB-TVF-010 at Middle Ventilation Building (MVB) of Central Wanchai Bypass (CWB)

**Central – Wan Chai Bypass
and Island Eastern Corridor Link**

**Investigation Report on Breakdown of
Tunnel Ventilation Fan Nos. MVB-TVF-009
and MVB-TVF-010
(Final Report)**

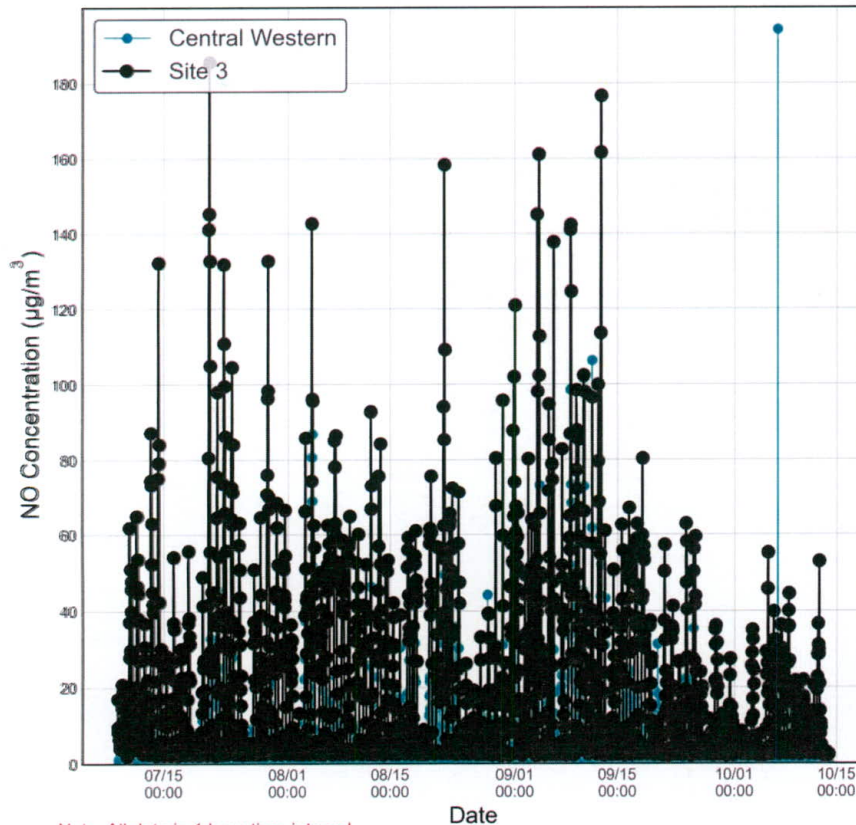
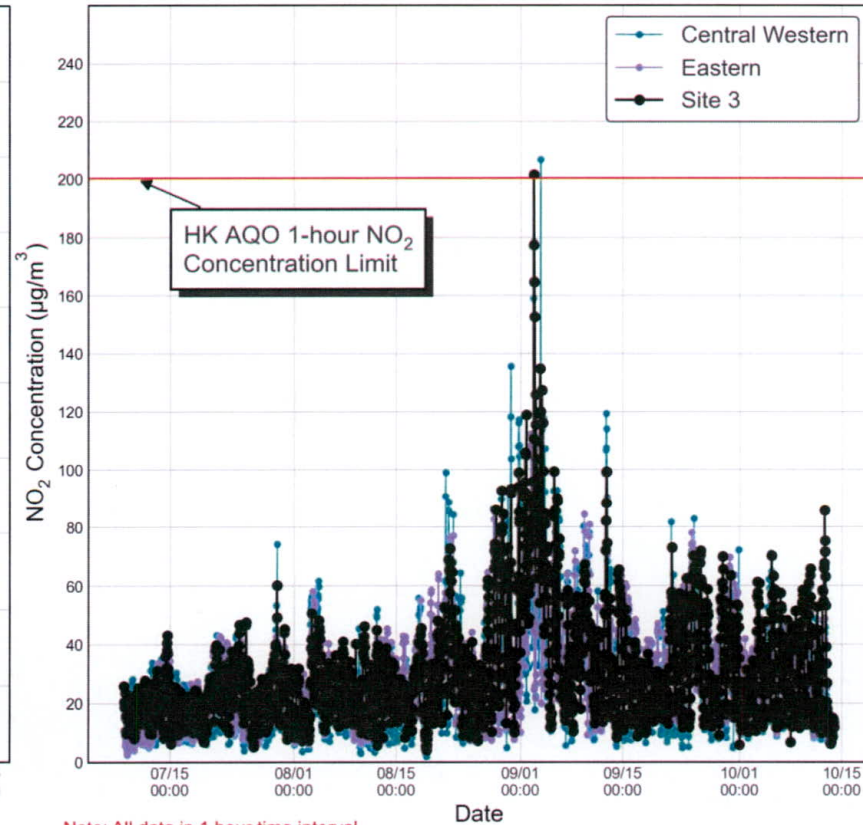
Site 3 ASR33

Most of hourly NO₂ concentration is below the 1-hour NO₂ concentration limit in HKAQO. One exceedance was observed on September 2, 2020 due to the recent high pollution episode all across Hong Kong.
