**Contract No. HY/2019/18**  
**Wanchai Development Phase II and Central-Wanchai Bypass**  
**Sampling, Field Measurement and Testing Works (Stage 4)**

**Investigation Report on Temporary Suspension of Operation of Tunnel Ventilation Fan Nos. MVB-TVF-012 and MVB-TVF-013 at Middle Ventilation Building (MVB) and Tunnel Ventilation Fan Nos. WVB-TVF-004 and 005 at West Ventilation Building (WVB) of Central Wanchai Bypass (CWB)**

**Investigation Report on Temporary  
Suspension of Operation of Tunnel  
Ventilation Fan Nos. WVB-TVF-004, WVB-  
TVF-005, MVB-TVF-012 and MVB-TVF-013  
(Final Report)**

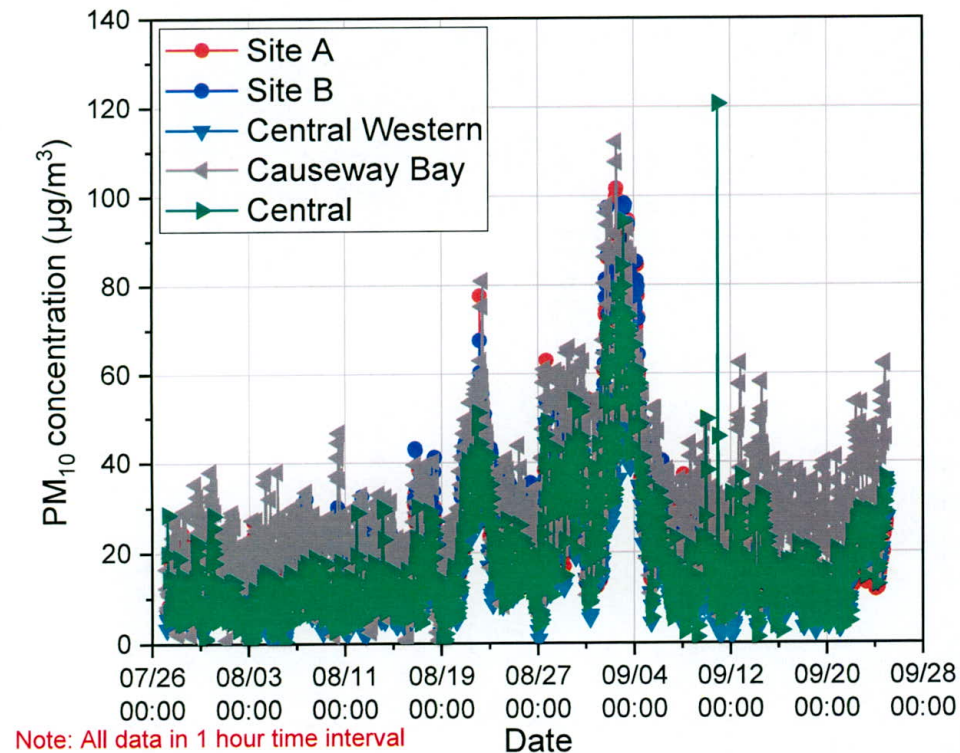
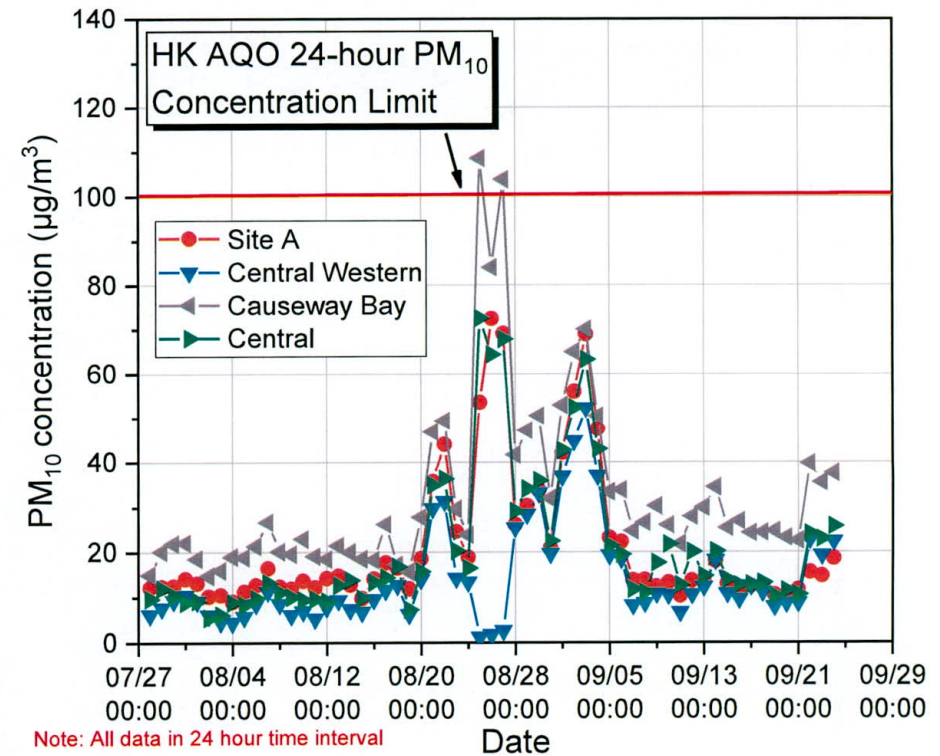
- **24-h average PM<sub>10</sub> concentration is below the 24-hour PM<sub>10</sub> concentration limit in HKAQO.**

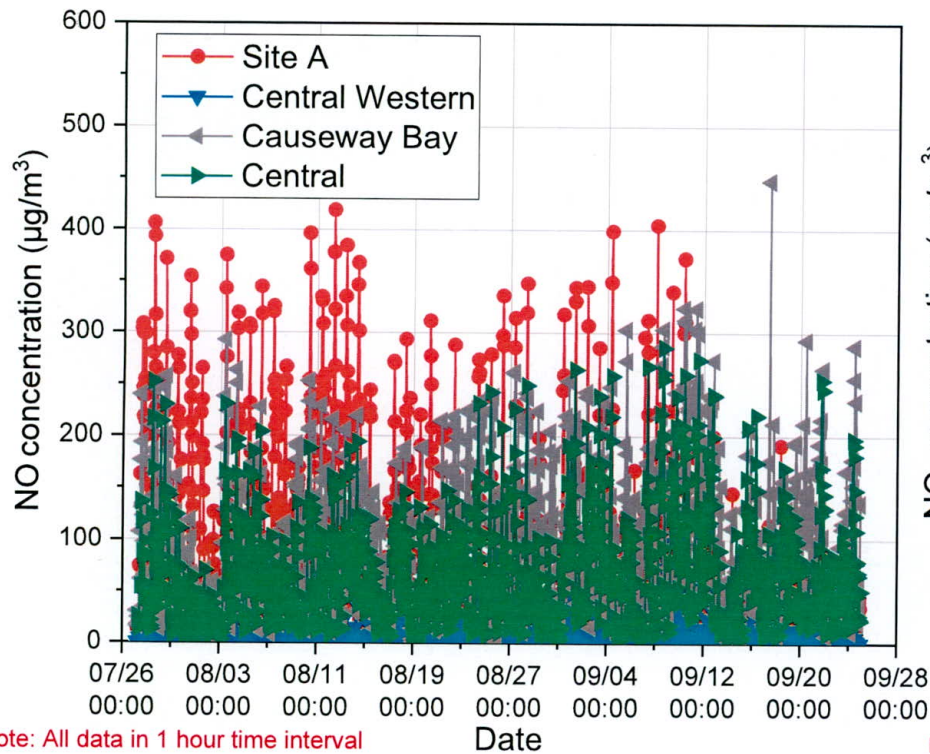
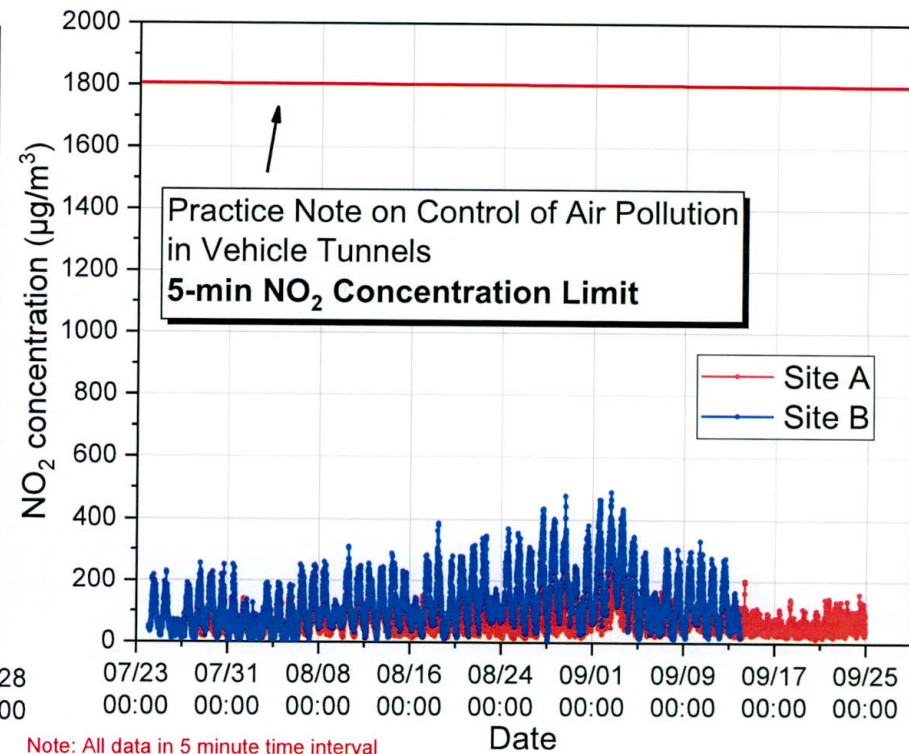
- **5-min average NO<sub>2</sub> concentration is below the 5-min concentration limit in the Practice Note on Control of Air Pollution in Vehicle Tunnels.**

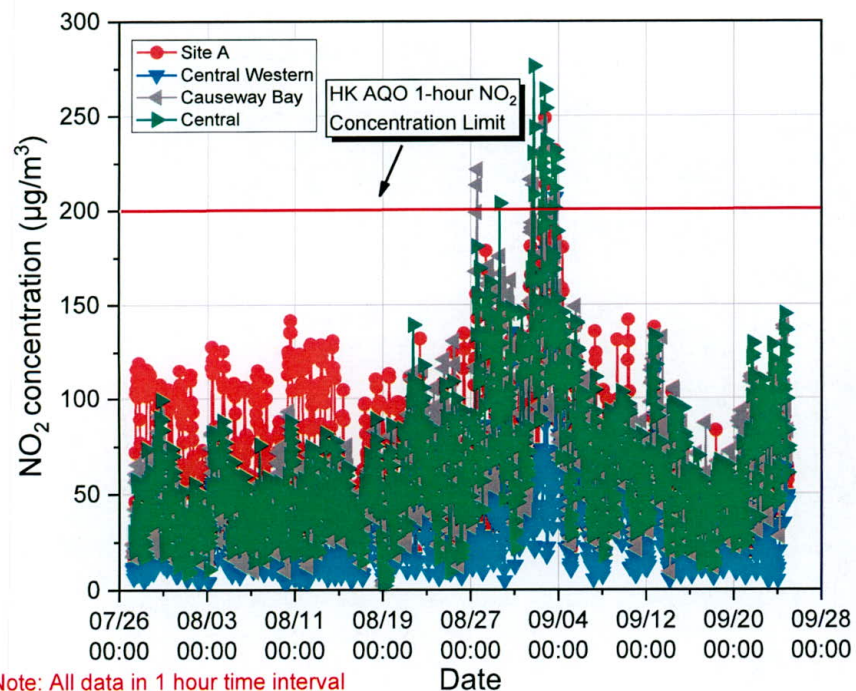
- Most of hourly NO<sub>2</sub> concentration is below the 1-hour NO<sub>2</sub> concentration limit in HKAQO. Four exceedances were observed due to the recent high pollution episode all across Hong Kong.

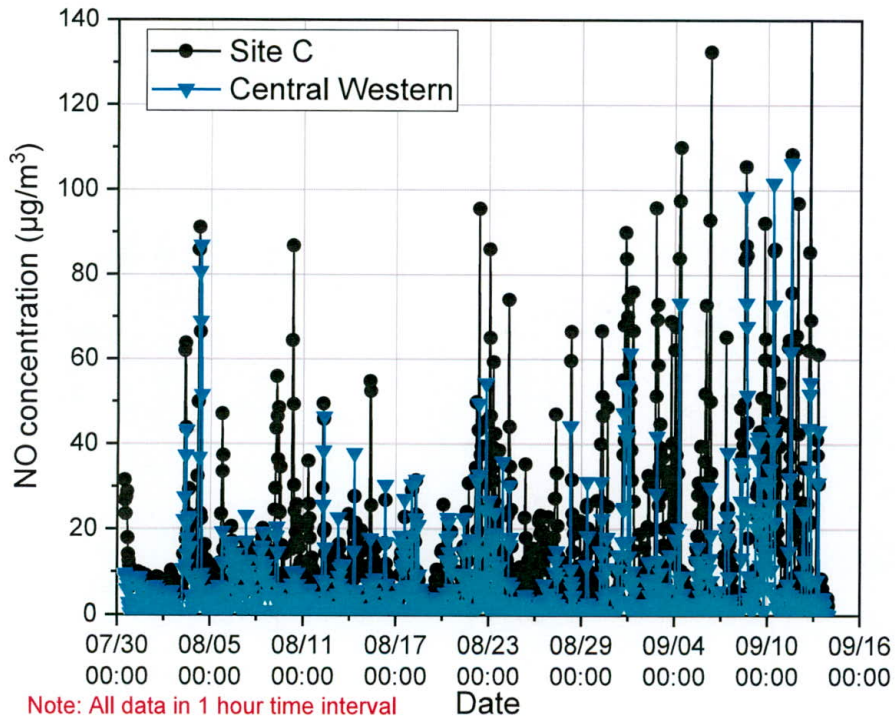
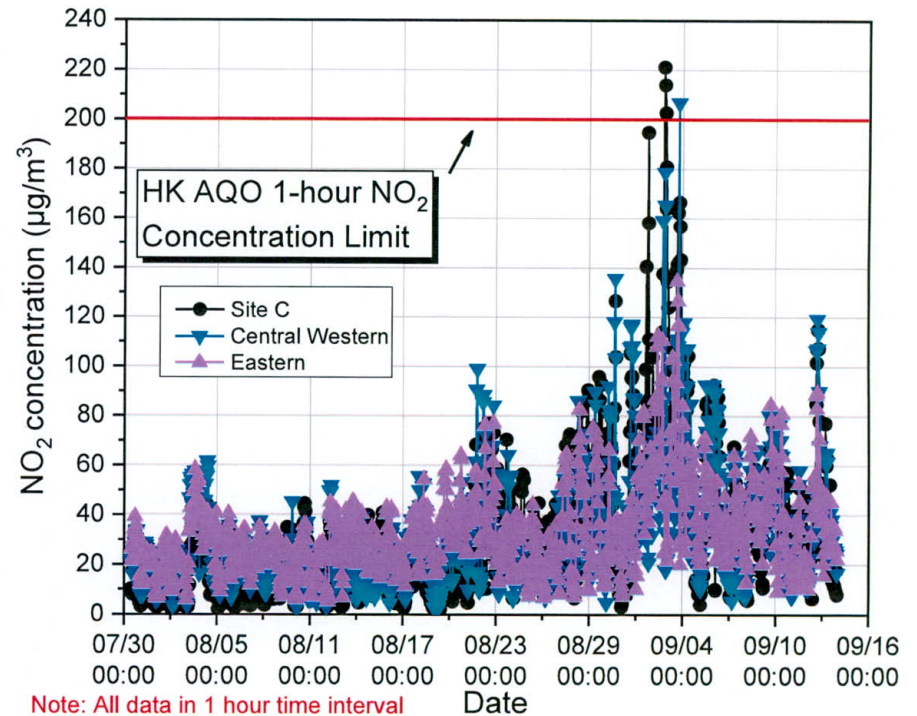
- Most of hourly  $\text{NO}_2$  concentration is below the 1-hour  $\text{NO}_2$  concentration limit in HKAQO. Three exceedances were observed due to the recent high pollution episode all across Hong Kong.

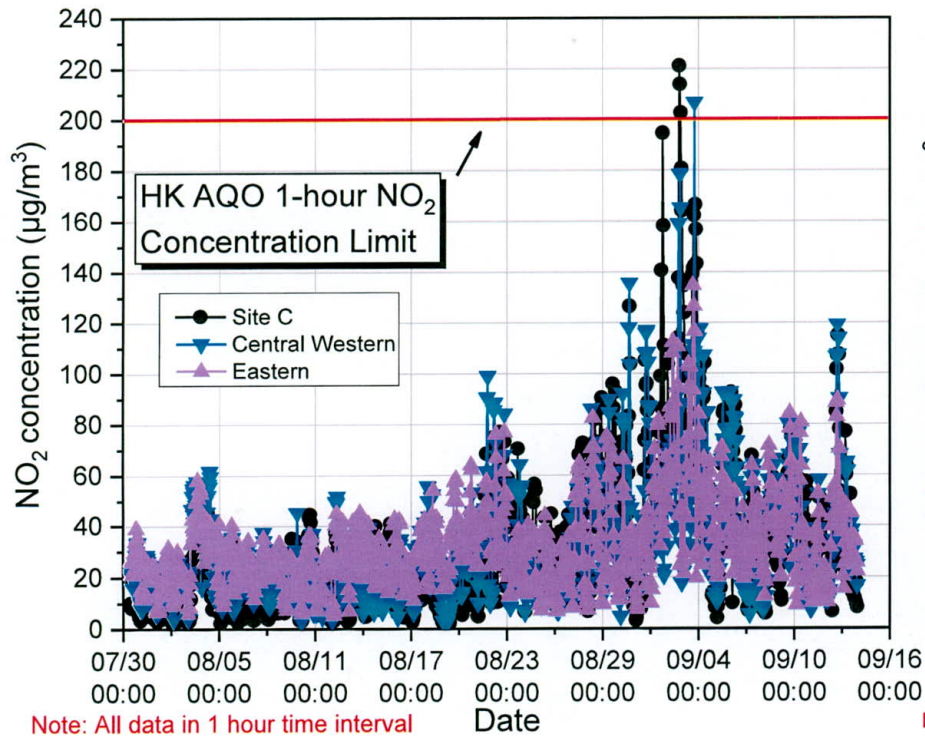
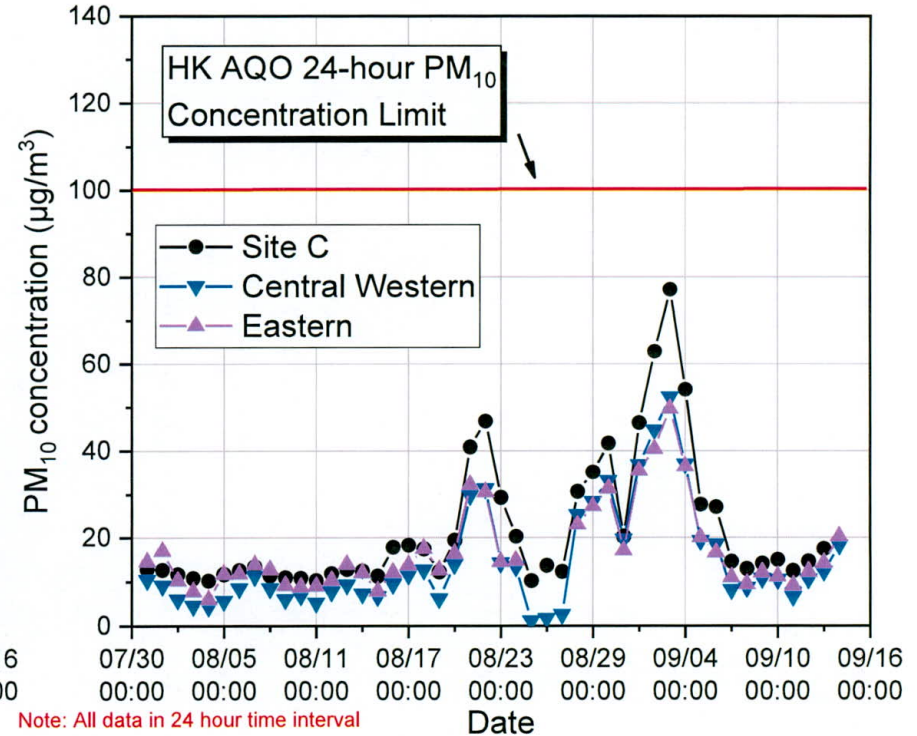
- 24-h average  $PM_{10}$  concentration is below the 24-hour  $PM_{10}$  concentration limit in HKAQO.
