Table 1 Response to EPD's Request for Supplementary Information (Ref: EPD's letter dated 9th March 2011)

ANNEX A

Update to EIA Report Section 4.6.4 Trees within the Project Site (Figures 1 and 3)

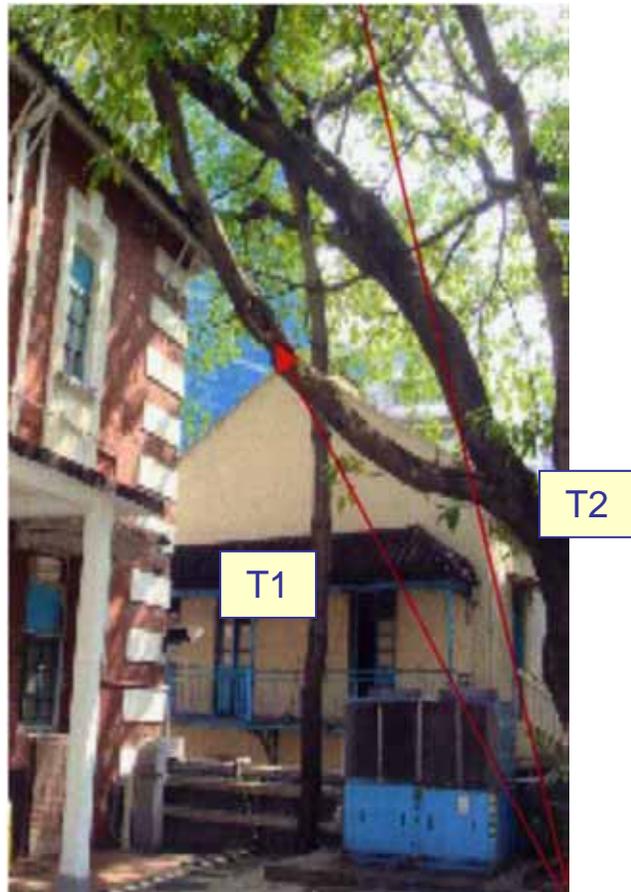
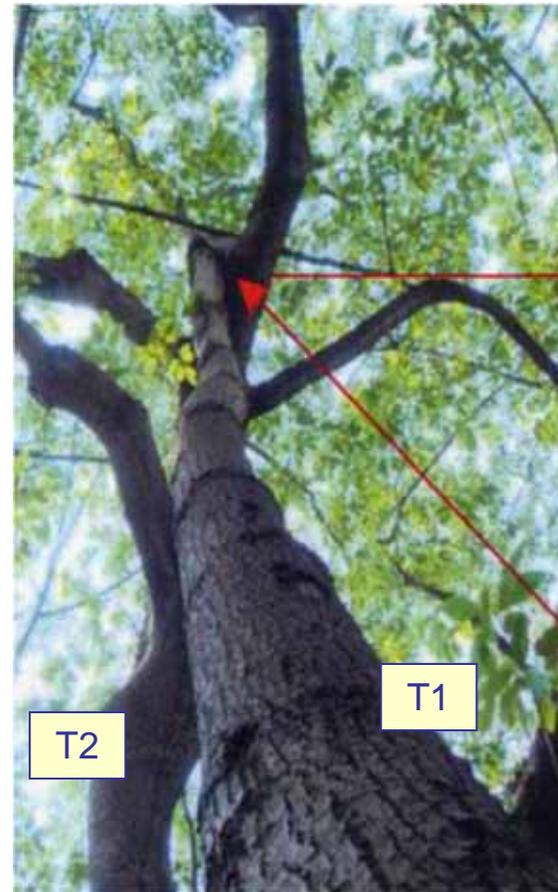
Figure 4. Before damage by Typhoon Fengshen, T1 conflicted with the much bigger and more vigorous neighbour T2, resulting in crown suppression and trunk bending of T1 (photos supplied by the Trust).

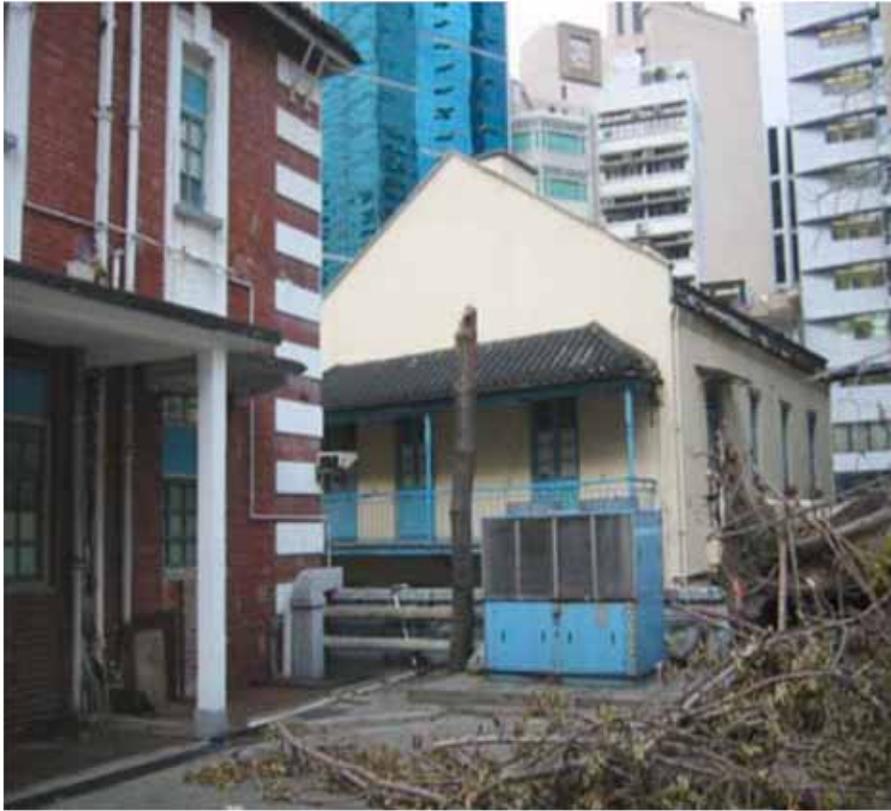
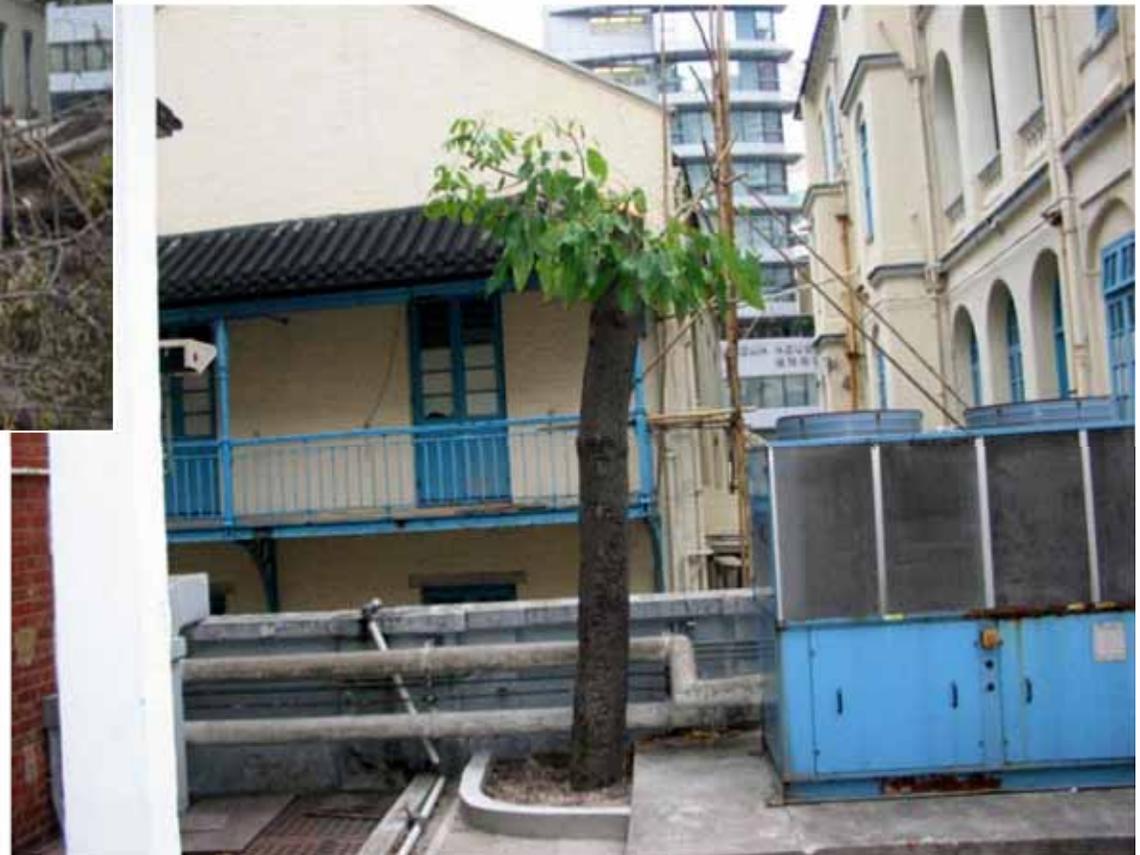
T1 was a medium-sized *Bombax ceiba*, around 25 years old, that measured 15 m tall and 4 m crown diameter before it was destroyed by Typhoon Fengshen on 25 June 2008. The gale force wind associated with typhoon signal number 8 snapped the trunk and completely removed its crown. Before the typhoon, the crown of T1 overlapped and intertwined with that of its notably larger neighbour T2. It is possible that T1 was brought down as collateral damage due to the collapse of the much larger and heavier T2. For a 15 m tall tree, the trunk diameter of 22 cm was on the low side and branch development was less than optimal, indicating that the tree's performance was of average or fair calibre. Only the lower segment of the trunk without any foliage was left of the tree after the typhoon though it is likely that the root system was able to remain more or less intact. Shortly after the typhoon, the top of the broken trunk was sawn to form a horizontal flat surface in an attempt to trim the breakage wound, leaving a trunk segment of 3.5 m tall. Following this, slender sprouts with new leaves developed from the edge of the wound to rebuild a tiny and unnatural crown. Measuring 1.9 m wide and with only a small amount of leaves, the reconstituted crown serves to resume a minimum amount of plant food production by photosynthesis to sustain the essential physiological functions of the emaciated tree. The wind force that caused the trunk snapping had created cracks that extend downwards from the wound.

Figure 5. The status of T1 after Typhoon Fengshen that struck on 25 June 2008 (left), and on 03 October 2008 showing initiation of sprouts from the top of the truncated trunk (right) (photos supplied by the Trust).

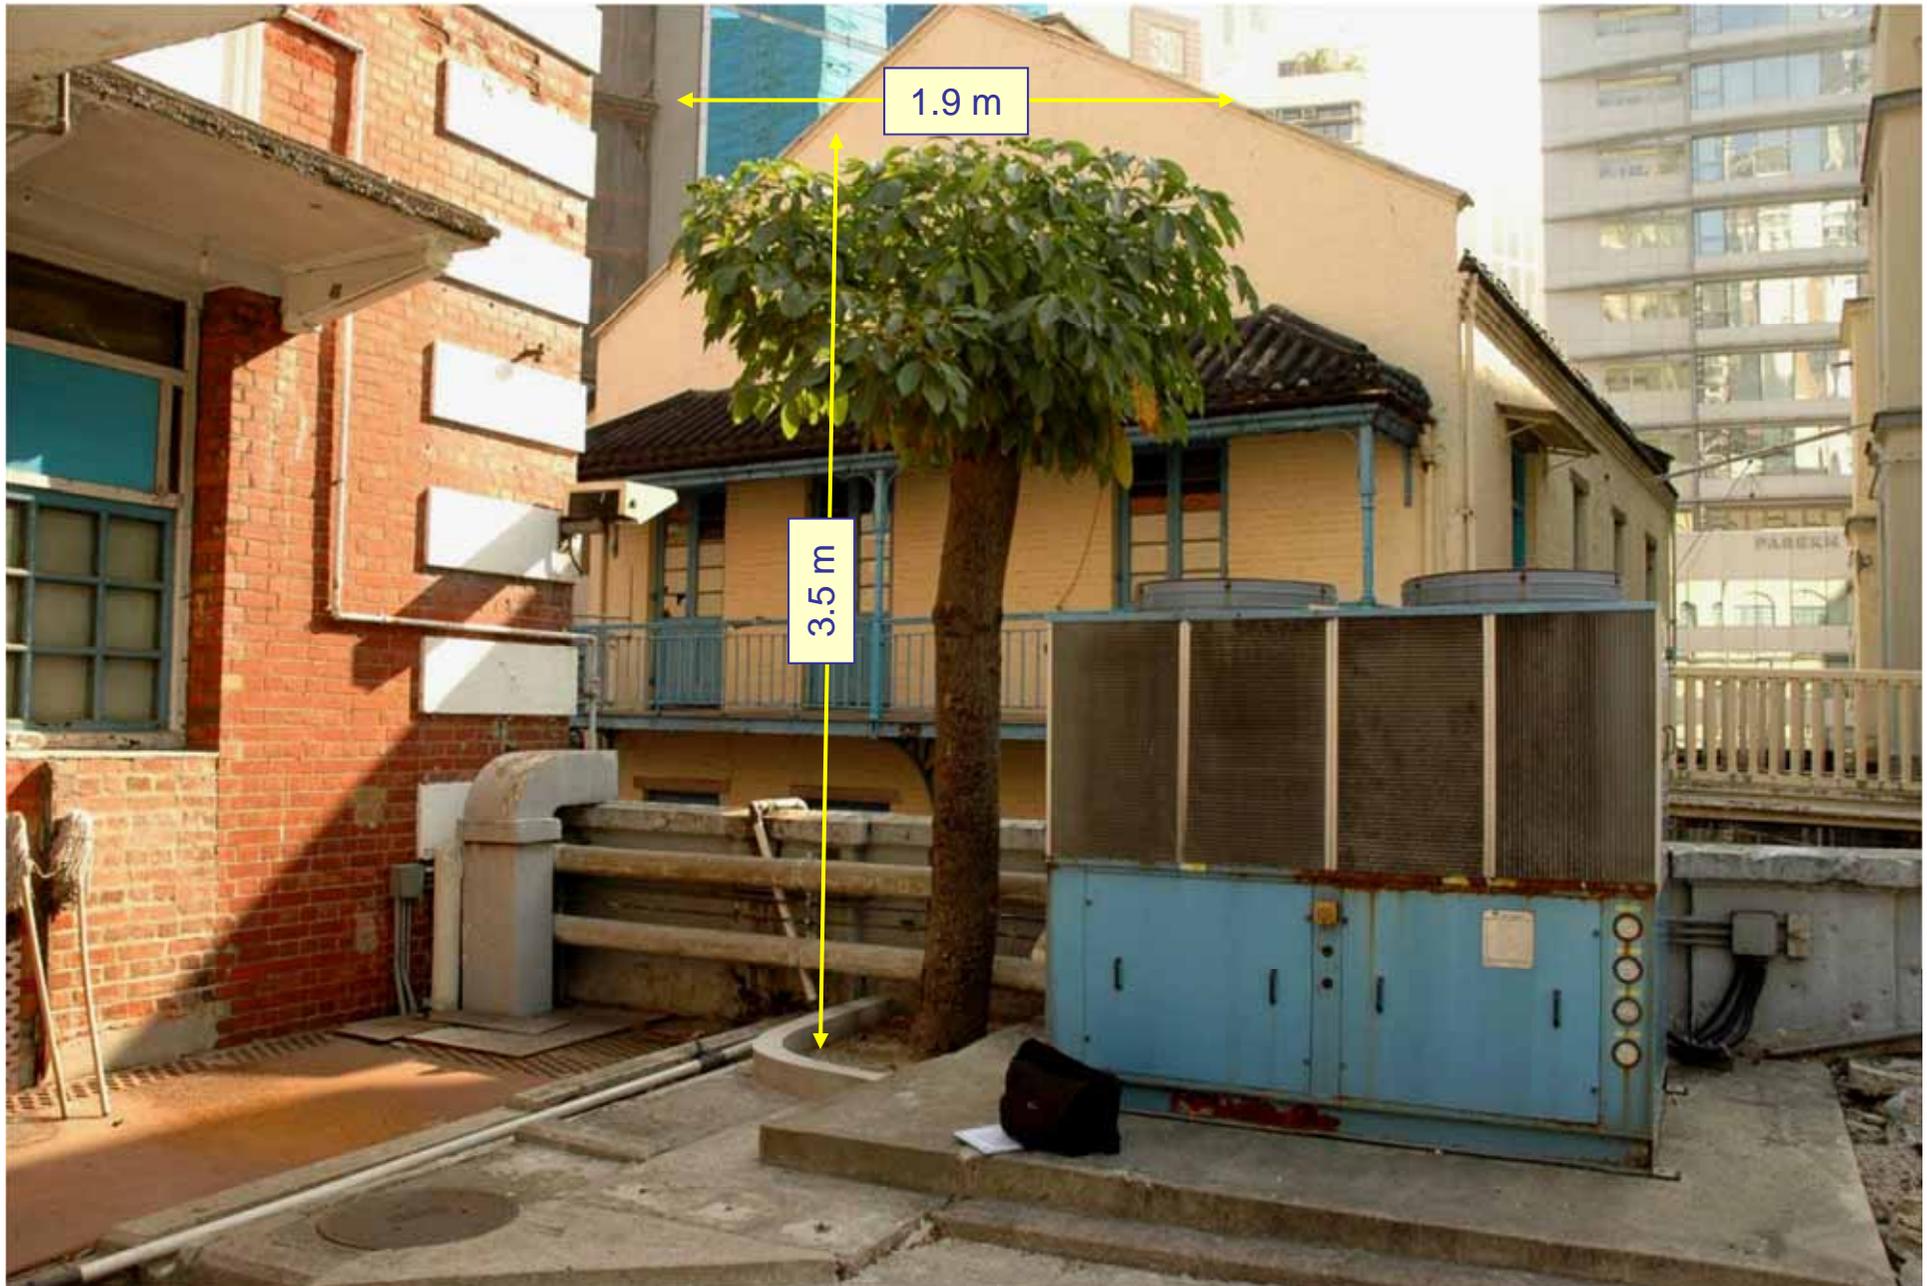
Figure 6. T1 (*Bombax ceiba*) was truncated during Typhoon Fengshen, leaving only the lower portion of the trunk. Sprouts have since emerged near the wound.

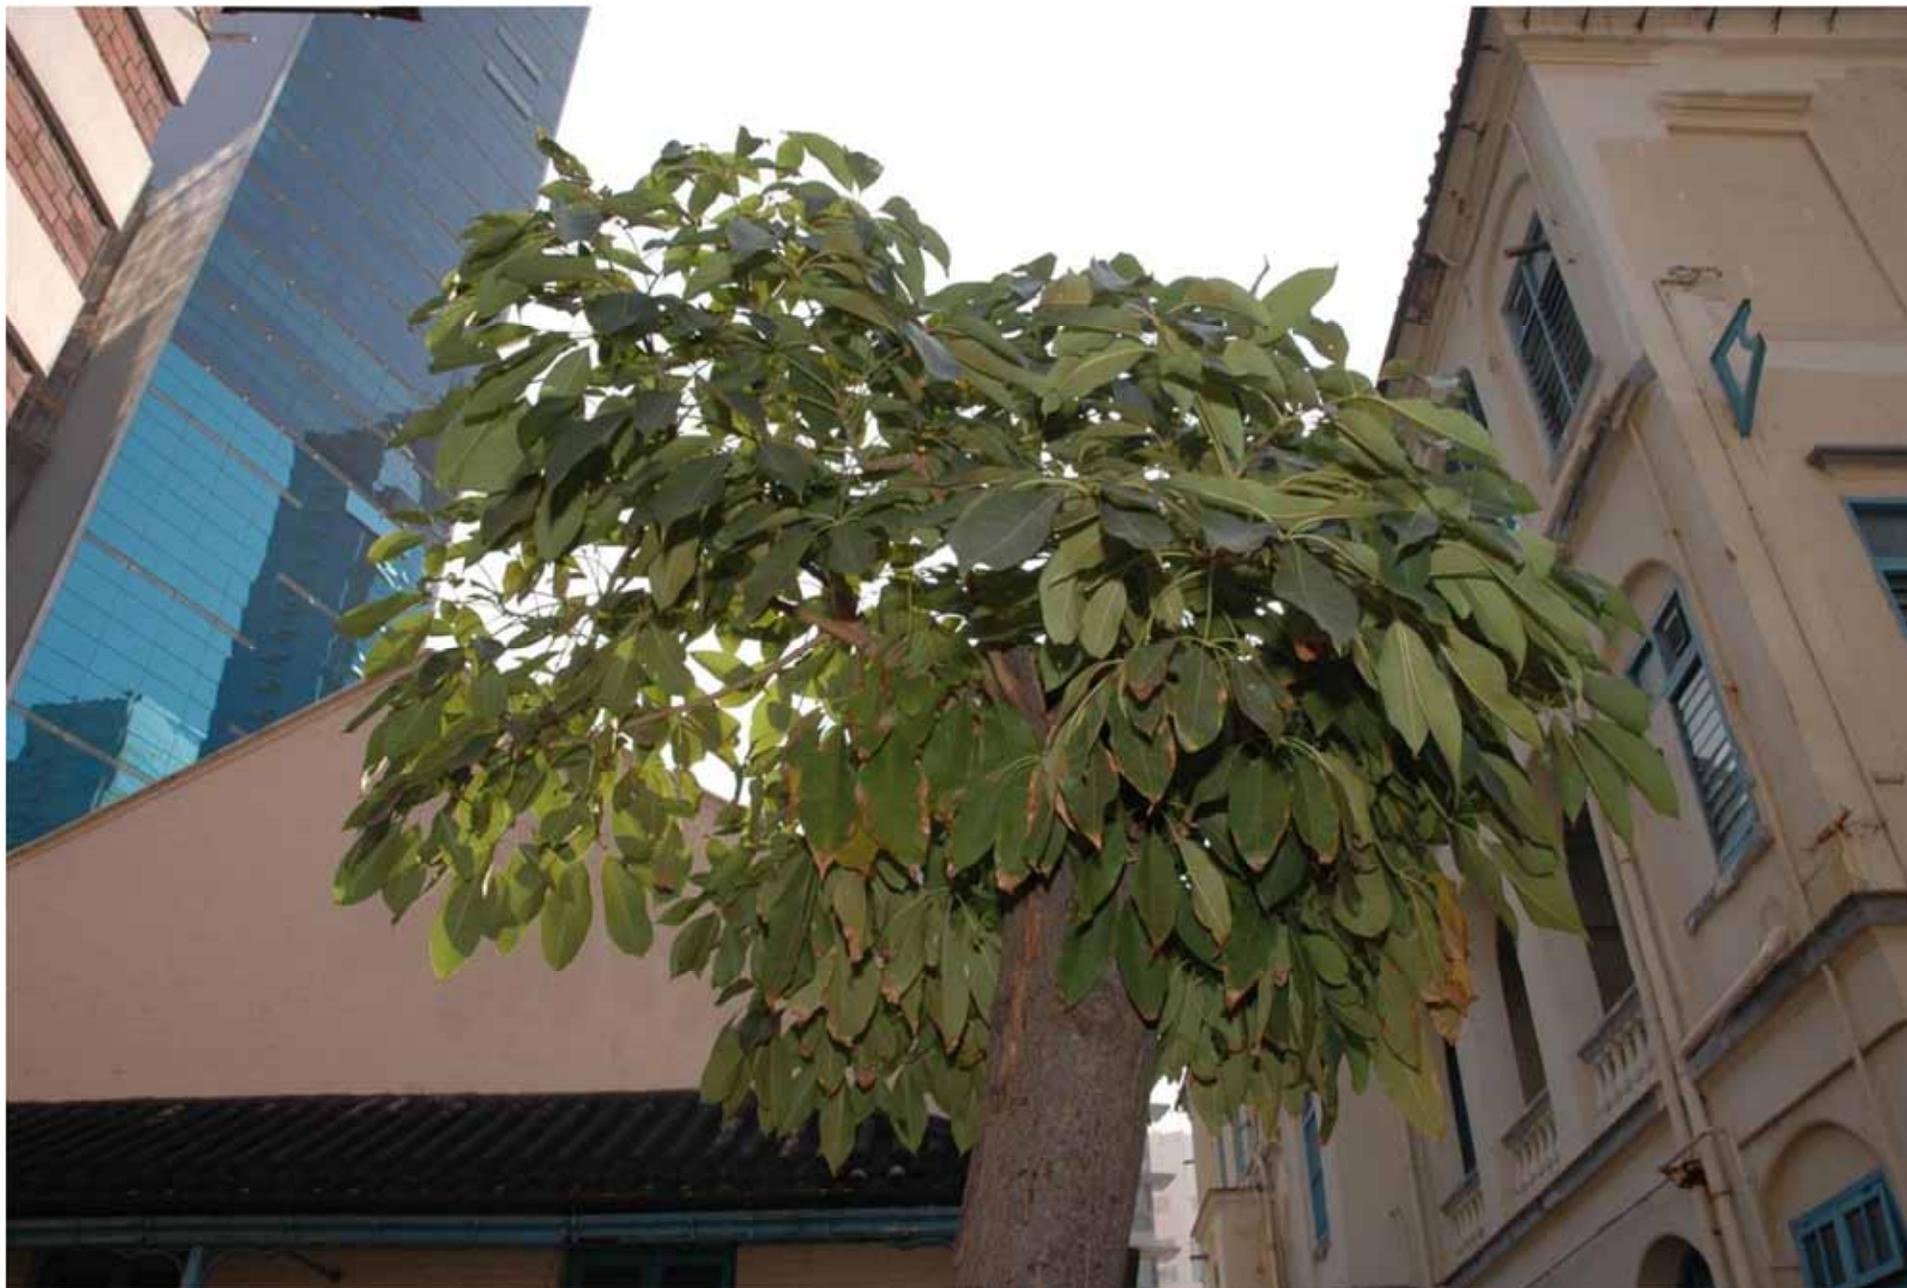
T1 is a broken tree, struggling to survive by developing some unnatural water sprouts and in poor health. Although it displays some apparent signs of recovery, they indicate the last-resort physiological and morphological responses of a tree that has been pushed to the extreme. Due to the massive structural losses and associated injuries, there is no hope that the tree regaining its health and restoring its natural neat and layered pagoda tree form, which in conjunction with its large reddish bloom, constitute the *raison d'être* for planting *Bombax ceiba*. With the loss of the leader trunk that would normally dominate the tree structure from base to tip, and dim prospect of forming a replacement leader, the tree's landscape and amenity value has been permanently depleted. In addition, there is a high risk of invasion by wood-decay fungi at the existing trunk breakage which would lead to a hazardous tree situation in due course.

Figure 7. The damaged T1 has sent out sprouts from latent buds at and around the wound to rebuild a small unnatural crown, with a live crown ratio of merely 5%.

Considering the above assessment and taking into account arboriculture and staff and visitor safety, it is suggested T1 be removed.

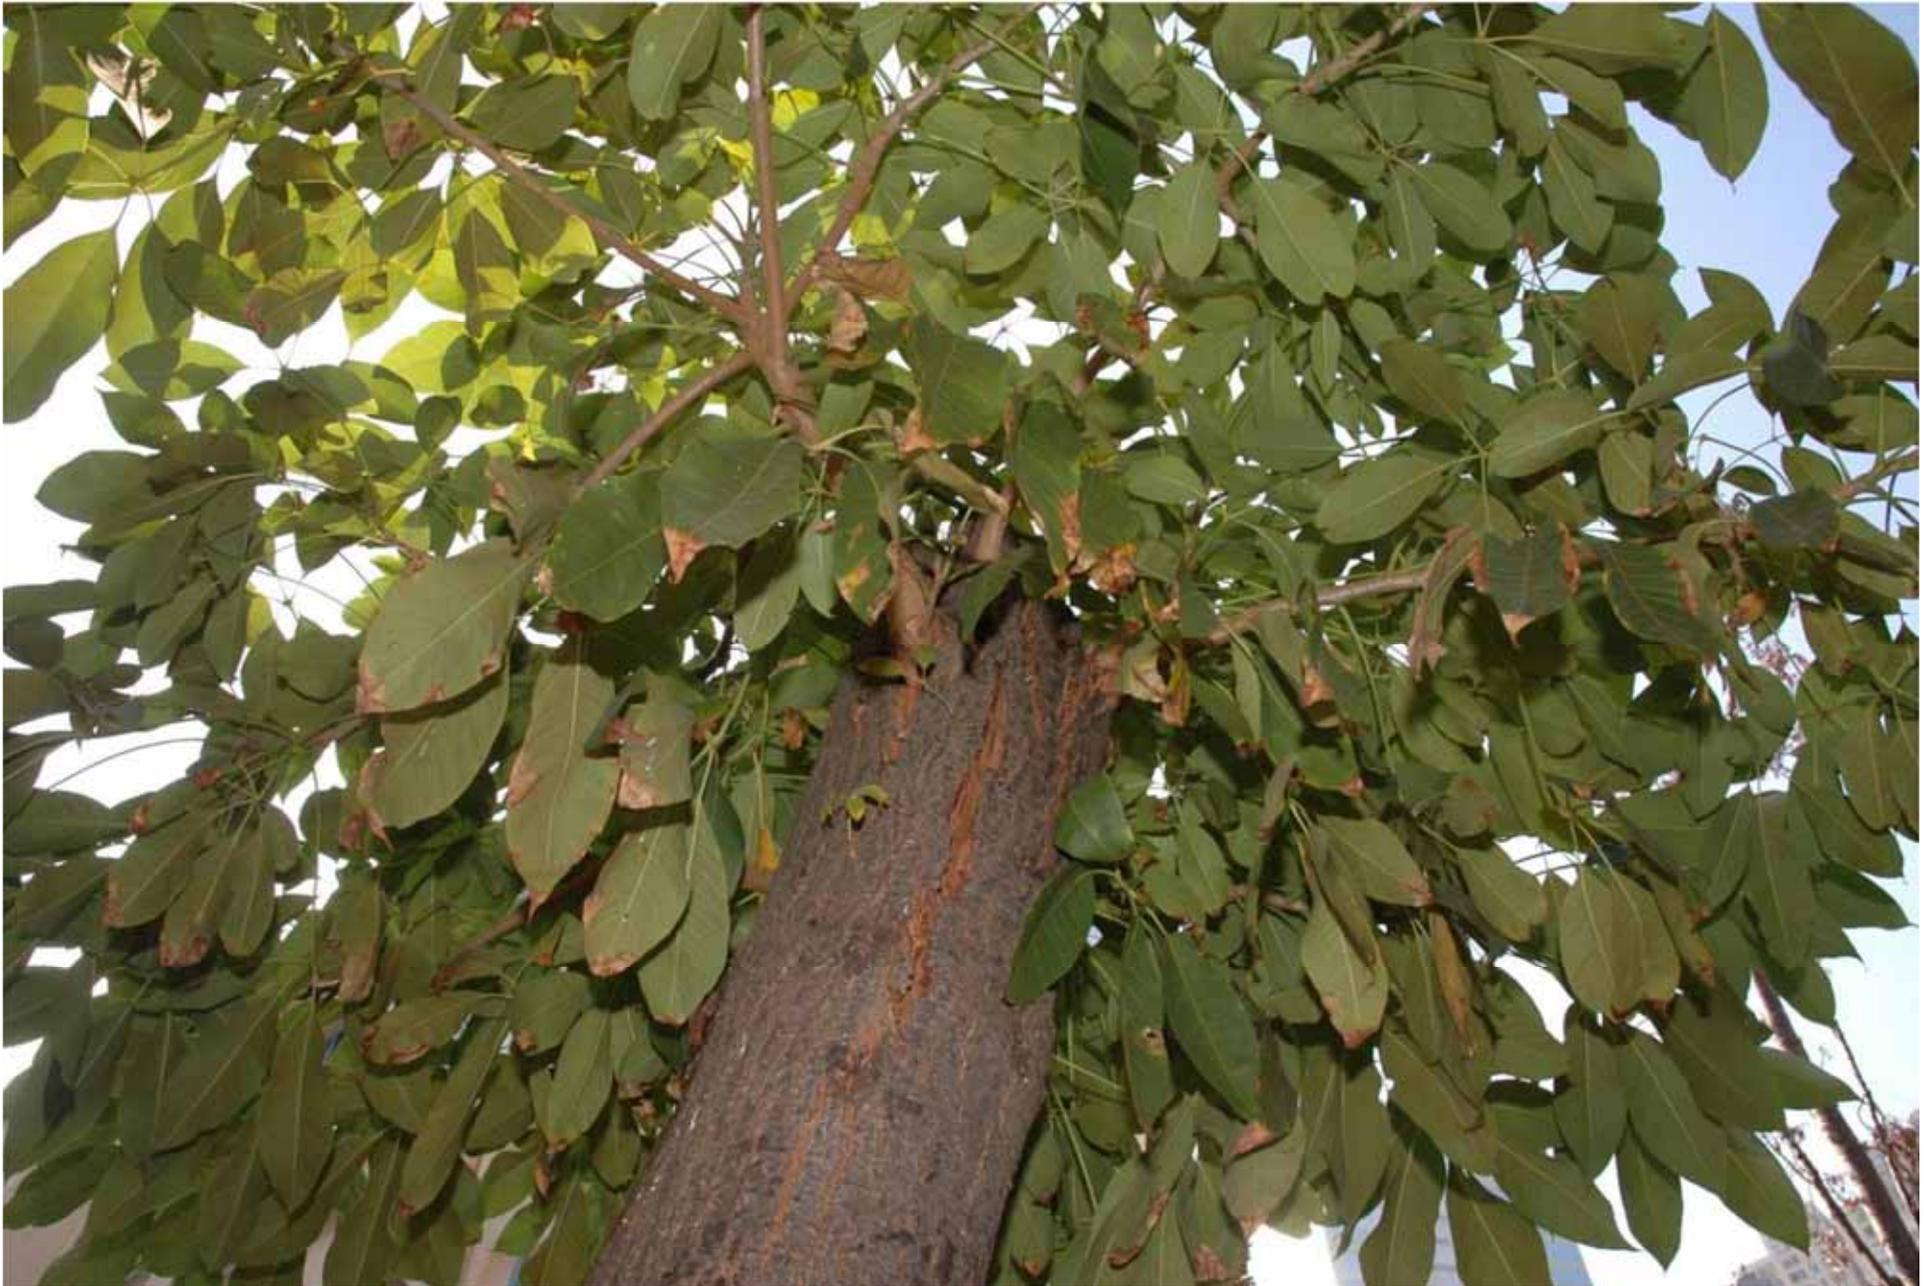
Figure 8. Close-up view of T1's broken trunk top showing vertical cracks and the haphazard emergence of thin sprouts with mechanically weak attachments.

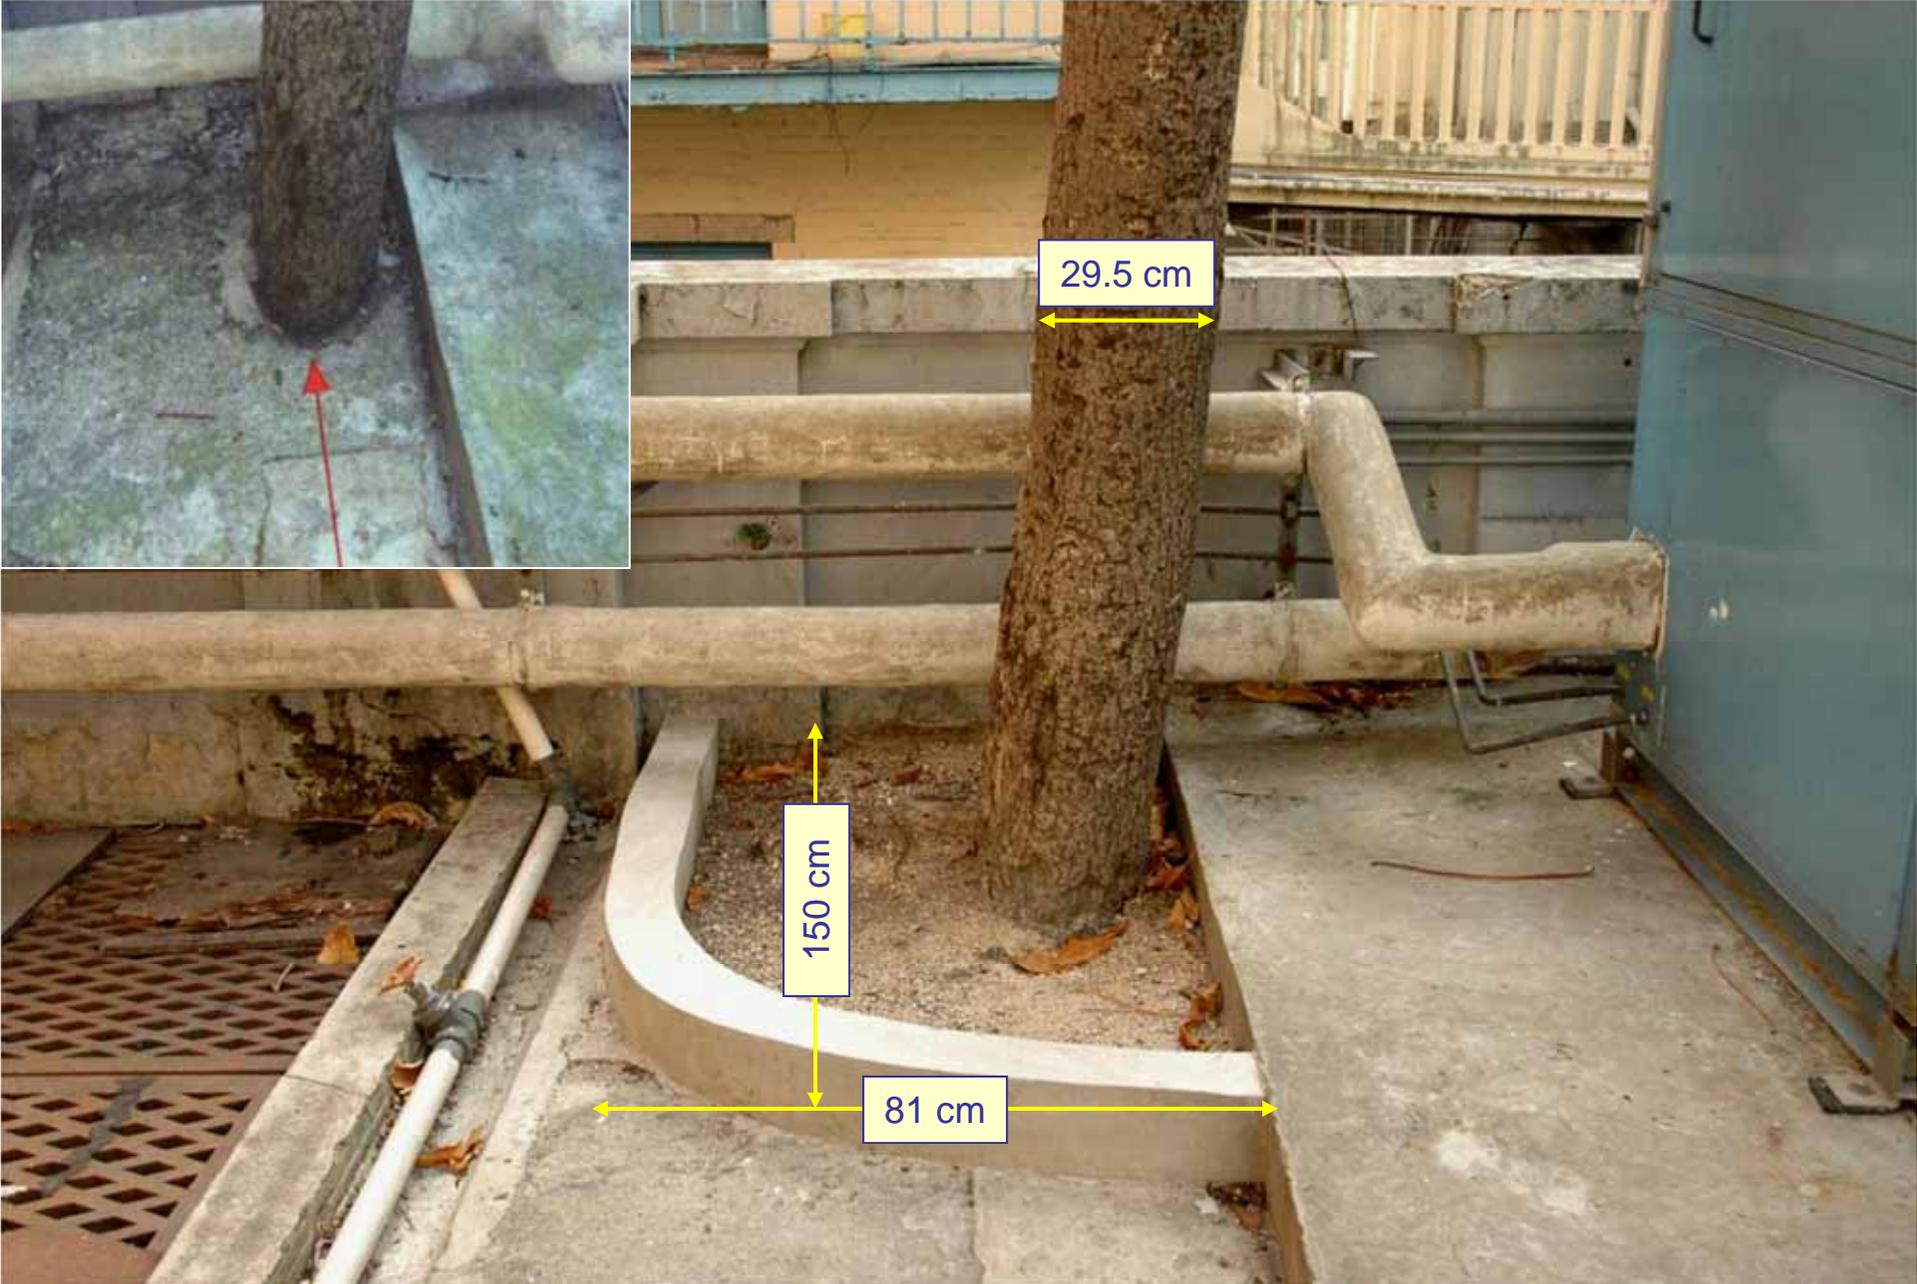
Shortly after the typhoon attack, a small tree pit with concrete rim measuring 150 cm by 81 cm was installed for T1, where previously its critical root zone had been completely sealed by concrete paving. With the east side of the tree site bordered by a retaining wall adjacent to the access road and the north side adjacent to a building the root extension of T1 is permanently curtailed on two sides. Its roots could only spread towards to the south and west in the compacted and sealed soil lying beneath the continuous concrete paving and the root system of T1 cannot be expected to develop normally.

Figure 9. T1 was previously sealed by concrete to the trunk base (inset) before damage by Typhoon Fengshen. A new small tree pit has since been installed to improve soil condition.

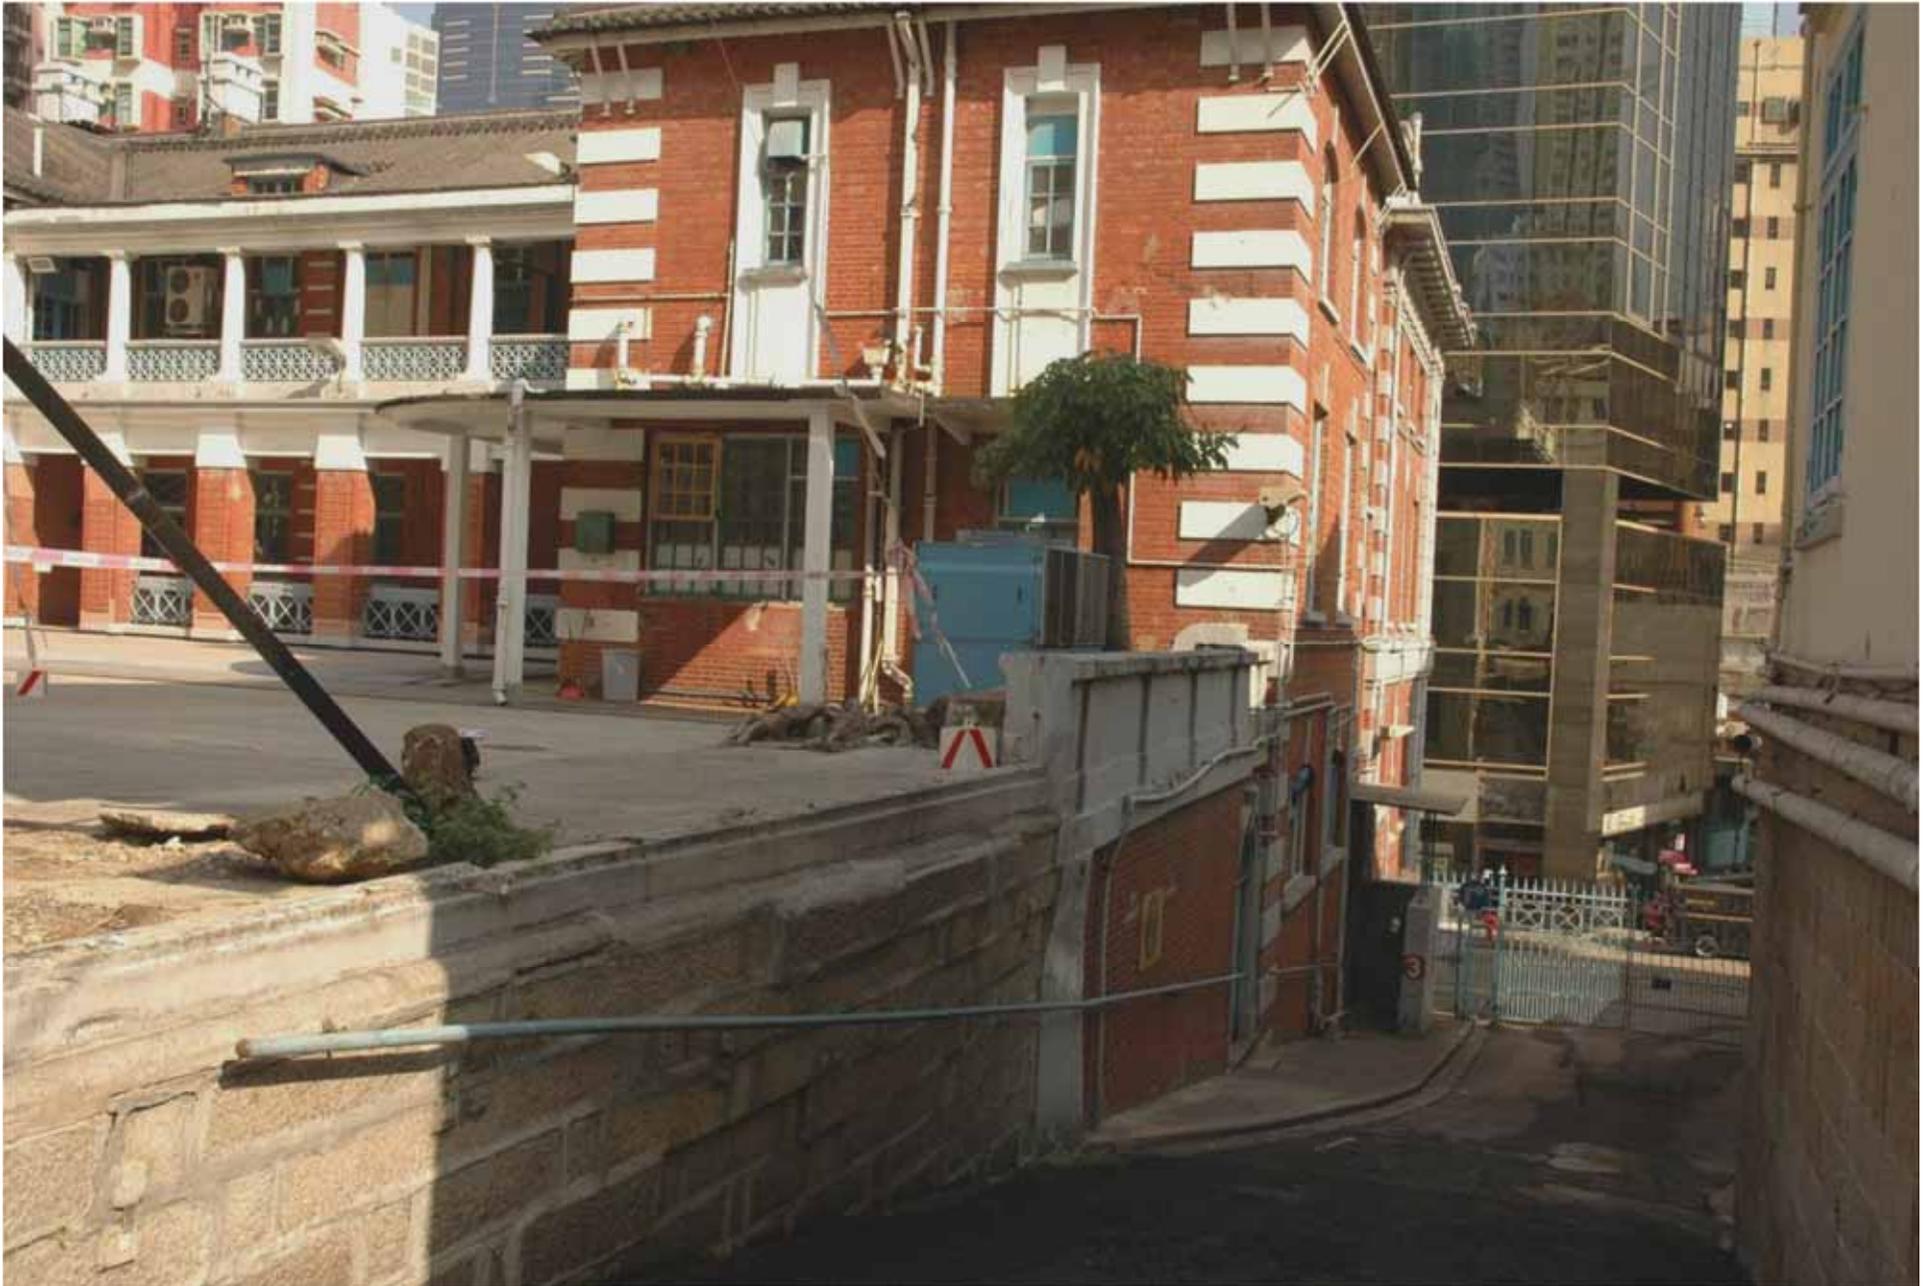
Figure 10. The east side of T1 has limited soil volume for root spread due to the presence of a retaining wall adjacent to the access road.

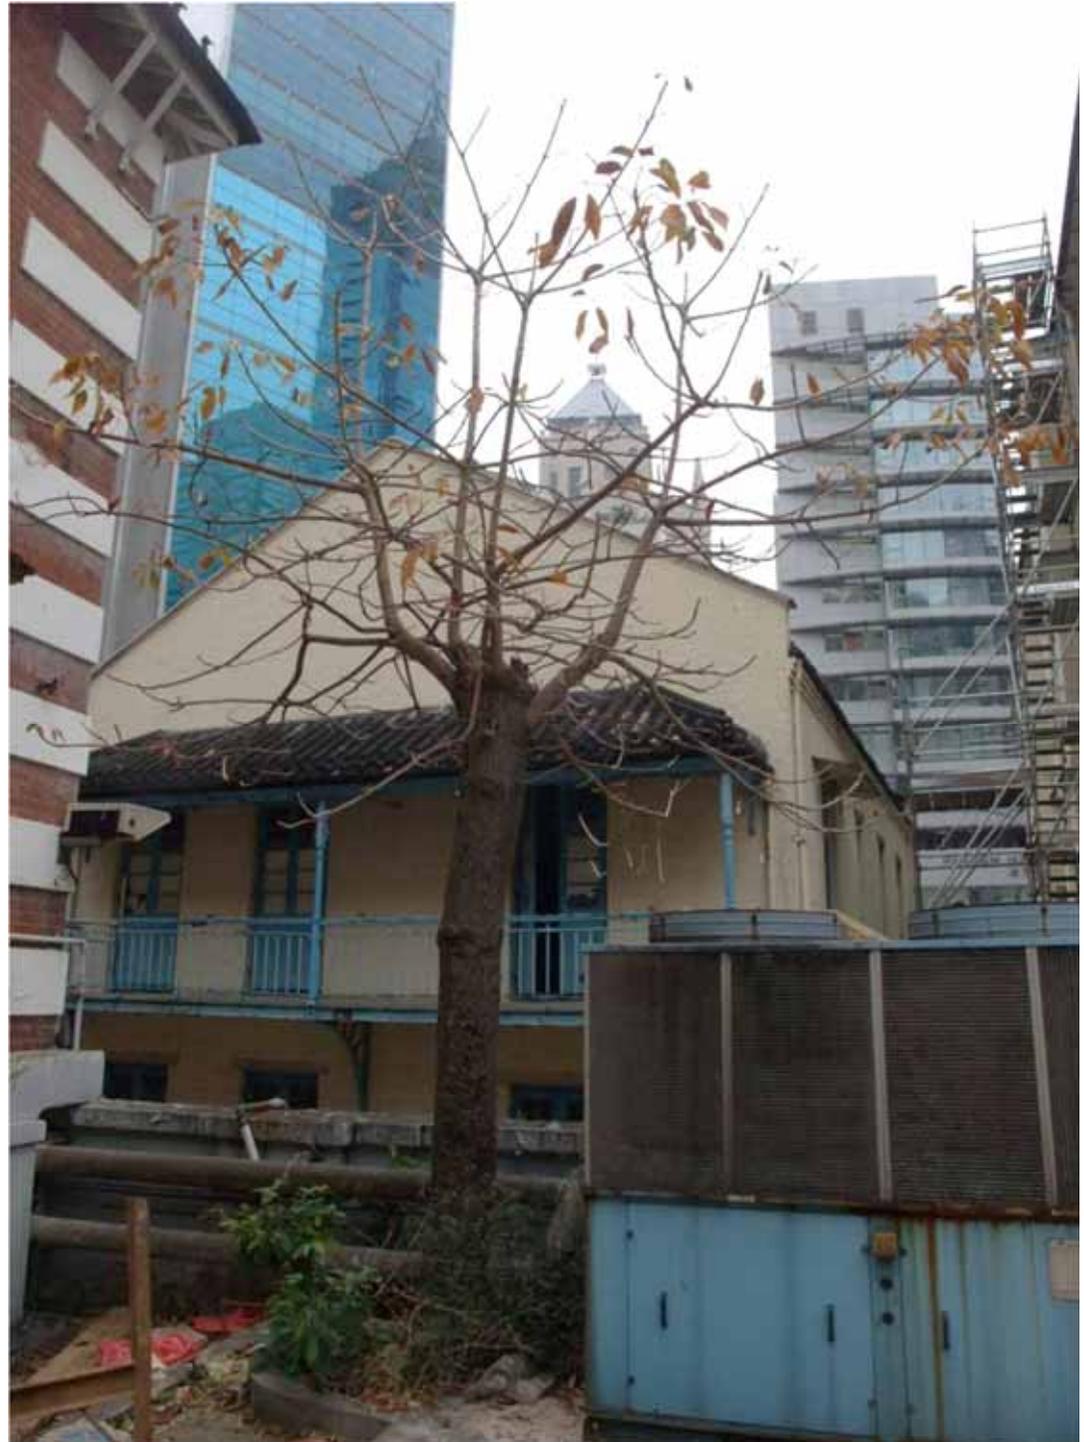
By local standards, many *Bombax ceiba* are older and have better structure and health than T1, which is now considered to be damaged and be in 'poor' health.

Figure 11. The condition of T1 on 17 March 2011, showing haphazard growth of expanded water sprouts from the truncated top of the trunk.

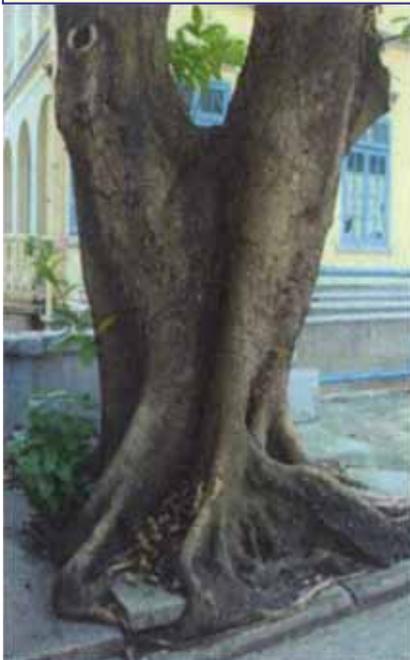
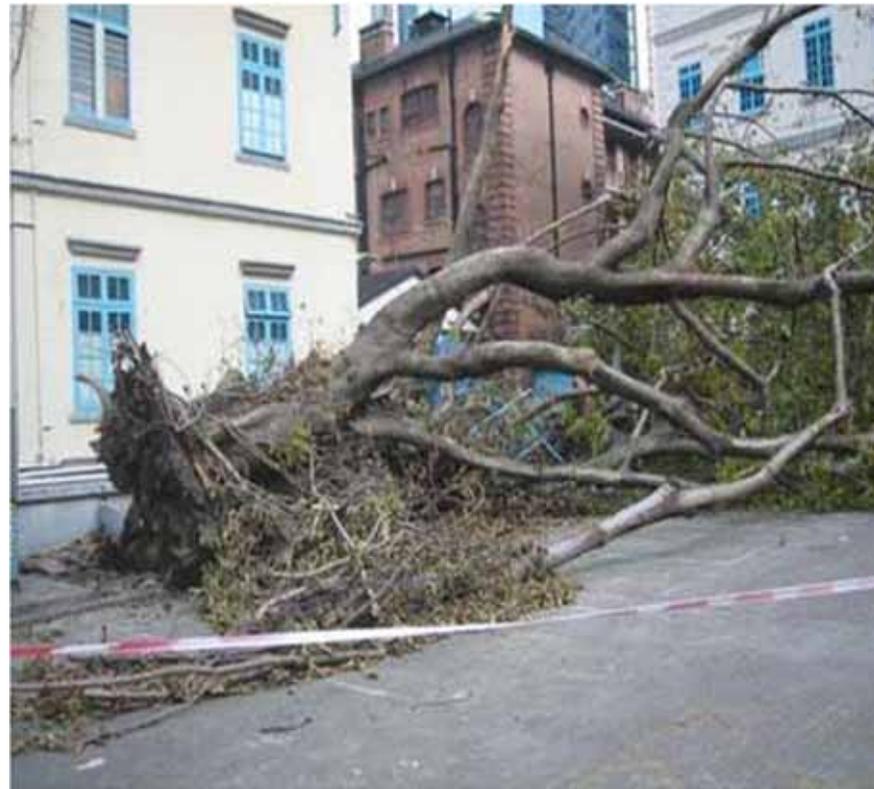
Lack of tree pit and spilling of roots on the concrete paving in the past

T2 was snapped by Typhoon Fengshen on 25 June 2008, and irretrievably lost. It was a large tree, around 70 years old, that measured 17 m tall by 24 m wide and had a trunk of 99 cm diameter. Gauged against the final dimensions of the species and in view of the chronic site constraints, the tree had probably attained its maximum size. The breakage at the time of the typhoon occurred at the trunk base, leaving the above-ground part of the tree lying en masse on the ground. This has now been removed and T2 is considered to be dead.

Figure 12. T2 (*Ficus virens*) had concrete paved to the trunk base (left); it was uprooted by Typhoon Fengshen on 25 June 2008, with the breakage occurring at the trunk base and the trunk and branches remaining largely intact (right) (photos supplied by HKJC).

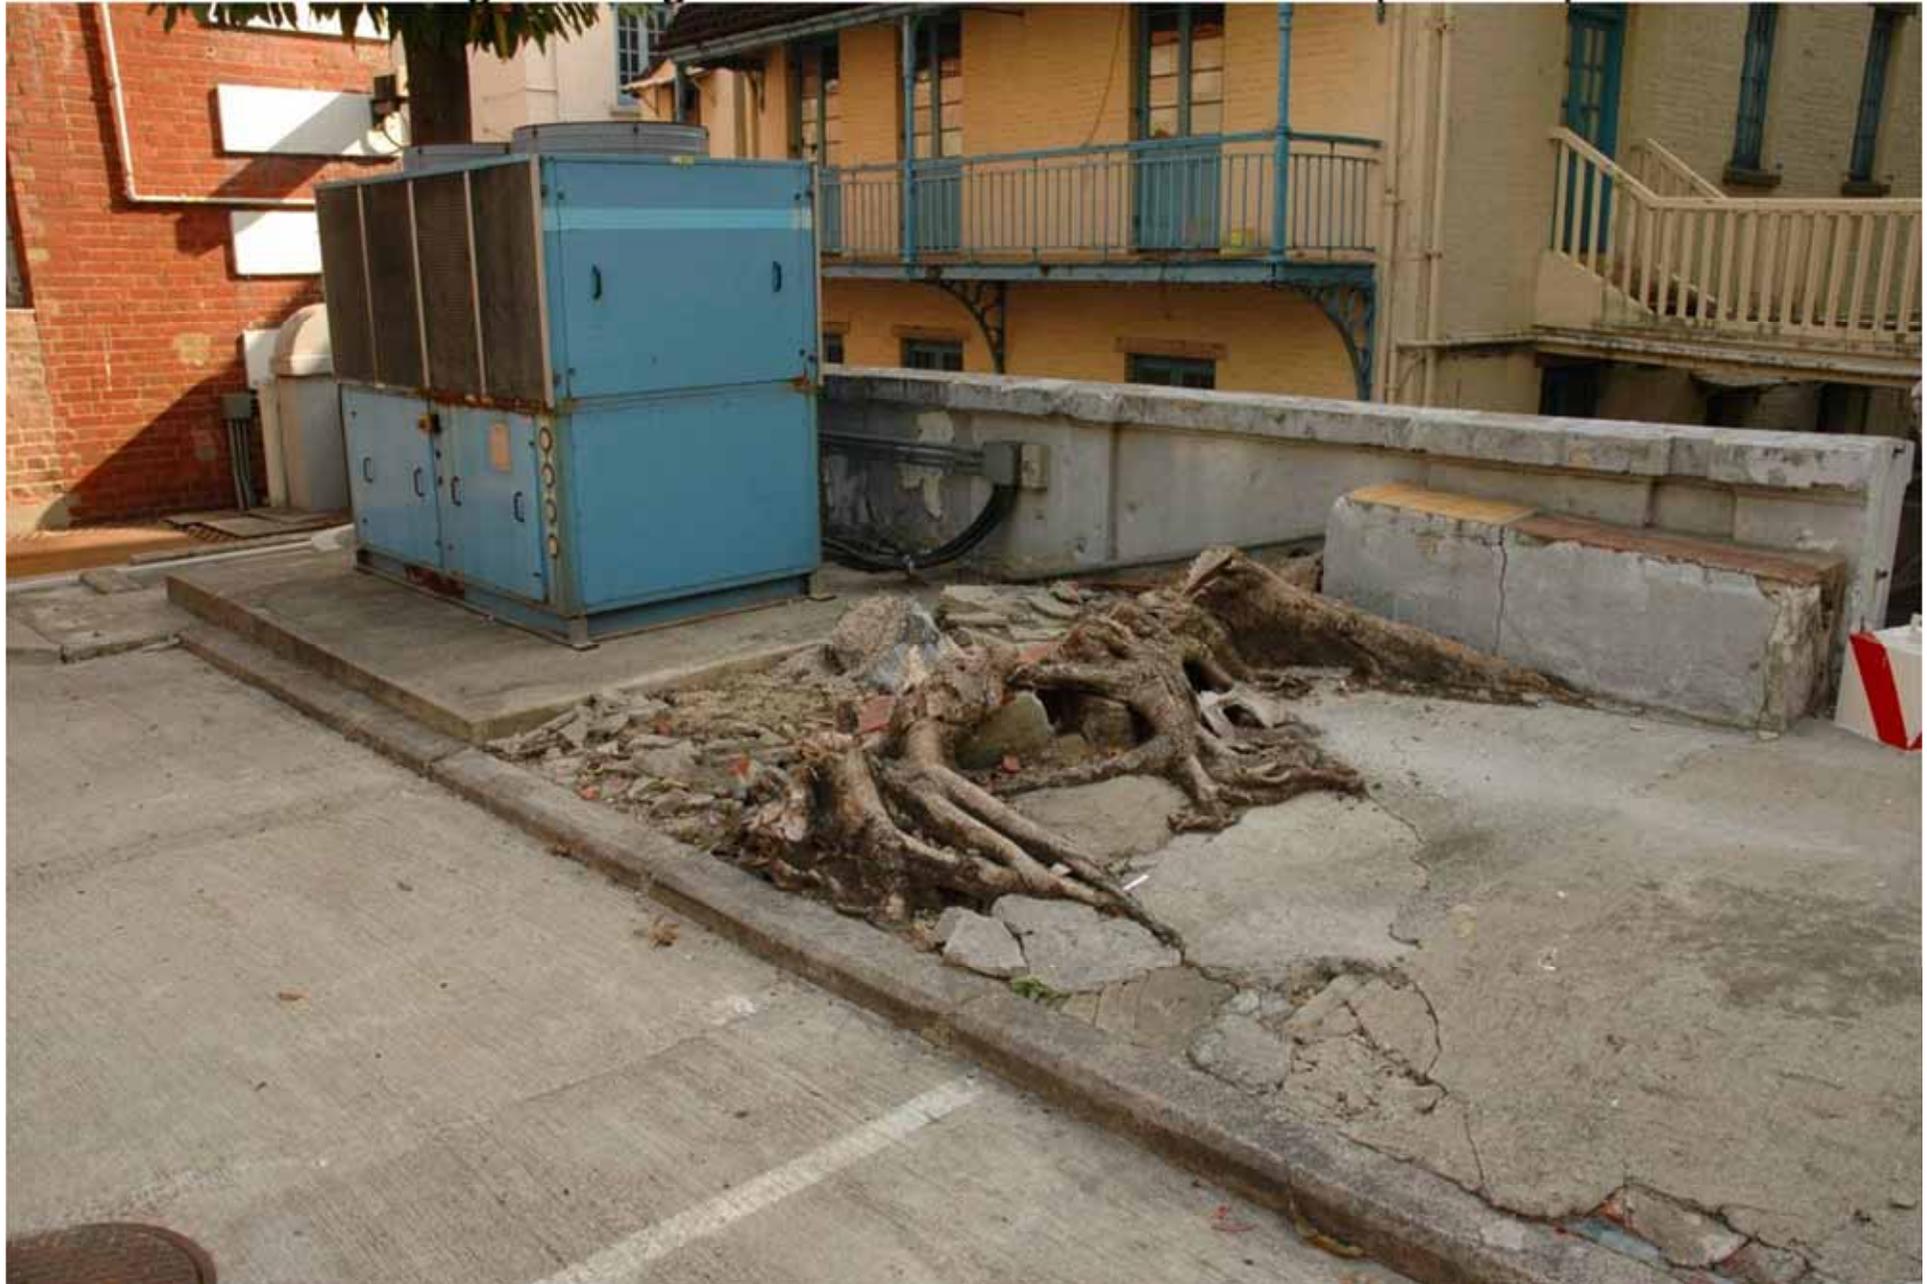
Figure 13. Remains of T2 which was snapped at the trunk base by Typhoon Fengshen. The remnant roots are found mainly on the south side; roots on the north were probably damaged during installation of the air conditioner (blue box).

Before its collapse, T2 was beset by some wood decay in its trunk, as indicated by photographs from an October 2007 tree report. It is now a dead and should be removed. Despite no compensatory planting being required, it is suggested that the entire strip of land that previously accommodated T1 to T4 should be revamped to provide a planting site with improved soil conditions for future tree growth and six trees be planted here, as detailed in CM6 of Table 4.5.
