Table 1 Response to EPD's Request for Supplementary Information (Ref: EPD's letter dated 9th March 2011)

ANNEX A

Update to EIA Report Section 4.6.4 Trees within the Project Site (Figures 1 and 3)

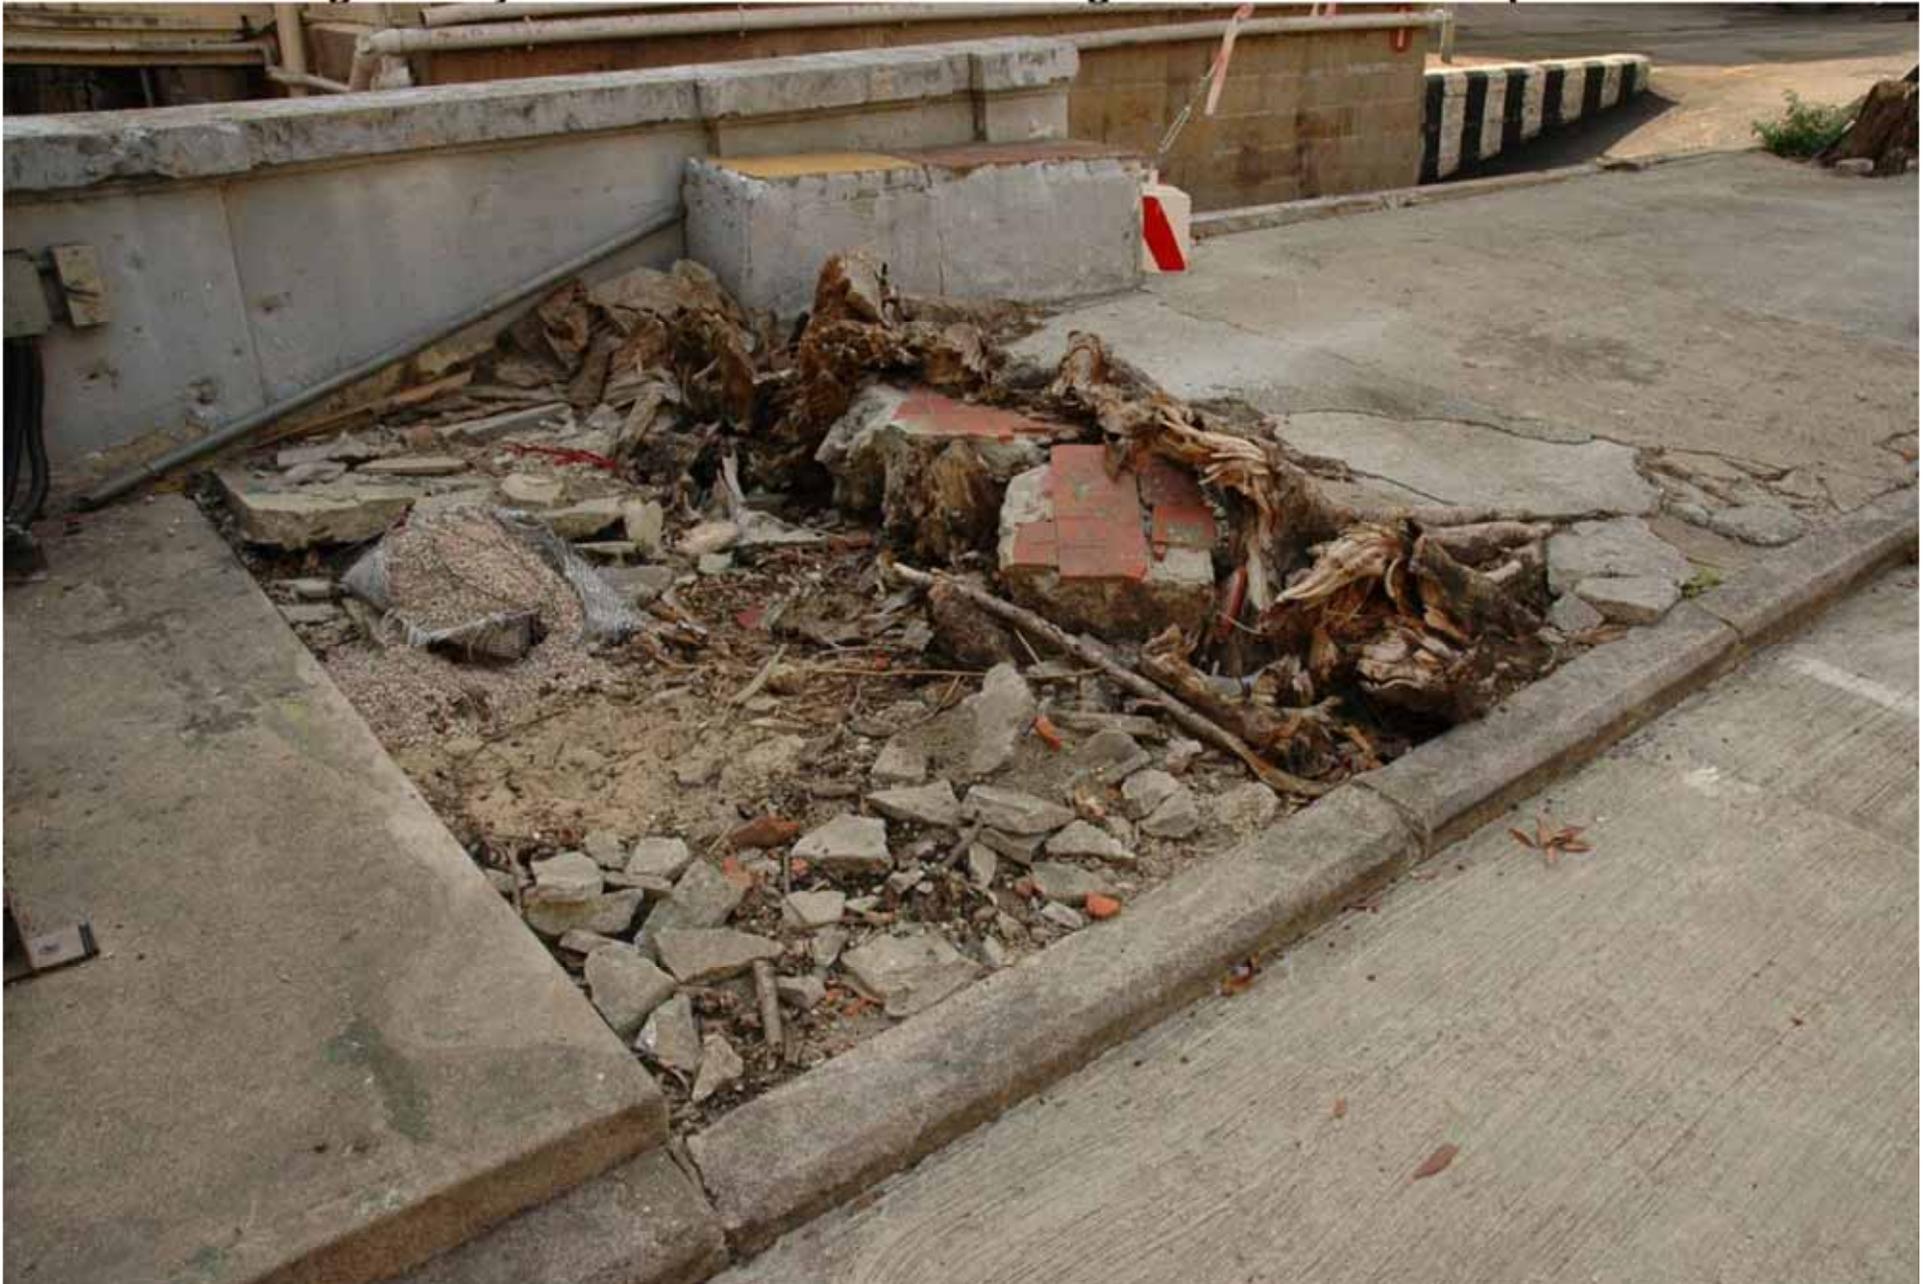
Figure 14. T2 was not provided with a proper tree pit, with concrete paved to the trunk base sealing the soil from air and water access. Old paving fragments (red tiles) engulfed by the tree in the course of its growth have been exposed.

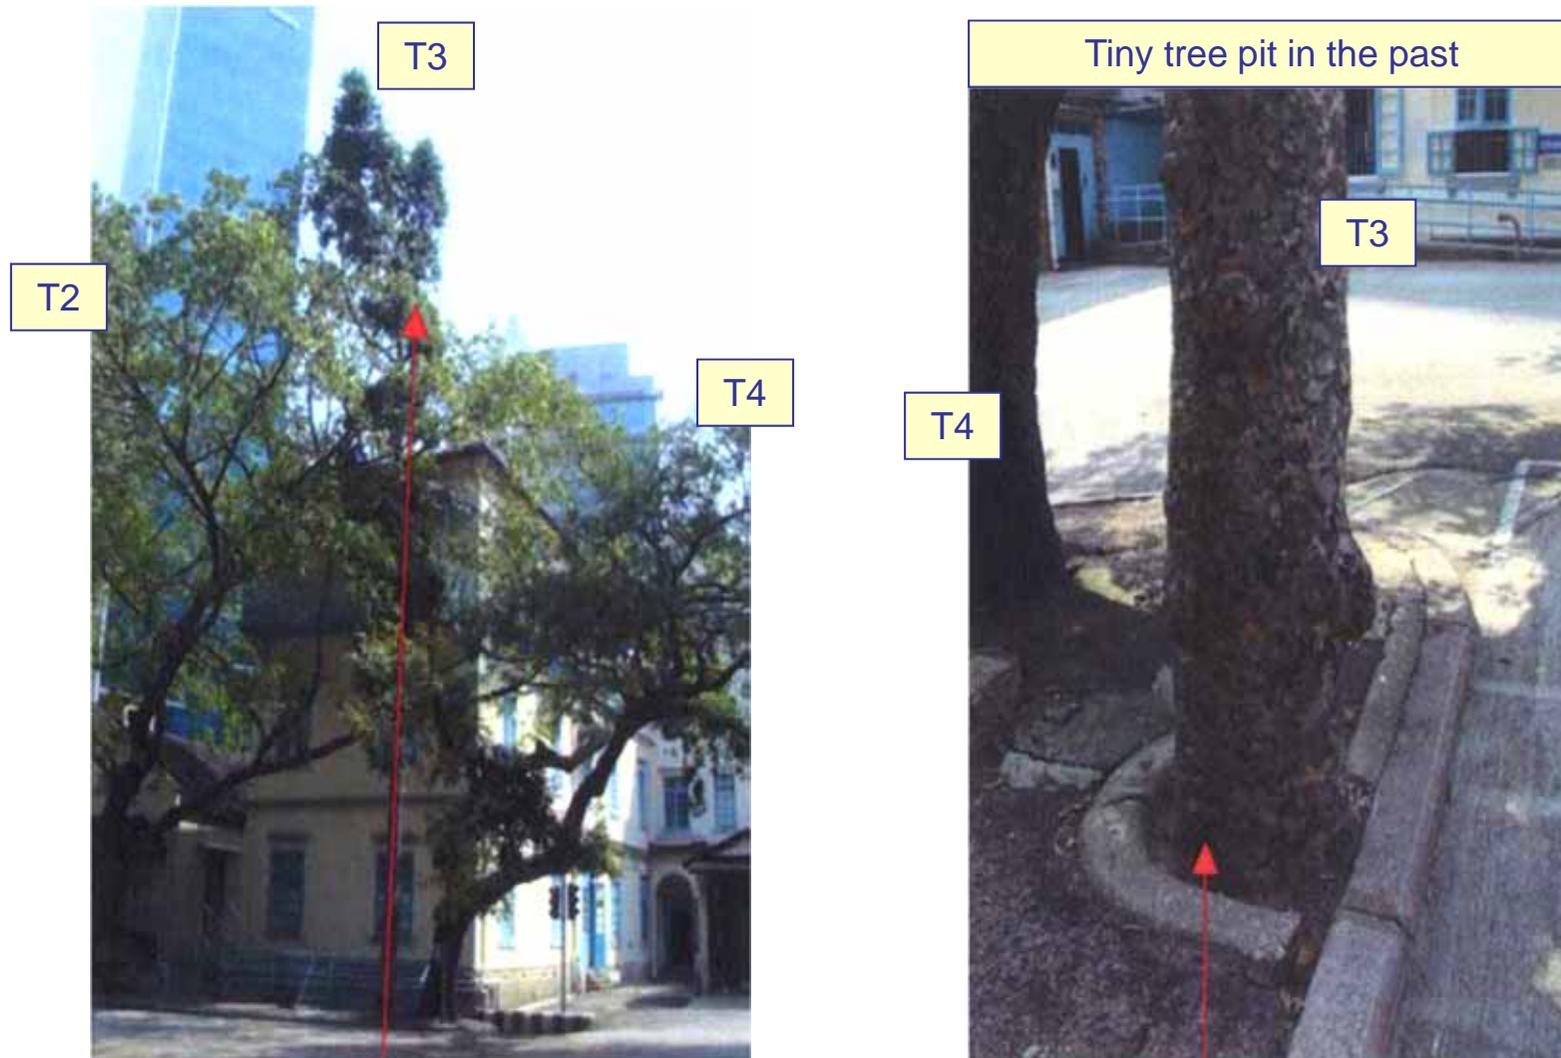
Figure 15. T3 (*Nageia nagi*) before damage by Typhoon Fengshen, with exceptionally restricted branch development and limited crown spread. Note the two neighbour trees (T2 and T4) that competed with T3 for growth space (photos supplied by the Trust).

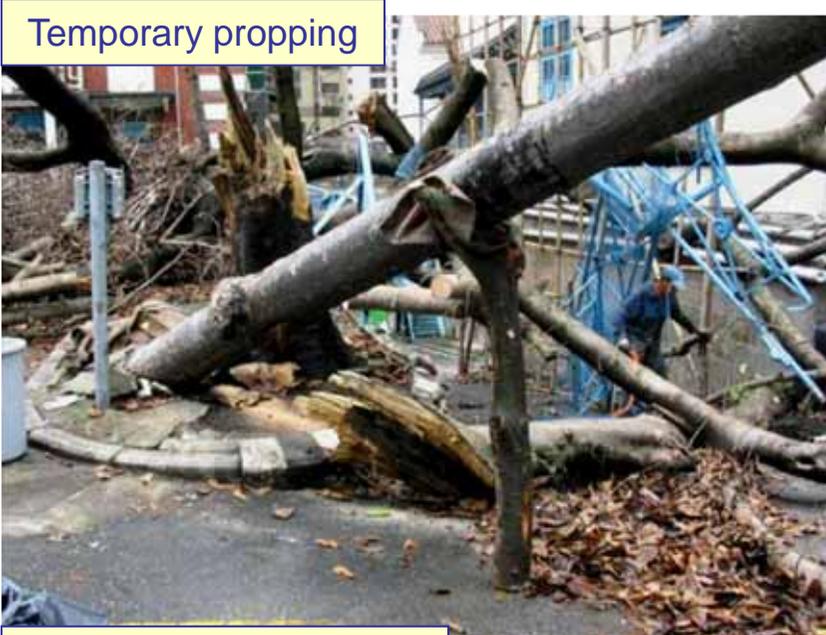
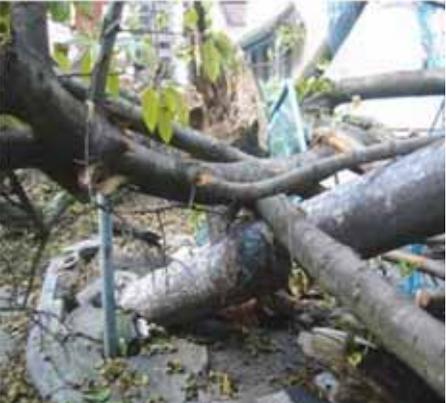
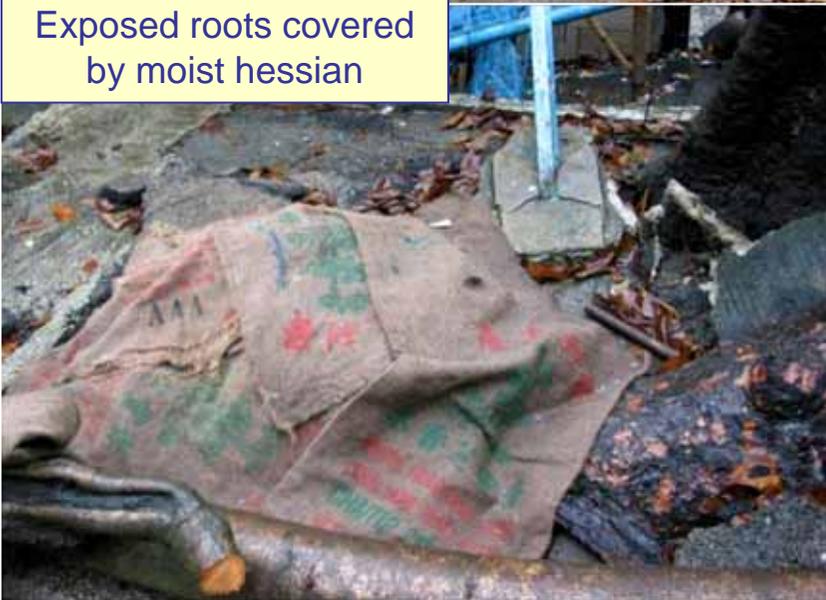
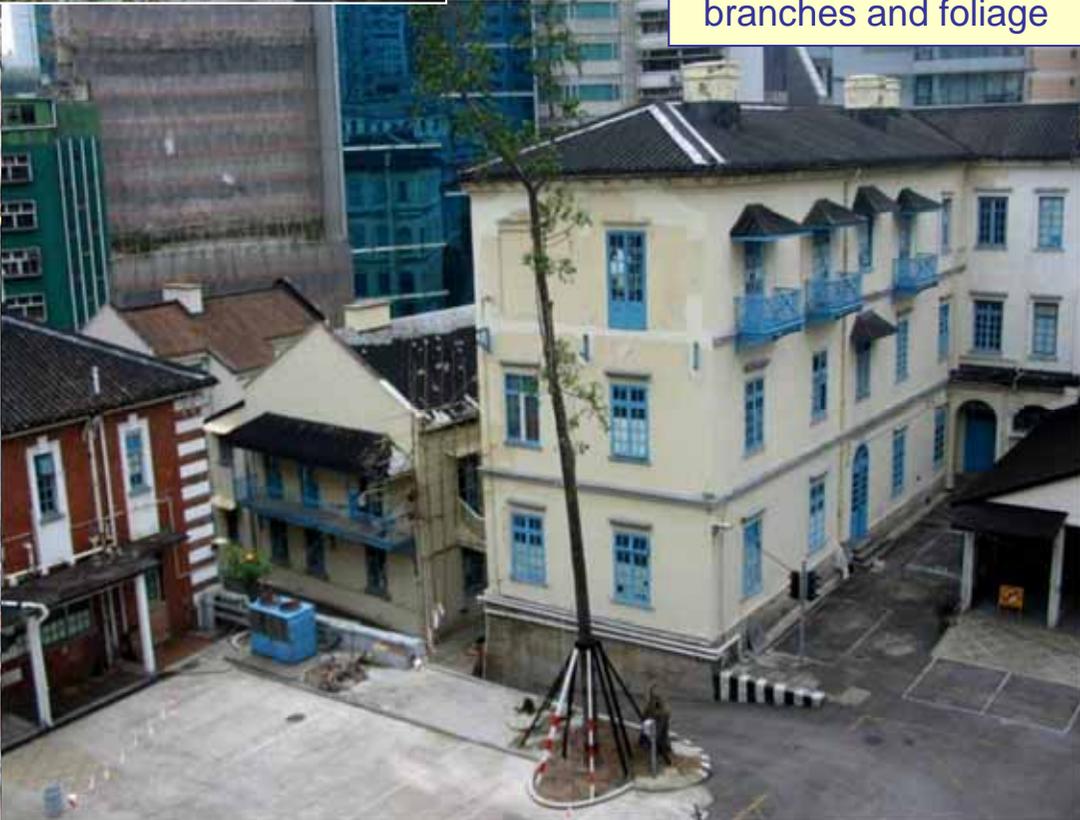
Salvaged tree with green but few branches and foliage

T3 was uprooted by Typhoon Fengshen on 25 June 2008. Previously it stood 20 m tall with an exceptionally limited crown spread of merely 6 m and a trunk diameter of 40 cm and was considered to be around 60 years old. A *Nageia nagi* of similar height would have the ability to develop a crown up to 10 m across. By local standards, T3 was probably the largest and oldest specimen of the species, even though its structure was not too representative of the species at its prime. Soon after the collapse, the tree was lifted to the upright posture and supported by a propping system composed of eight inclined steel bars connected to a steel ring around the trunk. In addition, the tree was pulled by three guy wires linked to a higher position of the trunk. Upon inspection in February 2009, it was concluded that T3 had died.

Figure 16. The rescue operations of T3 shortly after Typhoon Fengshen (left), and the salvaged tree with green leaves on 03 October 2008 (right) (photos supplied by the Trust).

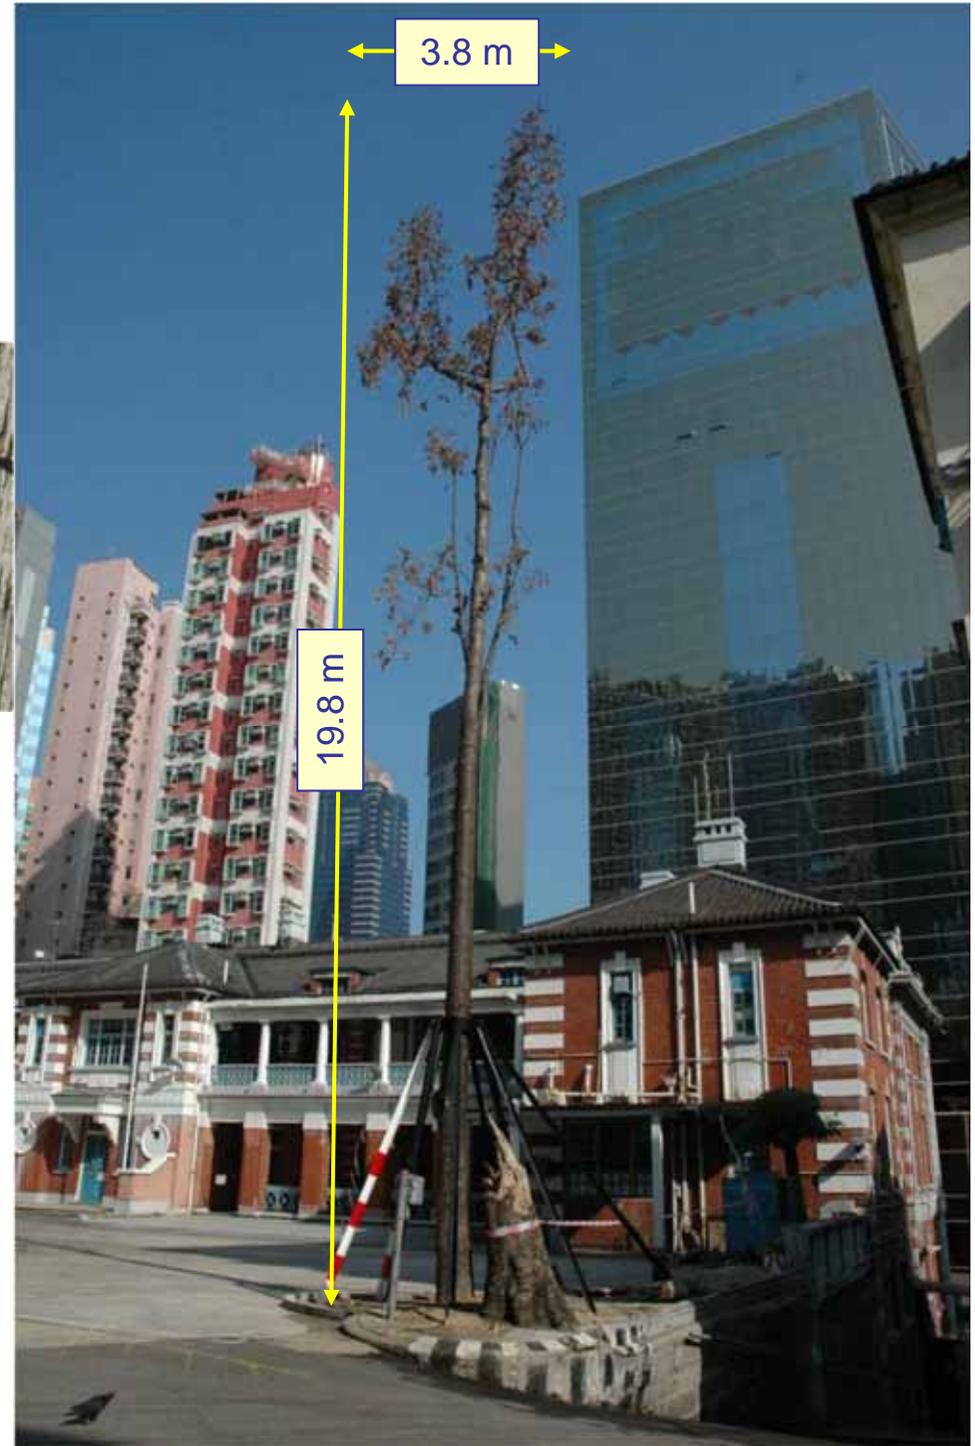
Figure 17. T3 (*Nageia nagi*) was toppled by Typhoon Fengshen. It was subsequently lifted to an upright posture, and supported by props and guy cables. The evergreen tree has lost most of its branches and leaves, and all the remnant foliage have wilted.

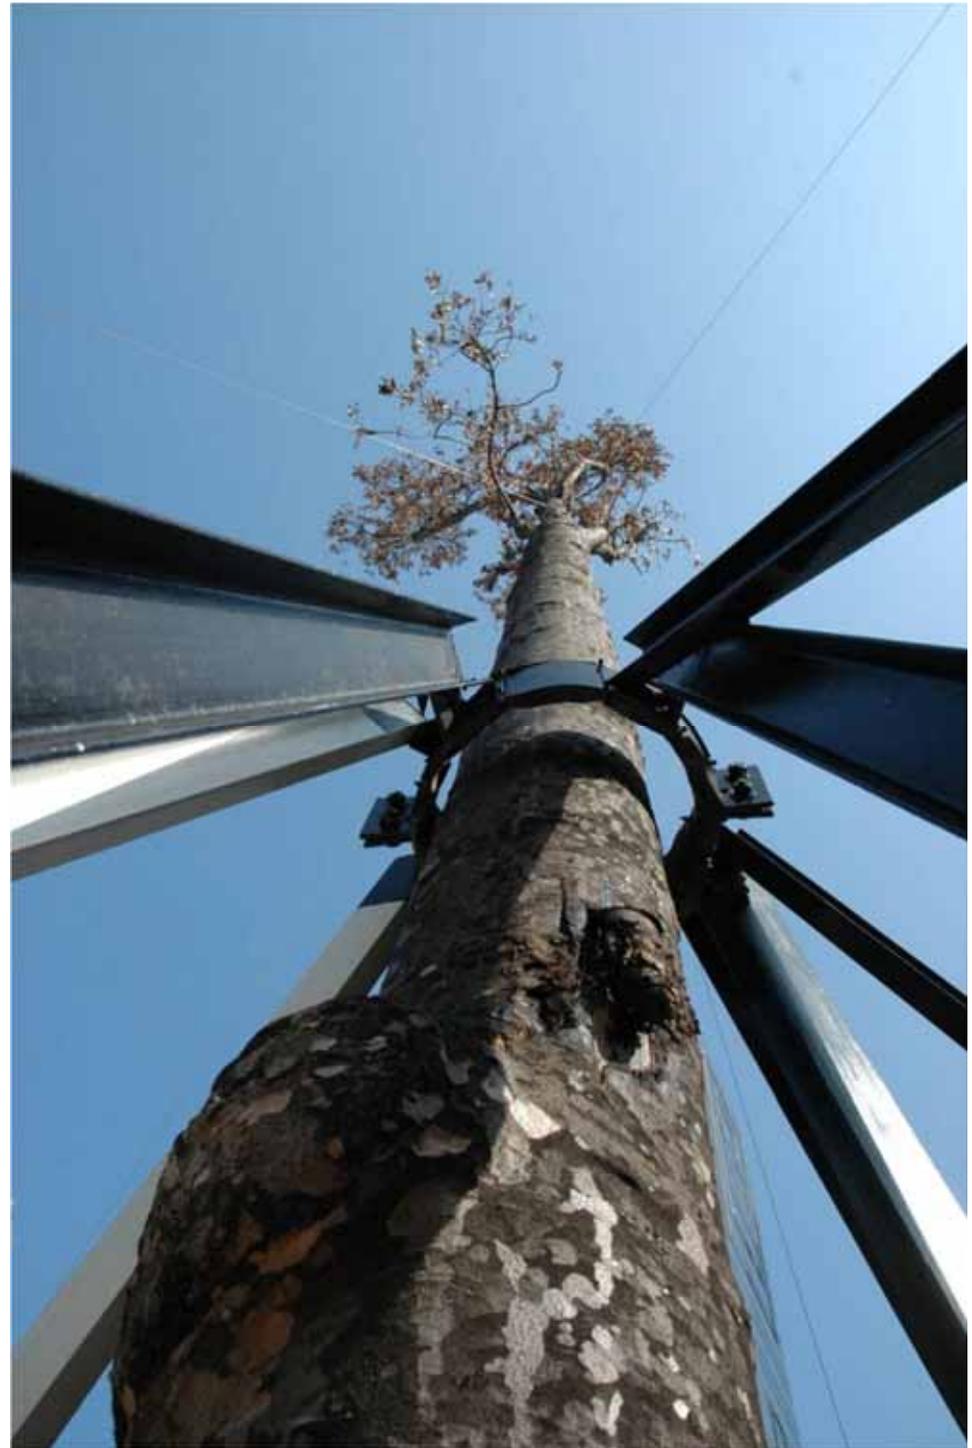
Figure 18. The tree prop supporting T3 has been designed to avoid physical contact with the trunk. Note the tiny amount of remnant branches and leaves, resulting in a crown ratio of merely about 10%.

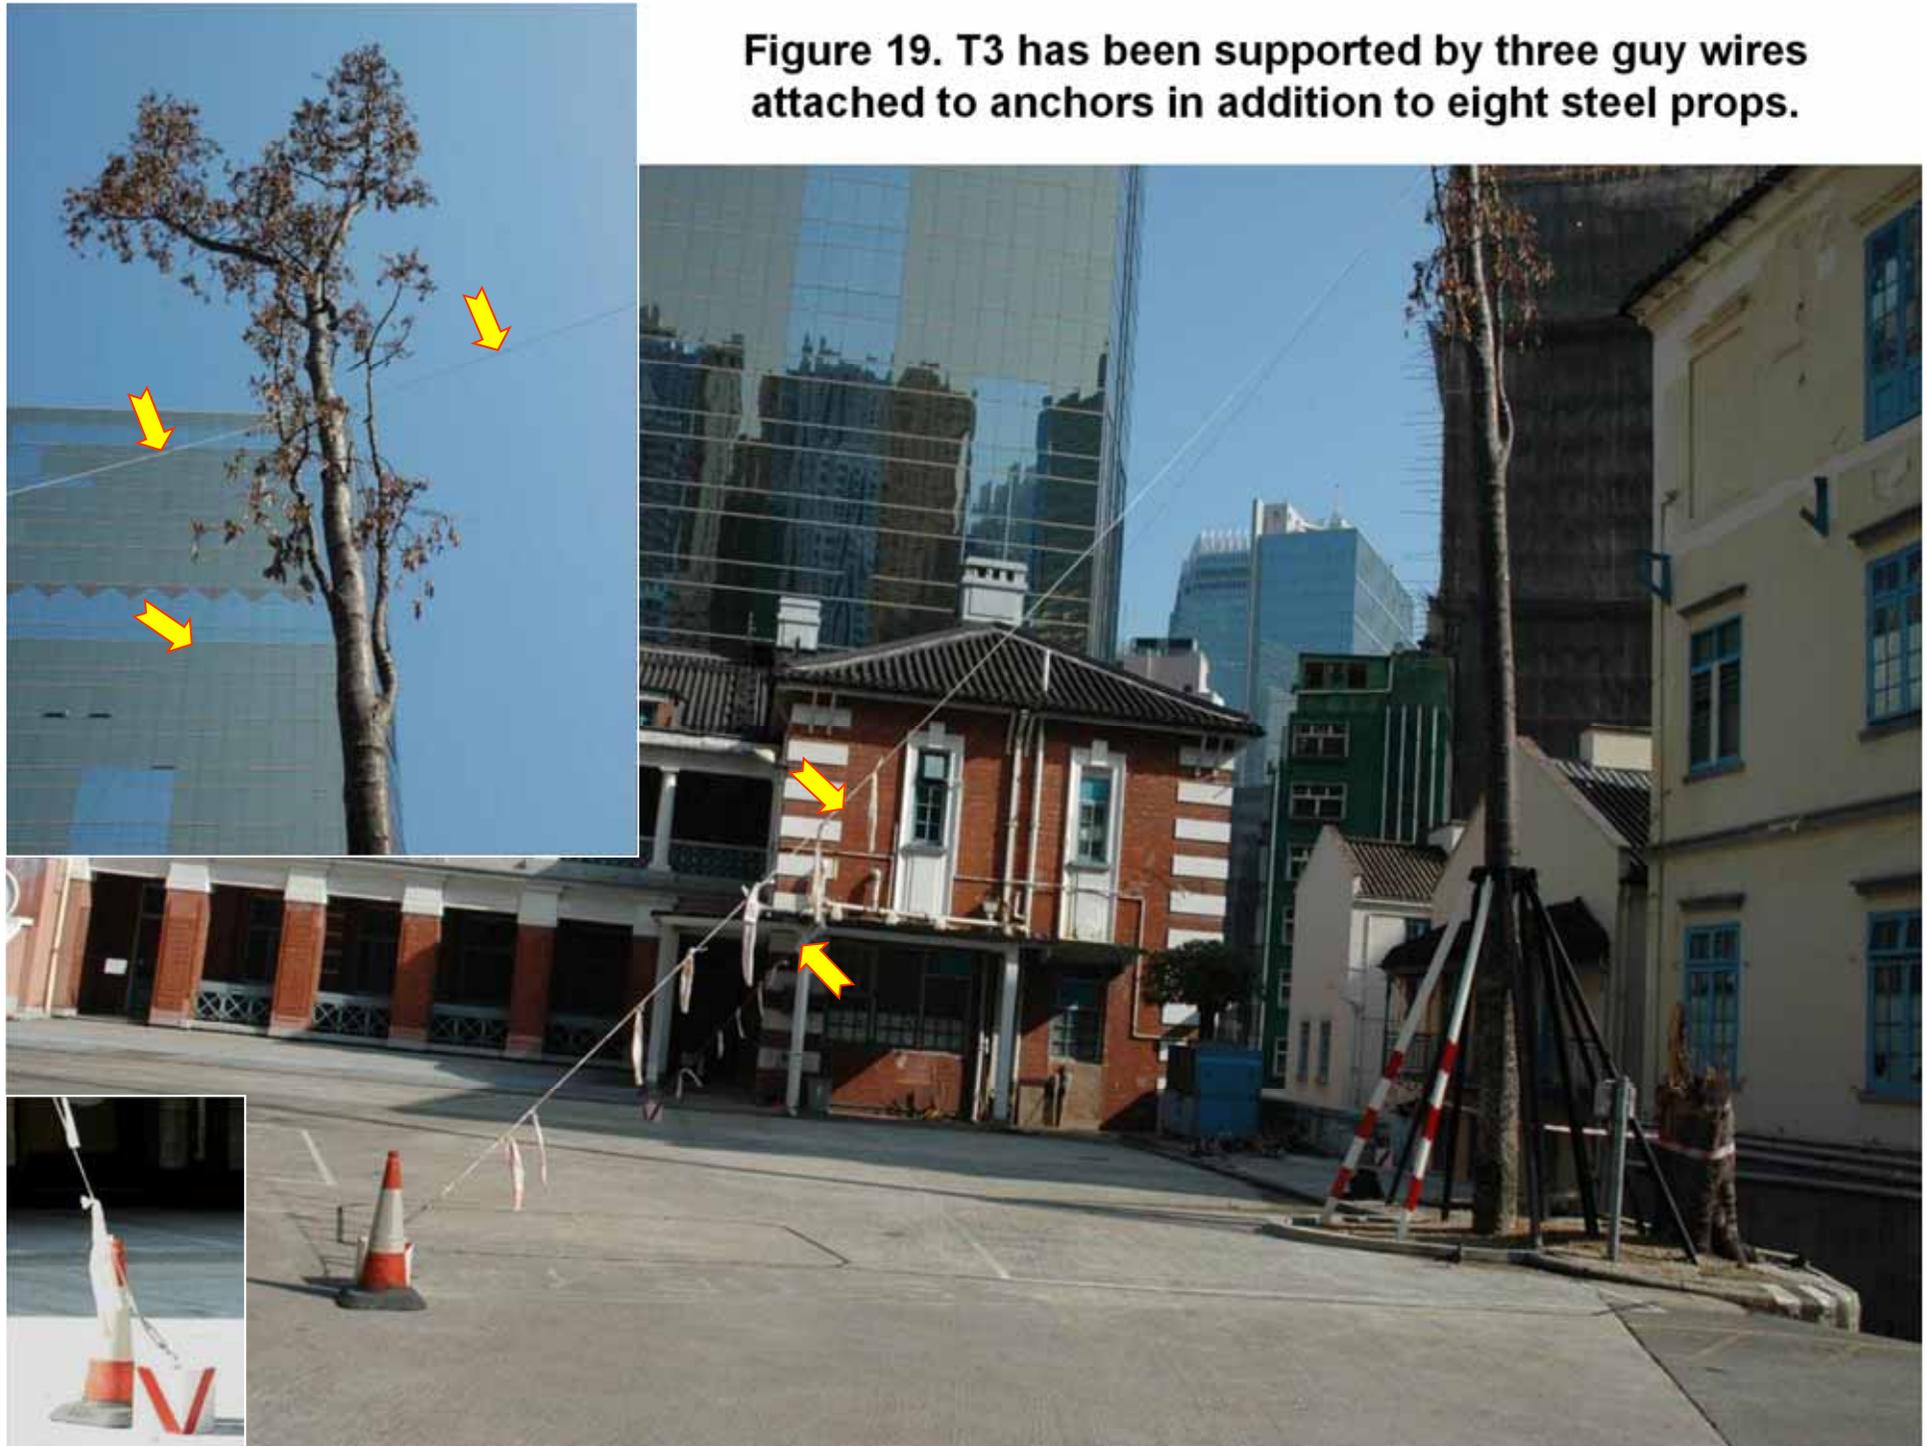
Figure 19. T3 has been supported by three guy wires attached to anchors in addition to eight steel props.

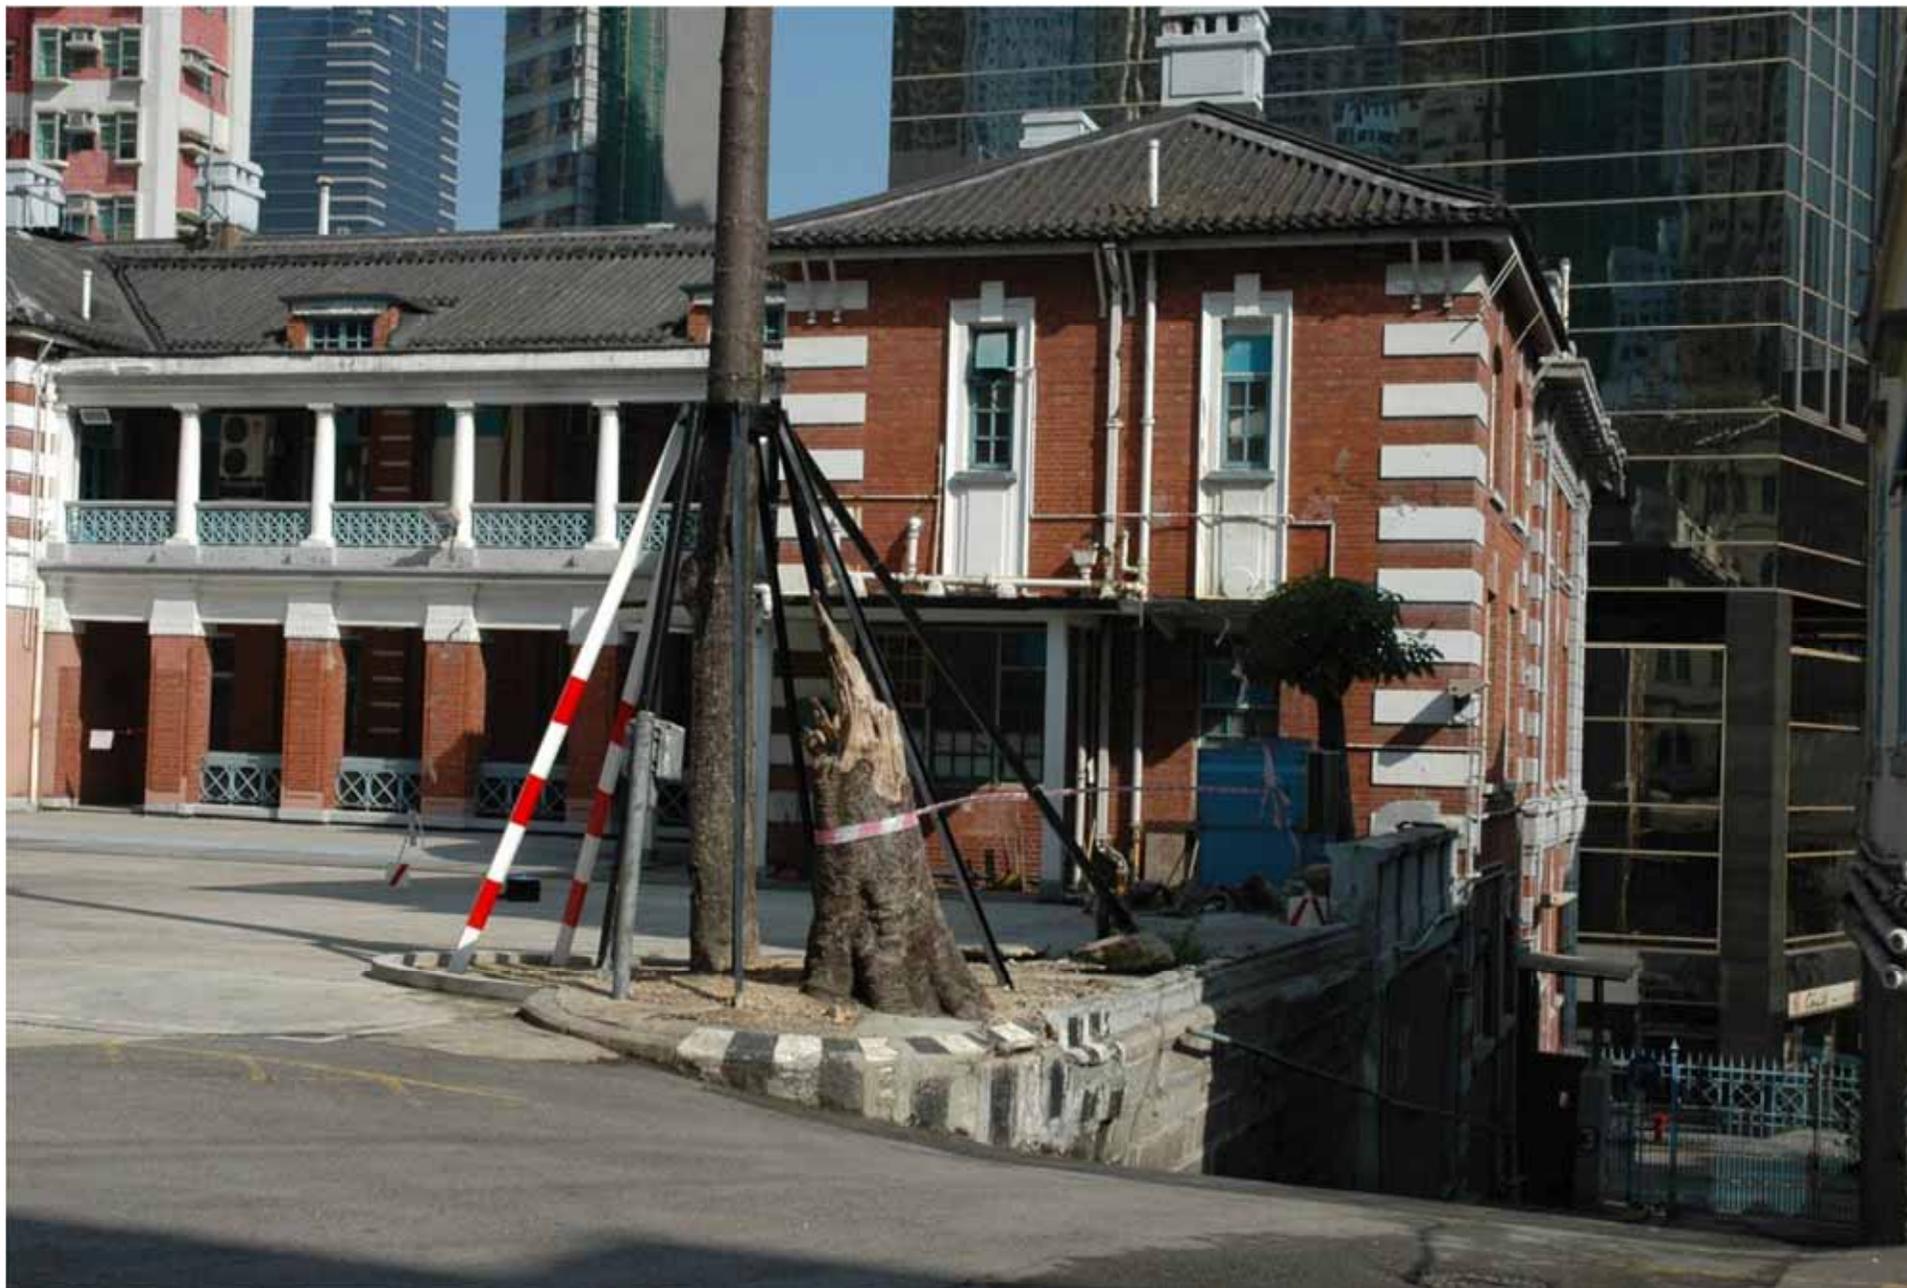
Figure 20. Root extension of T3 towards the east is restricted by the retaining wall on the edge of the access road.

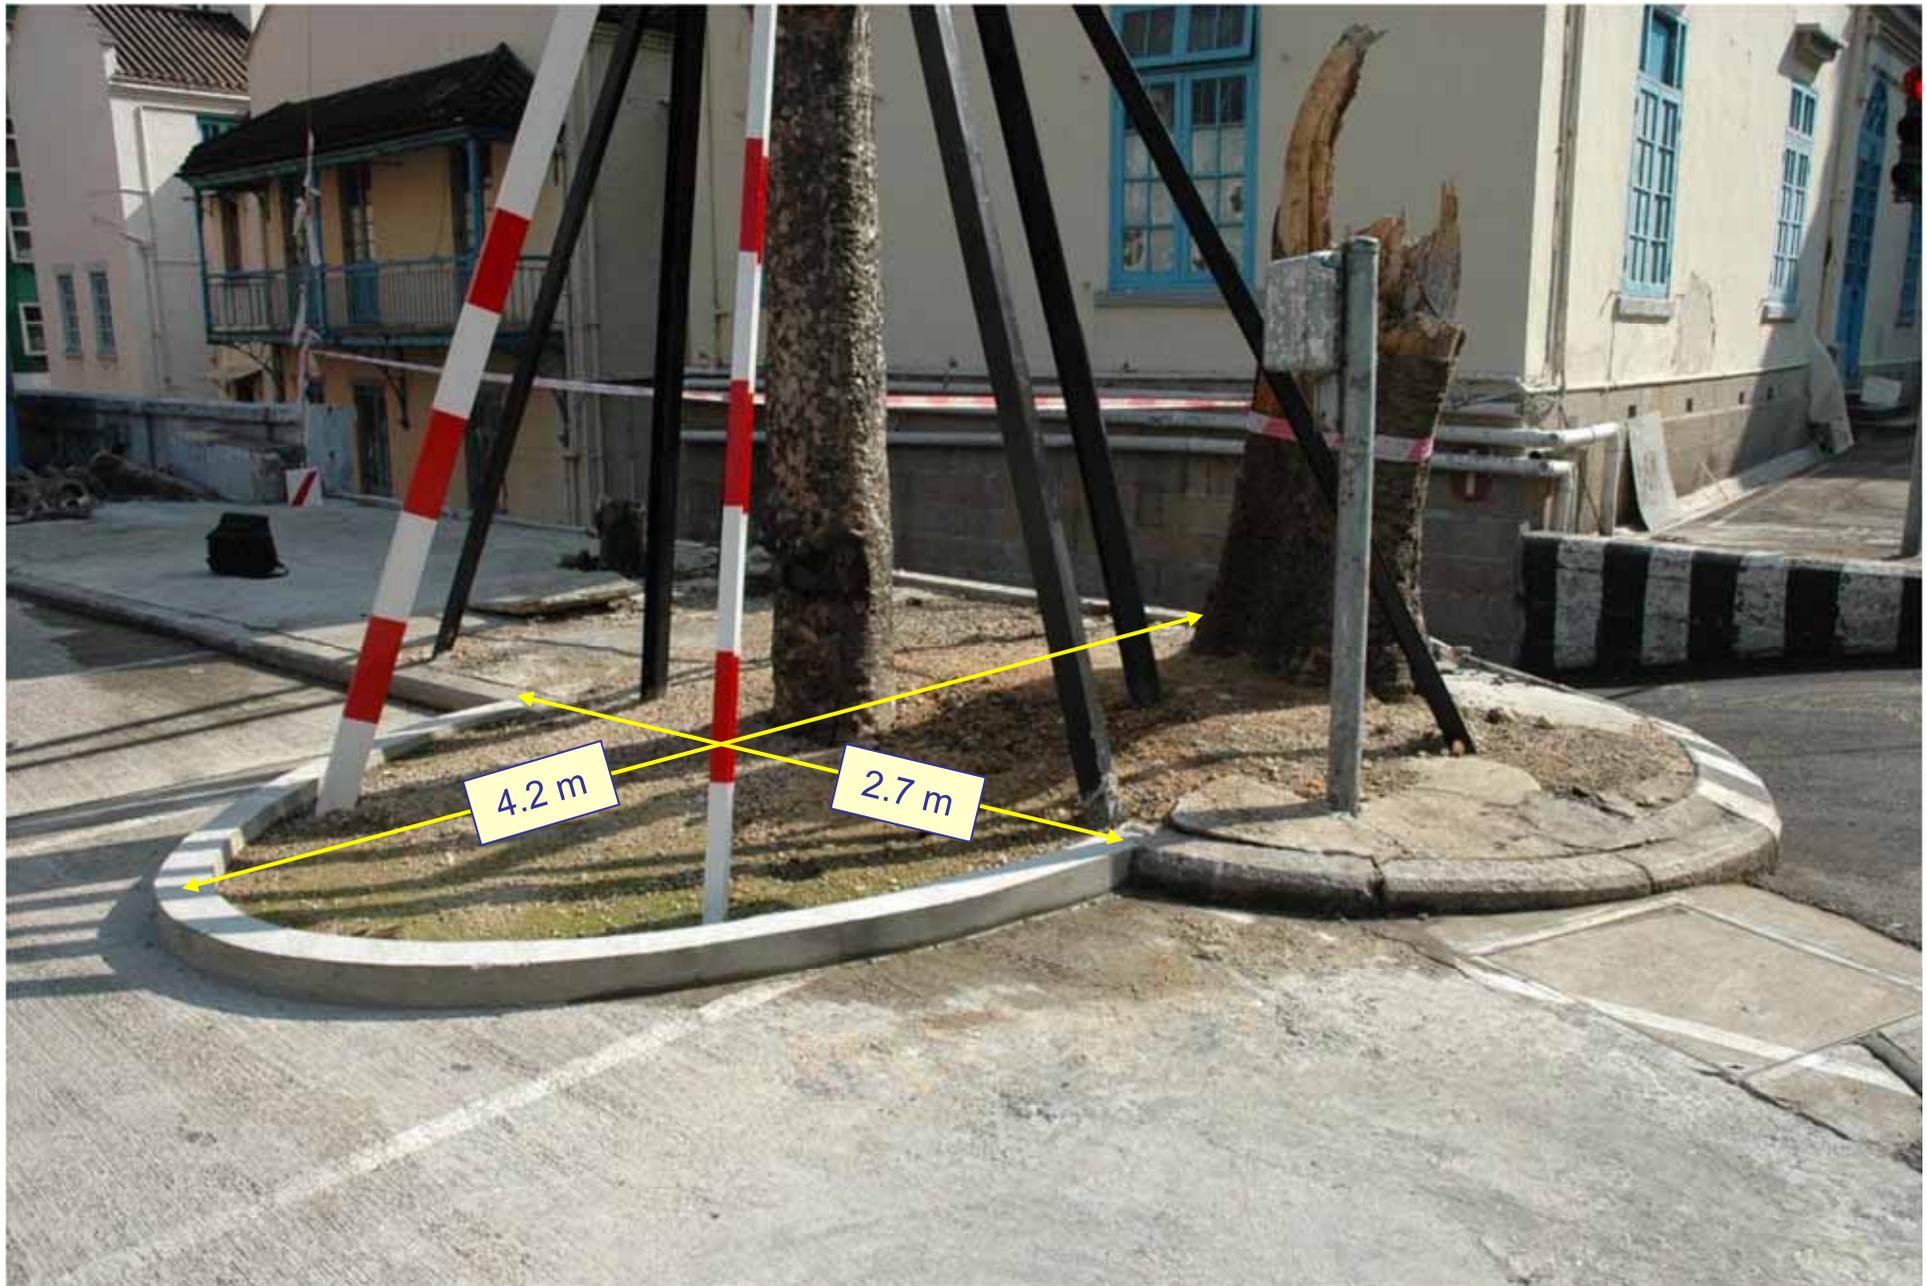
Figure 21. The original tiny tree pit of T3 has been enlarged in conjunction with the salvage operation conducted after Typhoon Fengshen.

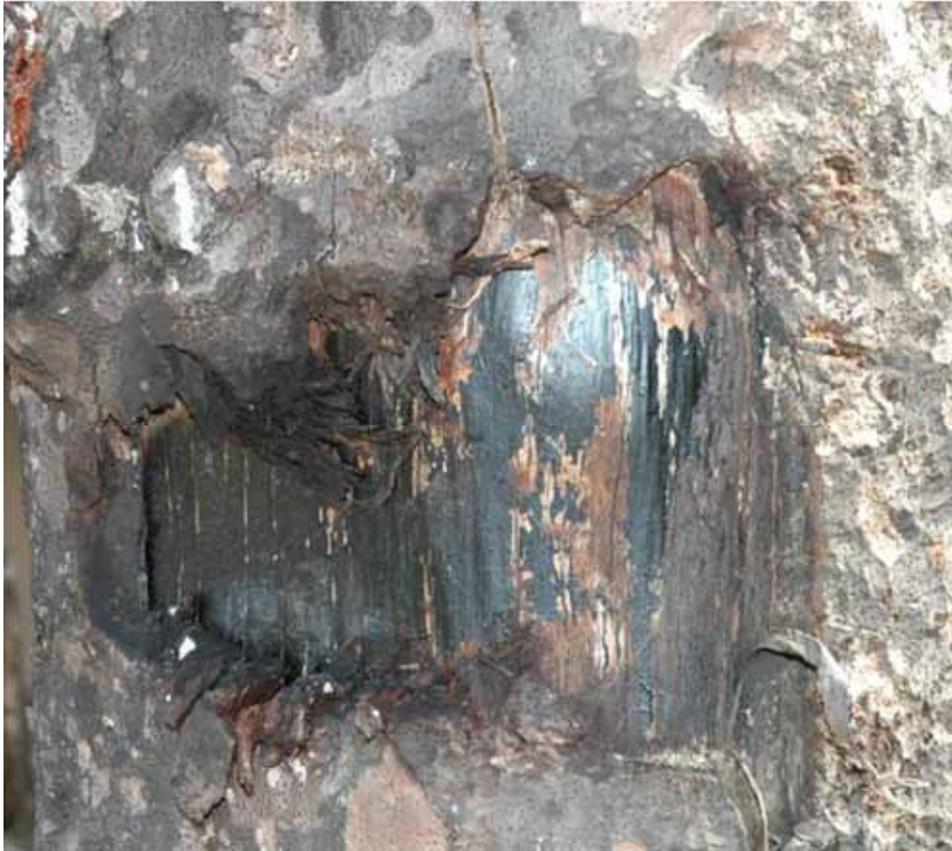
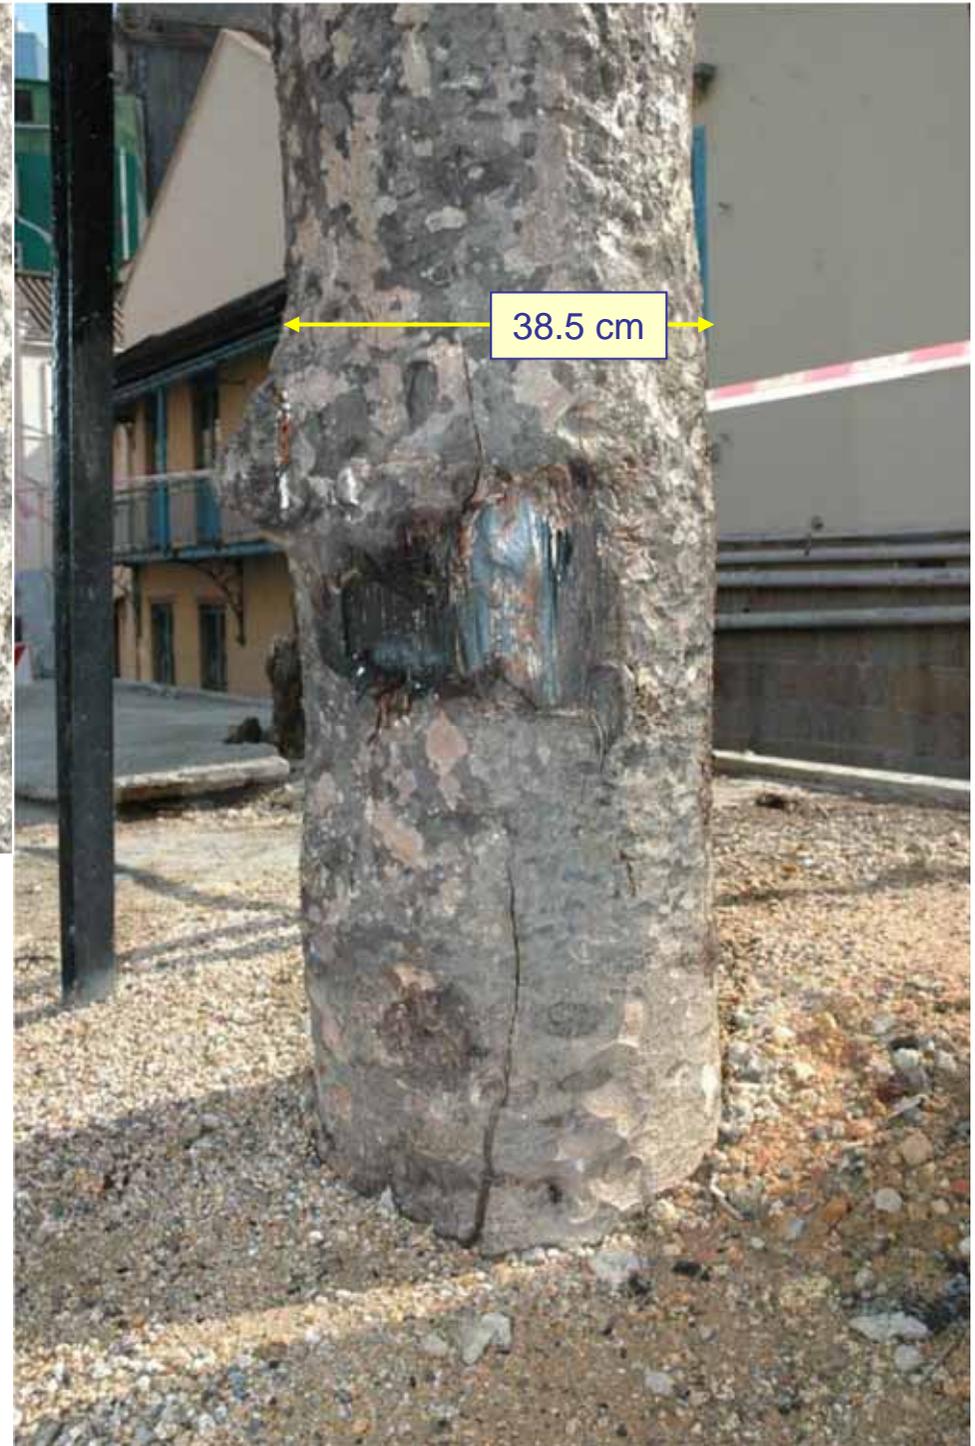
Figure 22. The lower part of the trunk of T3 on the southwest side has a large wound with loss of bark and some sapwood. Several conspicuous vertical cracks have developed, extending from the base upwards and from the wound upwards. These injuries could have been incurred when the tree collapsed during Typhoon Fengshen.

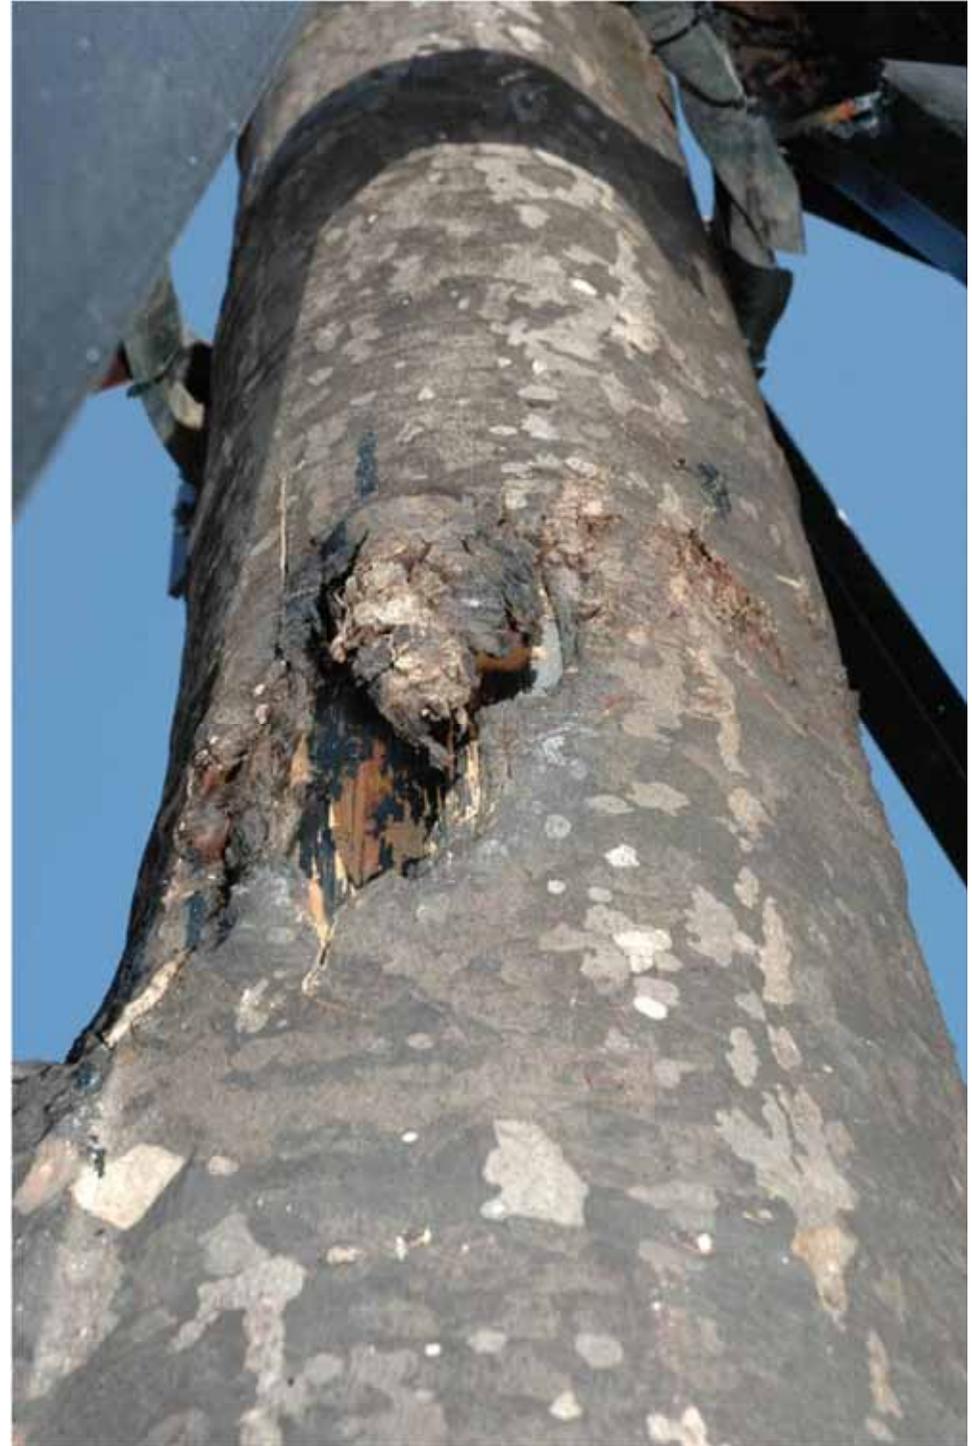
Figure 23. Another wound is found higher up the trunk of T3, also with loss of bark and some sapwood. The wound could become a portal for invasion by the tree's natural enemies, including the air-borne spores of wood-decay fungi.

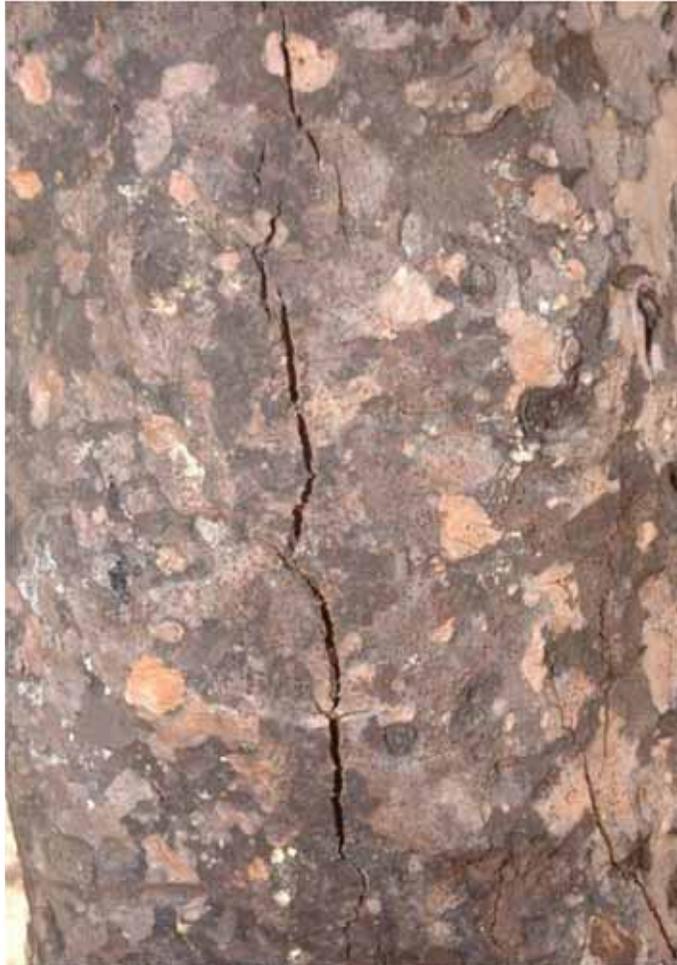
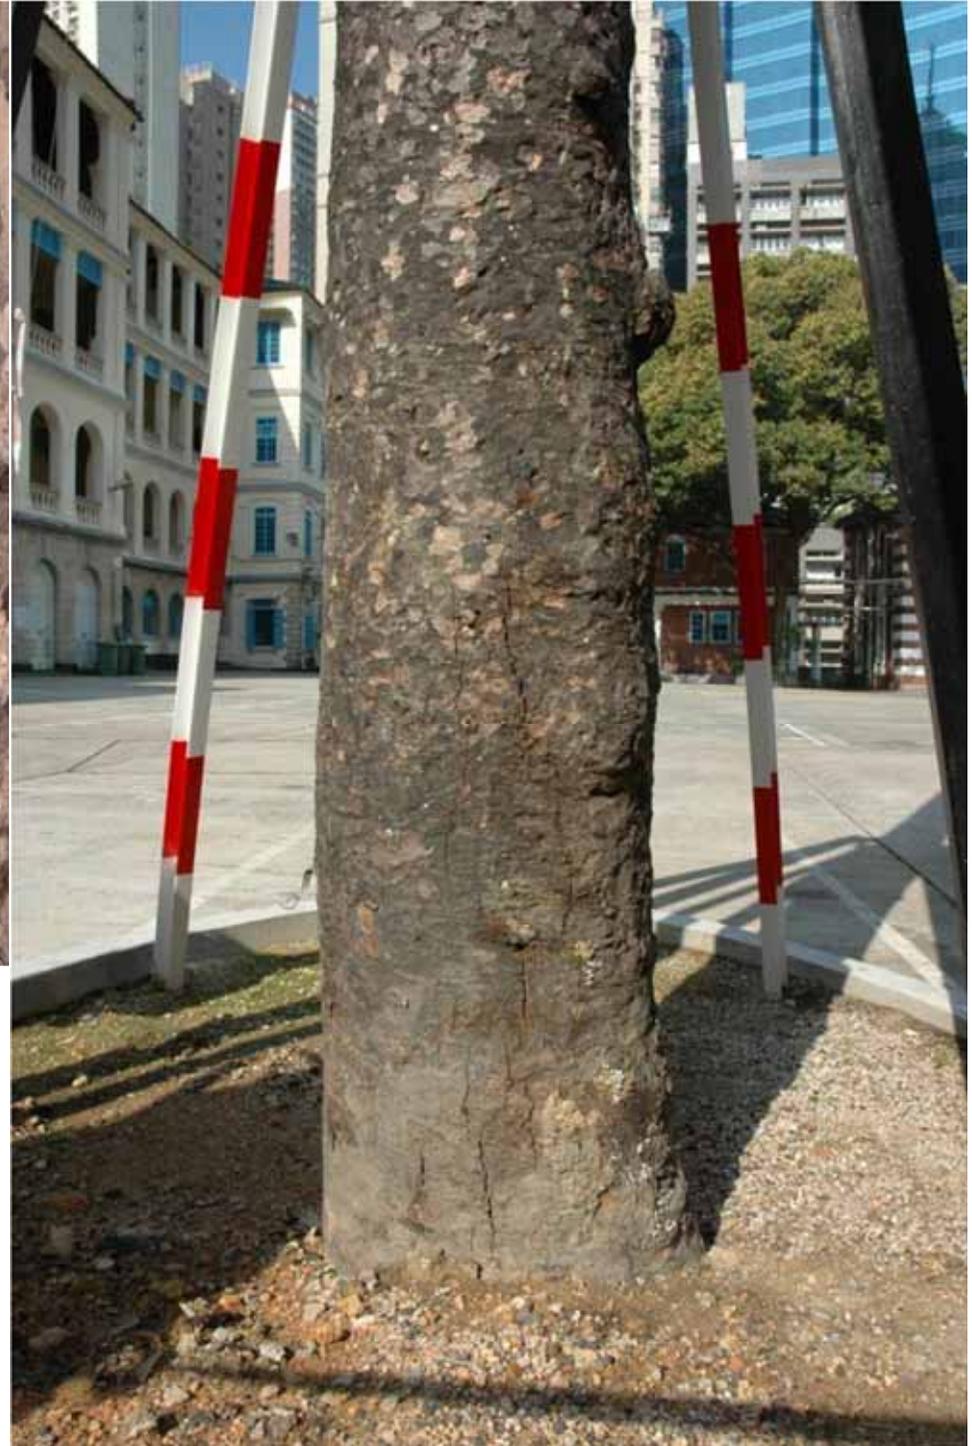
Figure 24. On the east side of the lower trunk of T3, a series of vertical cracks have developed. They could have been incurred when the tree collapsed during Typhoon Fengshen. Note the lack of a trunk flare, indicating that the ground level around the tree has been raised in the past to bury the trunk base.
