Table 1 Response to EPD's Request for Supplementary Information (Ref: EPD's letter dated 9th March 2011)

ANNEX A

Update to EIA Report Section 4.6.4 Trees within the Project Site (Figures 1 and 3)

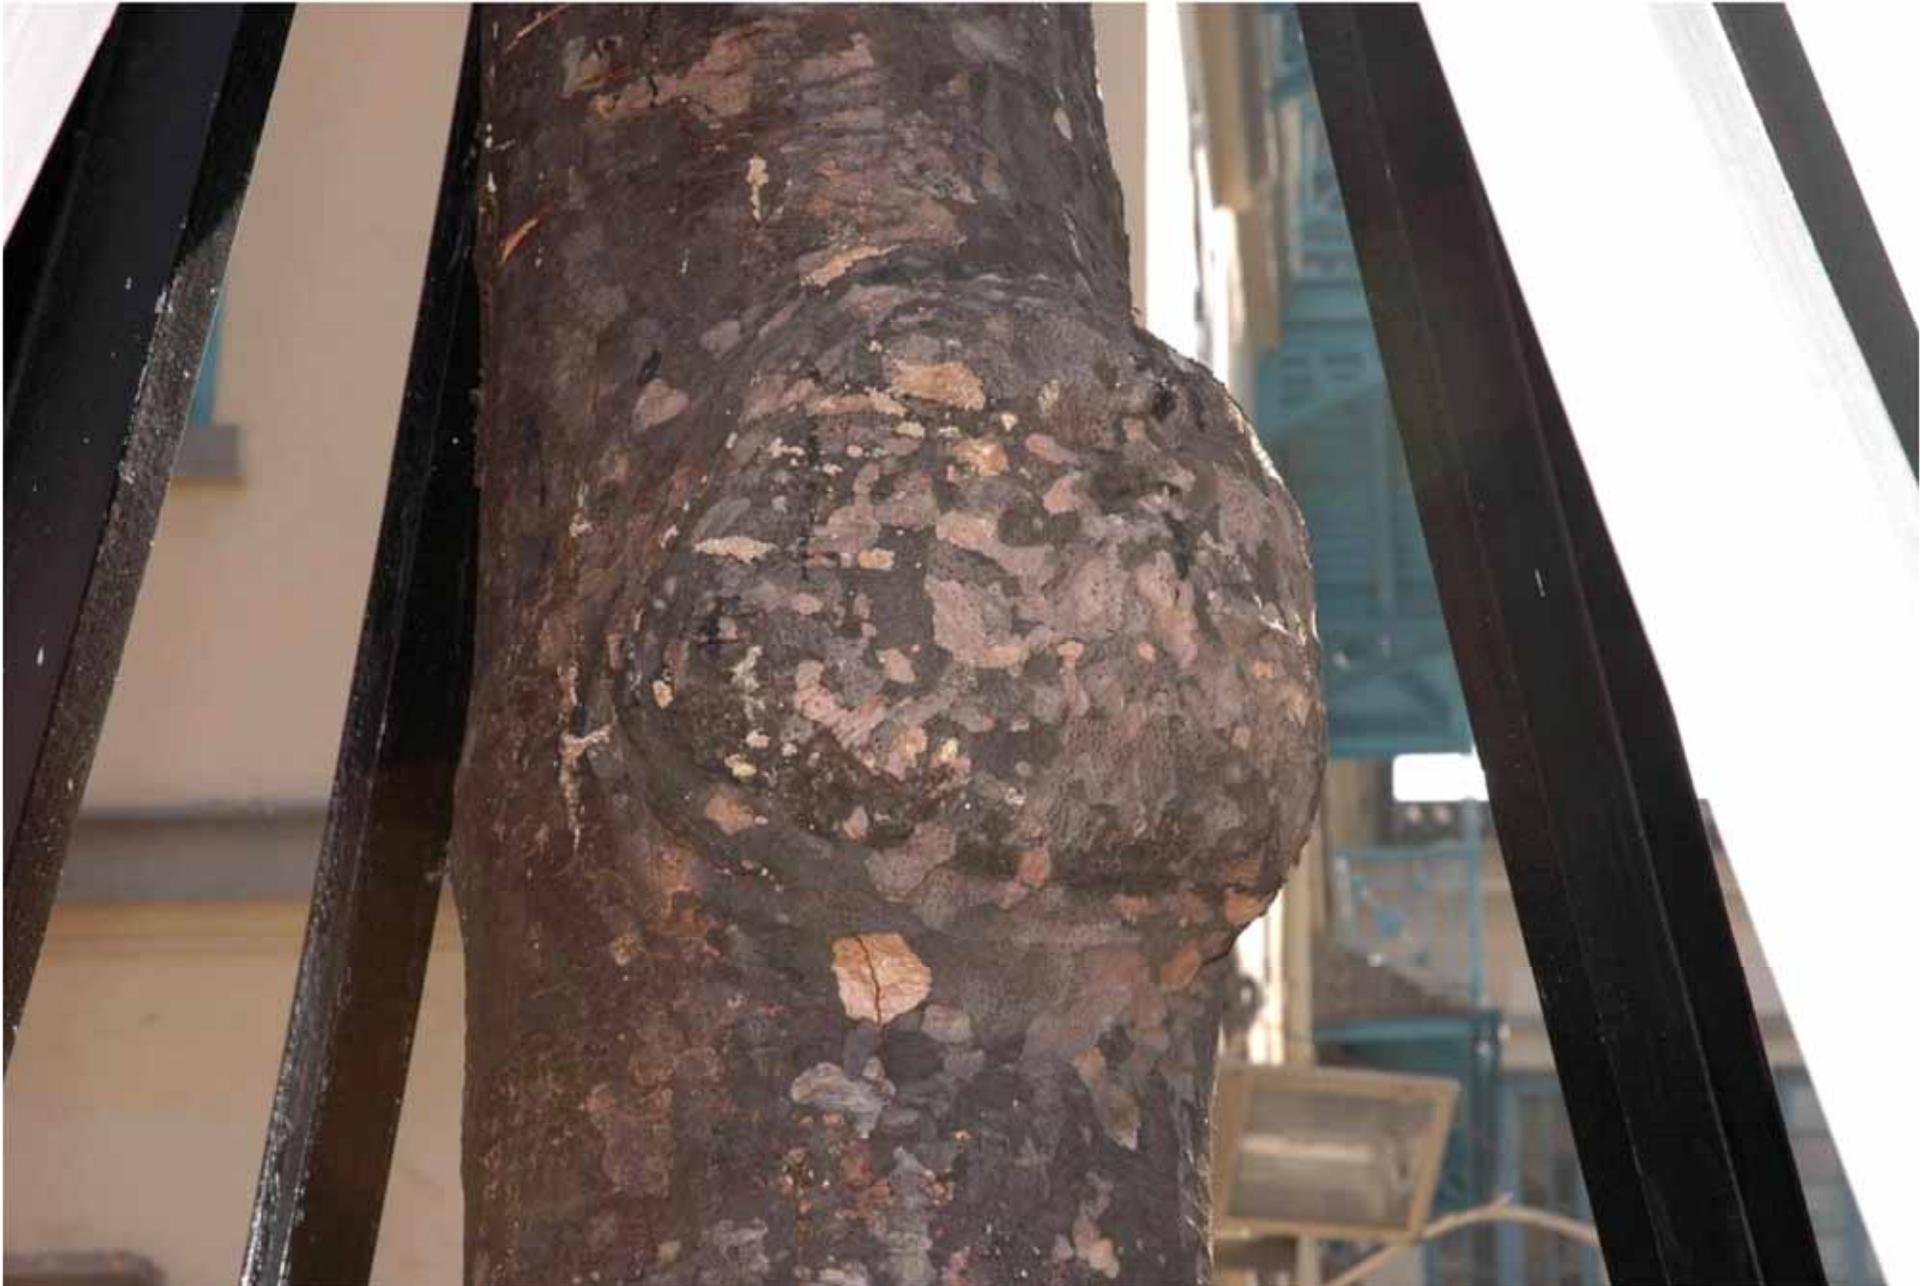
Figure 25. A gall has developed on the trunk of T3, which is usually connected with the invasion of woody tissues by a pathogenic microorganism.

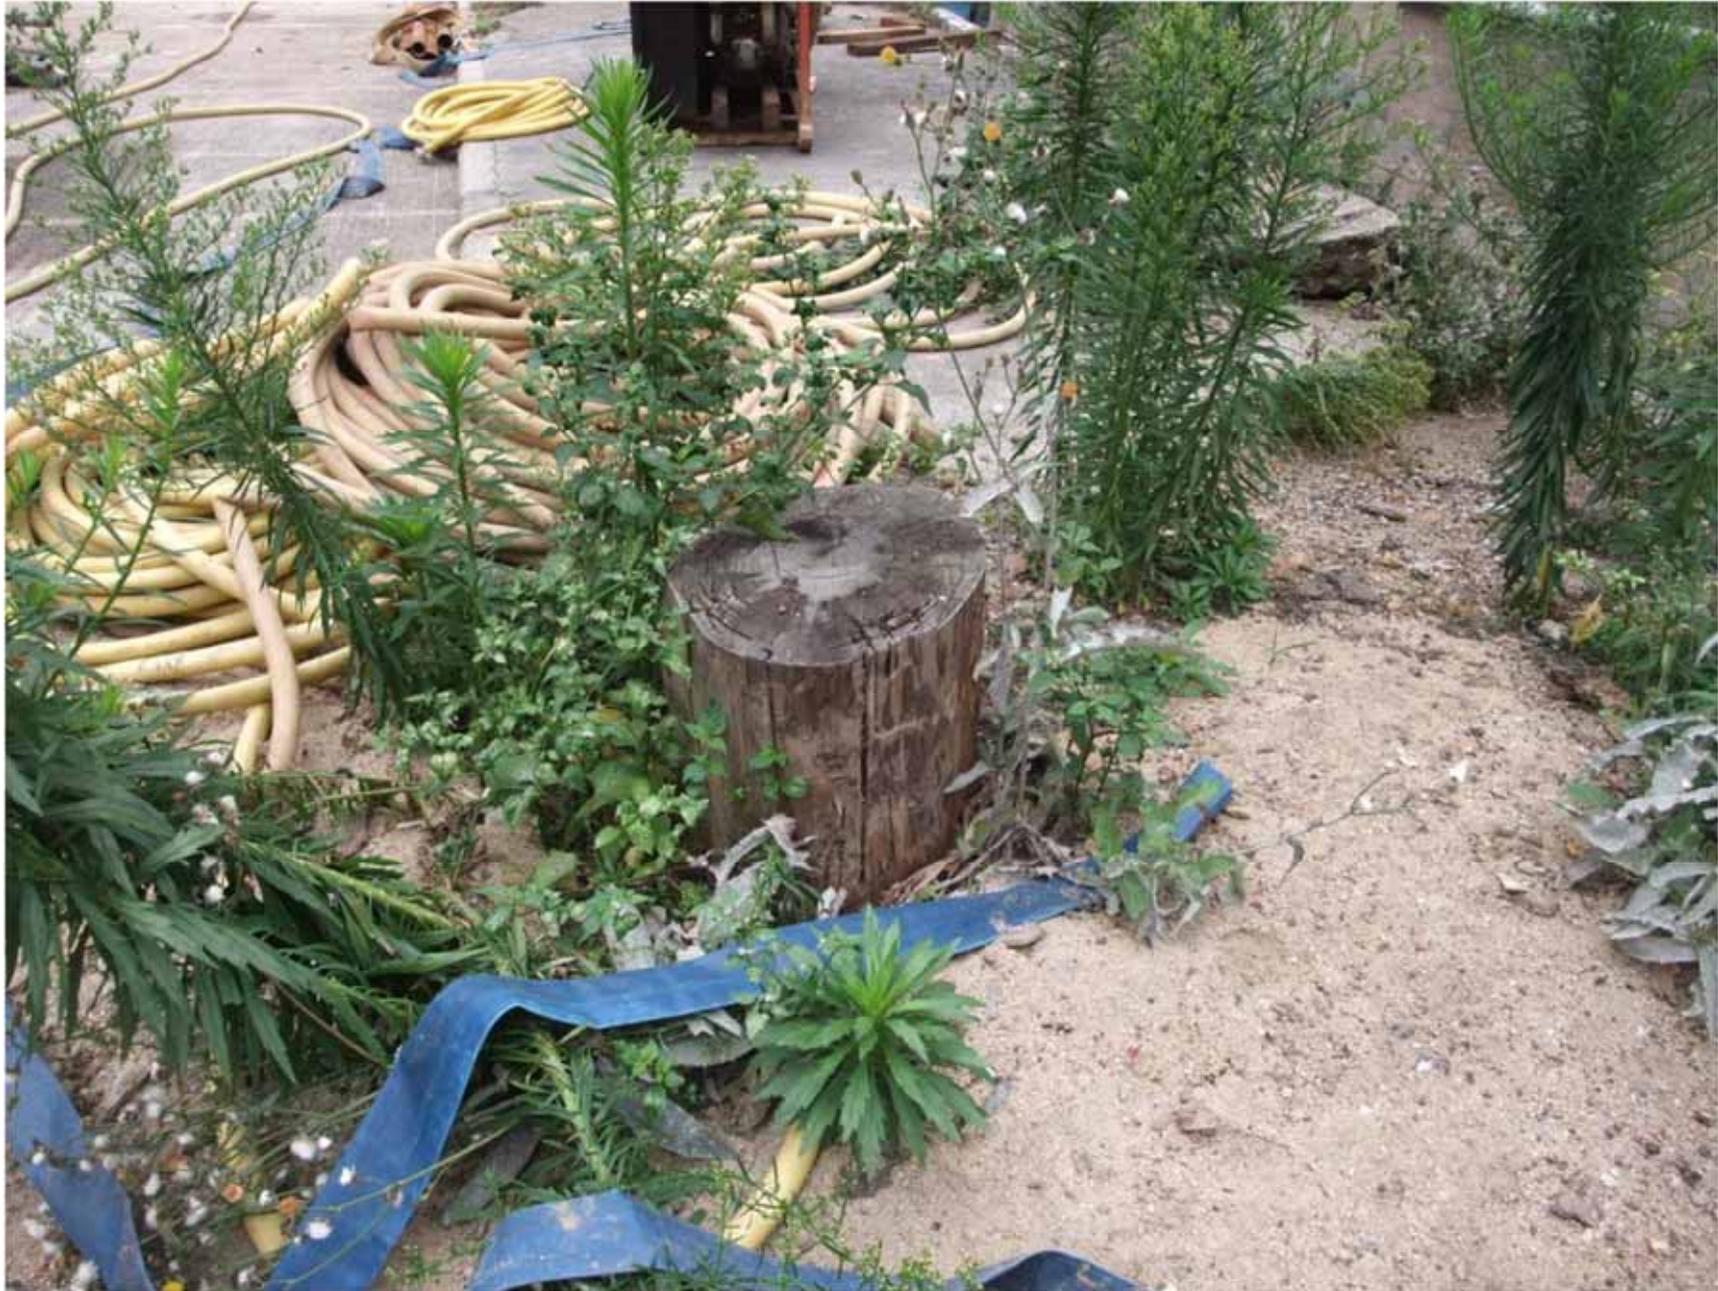
T3 is now considered to be dead as a result of toppling by Typhoon Fengshen which brought massive root breakage and injuries and should be removed. Despite no compensatory planting being required, it is suggested that the entire strip of land that previously accommodated T1 to T4 should be revamped to provide a planting site with improved soil conditions for future tree growth and six trees be planted here, as detailed in CM6 of Table 4.5.

Figure 26. The stump of the dead T3 on 17 March 2011.

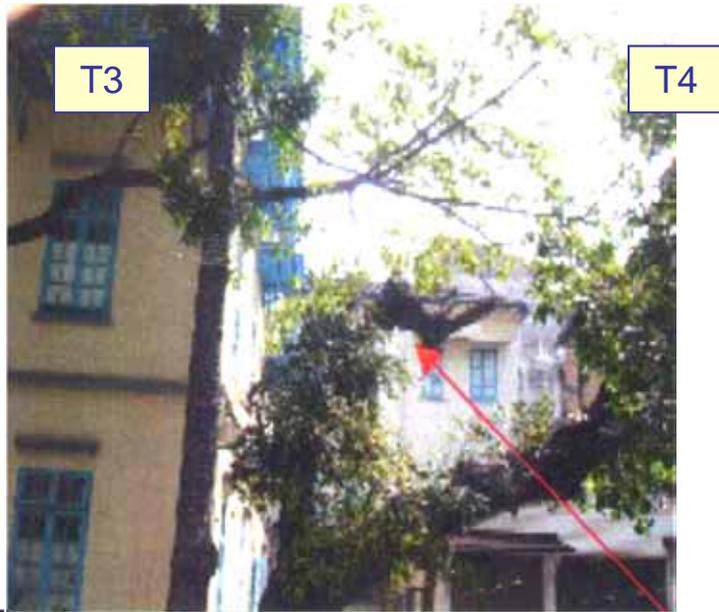
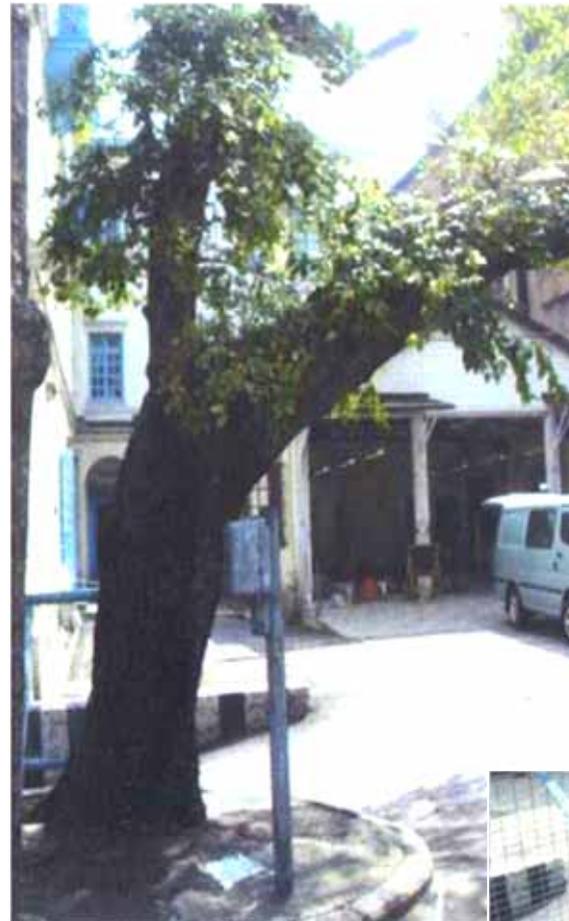
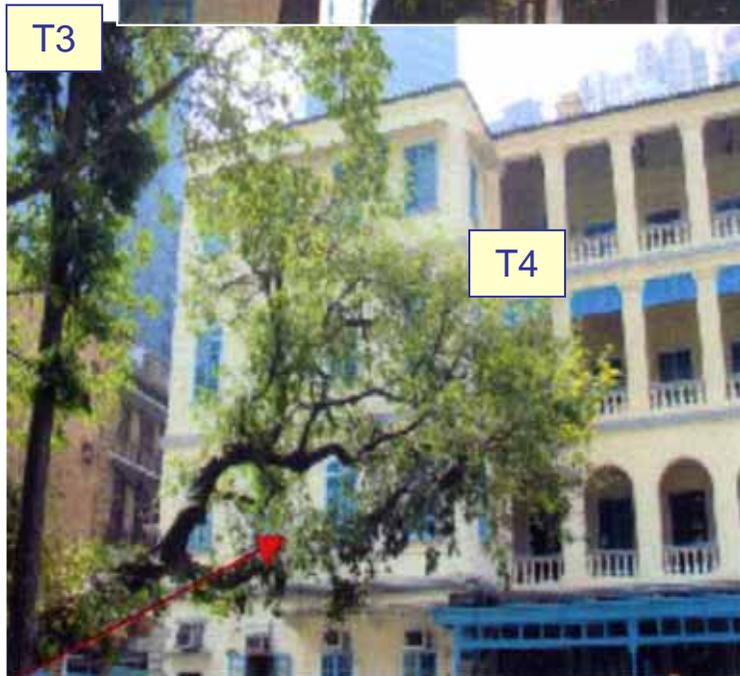
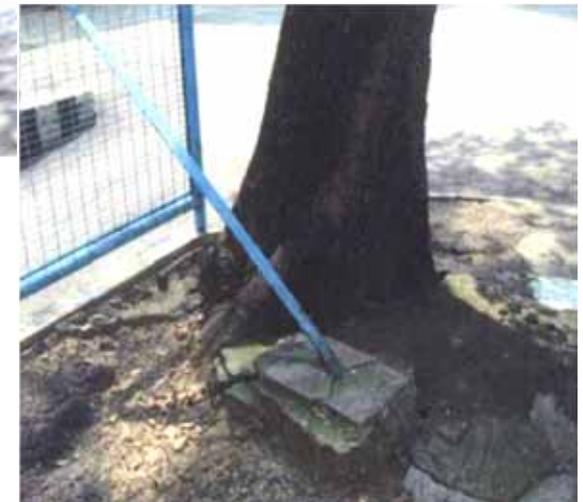
Figure 27. Before damage by Typhoon Fengshen, T4 (*Celtis sinensis*) had restricted crown development only on the south side, and extensive dead and dying branches. Note the limited exposed soil at the trunk base (photos supplied by the Trust).

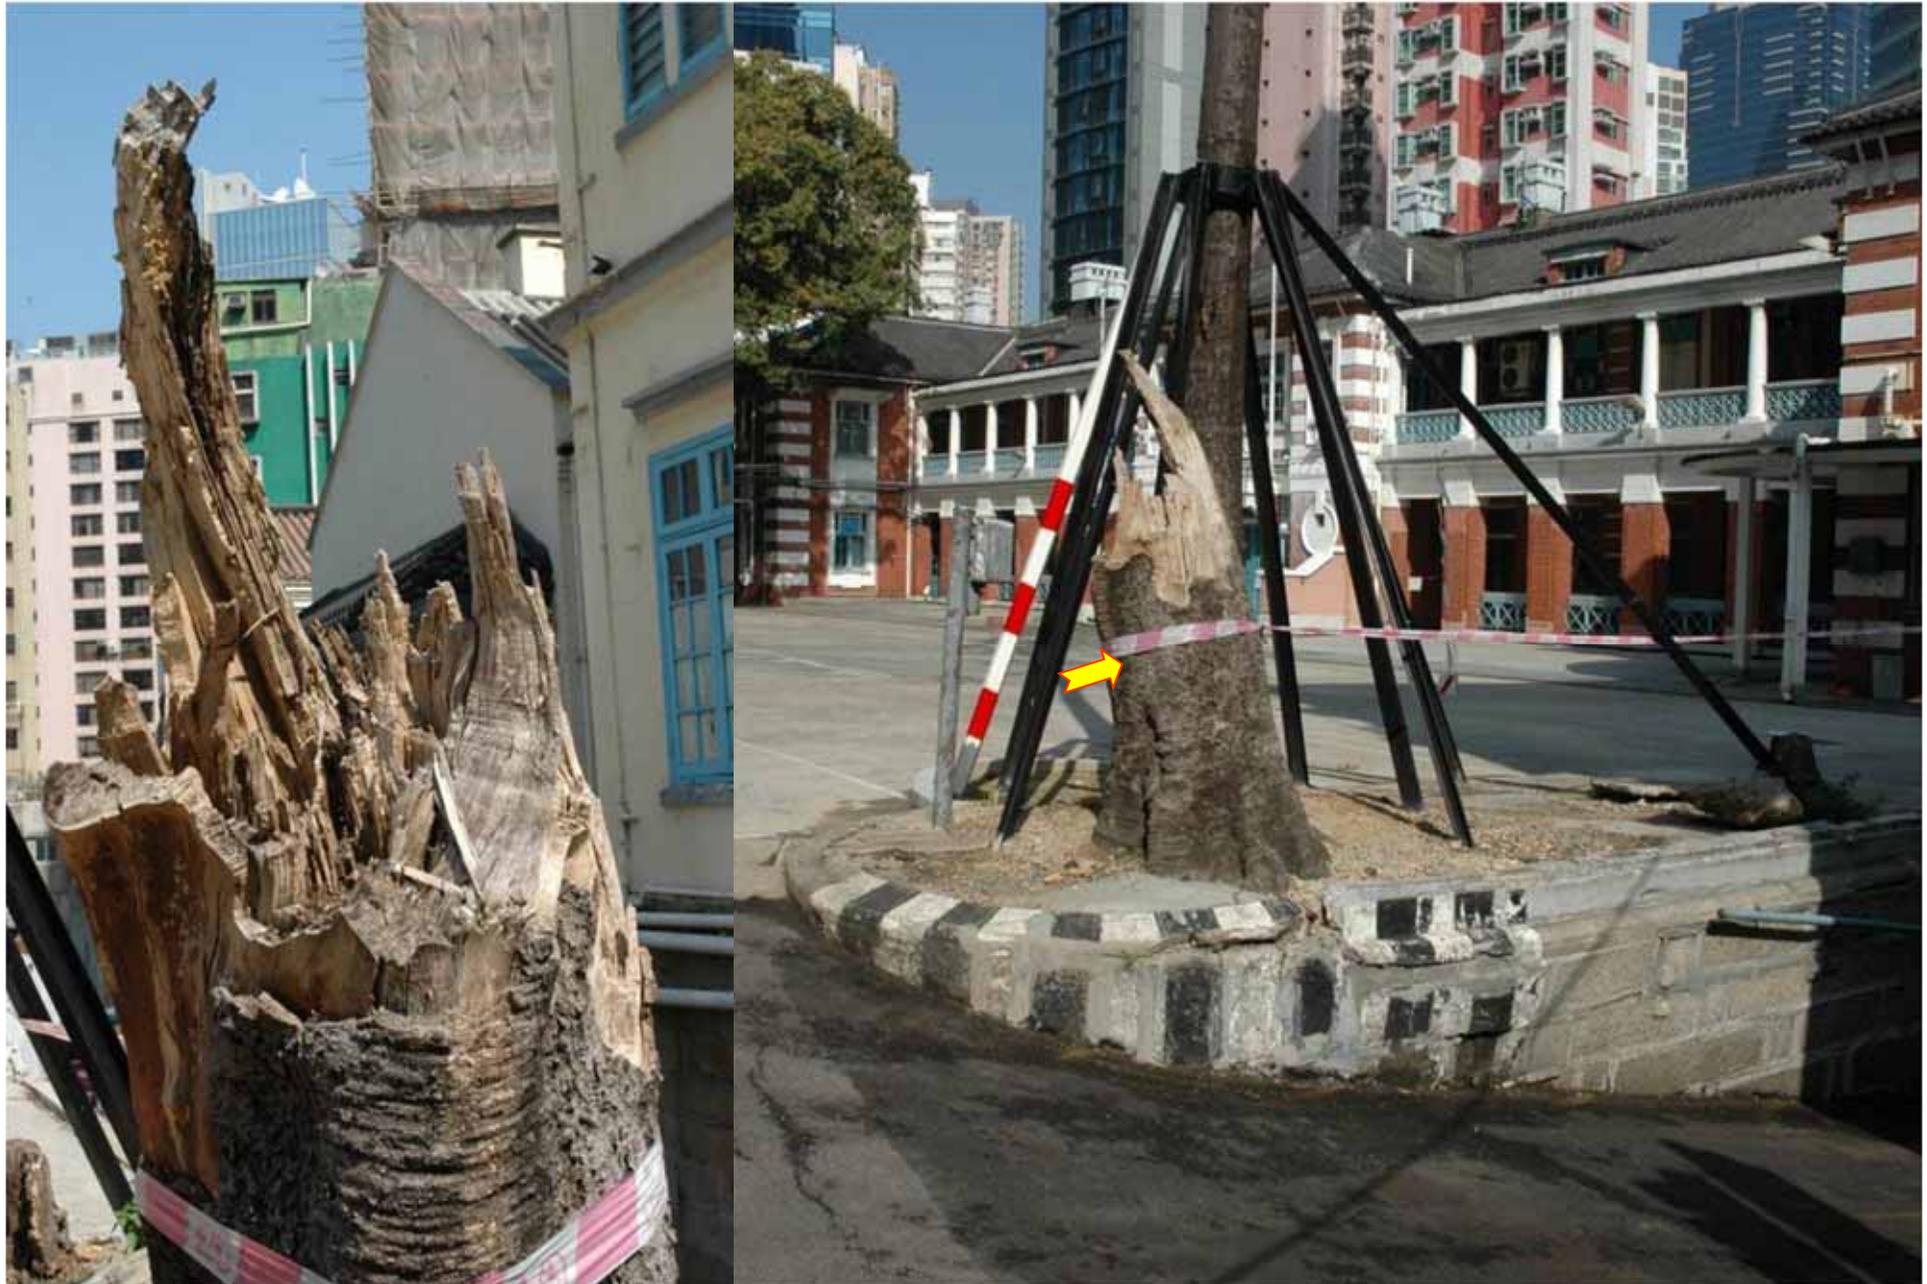
T4 was snapped at about 1.8 m from the ground by Typhoon Fengshen on 25 June 2008, leaving a stump with jagged fractured wood at its top. It is a native broadleaf deciduous tree that commonly dwells in mature local woodlands and can reach 16 m height. An inspection in February 2009 concluded that prior to its snapping, T4 was already a hazardous tree that could have broken or toppled suddenly without any warning. T4 is now considered to be dead.

Figure 28. T4 was snapped by Typhoon Fengshen on 25 June 2008, leaving a stump with jagged fractured wood at its top.

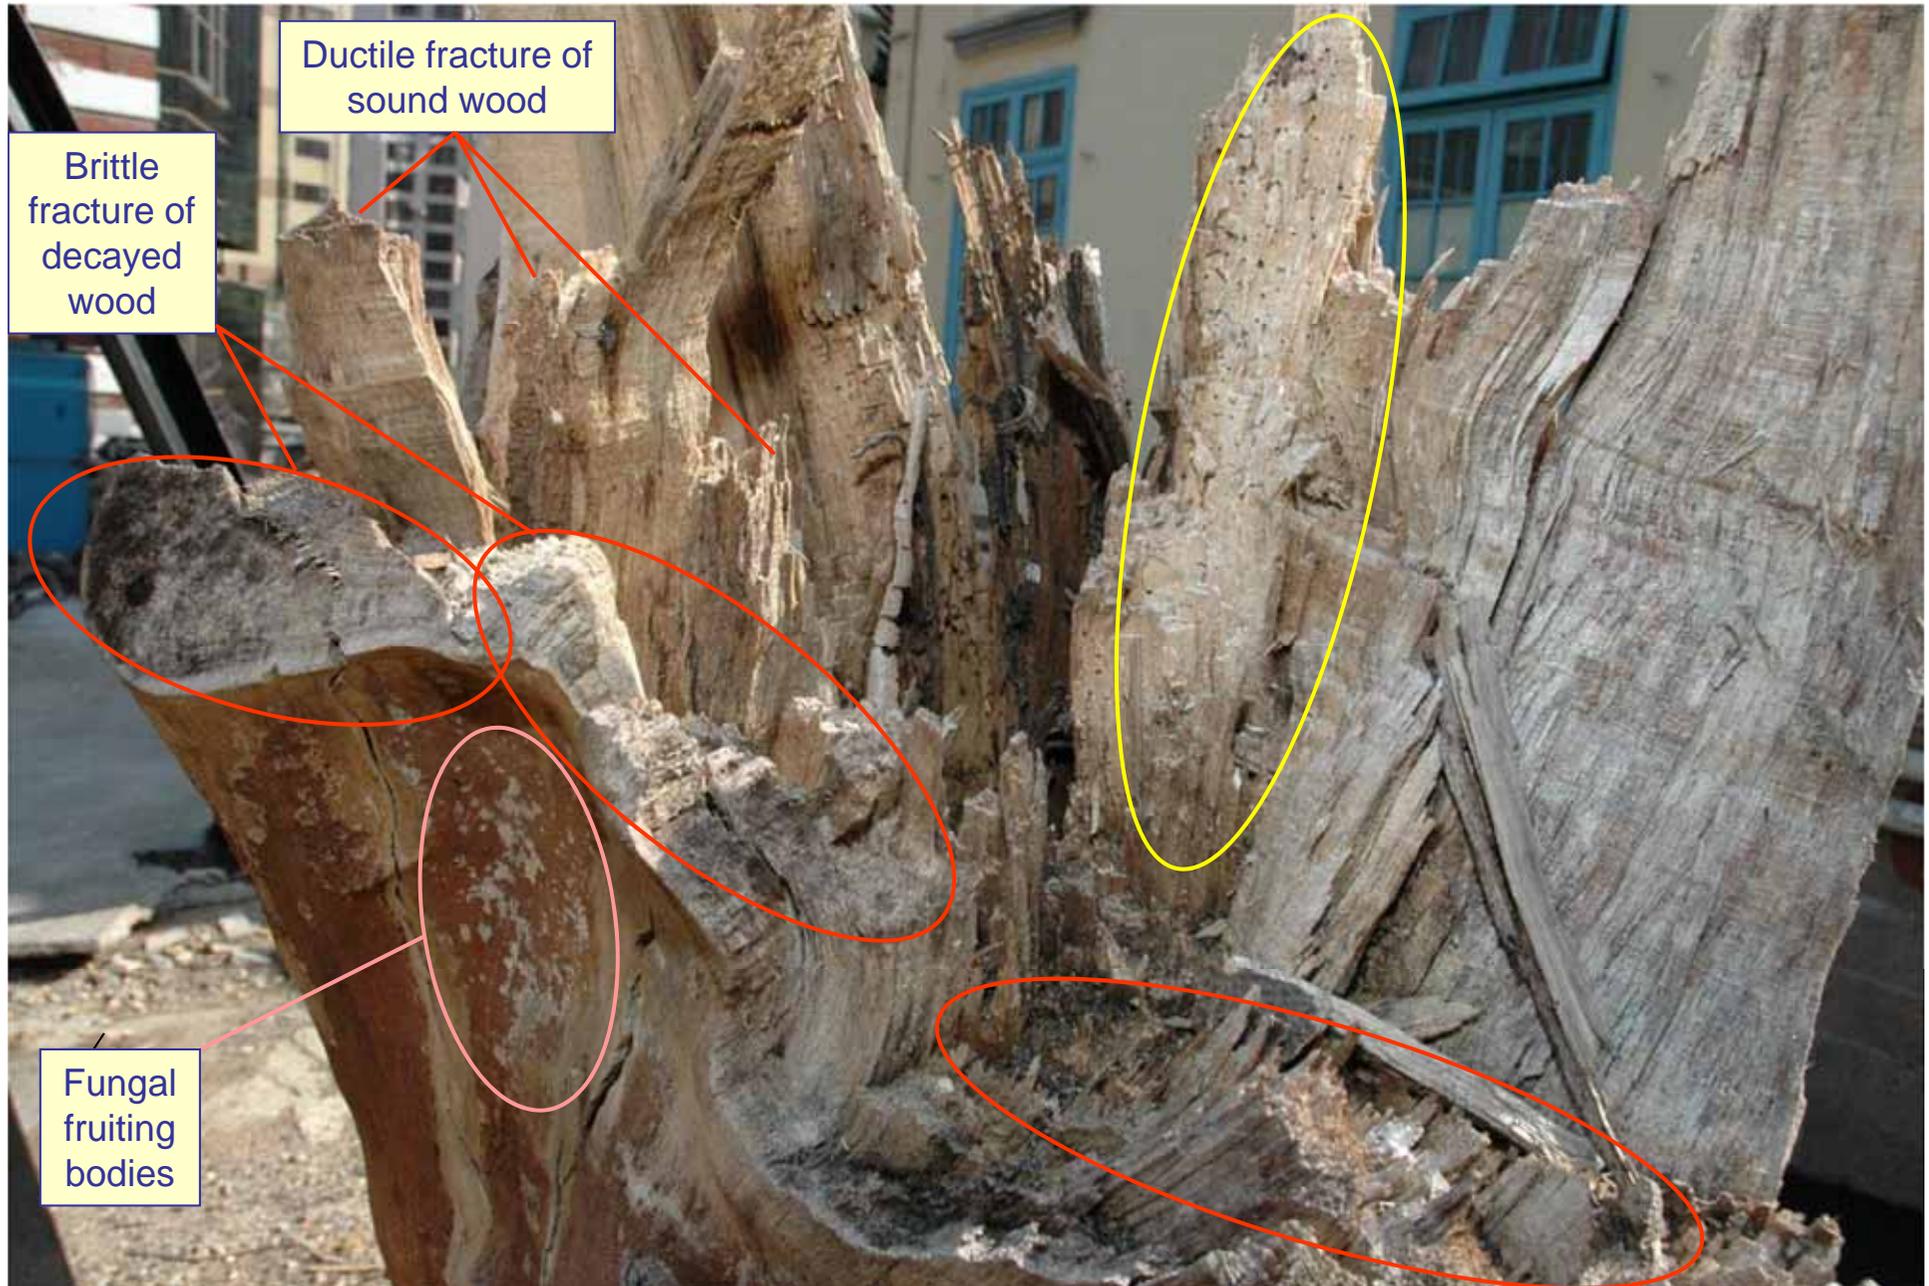
Figure 29. The fractured top of T4's stump has exposed decayed wood with weakened mechanical strength (red ovals), and symptoms of boring insect infestation (yellow oval).

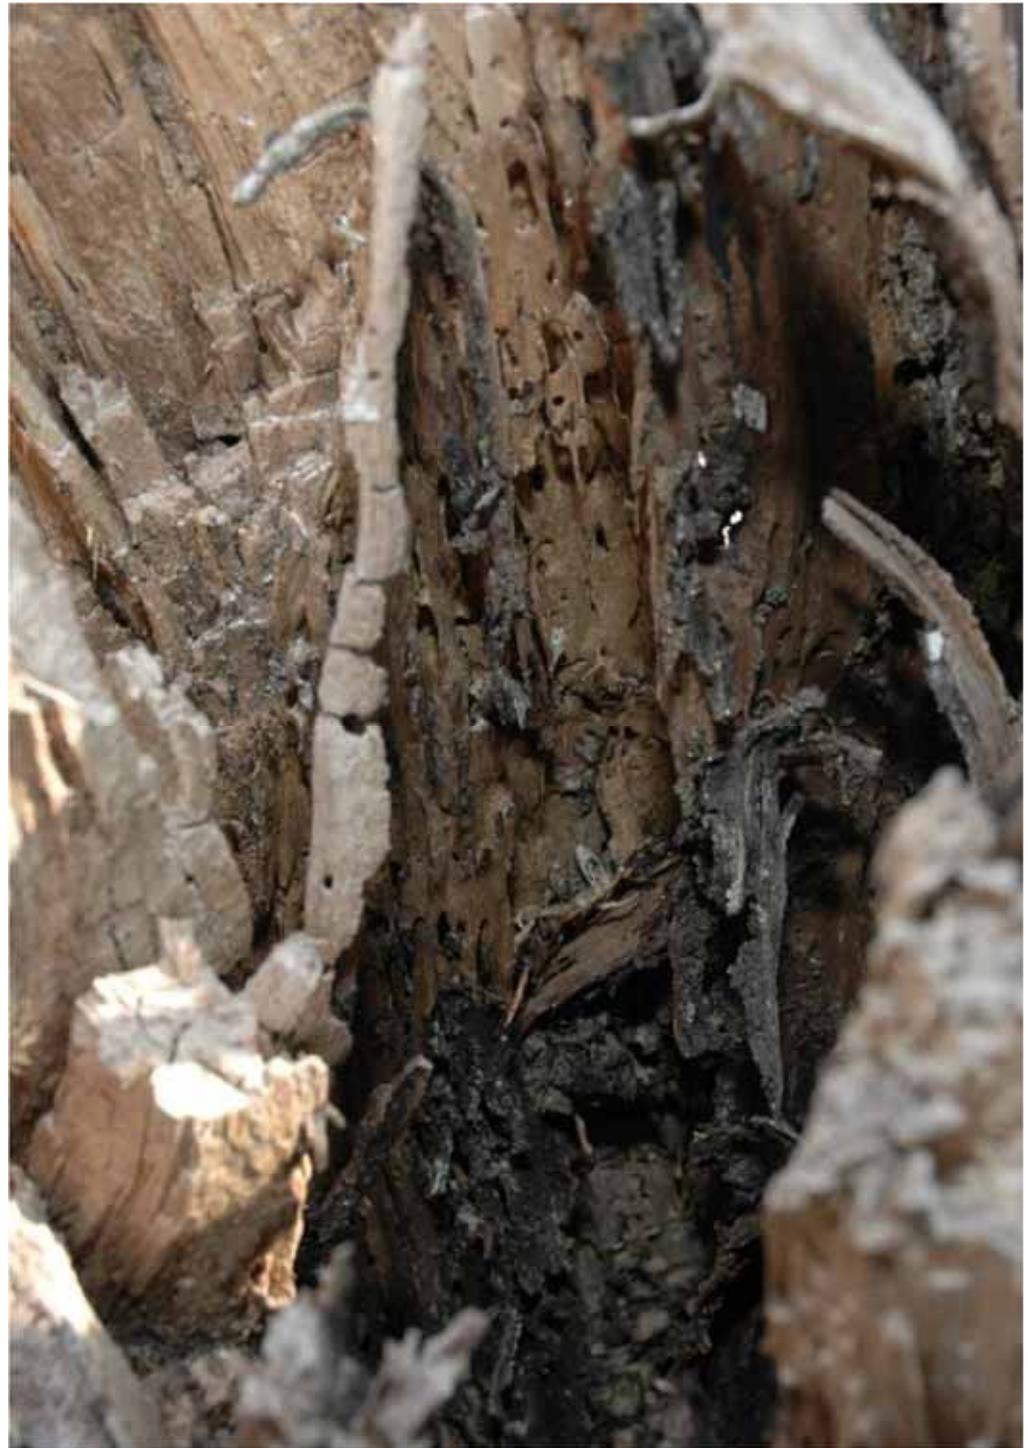
Figure 30. A cylindrical cavity is found in the centre of the T4 stump that extends towards the trunk base. On the walls of the cavity, the wood has been inflicted by advanced decay and symptoms of termite infestation. The extensive wood degradation had compromised the mechanical strength of the trunk, rendering it susceptible to breakage in high wind.

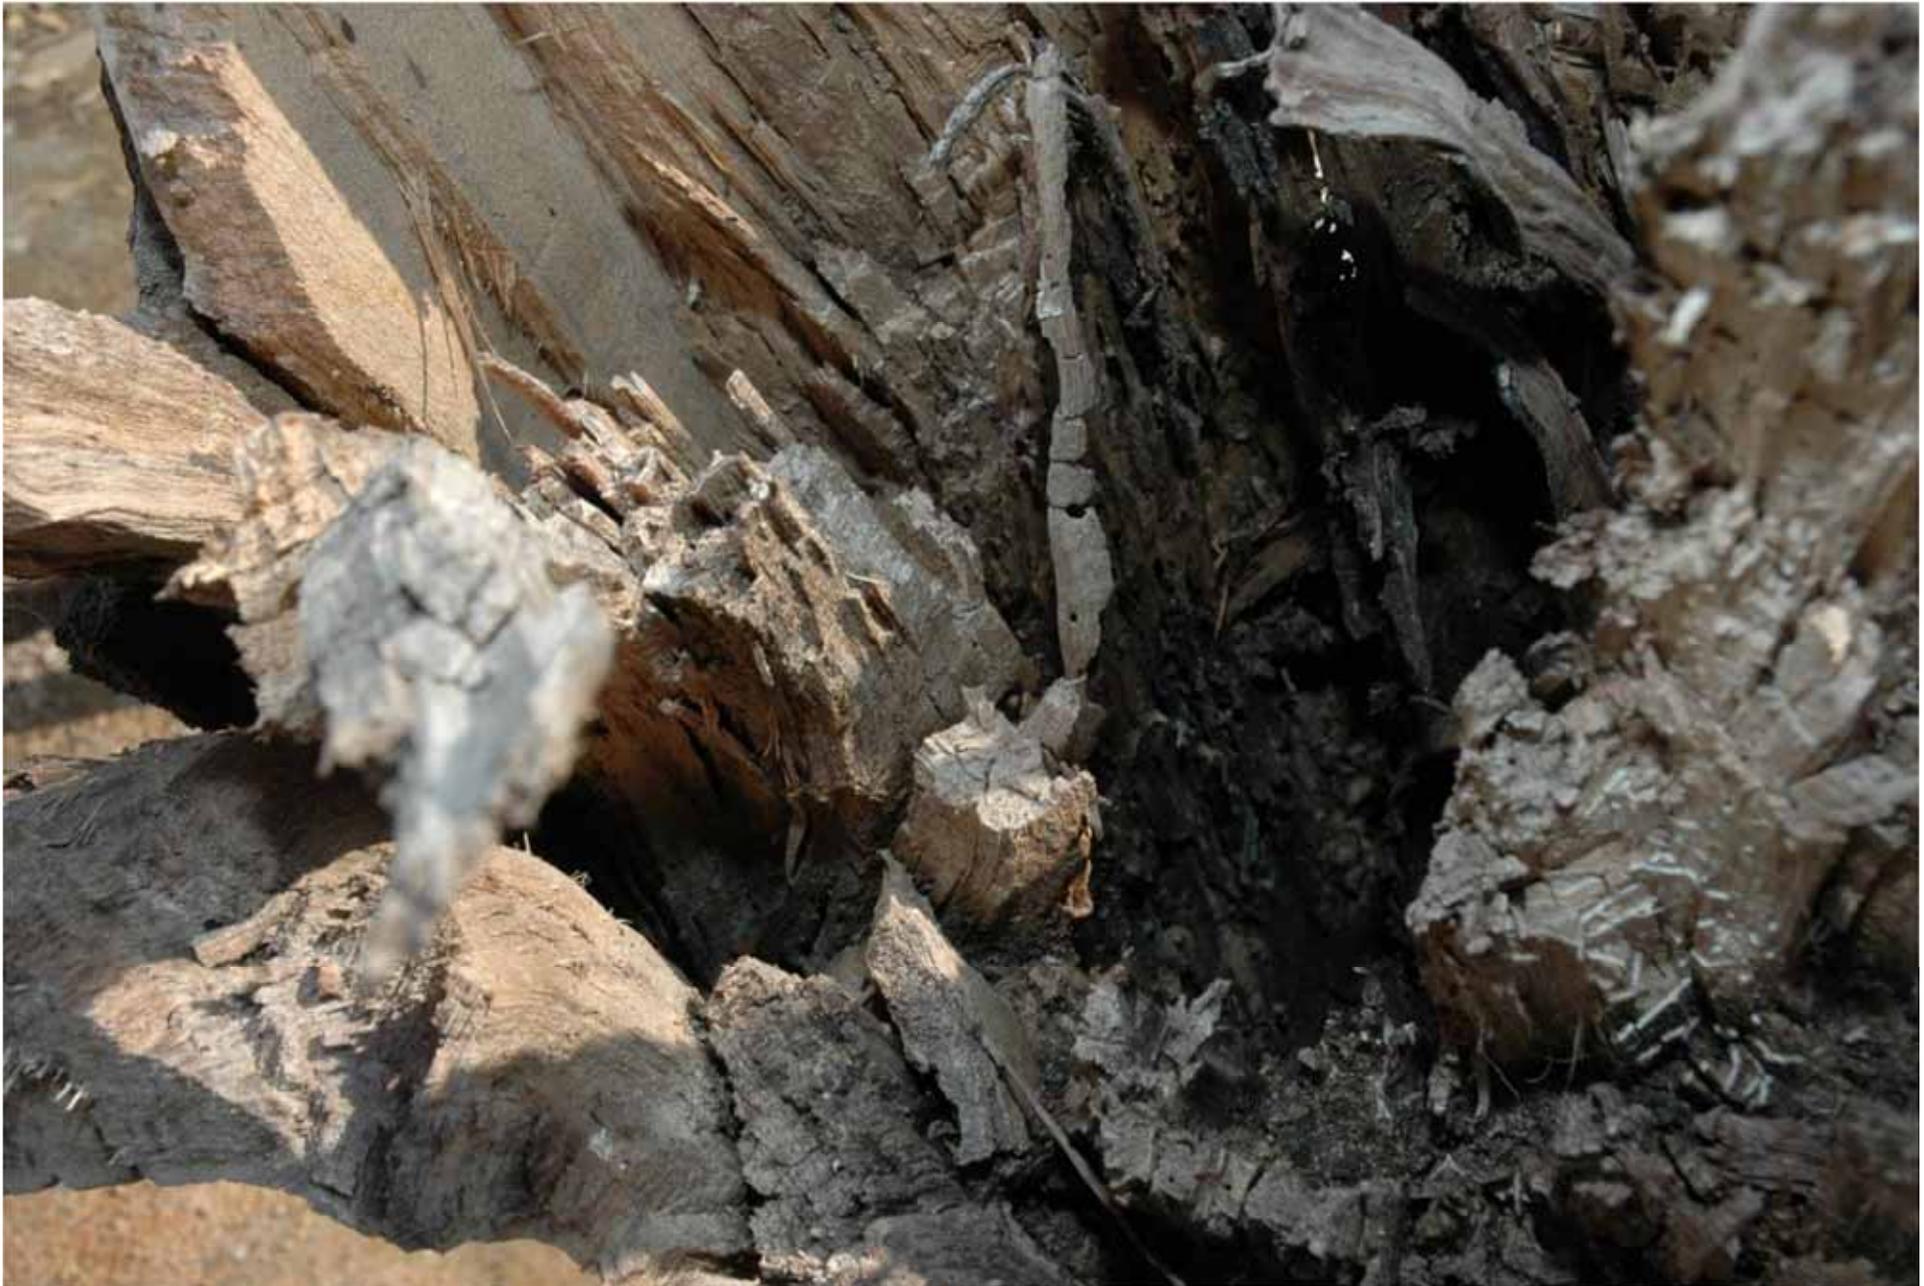
Figure 31. An interior view of the cavity in the T4 stump shows its longitudinal orientation and the degraded wood on its walls.

T4 is now considered to be dead and the stump of T4 should be removed with the major structural roots below the trunk base being extracted by a stump grinder. Despite no compensatory planting being required, it is suggested that the entire strip of land that previously accommodated T1 to T4 should be revamped to provide a planting site with improved soil conditions for future tree growth and six trees be planted here, as detailed in CM6 of Table 4.5.

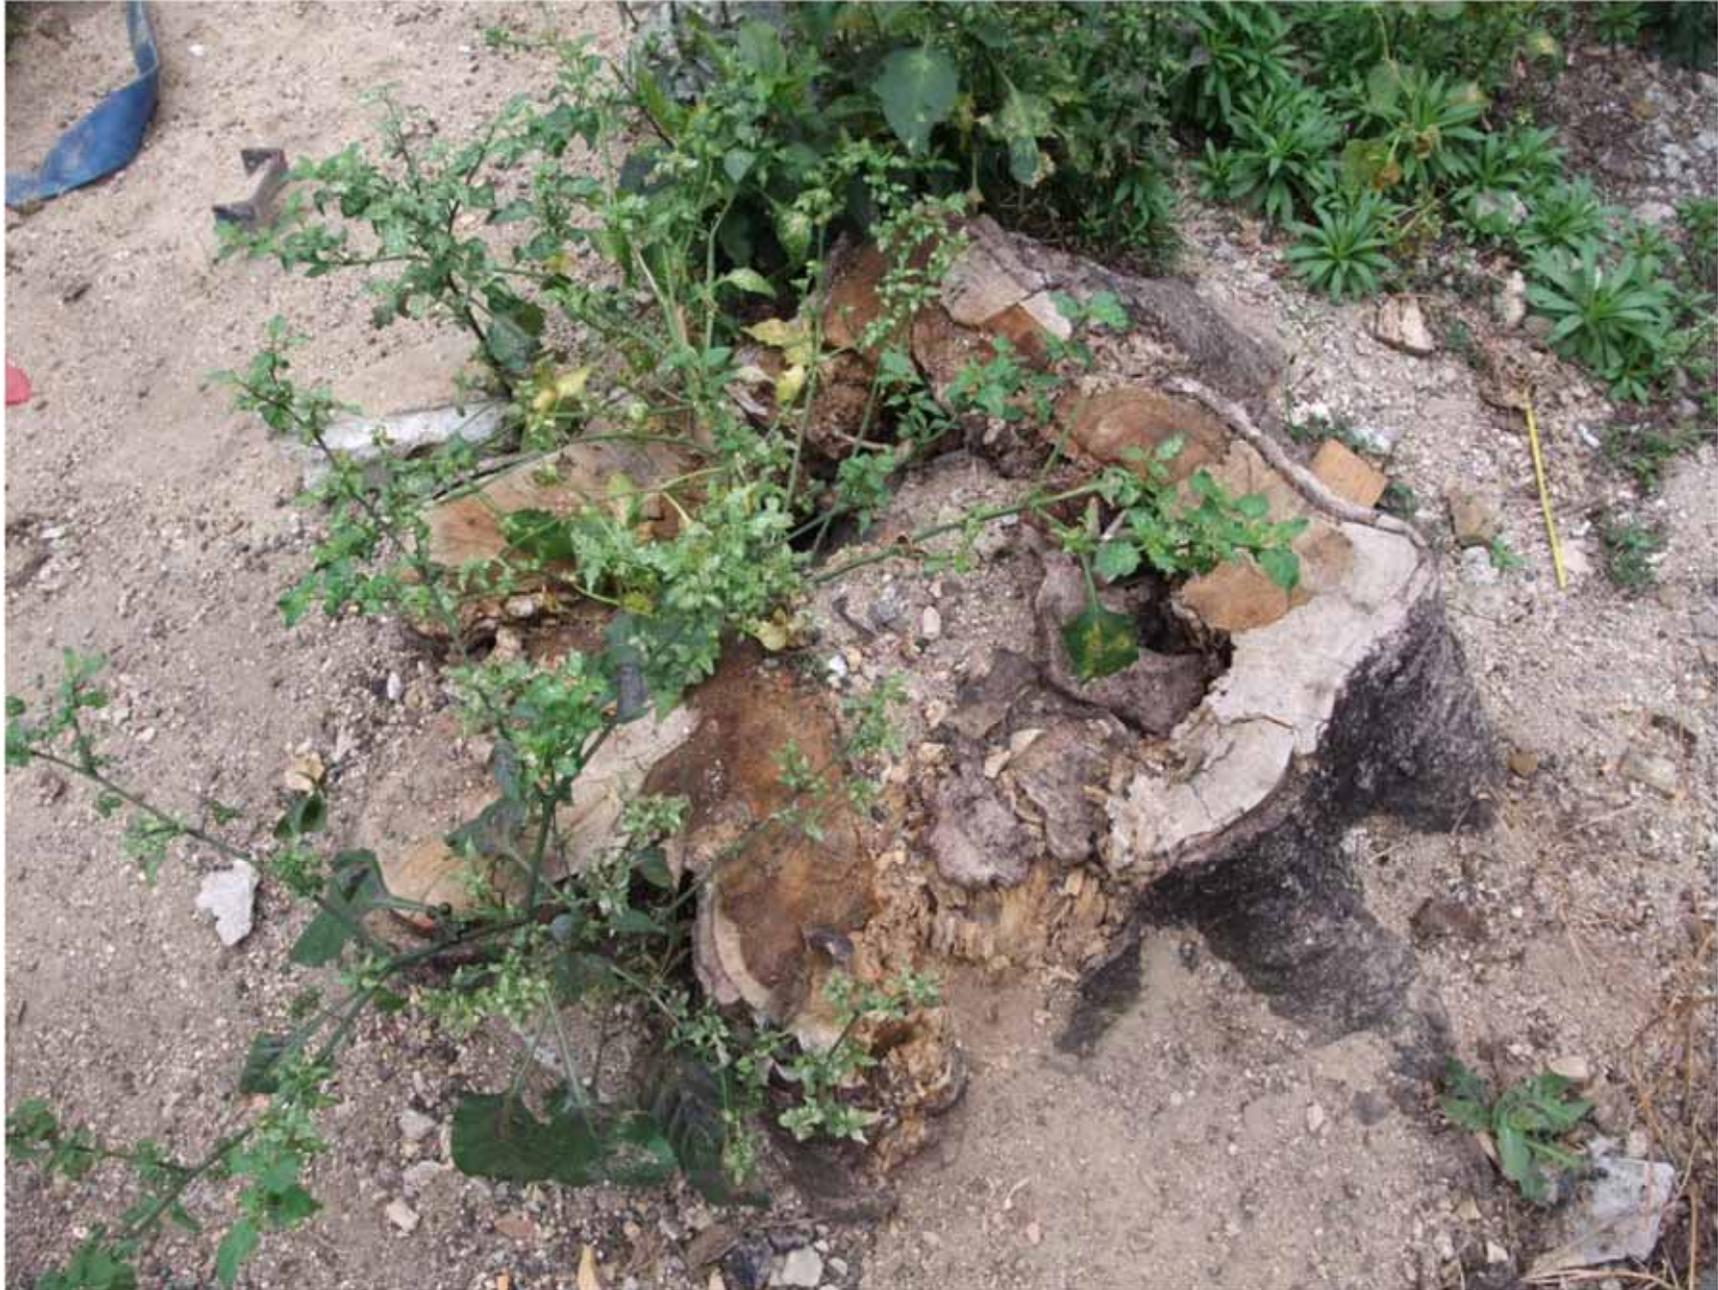
Figure 32. The stump of T4 on 17 March 2011.

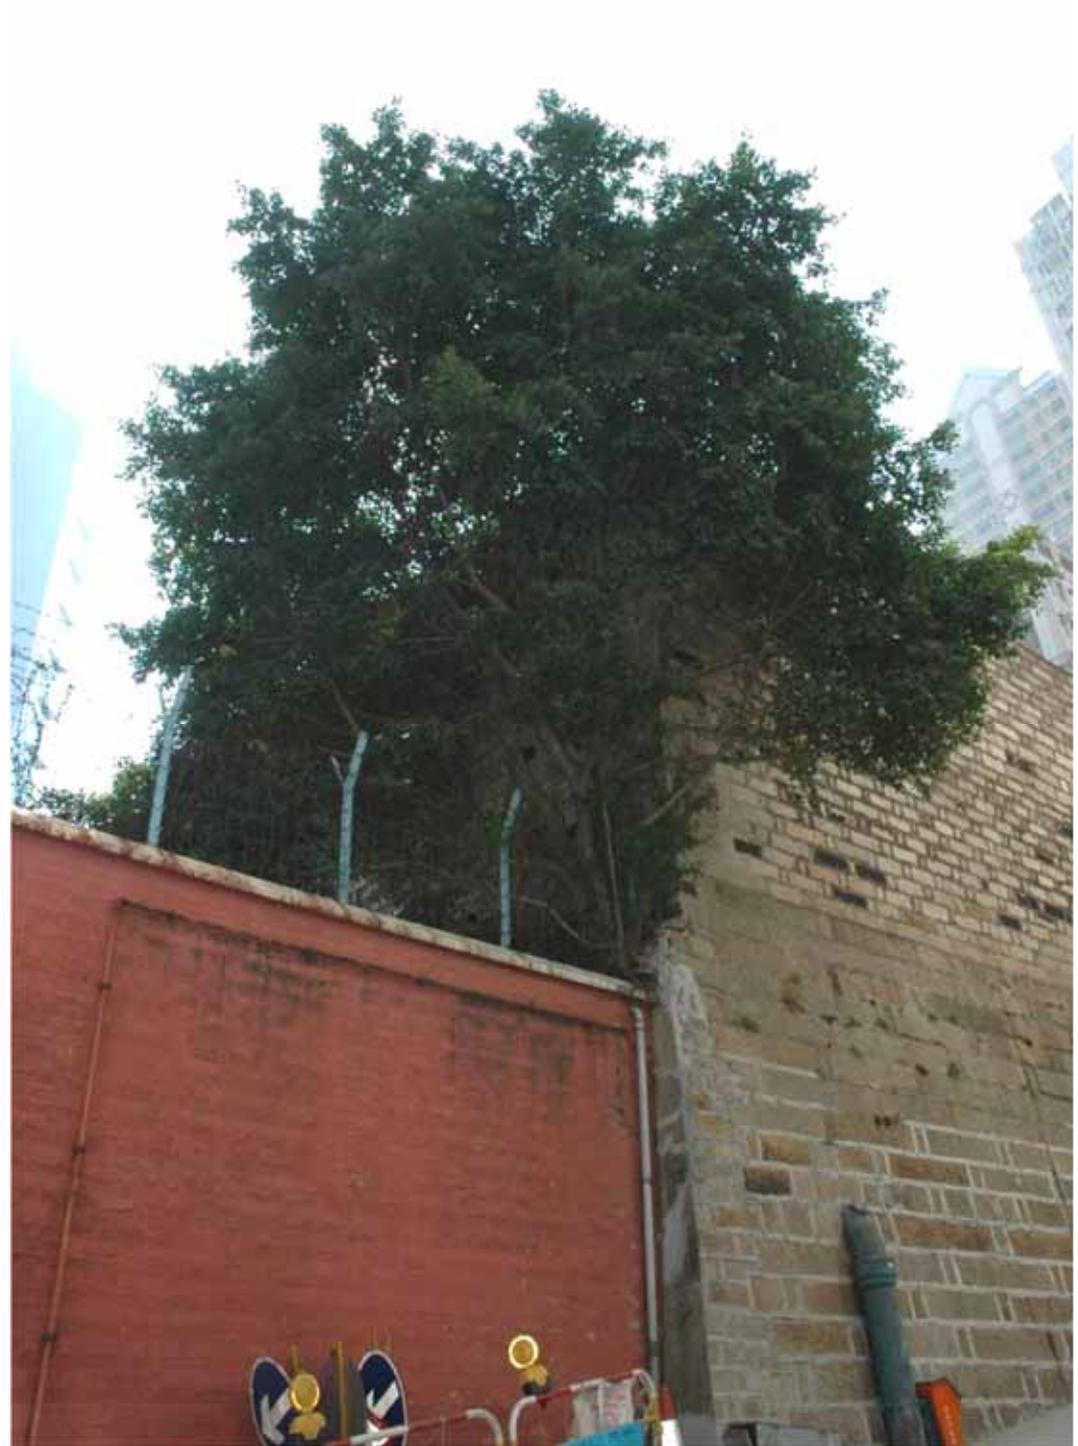
T10 is a wall tree that established spontaneously without human assistance. It has multiple trunks to support a full tree crown with dense branches and foliage, in a normal posture similar to a ground-growing Banyan. The tree measures approximately 6 m tall with a 6 m crown span. It is considered to be about 20 years old and in good health.

Figure 33. T10 (*Ficus microcarpa*) grows spontaneously at the edge of Old Bailey Road, on the stone retaining wall that marks the boundary of the ex-Central Police Station and the ex-Victoria Prison. The wall tree has developed a rather compact and dense crown about 5 m wide and a tree height reckoned from the trunk base of about 6 m. The live crown ratio is estimated to be 90%.

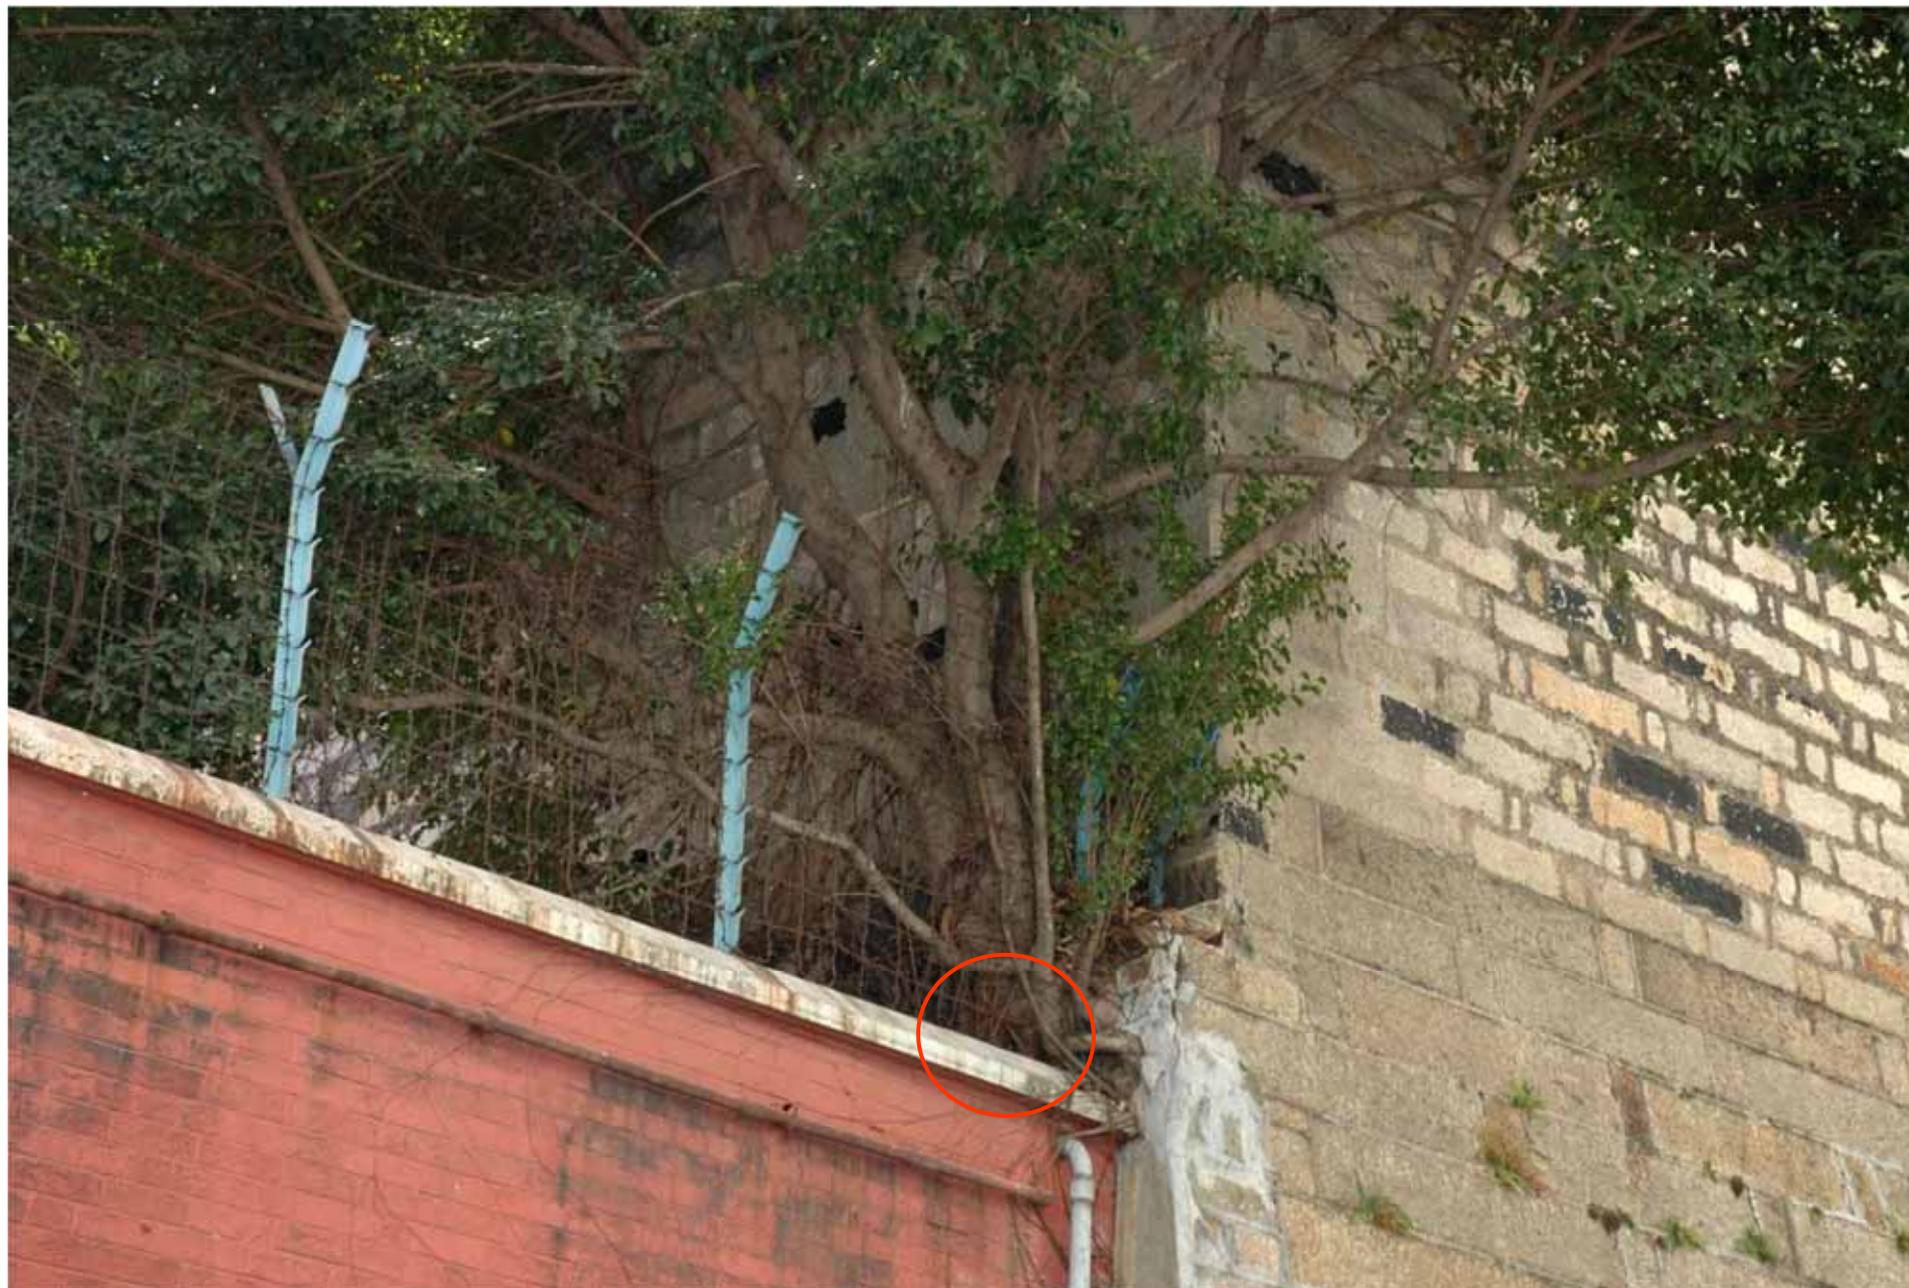
Figure 34. The trunk base of T10 is partly resting on the top of the brick wall that is attached to the adjacent stone retaining wall. Note the multiple stems of the wall tree.
