Table 1 Response to EPD's Request for Supplementary Information (Ref: EPD's letter dated 9th March 2011)

ANNEX A

Update to EIA Report Section 4.6.4 Trees within the Project Site (Figures 1 and 3)

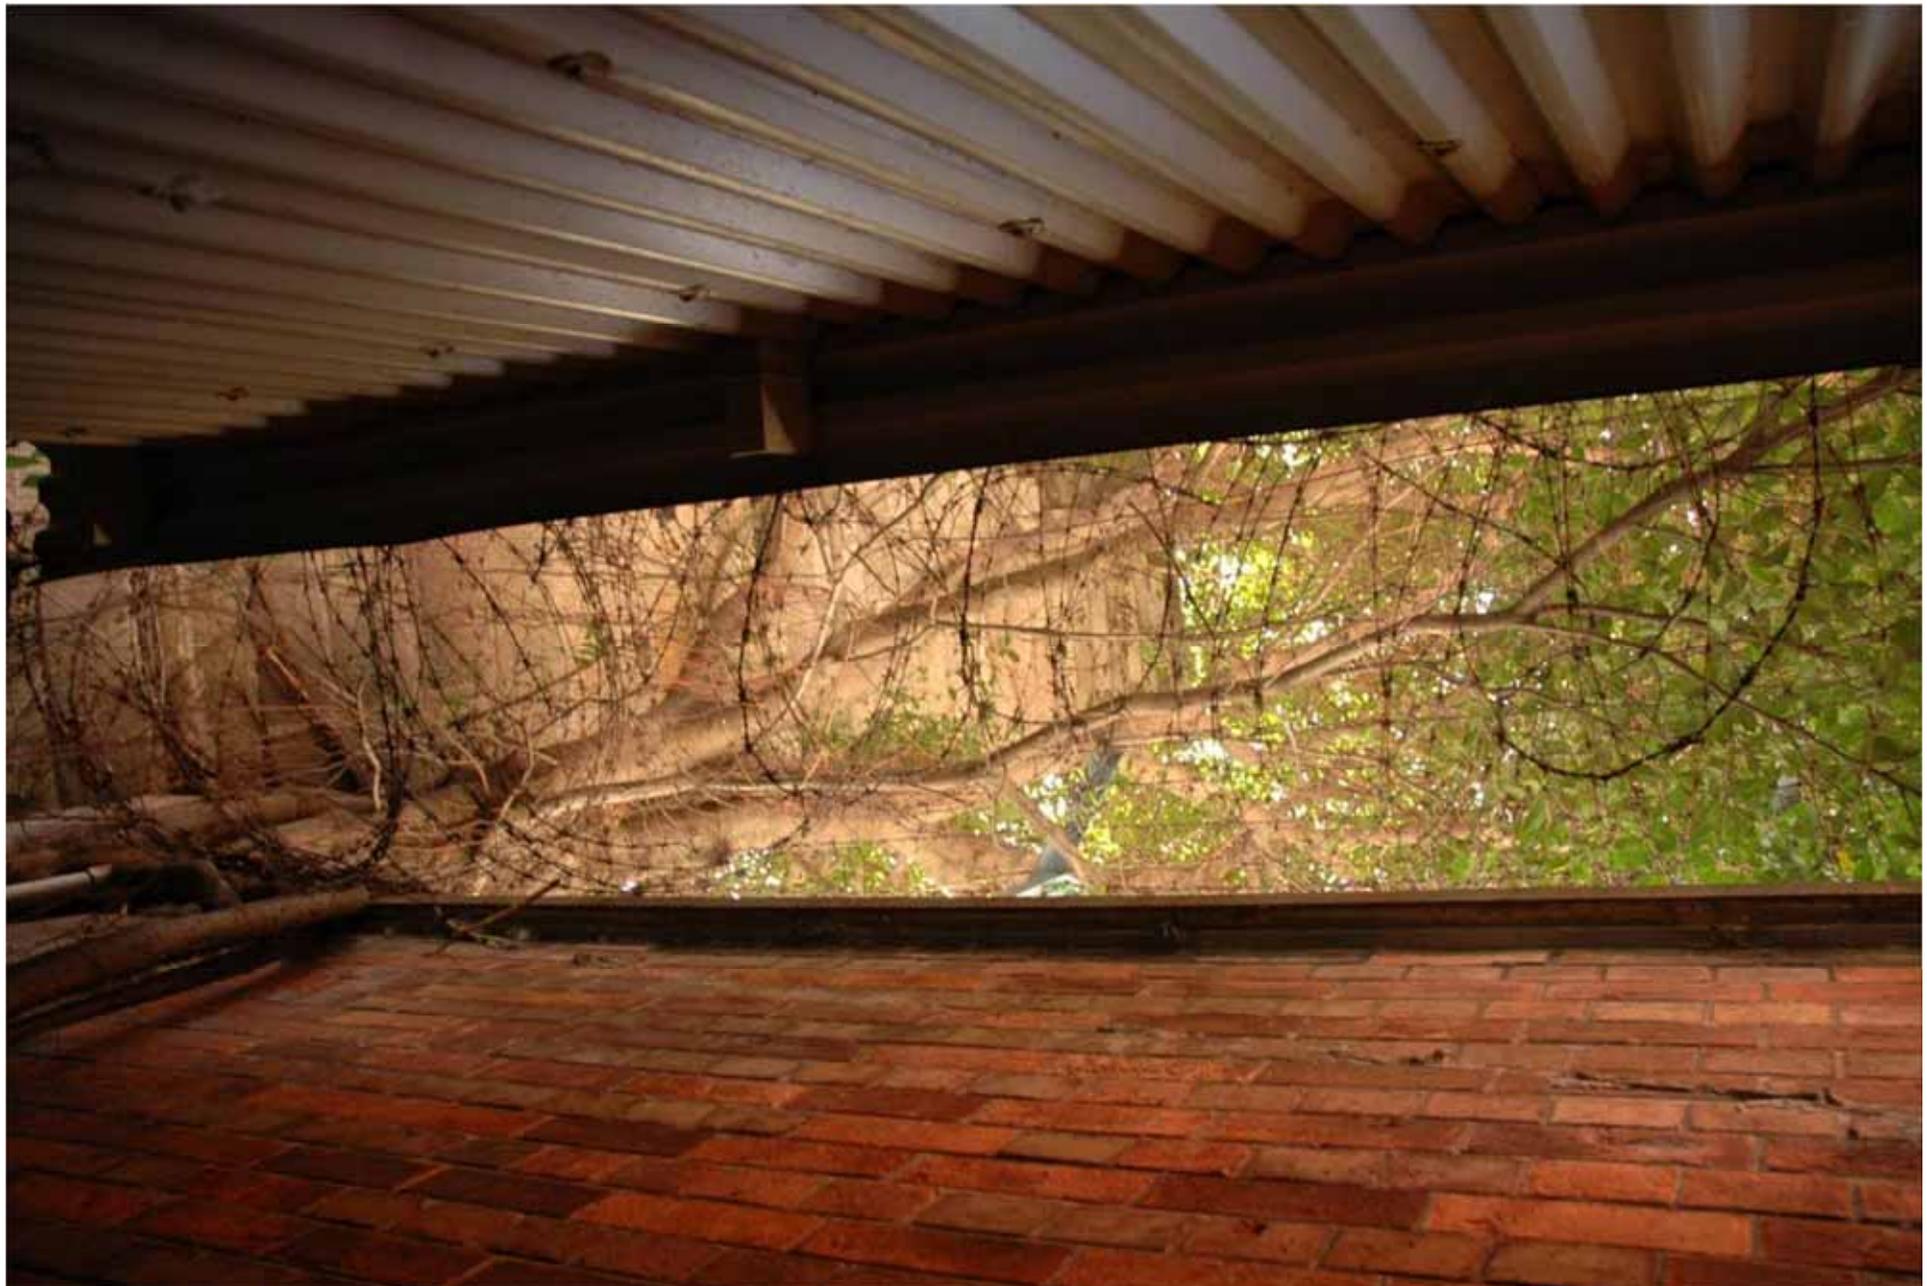
Figure 35. Looking upwards in the narrow alley where T10 is located shows its relation to the brick wall along the perimeter at Old Bailey Road and the stone retaining wall.

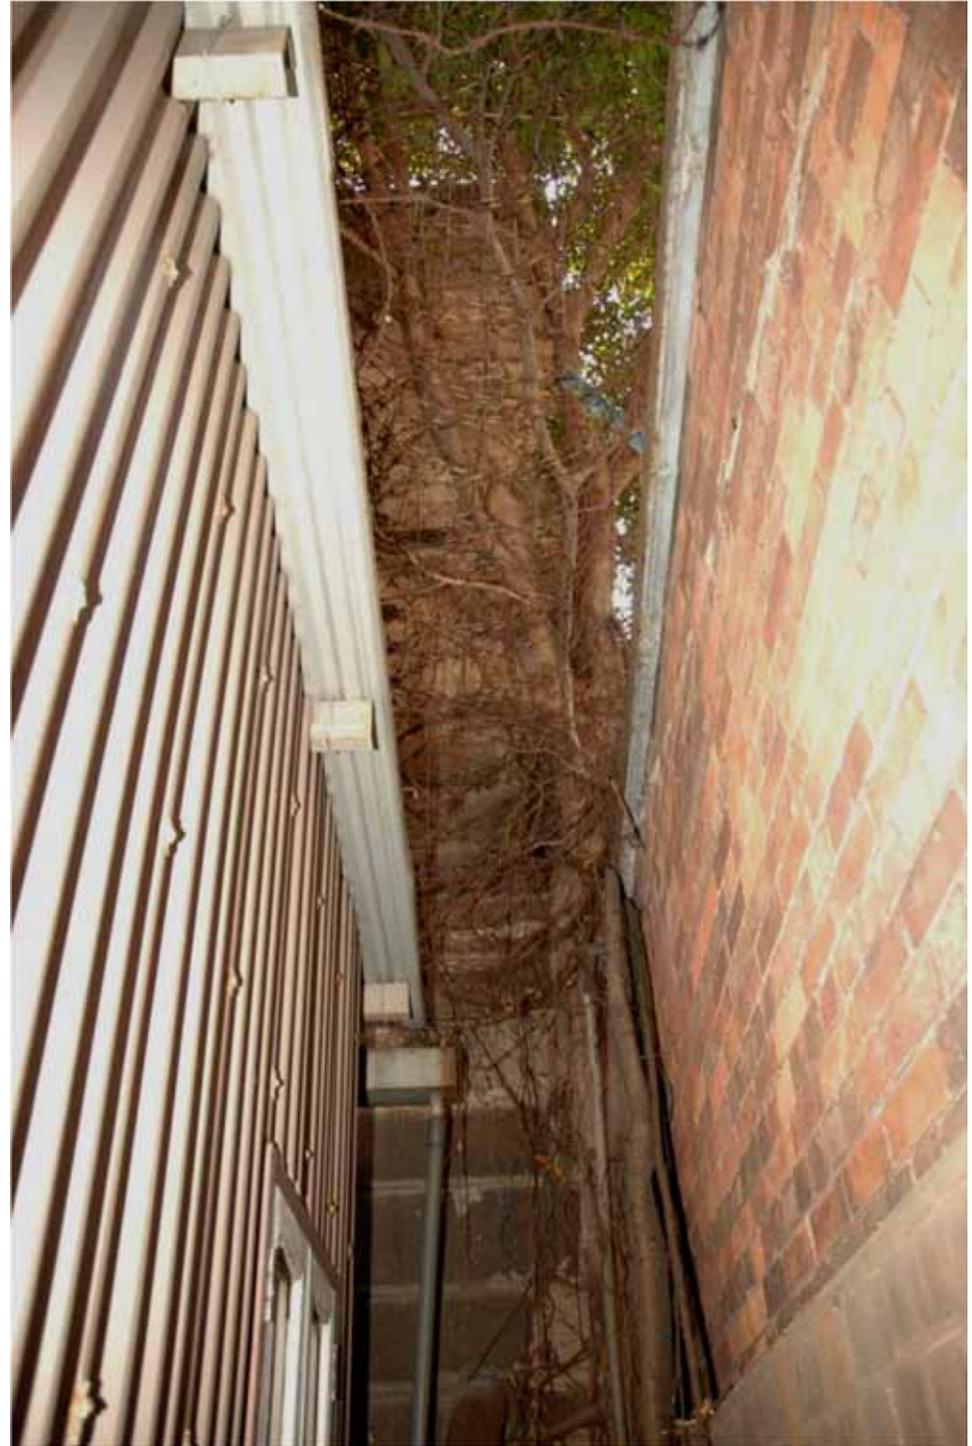
Figure 36. The surface roots of T10 spreads downwards along the stone retaining wall at the end of the narrow alley, and extends to the brick wall at its right.

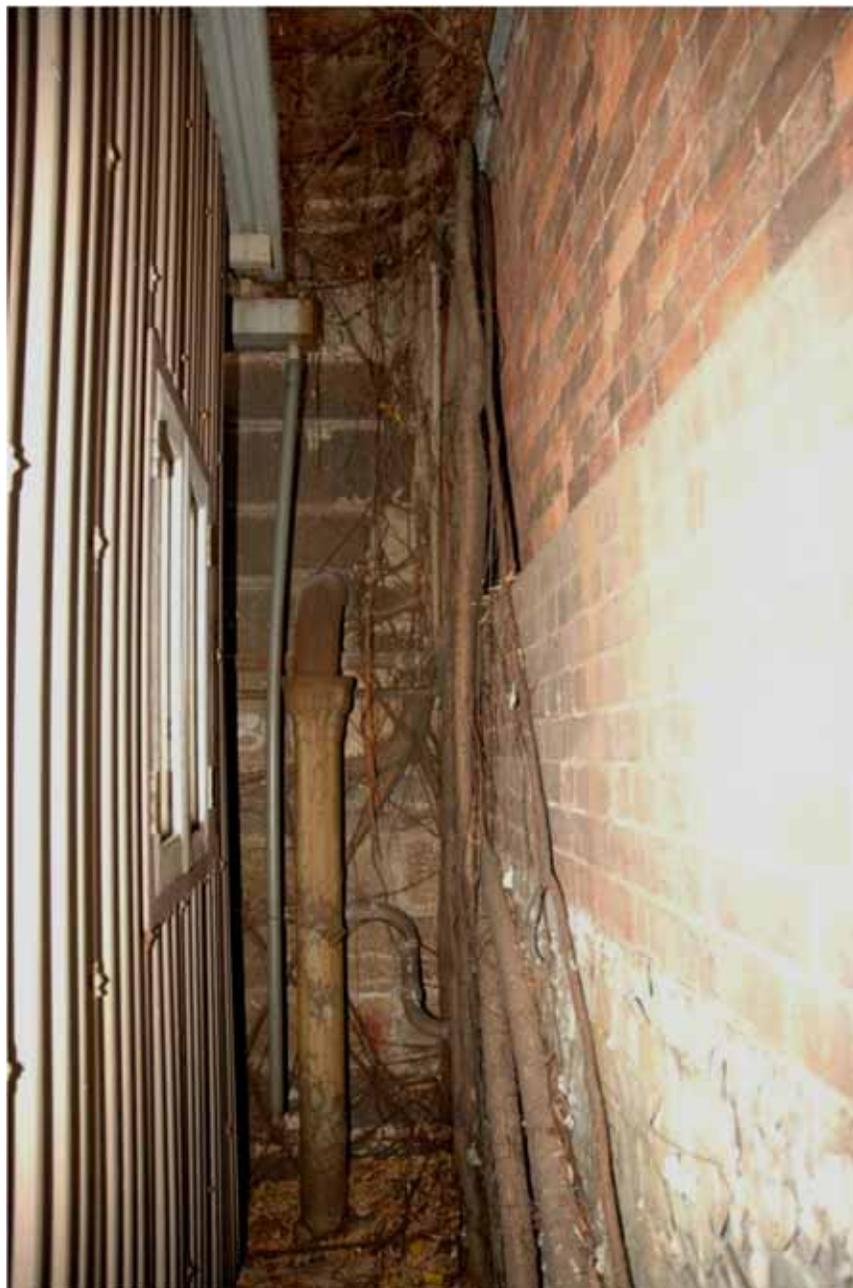
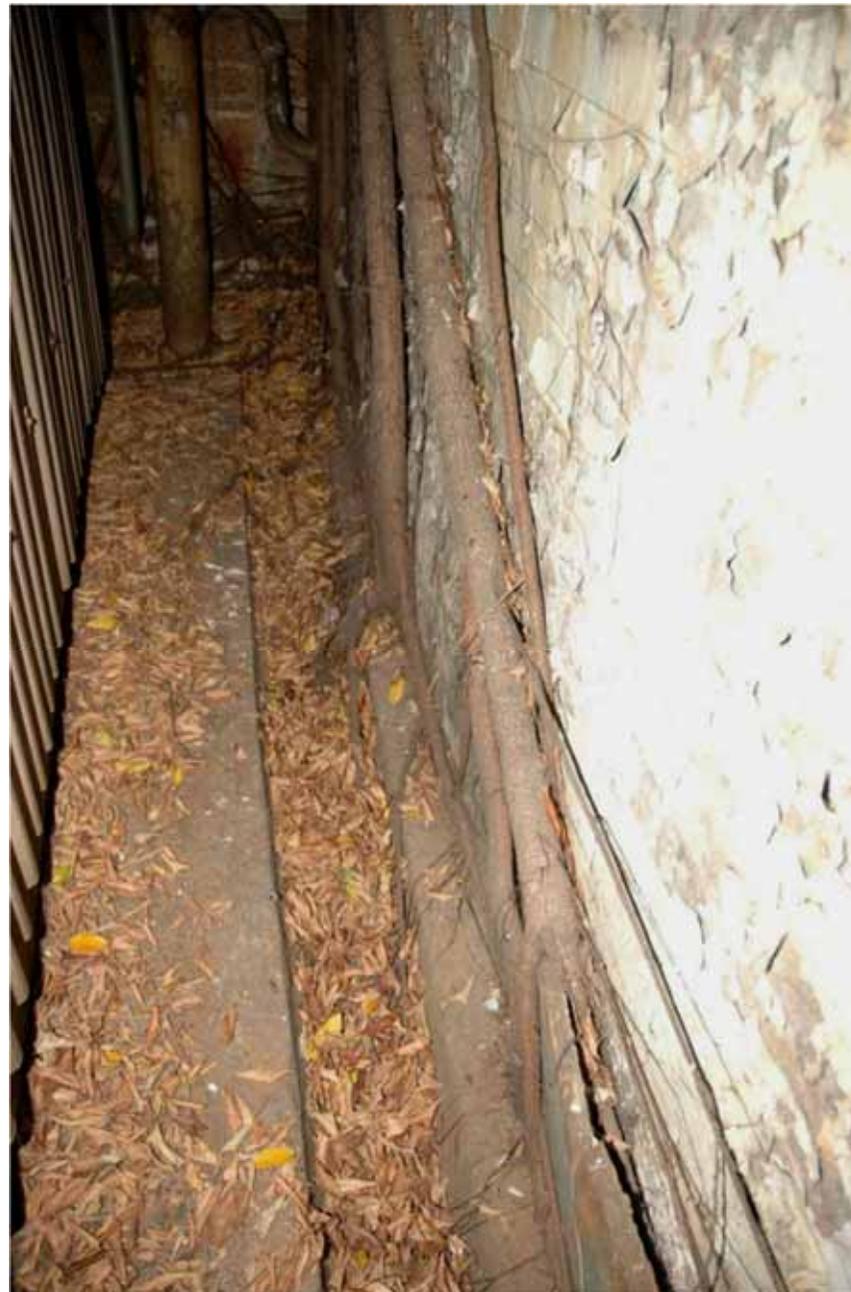
spread from the stone wall side onto the brick wall face and some roots attached to the brick wall have penetrated the slim gap between the wall toe and the concrete paving to enter the soil in the ground (“ground soil”). The retained soil and ground soil are collectively labelled “companion soil”. The wall tree has developed three main types of roots, namely: (1) woody lateral roots that run profusely on the wall surface with some penetration into the companion soil (“lateral roots”); (2) fine fibrous roots that spread in the companion soil lying adjacent to the walls (“feeding roots”); and (3) aerial roots that hang down from the branches (“aerial roots”). Aerial roots remain soft and flexible, unless they are connected to the lateral roots whereupon they become woody.

Figure 37. The roots of T10 has spread on the surface of the brick wall, with penetration into the soil under the concrete paving.

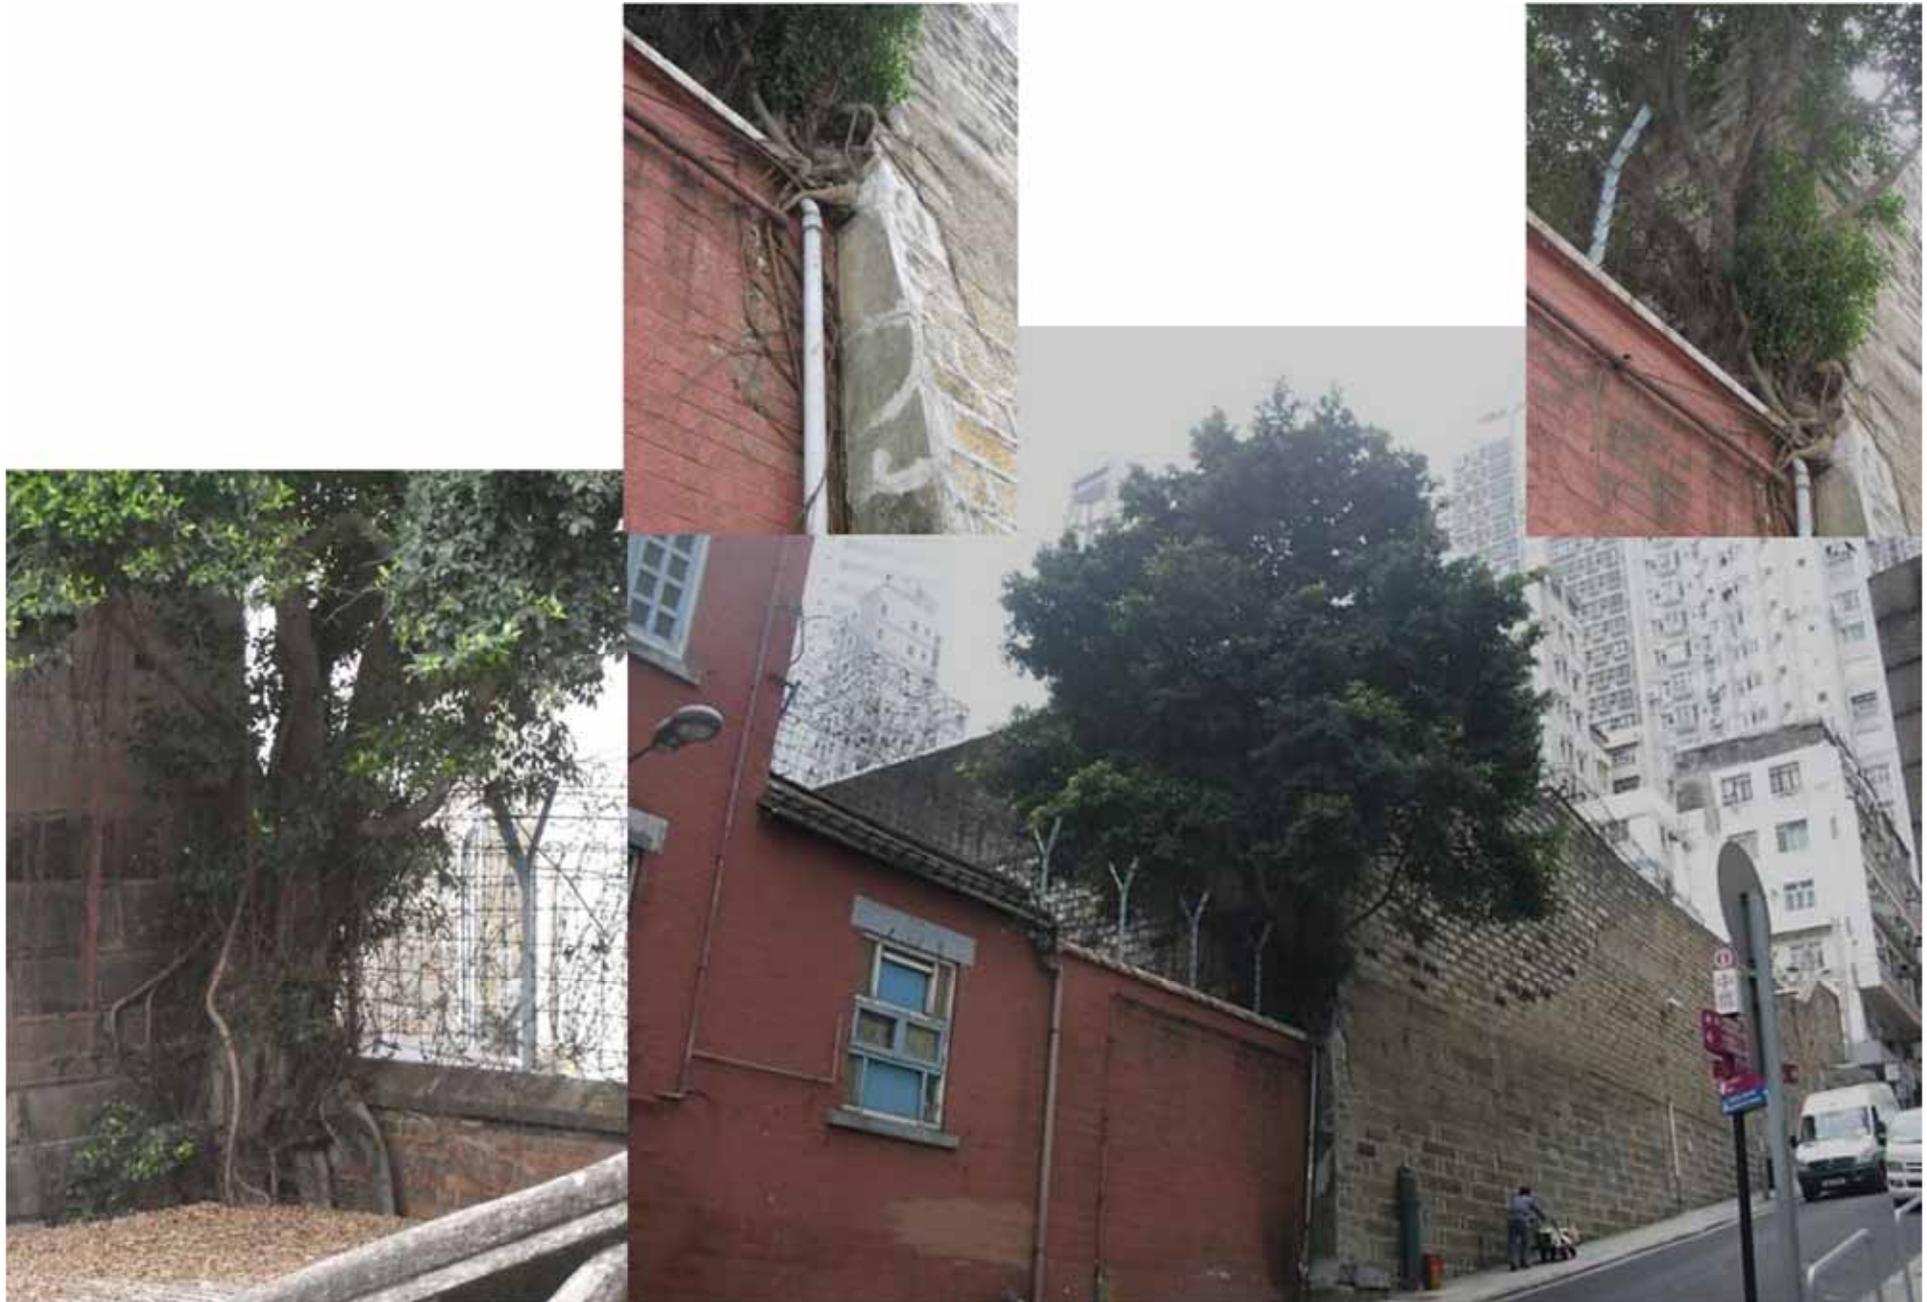
T10 is considered to be about 20 years old and in good health. The key factors that permit meritorious wall tree growth are a wall that is tall and long, old, composed of large stones, made of irregular stones (rubble), has a large amount of joints between masonry blocks, and is sheltered by adjacent notably taller buildings. These inherent wall attributes cannot be found on the subject wall and it is concluded that future growth of T10 would be at a sluggish rate.

Figure 38. The condition of T10 on 17 March 2011.

The size, tree form, performance, and landscape and amenity value of T10, in comparison with the large and robust wall trees in other parts of the city, are relatively low. Due to site and technical constraints, in situ preservation and transplanting cannot be recommended. Overall, considering alternative locations of the new access road would require the demolition of high quality and culturally valuable heritage structures, the felling of T10, a relatively average wall tree, is deemed an acceptable option.
