Reprovisioning of Diamond Hill Crematorium: Contamination Assessment Plan

Hong Kong Productivity Council /
Architectural Services Department

5 February 2003
Final Report

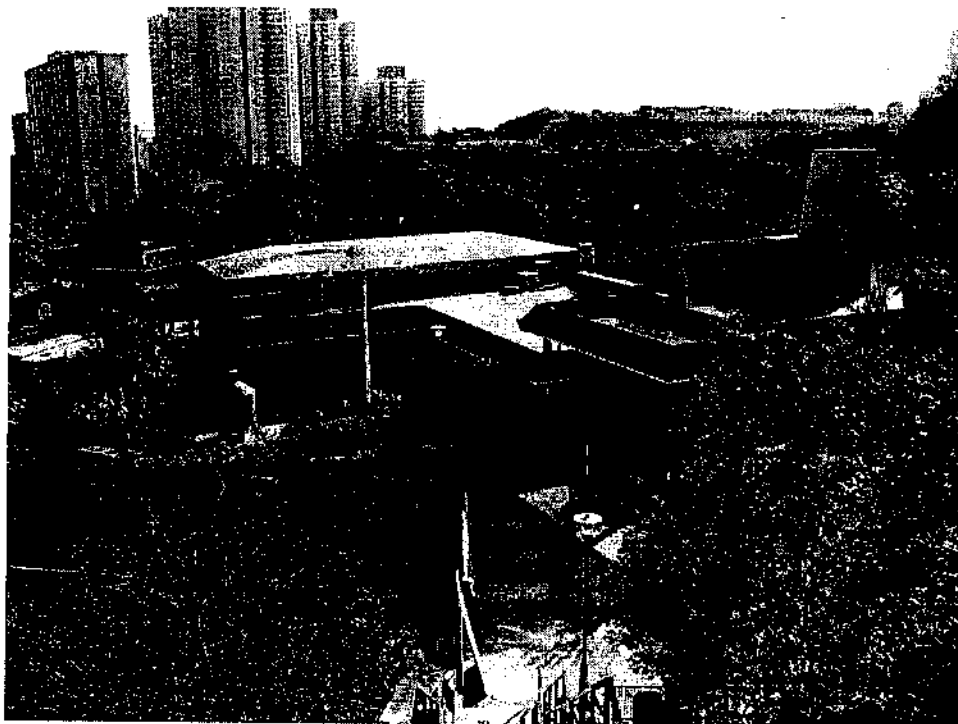
Photograph 2: Crematorium Building from North, showing Stack (to left of photo)

It is considered unlikely that stack emissions would give rise to significantly elevated concentrations of soil contaminants under normal conditions. However, the possibility cannot be discounted and hence sampling and analysis will be carried out. Aerial deposition of contaminants arising from stack emissions would be greatest in the downwind direction from the stack. The prevailing wind direction is from east to west, meaning that aerial emissions from the stack would be predominantly carried to the west. Sampling effort will therefore be concentrated to the west of the stack, although confirmatory sampling will also be carried out to the north, south and east of the stack.

- 1.14.8 To the west of the stack, surface samples will be taken from a depth of 0 – 0.1m below ground level, in order to determine whether elevated concentrations of contaminants are present at the surface as a result of aerial deposition from stack emissions. Since the
