**Contract No. : EP/SP/52/06**  
**Development of an EcoPark in Tuen Mun Area 38**

**ENVIRONMENTAL MONITORING AND AUDIT**

**MONTHLY EM&A REPORT for**

**MAY 2007**

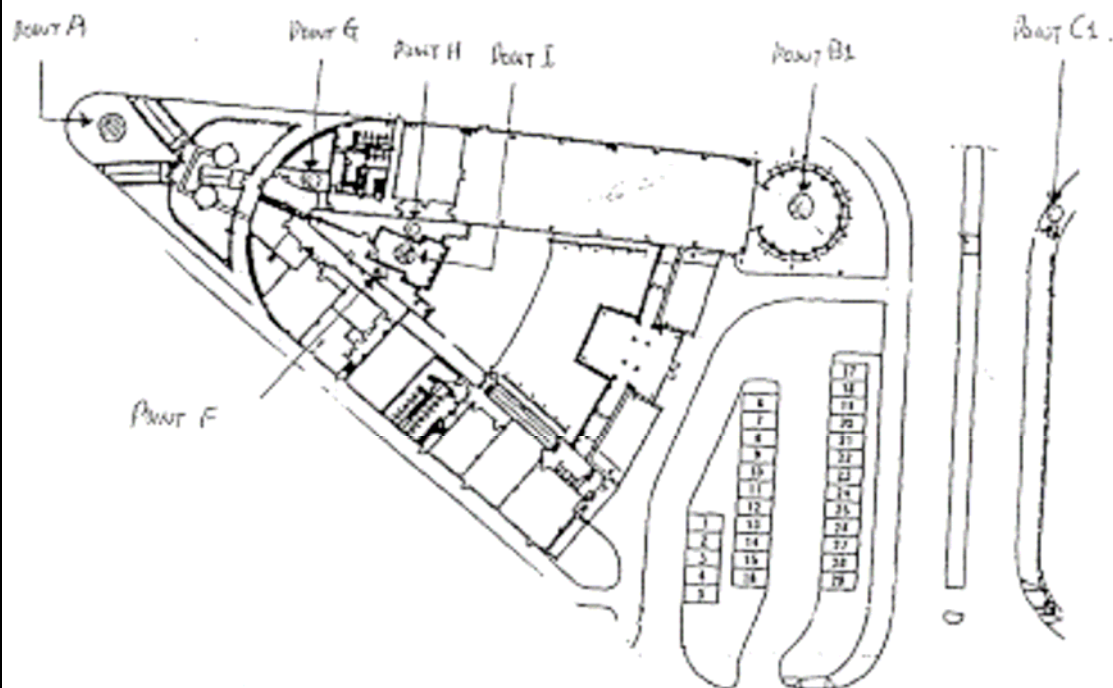
Location 位置	Time 時間 (hrs)	Result 結果				
		CH <sub>4</sub> (%)	CO <sub>2</sub> (%)	O <sub>2</sub> (%)	Bal. Gas (%)	Baro. Pressure (mmHg)
Point A	1526	0	0	18.3	81.6	29.82
Point B1 (Production Gallery)	1533	0	0	18.1	81.9	29.82
Point C1 (FMH049)	1535	0	0	18.1	81.8	29.82
Point F (E&M room)	1529	0	0	18.2	81.7	29.82
Point G (FS room)	1527	0	0	18.3	81.7	29.82
Point H (E&M room)		not accessible				
Point I (E&M room)		not accessible

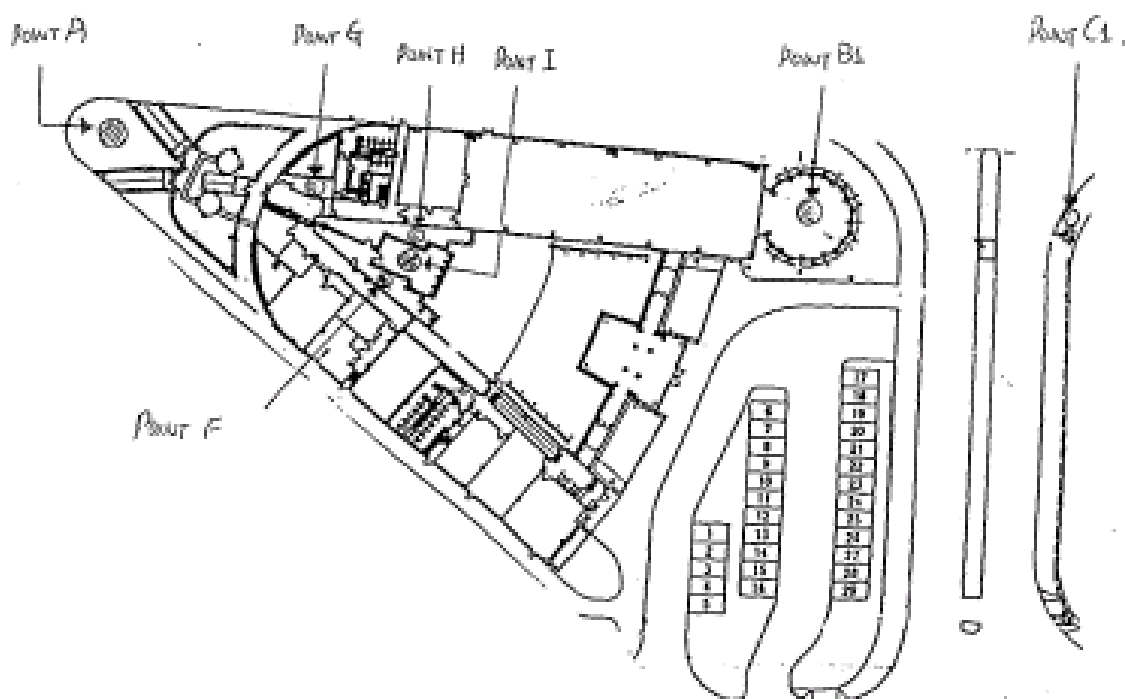
Location 位置	Time 時間 (hrs)	Result 結果				
		CH <sub>4</sub> (%)	CO <sub>2</sub> (%)	O <sub>2</sub> (%)	Bal. Gas (%)	Baro. Pressure (mmHg)
Point A	1550	0	0	18.4	81.5	29.72
Point B1 (Production Gallery)	1604	0	0	18.1	81.9	29.72
Point C1 (FMH049)	1607	0	0	17.8	82.1	29.72
Point F (E&M room)	1555	0	0	18.3	81.6	29.72
Point G (FS room)	1552	0	0	18.4	81.6	29.72
Point H (E&M room)	1559	0	0	18.1	81.8	29.72
Point I (E&M room)	1557	0	0	18.2	81.7	29.72

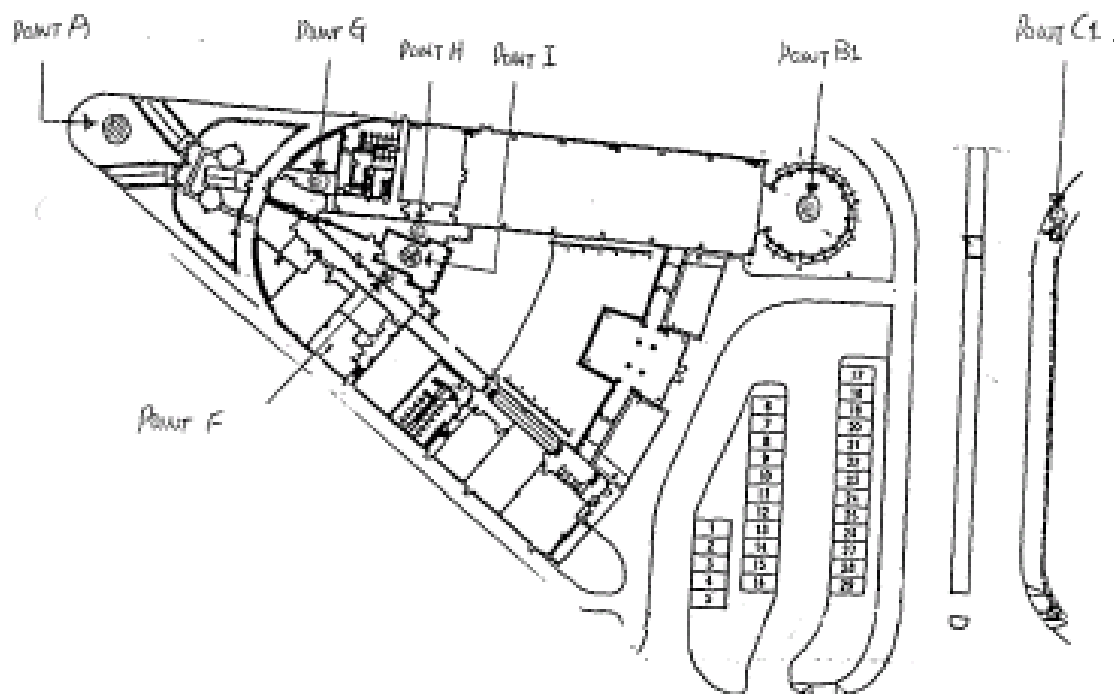
Location 位置	Time 時間 (hrs)	Result 結果				
		CH <sub>4</sub> (%)	CO <sub>2</sub> (%)	O <sub>2</sub> (%)	Bal. Gas (%)	Baro. Pressure ("Hg)
Point A	1515	0	0	18.4	81.5	29.53
Point B1 (Production Gallery)	1530	0	0	18.0	81.9	29.53
Point C1 (FMH49)	REPEATED					
Point F (E&M room)	1522	0	0	18.3	81.6	29.53
Point G (FS room)	1518	0	0	18.3	81.7	29.53
Point H (E&M room)	1521	0	0	18.3	81.6	29.53
Point I (E&M room)	1524	0	0	18.1	81.9	29.53

Site layout Point C1 (FMH49) 1533 0 0 18.1 81.9 29.53
