Contract No. : EP/SP/52/06
Development of EcoPark in Tuen Mun Area 38

ENVIRONMENTAL MONITORING AND AUDIT

MONTHLY EM&A REPORT for

October 2009

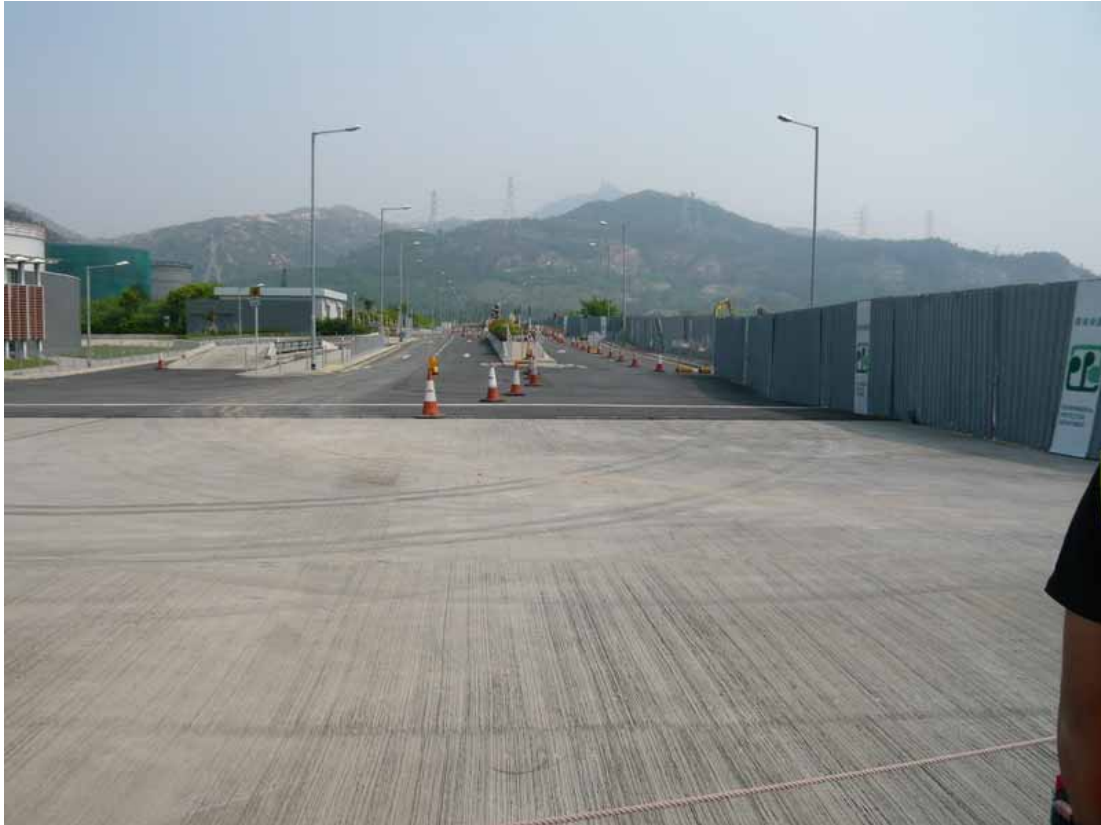
- 5) Sections of hoardings and fabric wraps along Road A were damaged by the typhoon on 18 September 2009. Contractor was reminded to repair the damaged hoardings and replace the fabric wraps to prevent dirt and dust being brought outside the construction site by wind.

Fig 1. Hoardings damaged by typhoon were restored.

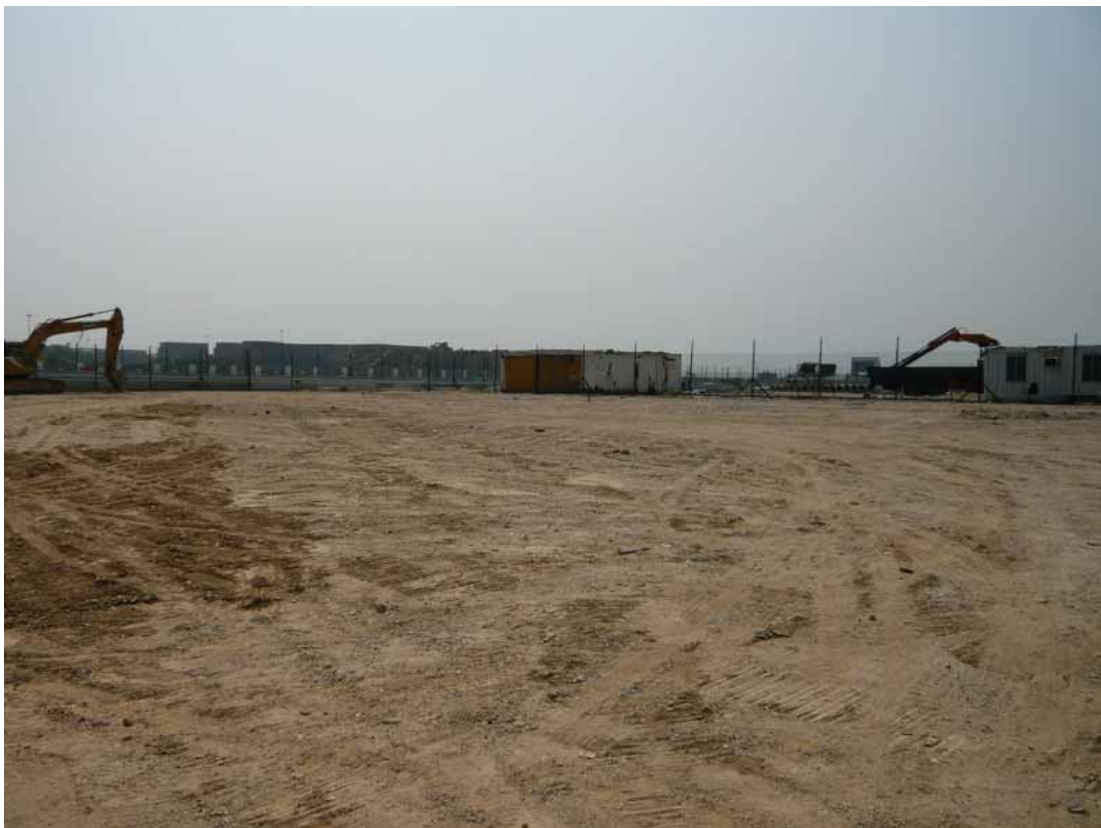
- 6) Pools of stalled water are found near lot P10 on 25 September 2009. Contractor was reminded that accumulated water should be treated properly to meet requirements specified in the issued discharge license, if appropriate.

18 September 09	Diesel overflowed into the drip tray for the power generator and surrounding areas.	Contractor was advised to monitor the diesel filling process and ensure the valves on the drip trays shuts completely.	Contractor reminded the workers to be careful on the filling process and overflowing did not occur again.	02 October 09 (Photographic proof will be available in the next reporting month)
18 September 09	Sections of hoardings and fabric wraps along Road A were damaged by typhoon.	Contractor was reminded to repair the damaged hoardings and replace the fabric wraps to prevent dirt and dust being brought outside of the construction site by wind.	Contractor took action to replace the fabric wraps along the damaged sections.	02 October 09 (See Fig. 1)
25 September 09	Pools of stalled water are found near lot P10.	Contractor was reminded that accumulated water should be treated properly to meet requirements specified in the issued discharge license, if appropriate.	Contractor took action to remove and treated the muddy water near lot P10.	02 October 09 (See Fig. 2)

Fig 2. Lot P10 has been flattened and no stalled water can be found.

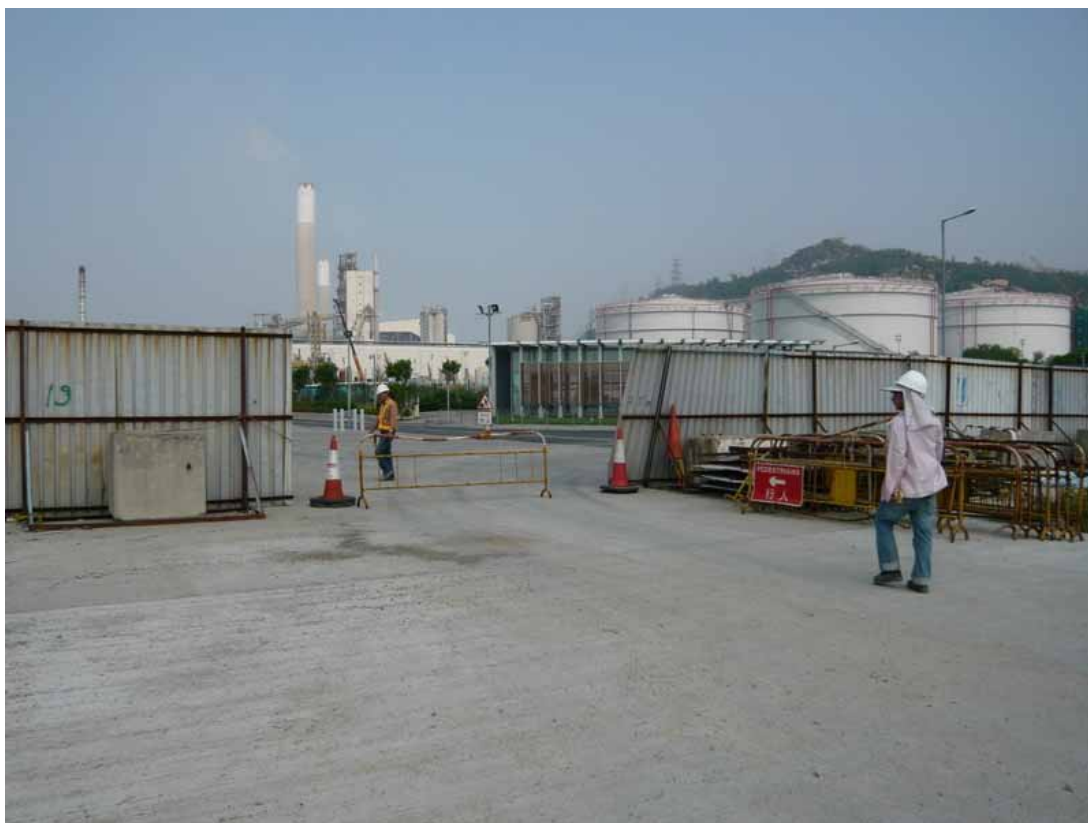
02 October 09 09 October 09 16 October 09	Sections of hoardings on Road A are loosened.	Contractor was reminded to repair and mount the loosened sections properly to prevent dirt and dust being brought outside of the construction site by wind.	Contractor took action to re-mount the hoardings properly.	To be followed in the next reporting month. (Tentative closing date: 30 November 2009)
09 October 09	Road A near waterfront is covered with dirt and dust, due to construction vehicles using the exit without any wheel washing facilities.	Contractor was reminded to properly fence off the site entrances and exits without any wheel washing facilities.	Contractor took action to wash dirt off the road and to block off the site entrance near waterfront to prevent heavy vehicle to pass through.	16 October 09 (See Fig. 3)

Fig 3. Contractor blocked off temporary site entrance near waterfront.

Road A near waterfront is covered with dirt and dust, due to construction vehicles using the exit without any wheel washing facilities. Contractor was reminded to properly fence off the site entrances and exits without any wheel washing facilities.
