**Contract No. : EP/SP/52/06**  
**Development of EcoPark in Tuen Mun Area 38**

**ENVIRONMENTAL MONITORING AND AUDIT**

**MONTHLY EM&A REPORT for**

**November 2009**

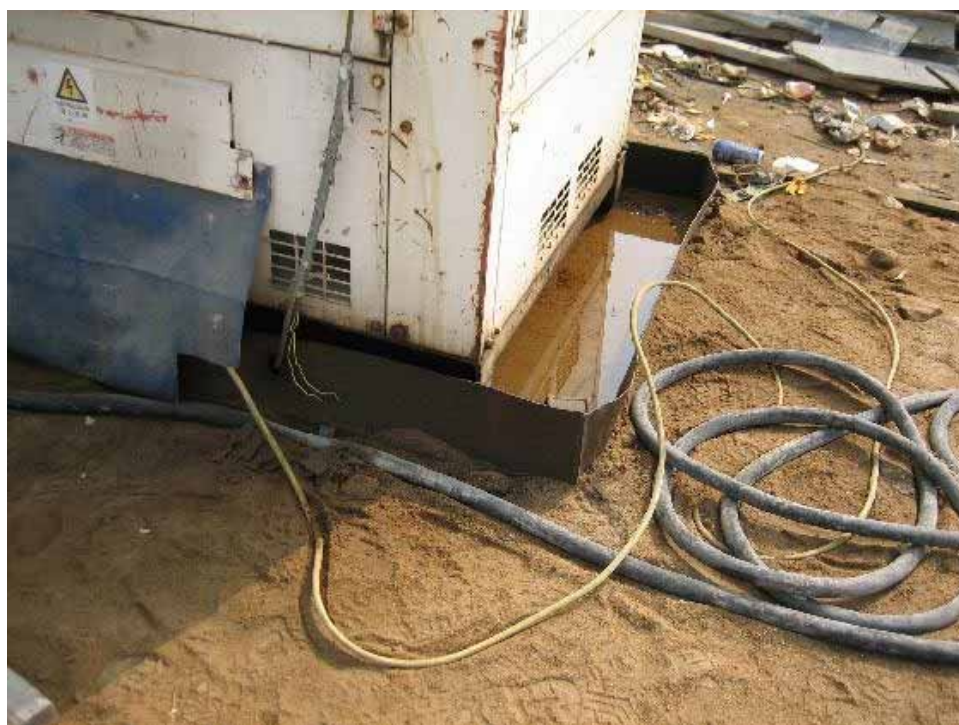
18 September 09	Diesel overflowed into the drip tray for the power generator and surrounding areas.	Contractor was advised to monitor the diesel filling process and ensure the valves on the drip trays shuts completely.	Contractor reminded the workers to be careful on the filling process and overflowing did not occur again.	02 October 09 (Ref. Fig. 1)
October 09	Drip pan has not yet been provided for the three plastic chemical drums adjacent to the cooling tower in the administration building.	ET was informed that a proper drip pan has been designed and will be constructed in October. Contractor was reminded to install the drip pans as soon as possible.	Contractor installed drip pans for the plastic chemical drums.	13 November 09 (Ref. Fig. 2)
23 October 09 to 13 November 09	Hoardings beside Road A have been removed temporarily due to construction program.	Contractor was reminded to re-install hoardings to prevent dirt and dust being brought outside of construction site by wind.	Contractor installed plastics wraps to prevent dirt and dust being brought outside of construction site by wind.	20 November 09 (Ref. Fig. 3)

Fig. 1 Drip tray leakage was repaired.

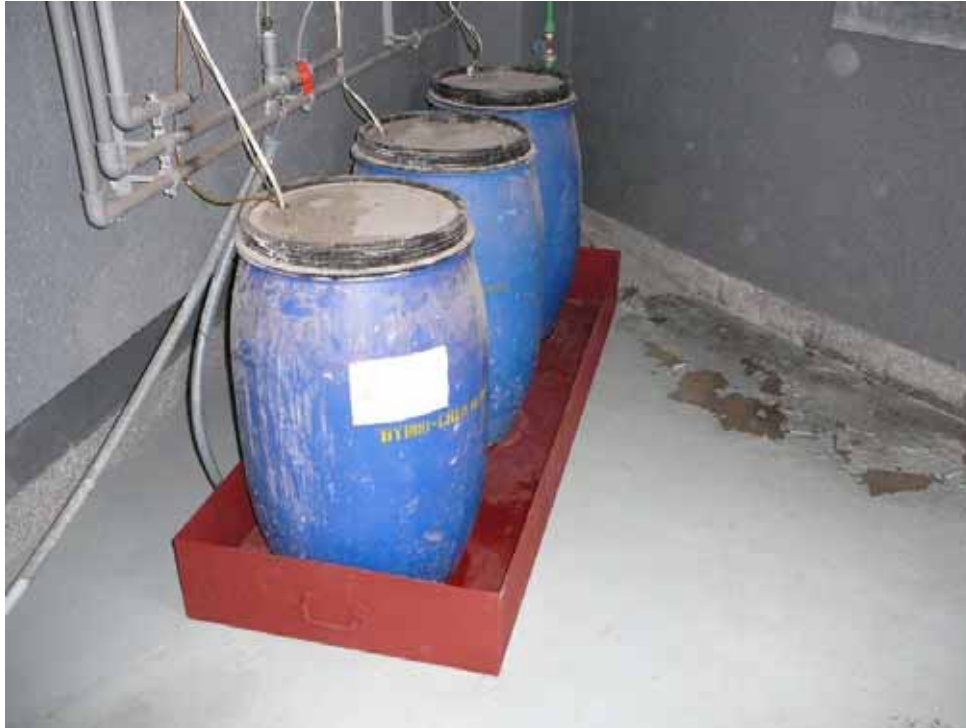
- 3) Drip pan has not yet been provided for the three plastic chemical drums adjacent to the cooling tower in the administration building. ET was informed that a proper drip pan has been designed and will be constructed in October. Drip pans were provided on 13 November 2009.

Fig. 2 Drip pan is provided for the three plastic chemical drums adjacent to the cooling tower in the administration building.

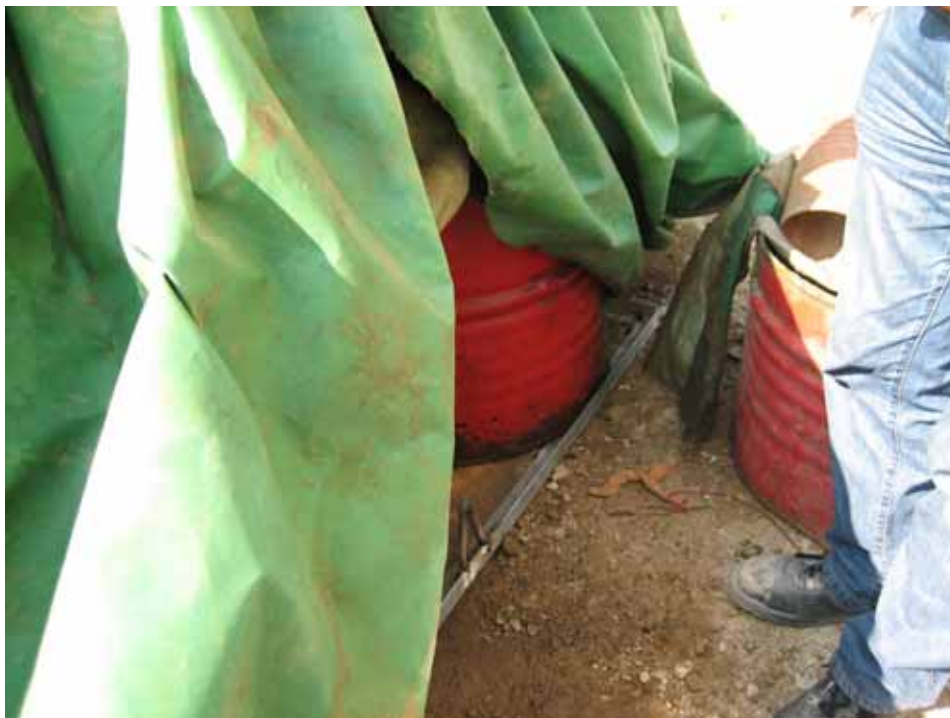
- 6) A few oil containers are found near the chemical drum storage cabinet without a drip tray. Contractor was reminded to place chemical containers on a drip tray or

inside the chemical drum storage cabinet immediately after use. Drip pans were used on 20 November 2009.

Fig. 4 Drip trays has been provided for the chemical drums near the chemical drum storage cabinet.
