**Contract No. : EP/SP/52/06**  
**Development of EcoPark in Tuen Mun Area 38**

**ENVIRONMENTAL MONITORING AND AUDIT**

**MONTHLY EM&A REPORT for**

**January 2010**

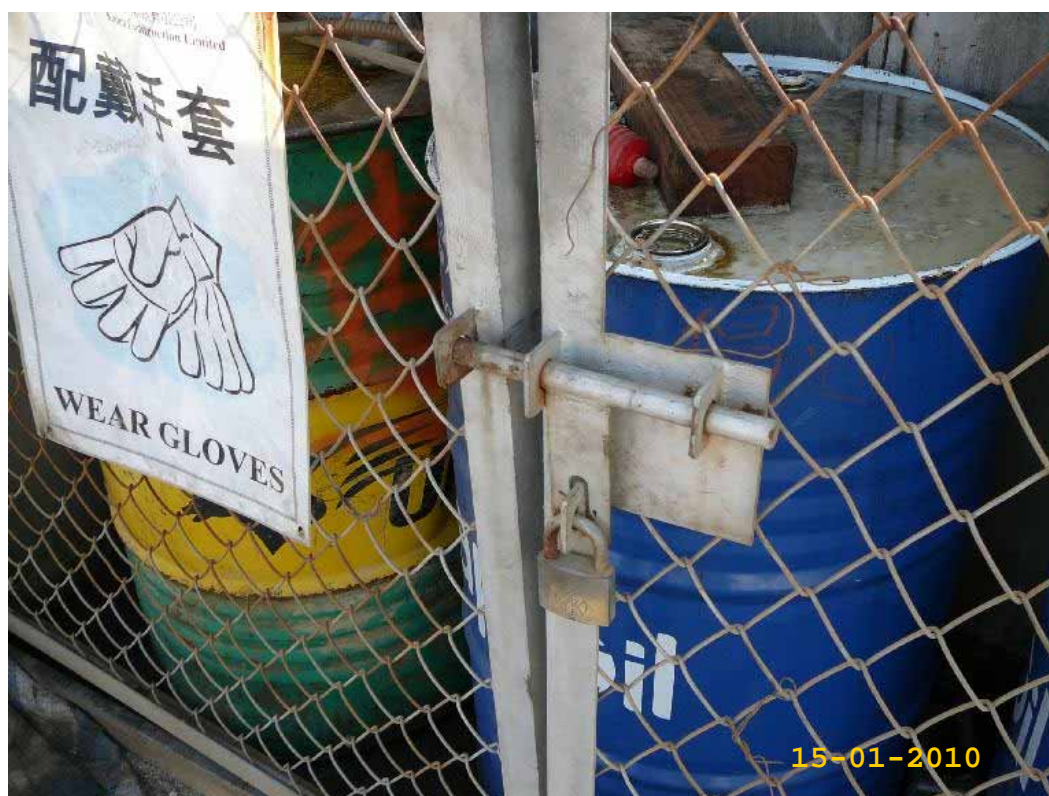
- 2) The doors for the chemical waste storage were bent and did not close and lock properly. Contractor was reminded to monitor and maintain the chemical waste storage facilities. This issue is closed on 15 January 2010.

Fig. 1 The doors of chemical storage can now close and lock.

Table 3.1 Summary of Site Inspections for Phase II construction site during January 2010				
Date	Observations	Advice from ET	Action taken	Closing Date
11 September 09 to 31 January 10	The automatic wheel washing machine malfunctioned on 11 September and found to be severely damaged on 18 September 2009.	Contractor was reminded to repair the automatic wheel washing machine and instruct workers to properly wash wheels of construction vehicles by hand.	Contractor reminded instructed drivers and workers to manually wash wheels of vehicles until further notice.	To be followed in the next reporting month. (Tentative closing date: 28 February 2010)
18 September 09 to 08 January 10	The doors for the chemical waste storage were bent and did not close and lock properly.	Contractor was reminded to monitor and maintain the chemical waste storage facilities and properly to ensure the storage facilities are secured.	Contractor appointed a worker to fix the doors again.	15 January 10 (Please refer to Fig. 1)

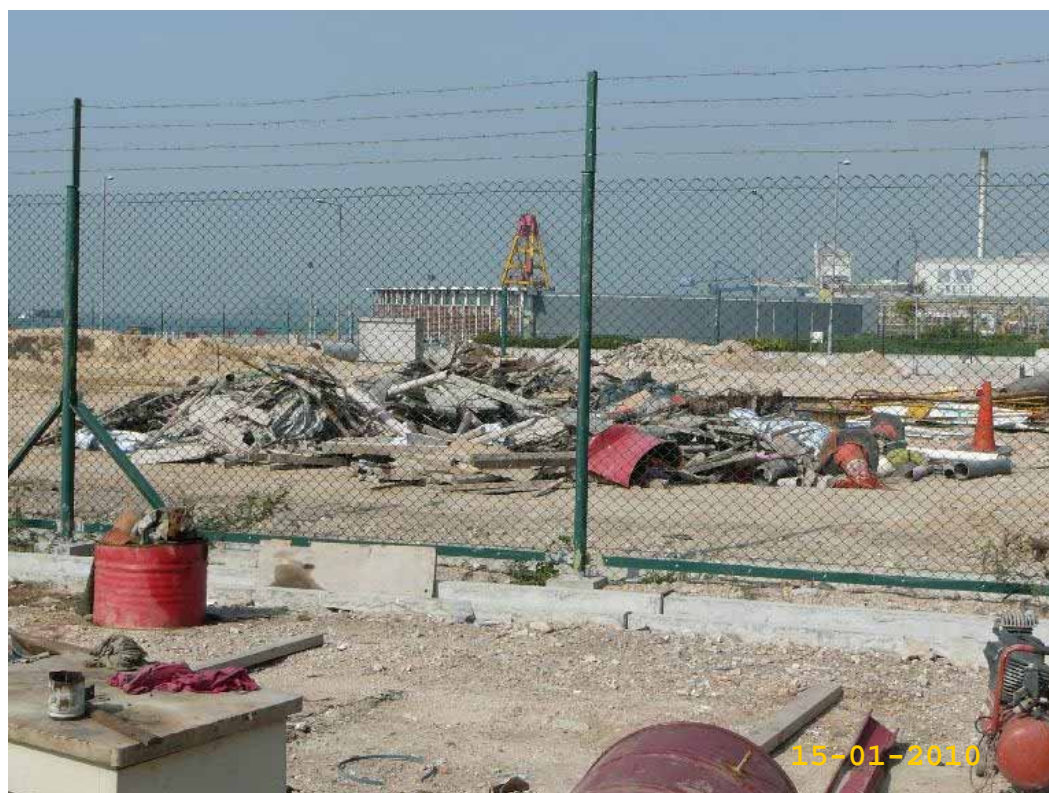
Fig. 2 Piles of waste wood and boards were temporarily stored at centralized collection location for further disposal from the site.

11 December 09 to 08 January 10	A pile of waste wood and board was observed in the middle of Lot 9.	Contractor was reminded to improve the housekeeping practice on site and properly dispose of C&D waste.	Contractor took action to remove and disposed of the pile of wood and board.	15 January 10 (Please refer to Fig. 2)
18 December 09 24 December 09 31 December 09	A power generator was found without a drip tray.	Contractor was reminded to provide proper oil containing facilities for stationary machineries and monitor for any oil leakage.	Contractor took action to place a drip tray for the power generator.	08 January 10 (Please refer to Fig. 3)

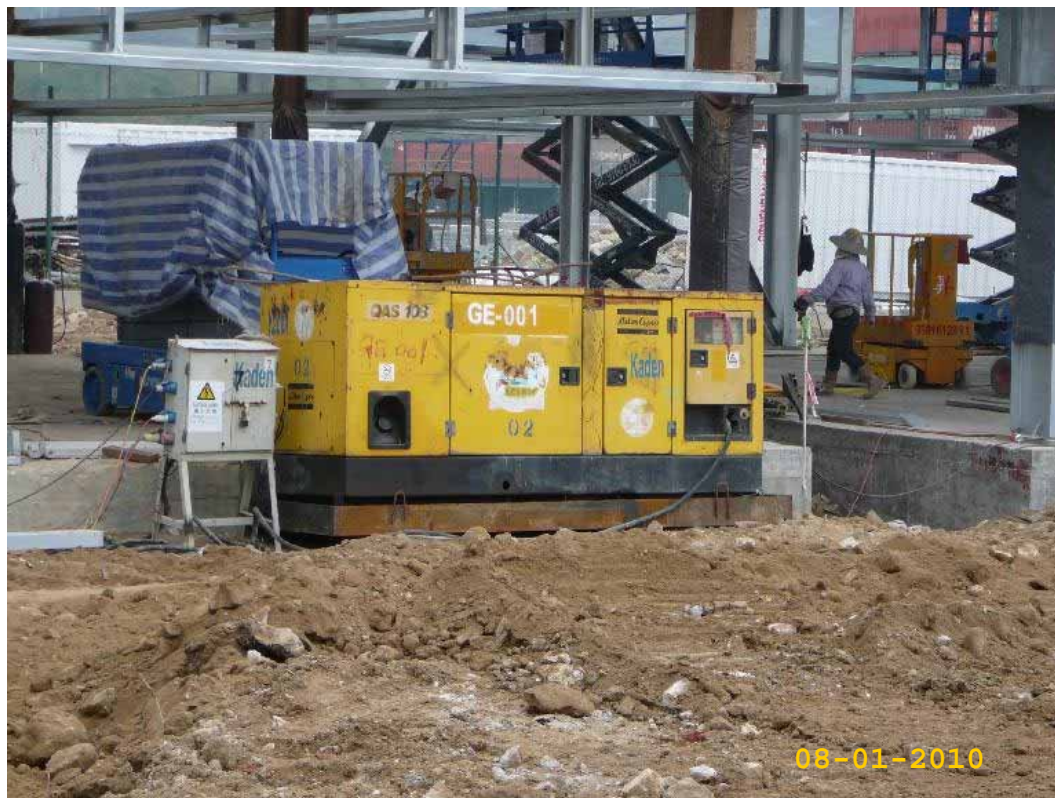
- 4) A power generator and a few drums were found without drip trays. Contractor was reminded to provide proper oil containing facilities for stationary machineries and oil drums, and monitor for any oil leakage. A drip tray is placed for the power generator on 8 January 2010. Tentative closing date is 28 February 2010.

Fig. 3 A drip tray was placed for the power generator.

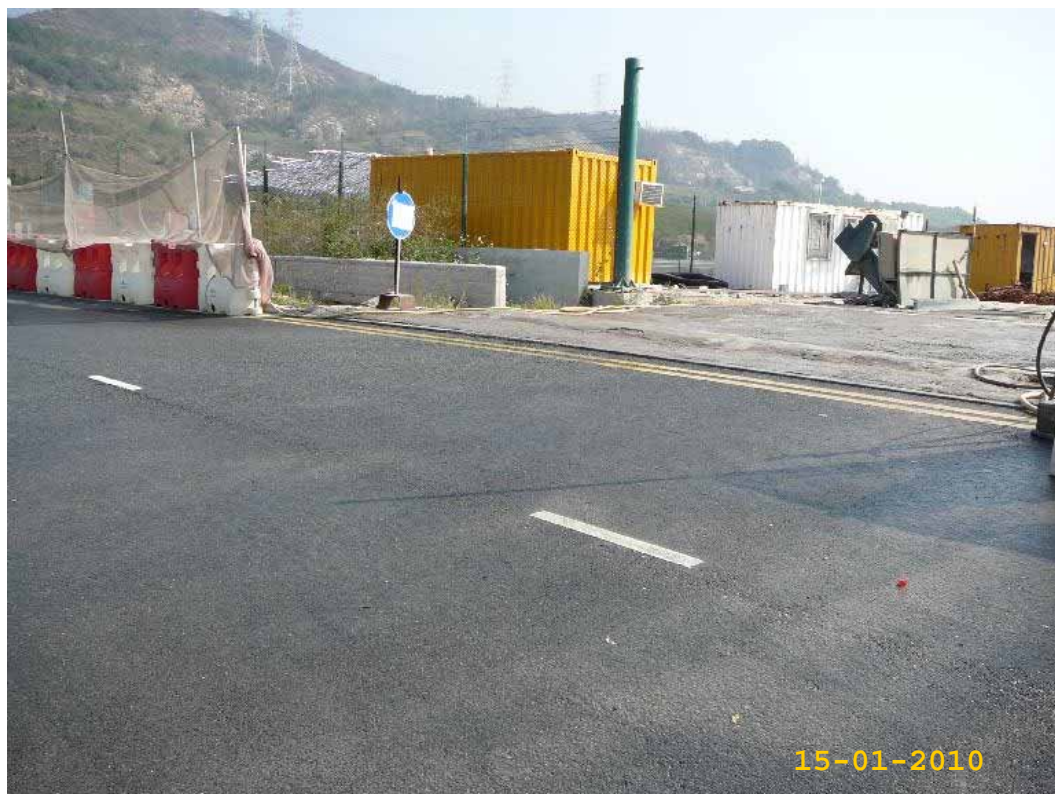
Fig. 4 Muddy water from wheel washing no longer flow into the storm drains.

Table 3.1 Summary of Site Inspections for Phase II construction site during January 2010				
Date	Observations	Advice from ET	Action taken	Closing Date
18 December 09 to 08 January 10	Muddy water from manual wheel washing was observed to flow into storm drains on Road A.	Contractor was reminded to clean wheels of construction vehicles inside the construction site to prevent muddy water from flowing outside the construction site.	Contractor took immediate action to instruct workers to stop immediately and move the vehicle back into construction site before continue to wash.	15 January 10 (Please refer to Fig. 4)
18 December 09	Food containers and general waste was scattered in Lot 8.	Contractor was reminded to provide proper rubbish disposal bins for workers and remind workers to maintain proper housekeeping.	Contractor took action to order workers to collect the general waste.	24 December 09 (Please refer to Fig. 5)

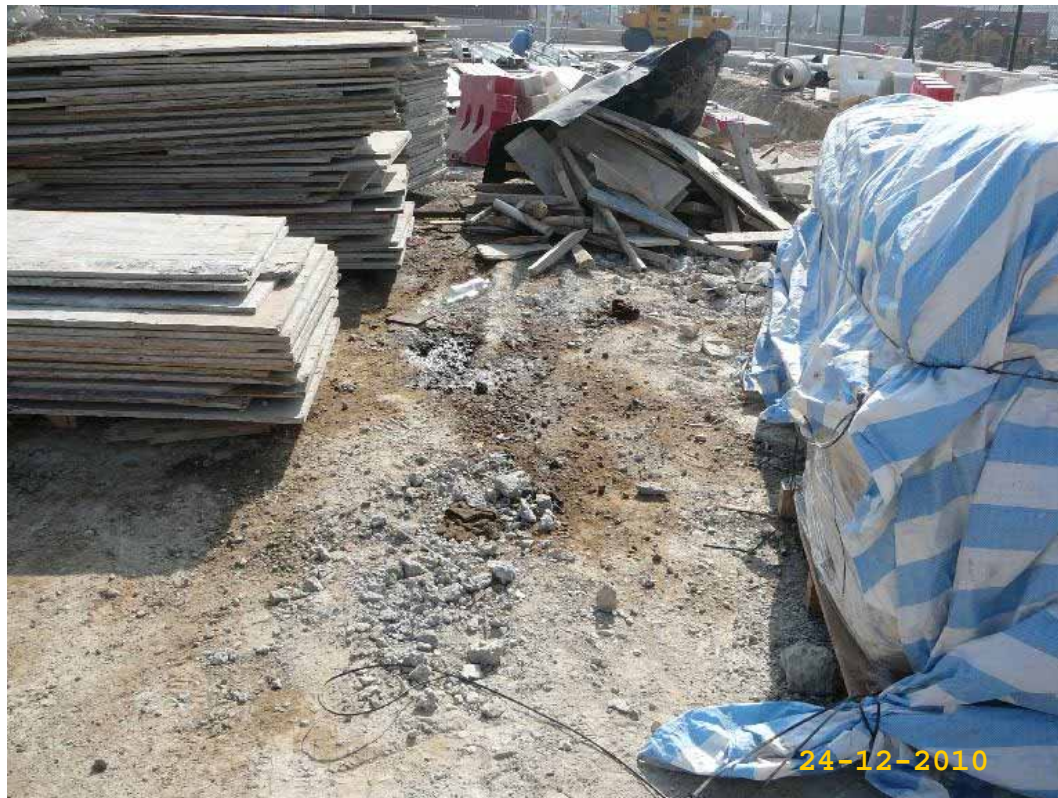
Fig. 5 General waste was collected in Lot 8.

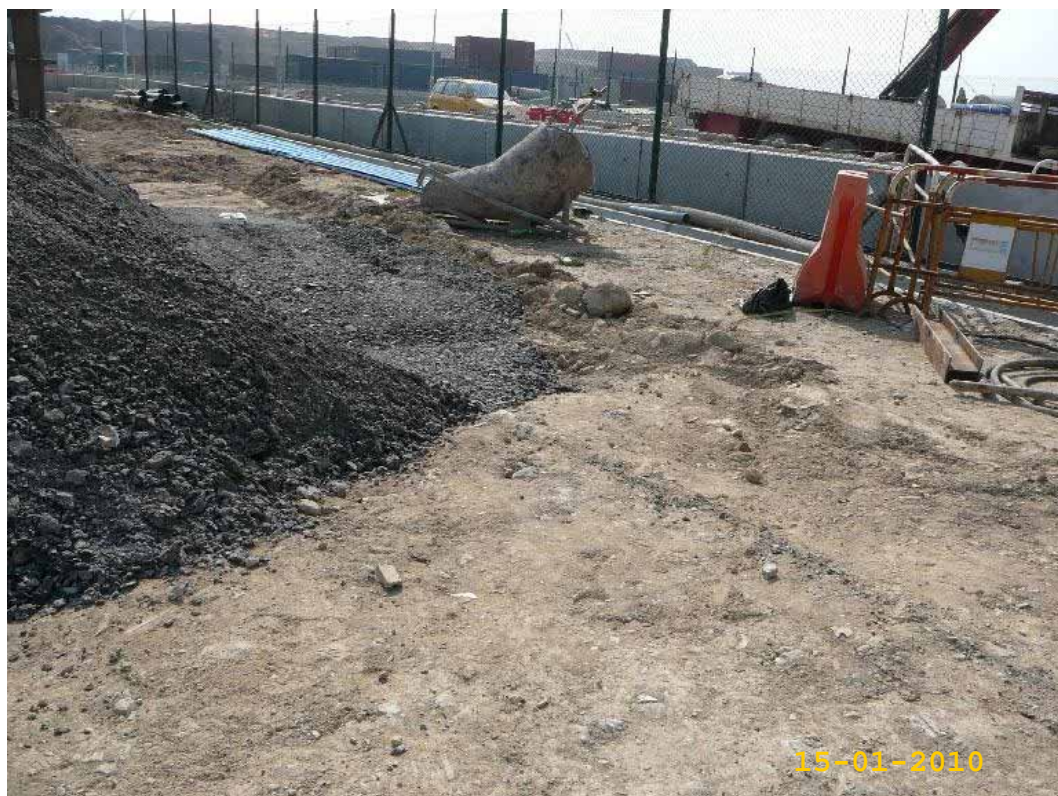
- 5) Machine oil was spread all over a concrete slab of the machine repairing area. Contractor was reminded to have oil and grease collecting facilities in place before proceeding with any major machine repairing work. This issue is closed on 15 January 2010.

Fig. 6 Contaminated concrete slab was removed.

18 December 09 to 08 January 10	Machine oil was spread all over a concrete slab of the machine repairing area.	Contractor was reminded to have oil and grease collecting facilities in place before proceeding with any major machine repairing work. Contractor was also reminded to properly collect and dispose of the contaminated concrete.	Contractor took action to remove the contaminated concrete slab.	15 January 2010 (Please refer to Fig. 6)
31 December 09 08 January 10	The connecting pipe on a water pump is cracked and water is spilled on the surrounding walls, resulting mud collected in the excavation pit.	Contractor was reminded to treat accumulated water properly to meet requirements specified in the issued discharge license, if appropriate.	Contractor took action to replace the cracked pipe and constructed a soak away point to treat the muddy water in the excavation pit.	15 January 2010 (Please refer to Fig. 7)

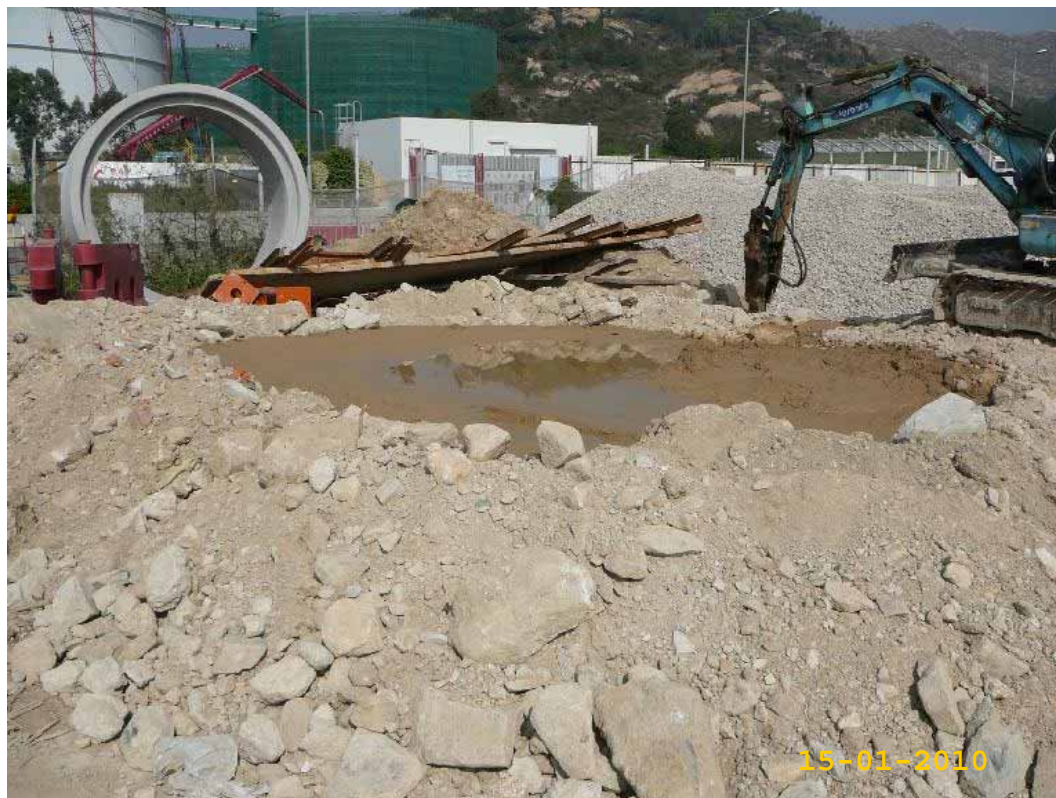
Fig. 7 Soak away point was constructed to treat the muddy water in the excavation pit.

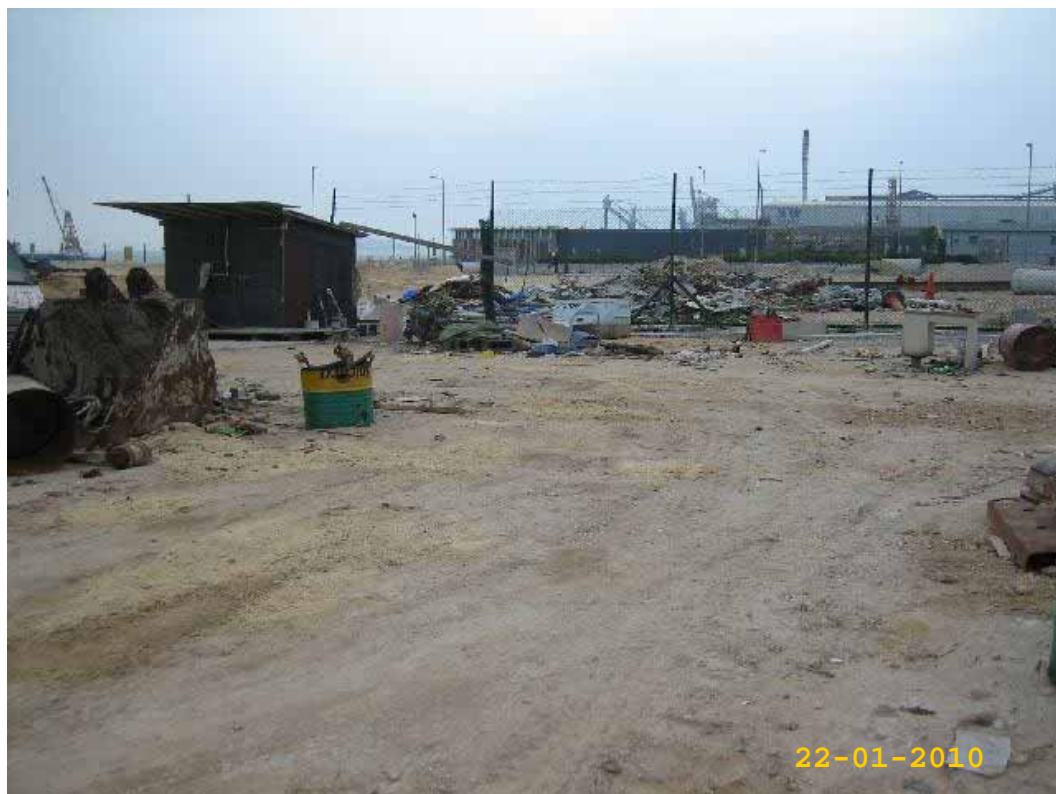
Fig. 8 Contaminated concrete and soil was removed.

05 January 10 08 January 10 22 January 10 29 January 10	Hoardings and wraps are missing or damaged along sections of Road A.	Contractor was reminded to re-install hoardings and wraps to prevent dirt and dust being brought outside of the construction site by wind.	--	To be followed in the next reporting month. (Tentative closing date: 28 February 2010)
15 January 10	Oil leakage on ground was found all around the machine workshop	Contractor was reminded to have oil and grease collecting facilities in place before proceeding with any major machine repairing work. Contractor was also reminded to properly collect and dispose of the contaminated concrete.	Contractor took action to remove the contaminated concrete and soil.	22 January 2010 (Please refer to Fig. 8)
