Contract No. : EP/SP/52/06
Development of EcoPark in Tuen Mun Area 38

ENVIRONMENTAL MONITORING AND AUDIT

MONTHLY EM&A REPORT for

February 2010

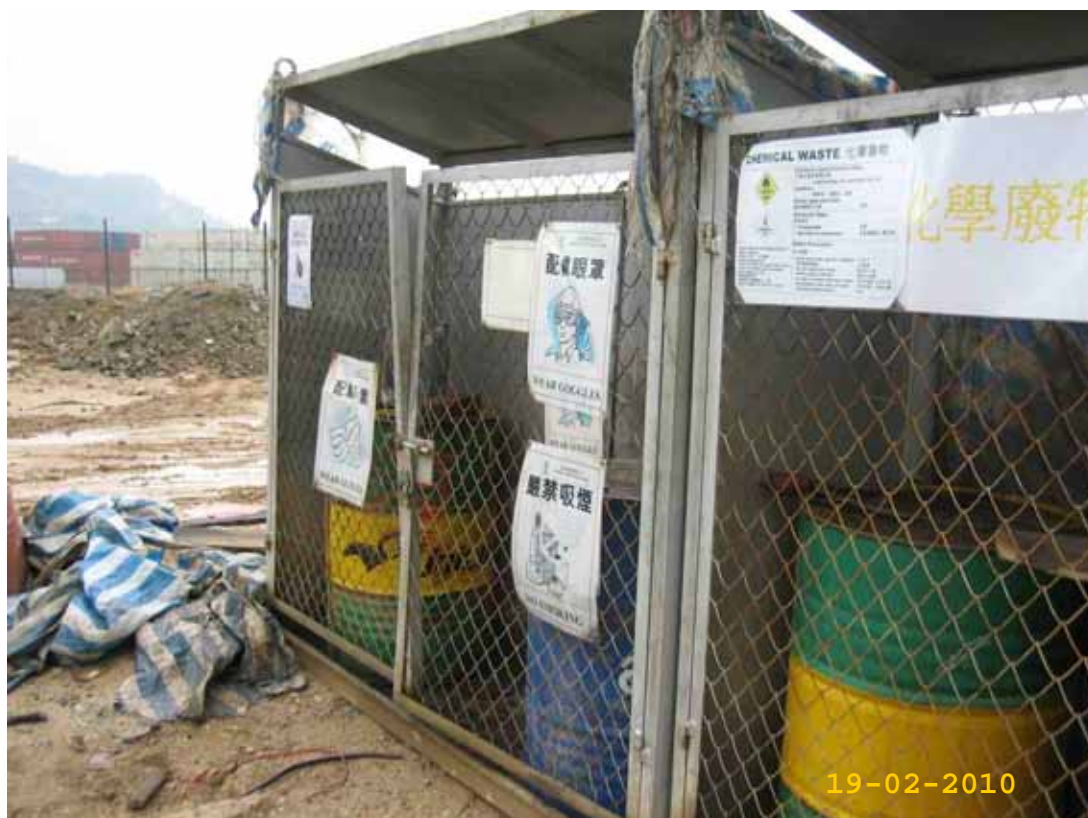
5 February 10 11 February 10	The doors for the chemical waste storage were bent and did not close and lock properly.	Contractor was reminded to monitor and maintain the chemical waste storage facilities and properly to ensure the storage facilities are secured.	Contractor appointed a worker to fix the doors again.	19 February 10 (Please refer to Fig. 2)
05 February 10 to 28 February 10	A pile of waste was observed in the middle of Lot 10.	Contractor was reminded to improve the housekeeping practice on site and properly dispose of C&D waste.	--	To be followed in the next reporting month. (Tentative closing date: 31 March 2010)
25 February 10	General waste was piled in Lot 14.	Contractor was reminded to monitor the waste collecting schedule and revise if the existing schedule does not adequately meet the current needs.	--	To be followed in the next reporting month. (Tentative closing date: 31 March 2010)

Fig. 2 Chemical storage doors are shut and locked.
