West Island Line Project

Audit Report – Part 4
(On-site and Off-site Compensatory Trees of Sai Ying Pun & HKU Stations)

Audit Report for the On-site and Off-site Compensatory Trees of Sai Ying Pun & HKU Stations

This report is Part 4 of the Audit Report; it is the last part of the Audit Report for the West Island Line. This report presents the findings of the audit inspection for the compensatory trees planted in Ki Ling Lane Playground (SYP Entrance B3) and the off-site planting of compensatory trees for SYP and HKU. The audit inspection was conducted on 13 February 2017.

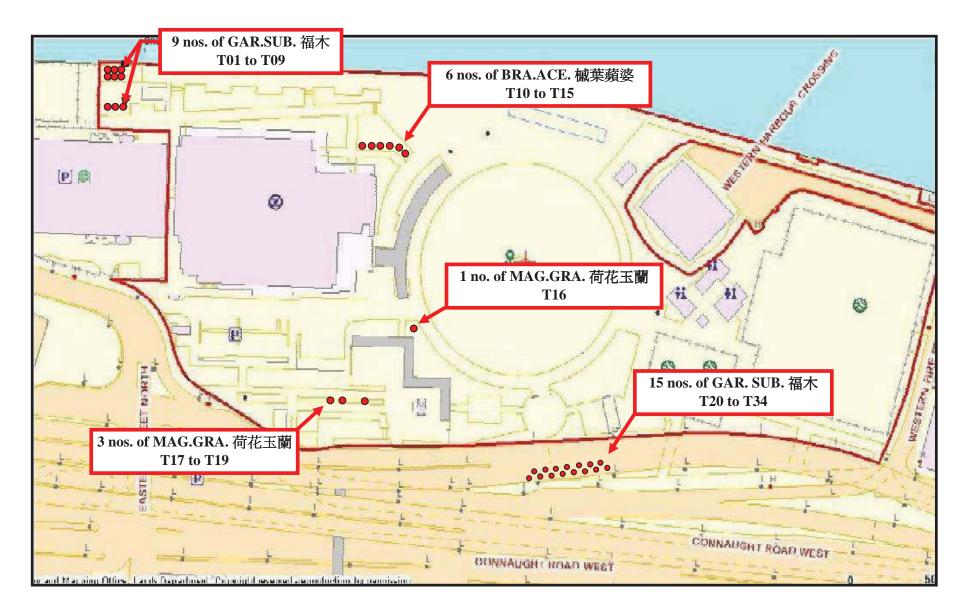
Layout Plan A - New Trees Location at Sun Yat Sen Memorial Park

- 24 additional *Garcinia subelliptica*, 6 additional *Brachychiton acerifolius*, and 3 additional *Magnolia grandiflora* are found on site.
- Overall trees health and form are in fair condition.

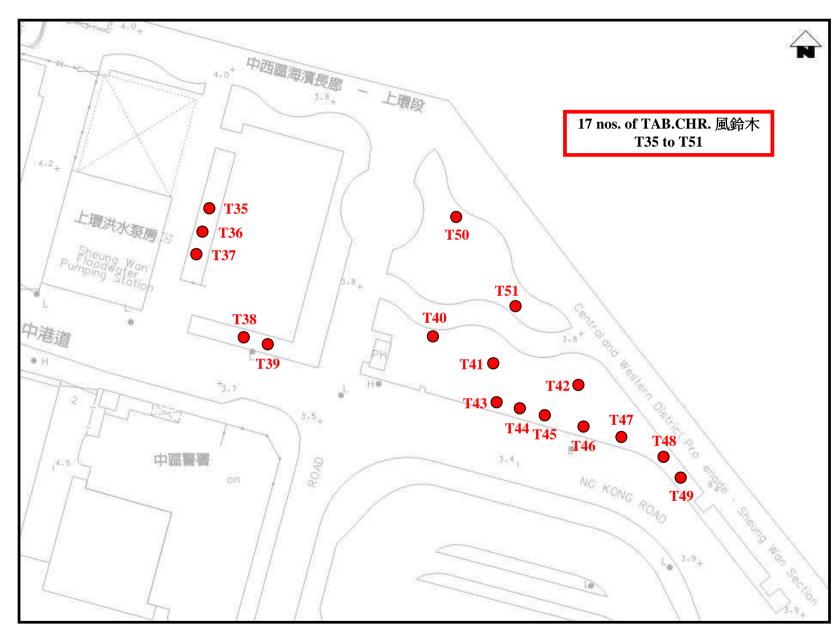
<u>Layout Plan B - New Trees Location at Central and Western District Promenade – Sheung Wan Section</u>

- 2 Tabebuia chrysotricha are not found.
- 9 trees (Tree ID: T35, T36, T37, T43, T44, T45, T46, T47 and T48 in Appendix B) differ from the compensatory planting proposal in size.
- 1 tree (Tree ID: T38 in Appendix B) differ from the compensatory planting proposal in tree location.
- 6 trees (Tree ID: T39, T40, T41, T42, T50 and T51 in Appendix B) differ from the compensatory planting proposal in both size and location.
- Overall trees health and form are in fair condition.

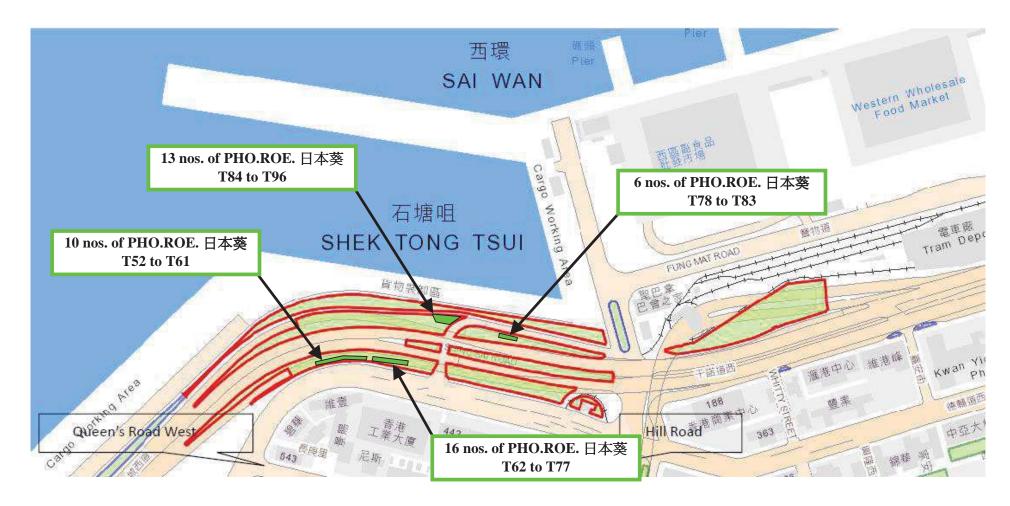
Layout Plan C - New Trees Location at Western District near Fung Mat Road

- 8 trees (6 *Melaleuca cajuputi* subsp. *Cumingiana*, 1 *Syzygium jambos* and 1 *Bauhinia variegate*) are replaced with *Phoenix roebelenii* and have been located differently from the TPP (Rev.F).
- 26 trees *Phoenix roebelenii* differ from the compensatory planting proposal in tree location.
- Overall trees health and form are in fair condition.
