PROVISION OF CREMATORS AT WO HOP SHEK CREMATORIUM

QUARTERLY ENVIRONMENTAL MONITORING & AUDIT REPORT (FEBRUARY 2010 – APRIL 2010)

Quotation Contract No. 9/2009/AB1
Provision of Cremators at Wo Hop Shek Crematorium - Independent Environmental Checker Service
Quarterly EM&A Report (February 2010 – April 2010)

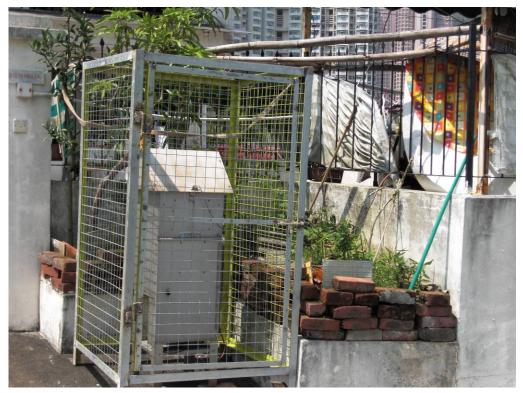
Ground floor within the front gate of 83 Wo Ka Lau Road

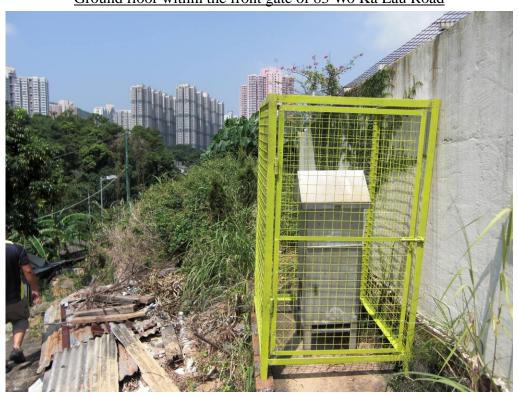
Ground floor boundary wall of house 51D of Wo Hop Shek San Tsuen
