APPENDIX 10A Built Heritage Catalogue

Ref: HB-01	Title: Village House	Category: Residential
Address: Nos. 126, 128 and 130 Cha Kwo Ling		Reference Plan:
Orientation: Southwest		Grading: Nil

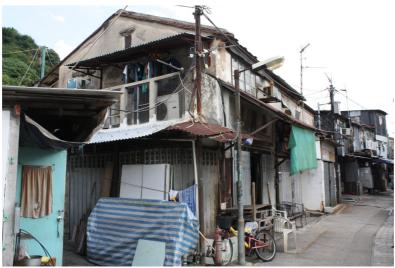
Existing Condition: Fair

Notes on modifications: The terrace row has been heavily modified by metal additions and repairs.

View of the Façade and Northwest Elevation of HB-01

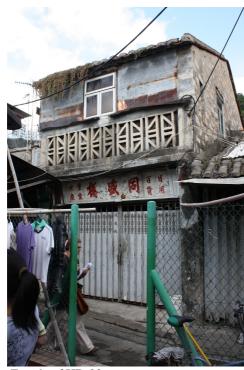
Existing Condition: Poor, the walls are being supported by struts.

Notes on modifications: Modern windows and doors have been added. Mid terrace unit has large metal sliding gate across the façade. Heavily modified appearance.

Façade of HB-02

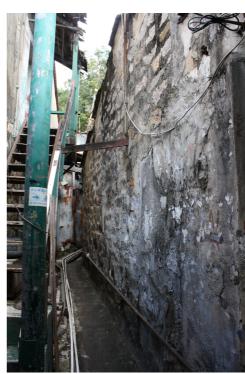
Northwest Elevation of HB-02

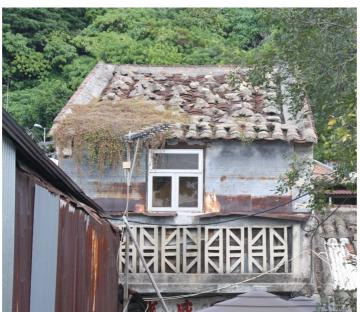
Central two storey terrace unit with pitched traditional style tile roof. The unit beside It also has a traditional style tile pitched roof, but a modern sliding gate has replaced the original façade. It's appearance has been heavily modified with repairs and additions.

Upper Façade and roof of HB-02

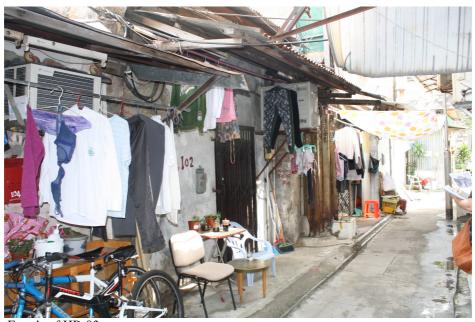
Notes on modifications: The building has been heavily modified with modern gate and roofing material.

Façade of HB-03

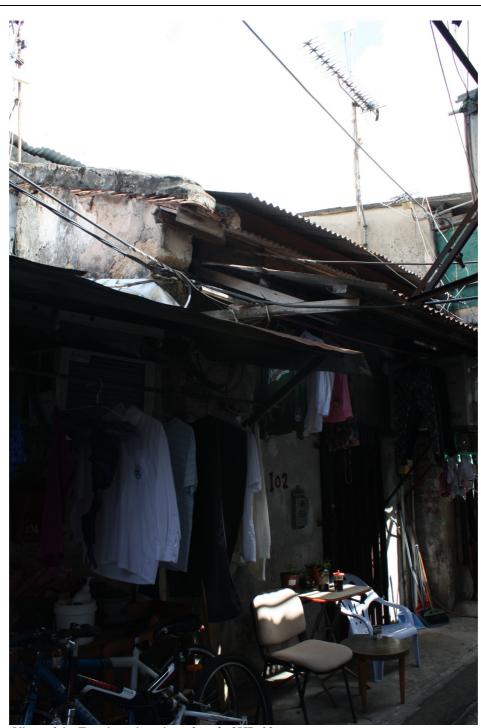
Terrace unit with render exterior wall covering. Some sections of wall reveal pounded earth and there are some traditional tiles on the edges of the roof.

View of the Façade and section of roof of HB-03

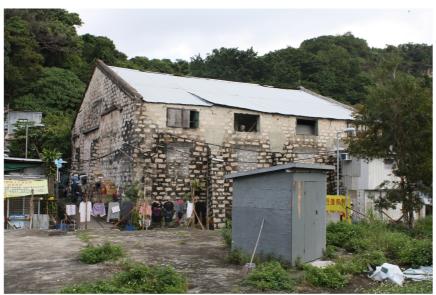
Notes on modifications: Roof has been replaced with corrugated metal sheets.

General View of HB-05 showing the Southwest and Southeast Elevations

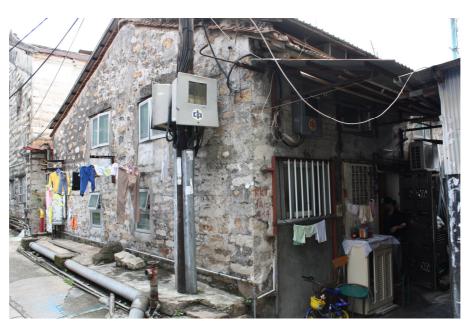
Notes on modifications: Modern windows, gates and doors have been added to the building. The roof is a modern replacement

HB-09: Facade and Western Elevation

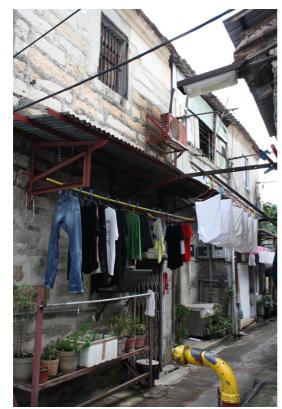
Modern windows, aircon units, cables, junction boxes, corrugated metal sheets and metal security screen have all been added to the building. During the subdivision of the building, it has been divided into three sections, each with its own entrance.

The Façade of Law's Mansion (HB-10)

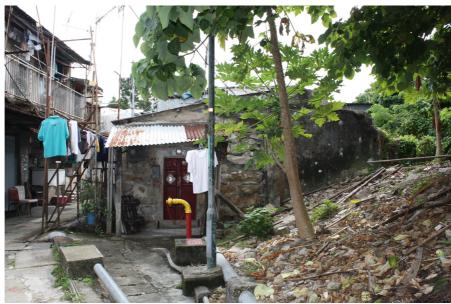
Section of a larger structure that remains after fire damage. The walls are of cut stone and covered with render. The door is wooden and is set in a modern concrete frame.

Existing Condition: Fair to Poor

Front Elevation of HB-11

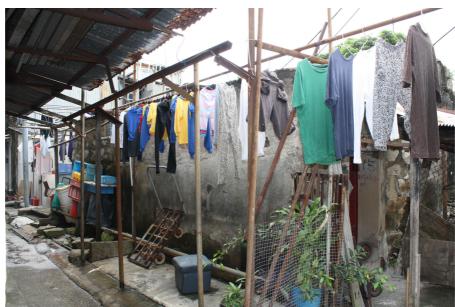
The village house is a stone structure but has been damaged from fire.

Rear Elavation of HB-11
