**JOB No.: TCS00491/09**

**DSD CONTRACT No.: DC/2009/08**

**CONSTRUCTION OF YUEN LONG SOUTH BRANCH  
SEWERS AND EXPANSION OF HA TSUEN SEWAGE  
PUMPING STATION**

**THE THIRD RESULTS OF LANDSCAPE AND VISUAL IMPACT MONITORING  
FOR APRIL 2010 (NO.3)**

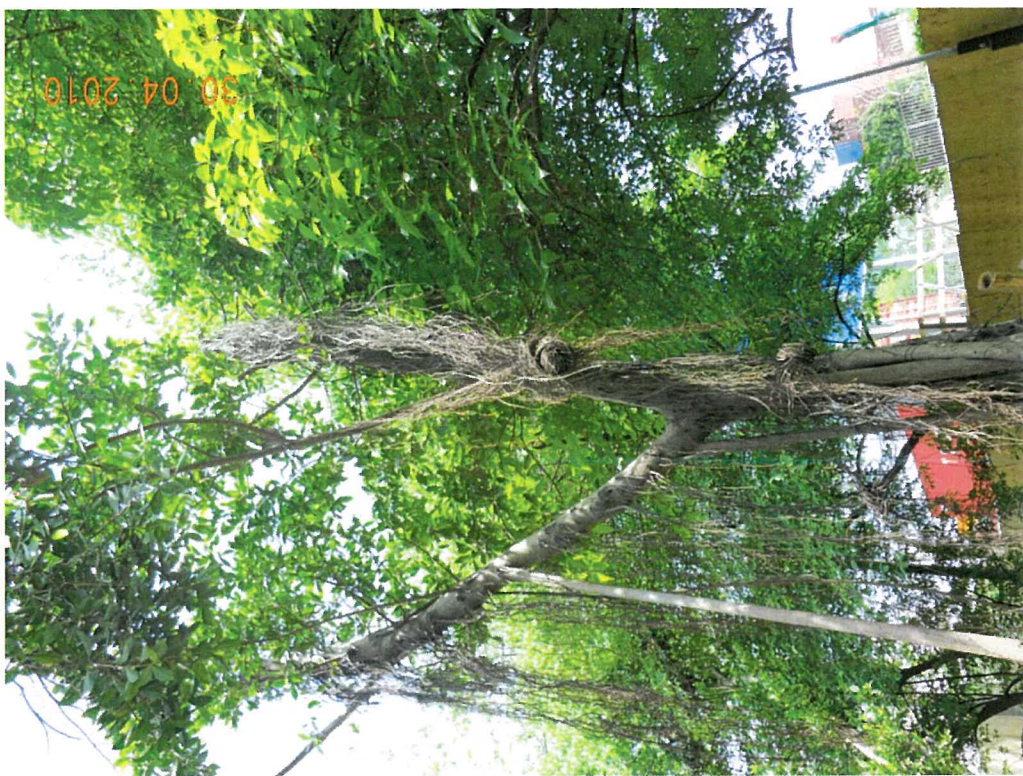
| Tree Nos. | Health | Tree Form | Comments | Suggested treatment |
|---|---|---|---|---|
| D1240 | Fair | Fair | The aerial root were knot | Release the knot |

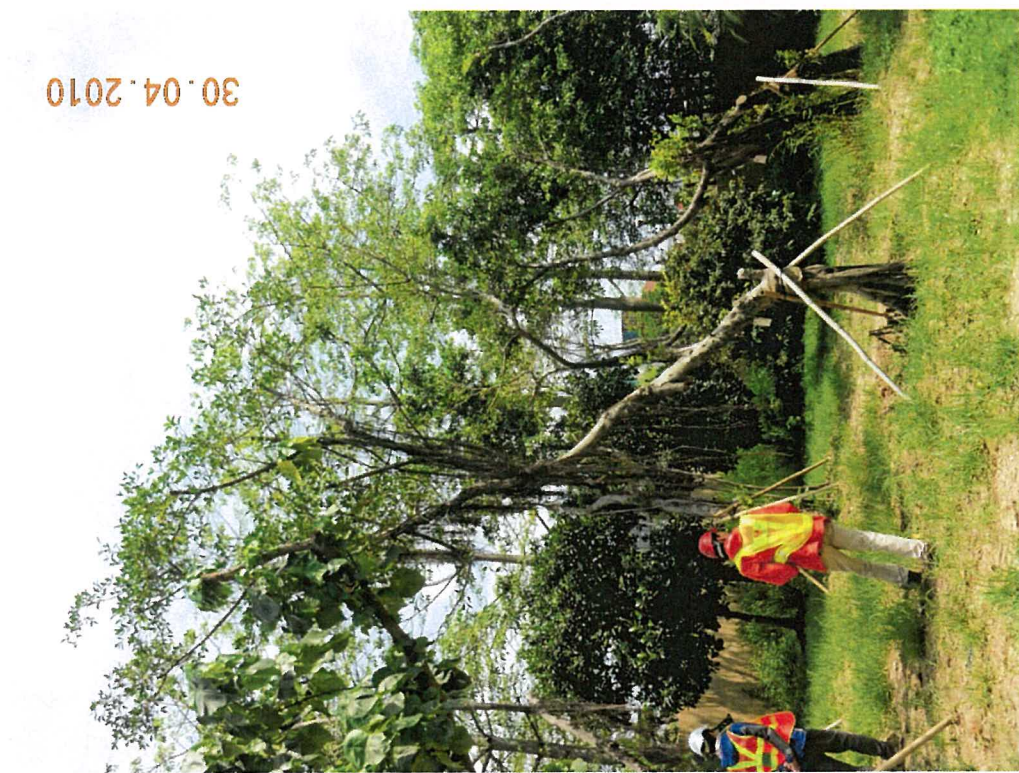
| Tree Nos. | Health | Tree Form | Comments | Suggested treatment |
|---|---|---|---|---|
| D1233 | Fair | Fair | The aerial root were knot | Release the knot |

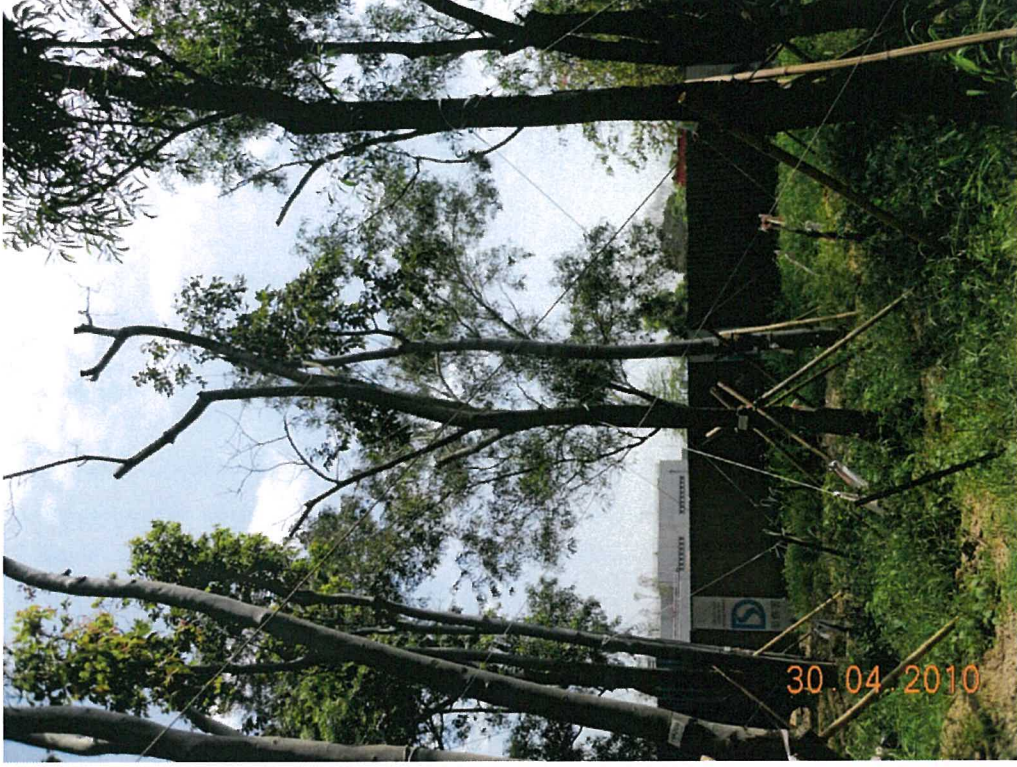
| Tree Nos. | Health | Tree Form | Comments | Suggested treatment |
|---|---|---|---|---|
| HA211 | Fair | Fair | Found bud | Water more frequently |

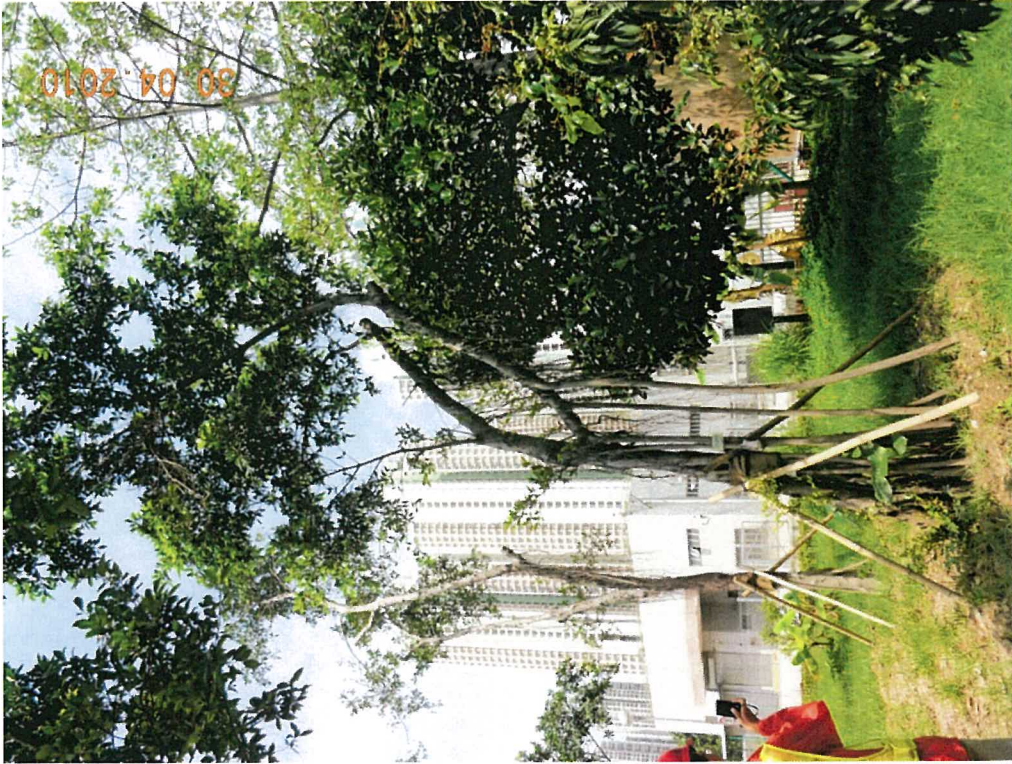
| Tree Nos. | Health | Tree Form | Comments | Suggested treatment |
|---|---|---|---|---|
| D1245 | Fair | Fair | Found weeds | Remove the weeds and 海芋 |

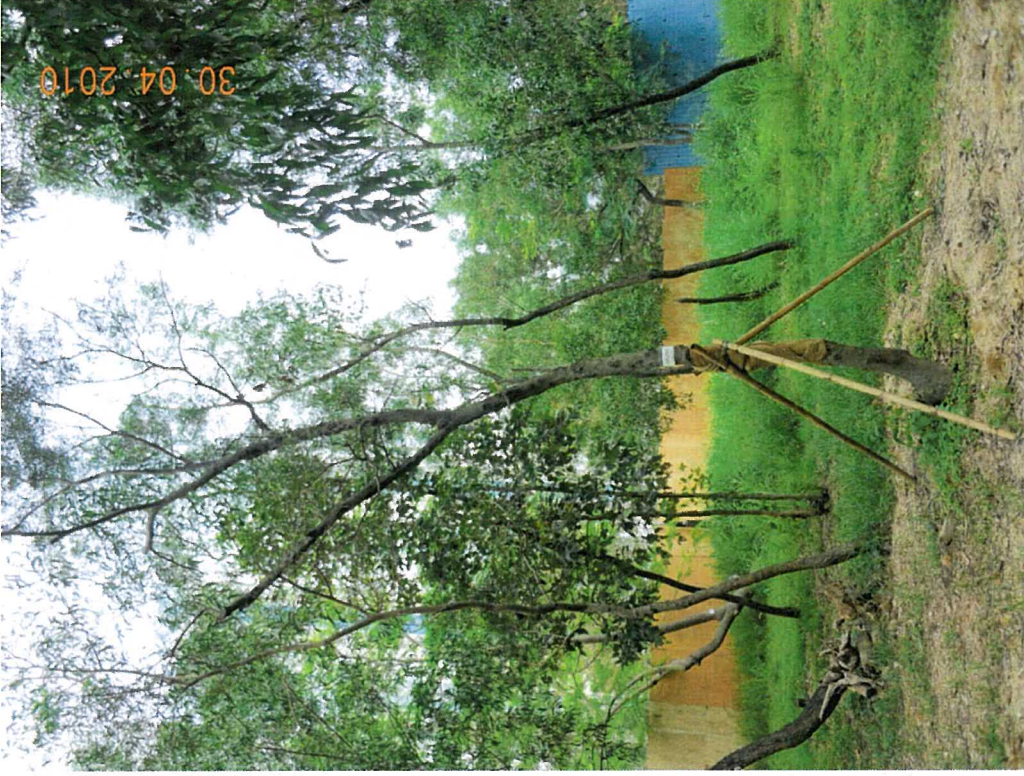
| Tree Nos. | Health | Tree Form | Comments | Suggested treatment |
|---|---|---|---|---|
| HA260 | Dying | Fair | Dying | Water more frequently |

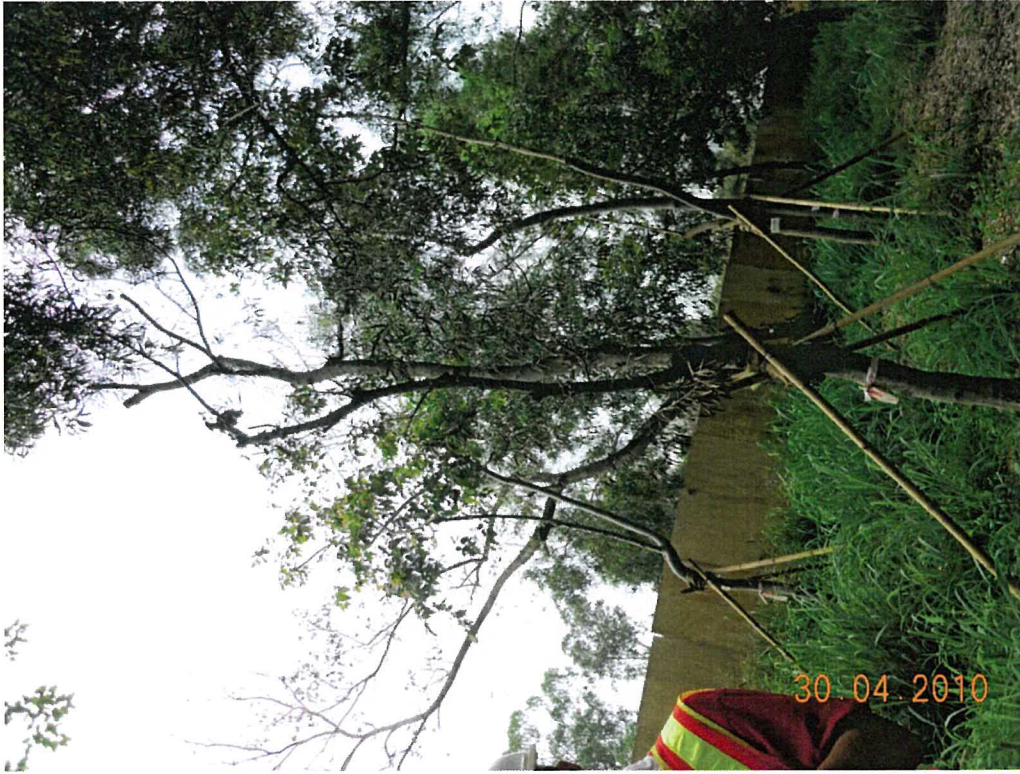
| Tree Nos. | Health | Tree Form | Comments | Suggested treatment |
|---|---|---|---|---|
| HA245 | Dying | Fair | Dying | Water more frequently |
