CONSTRUCTION OF YUEN LONG SOUTH BRANCH  
SEWERS AND EXPANSION OF HA TSUEN SEWAGE  
PUMPING STATION

THE TWENTY-FIRST RESULTS OF  
LANDSCAPE AND VISUAL IMPACT MONITORING FOR  
OCTOBER 2011 (No.21)

Contract No.: DC/2009/08  
 Contract title: Construction of Yuen Long South Sewer and Expansion of Ha Tsuen Sewage Pumping Station  
 Contractor: China State Construction Engrg. (HK) Ltd.  
 Location: Ha Tsuen Sewage Pumping Station  
 Inspection Date: 27-Oct-2011

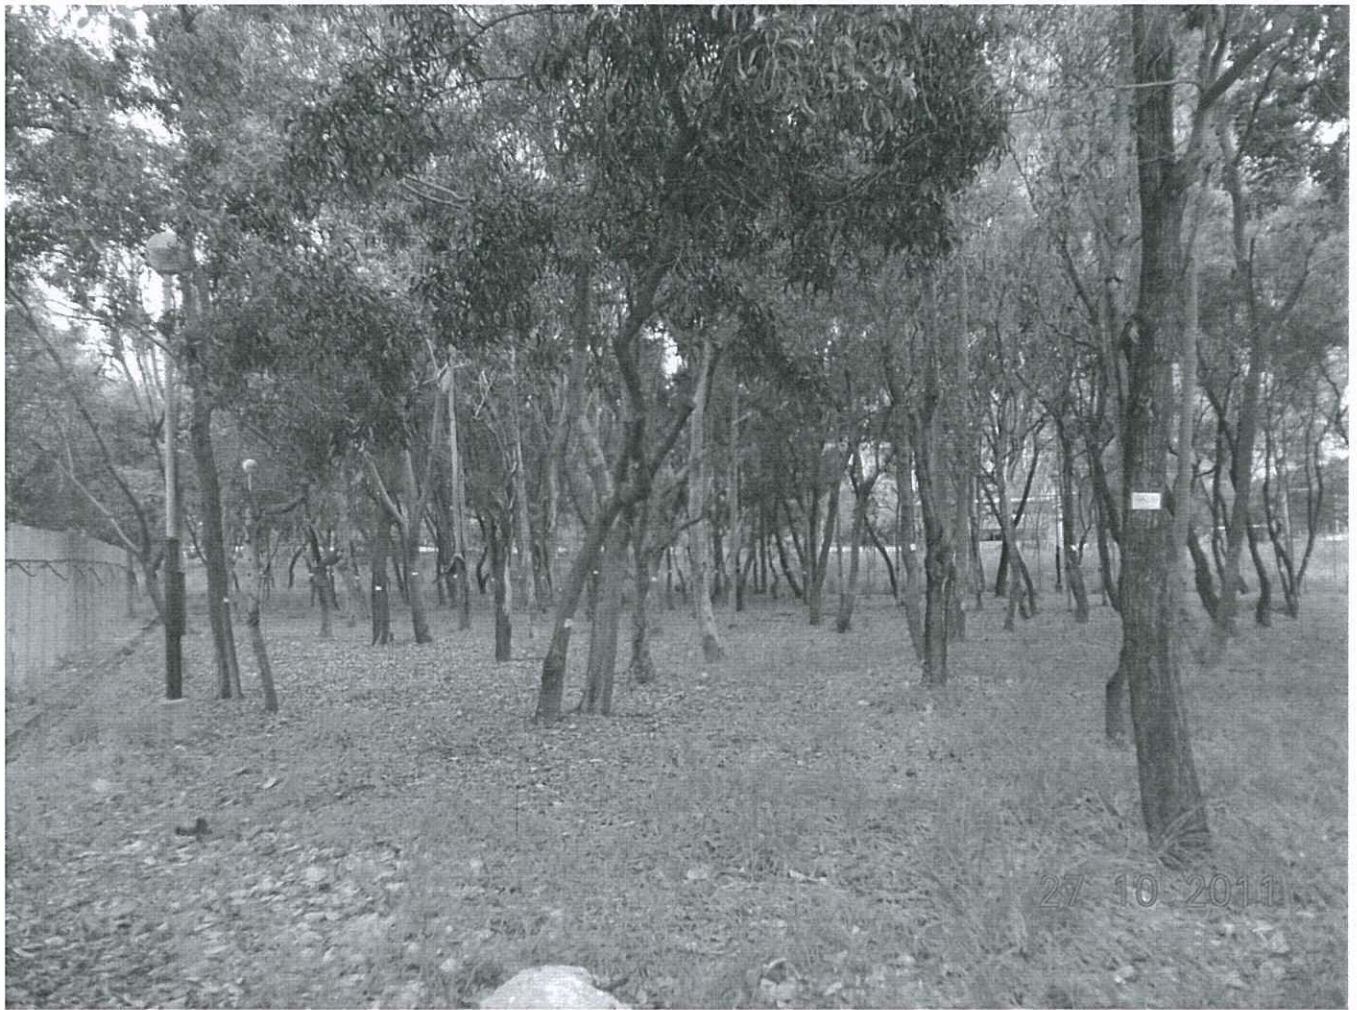
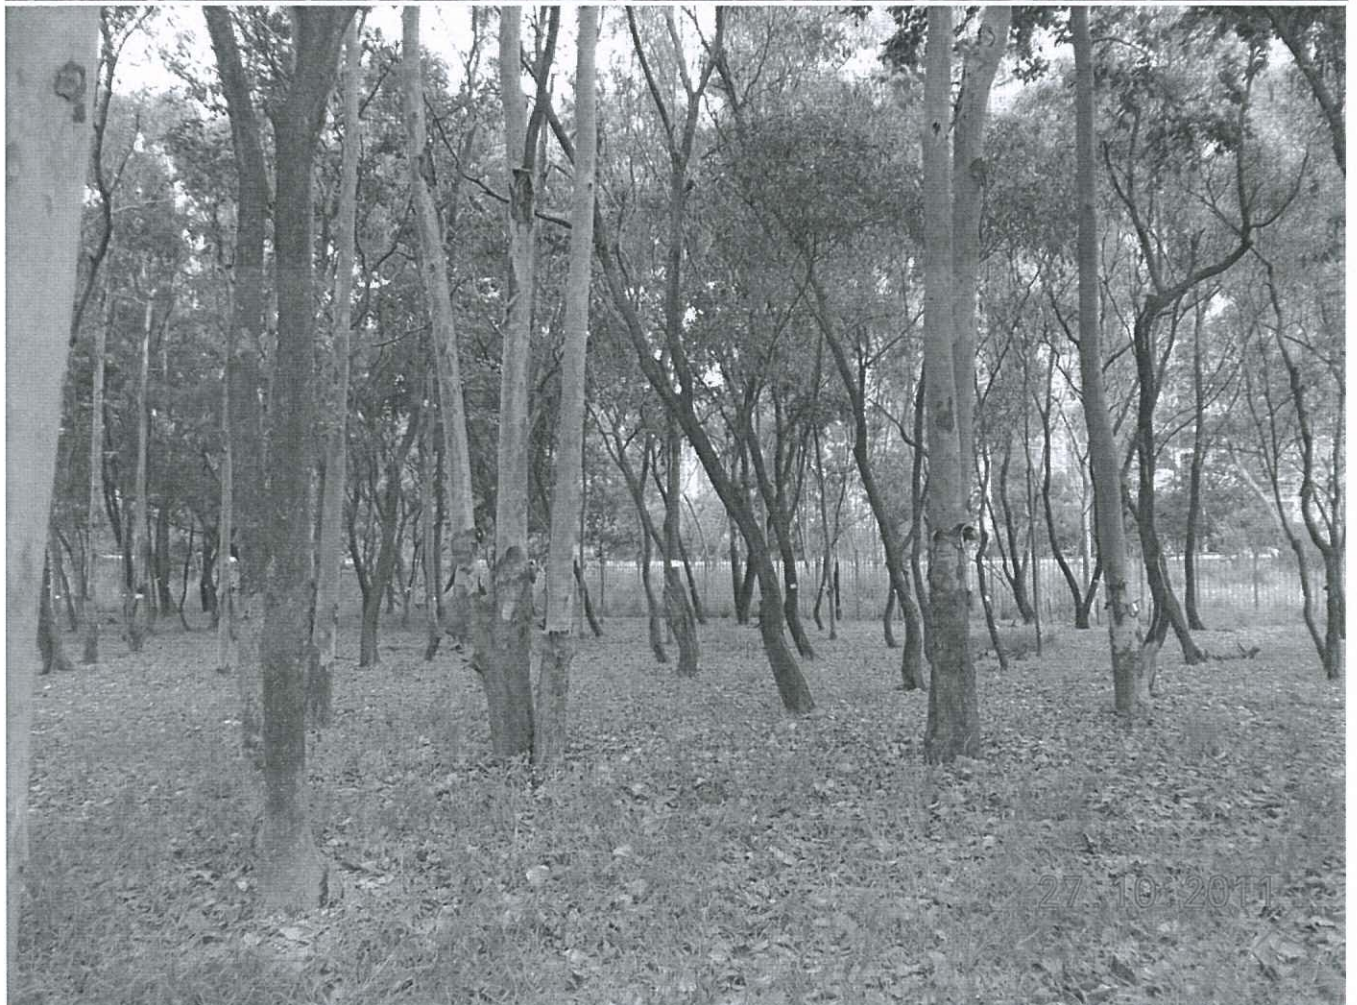
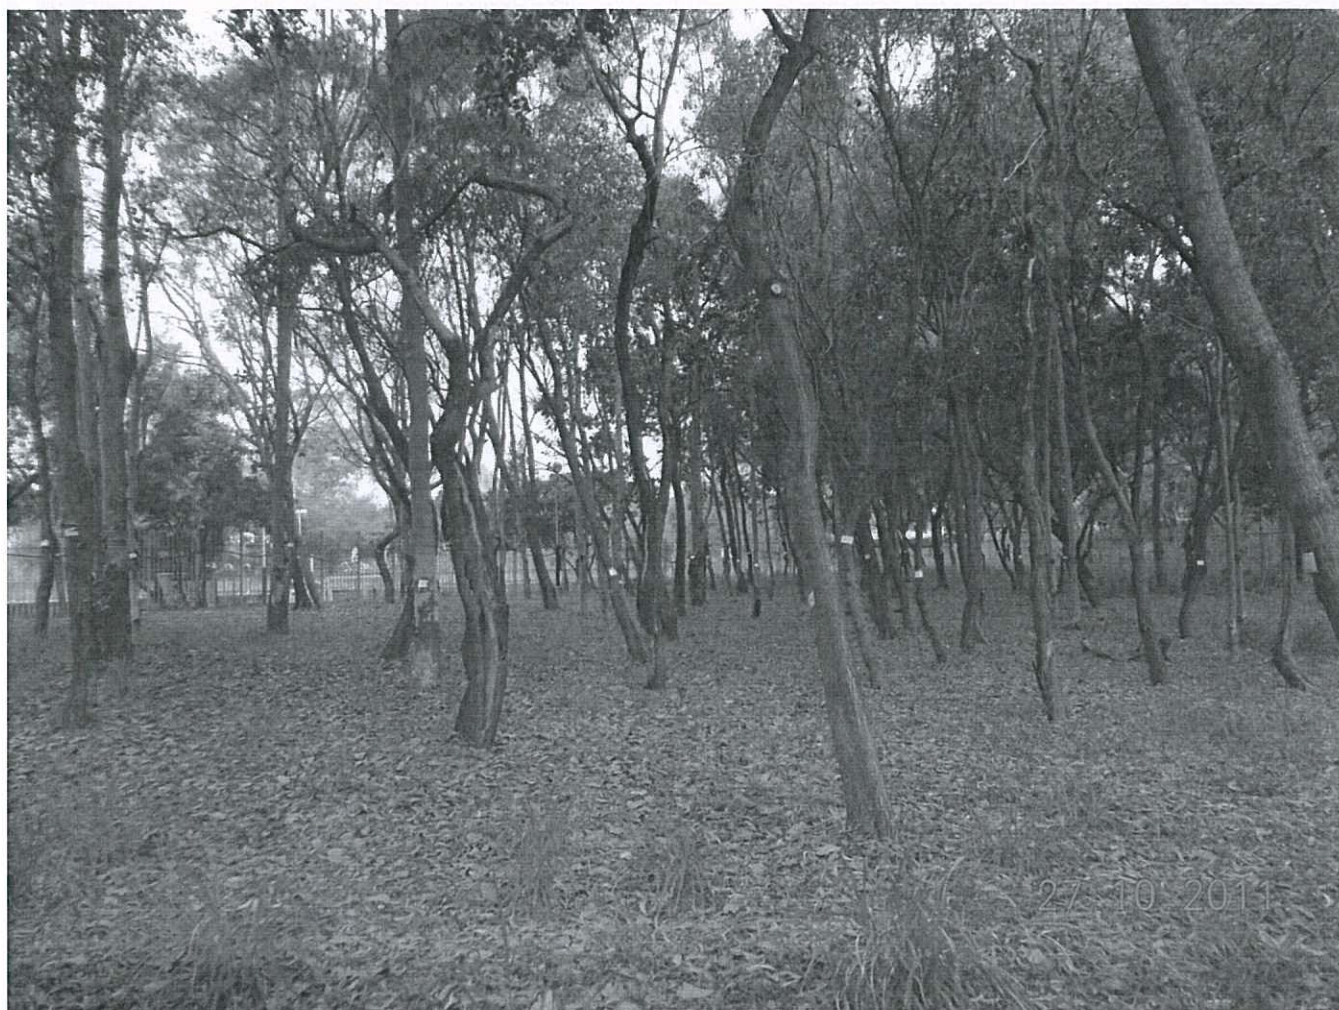
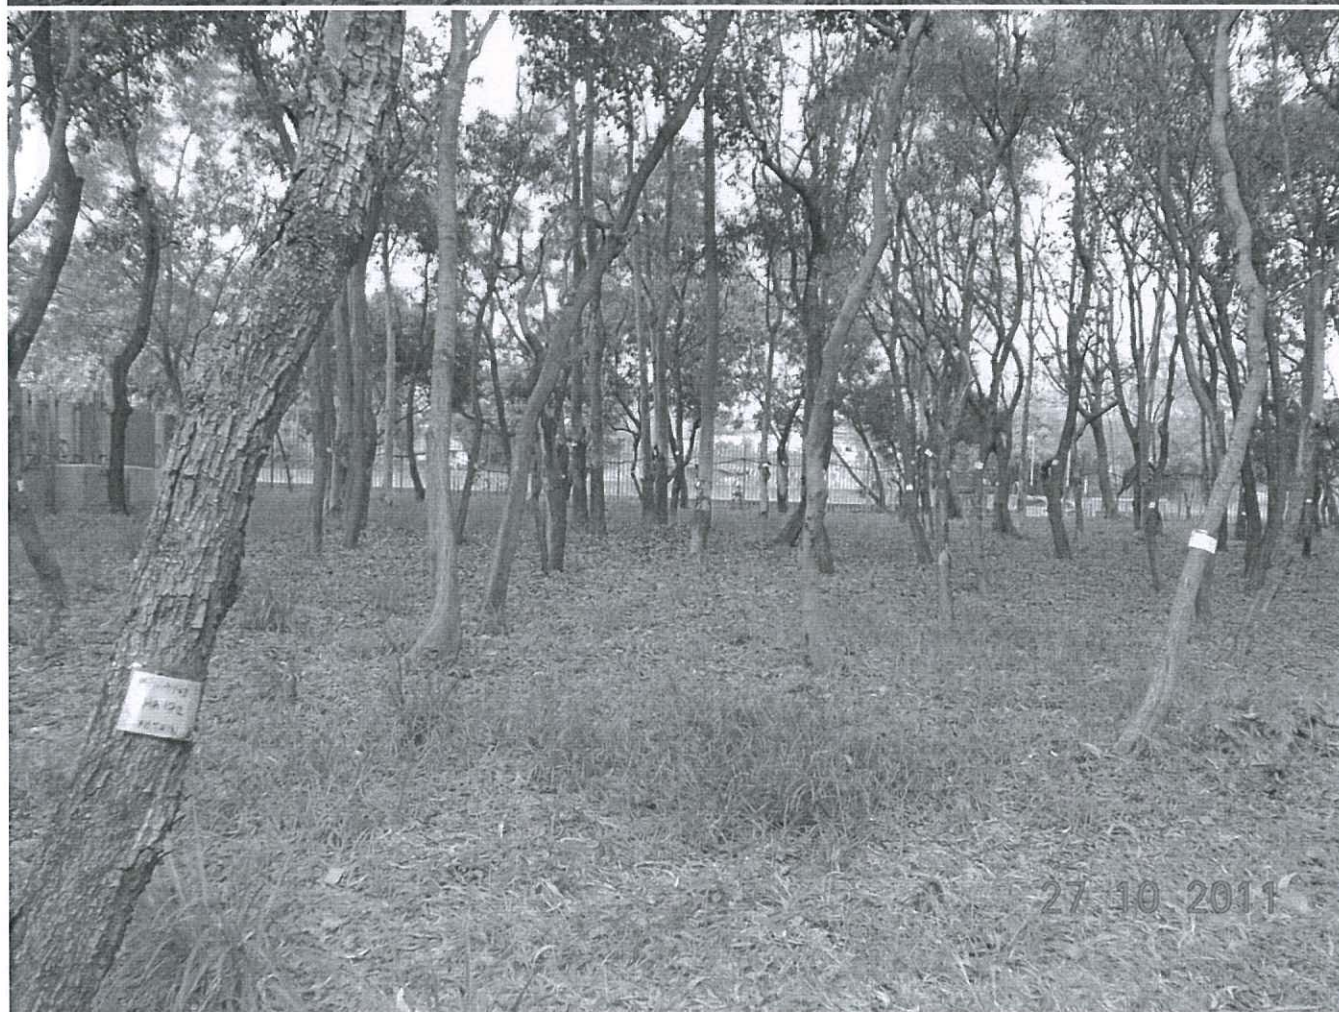
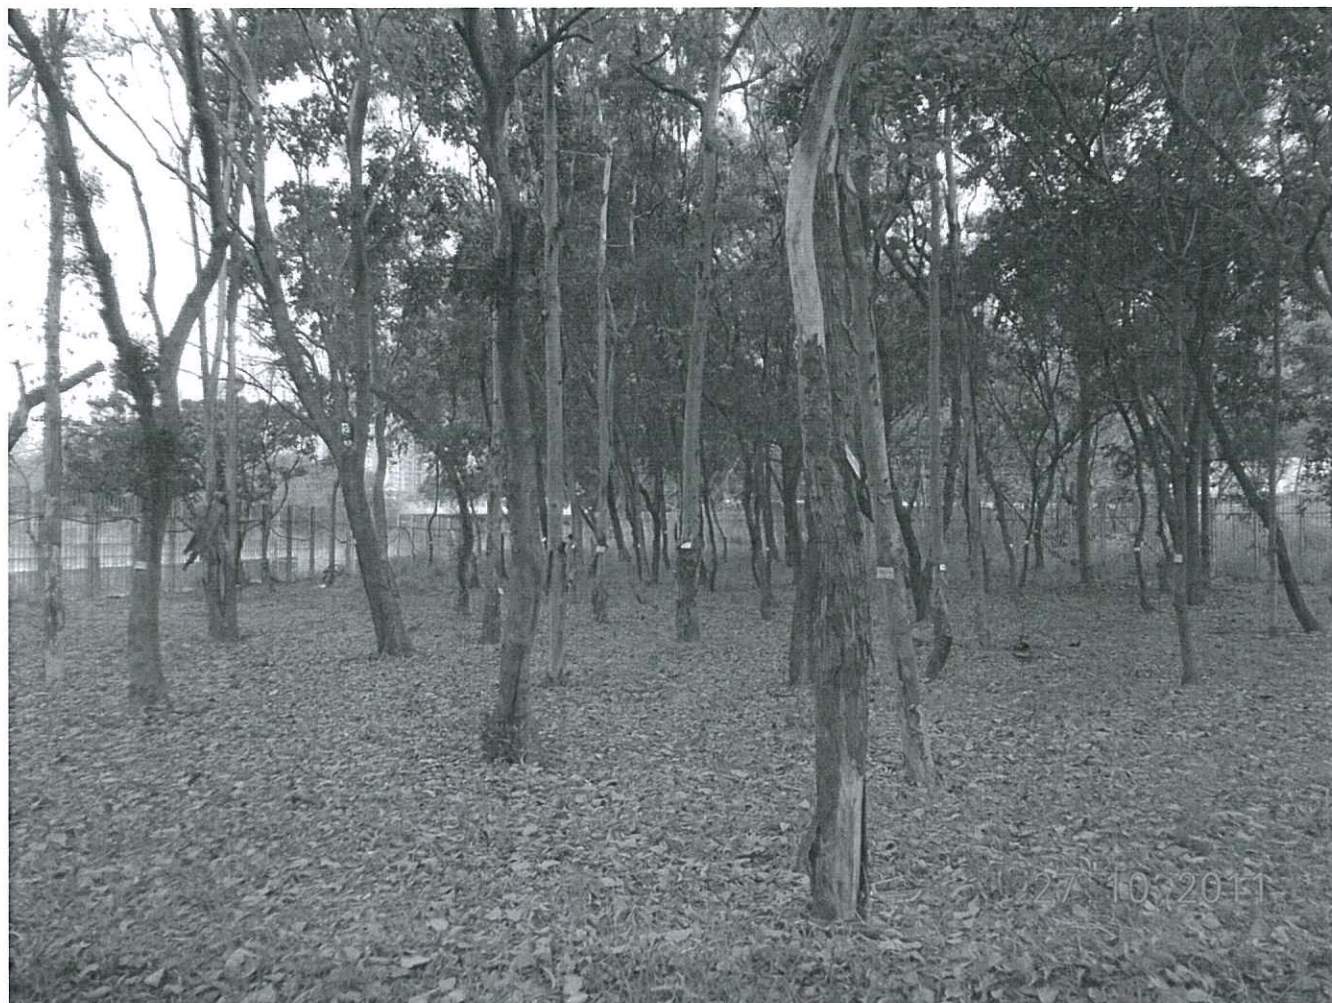
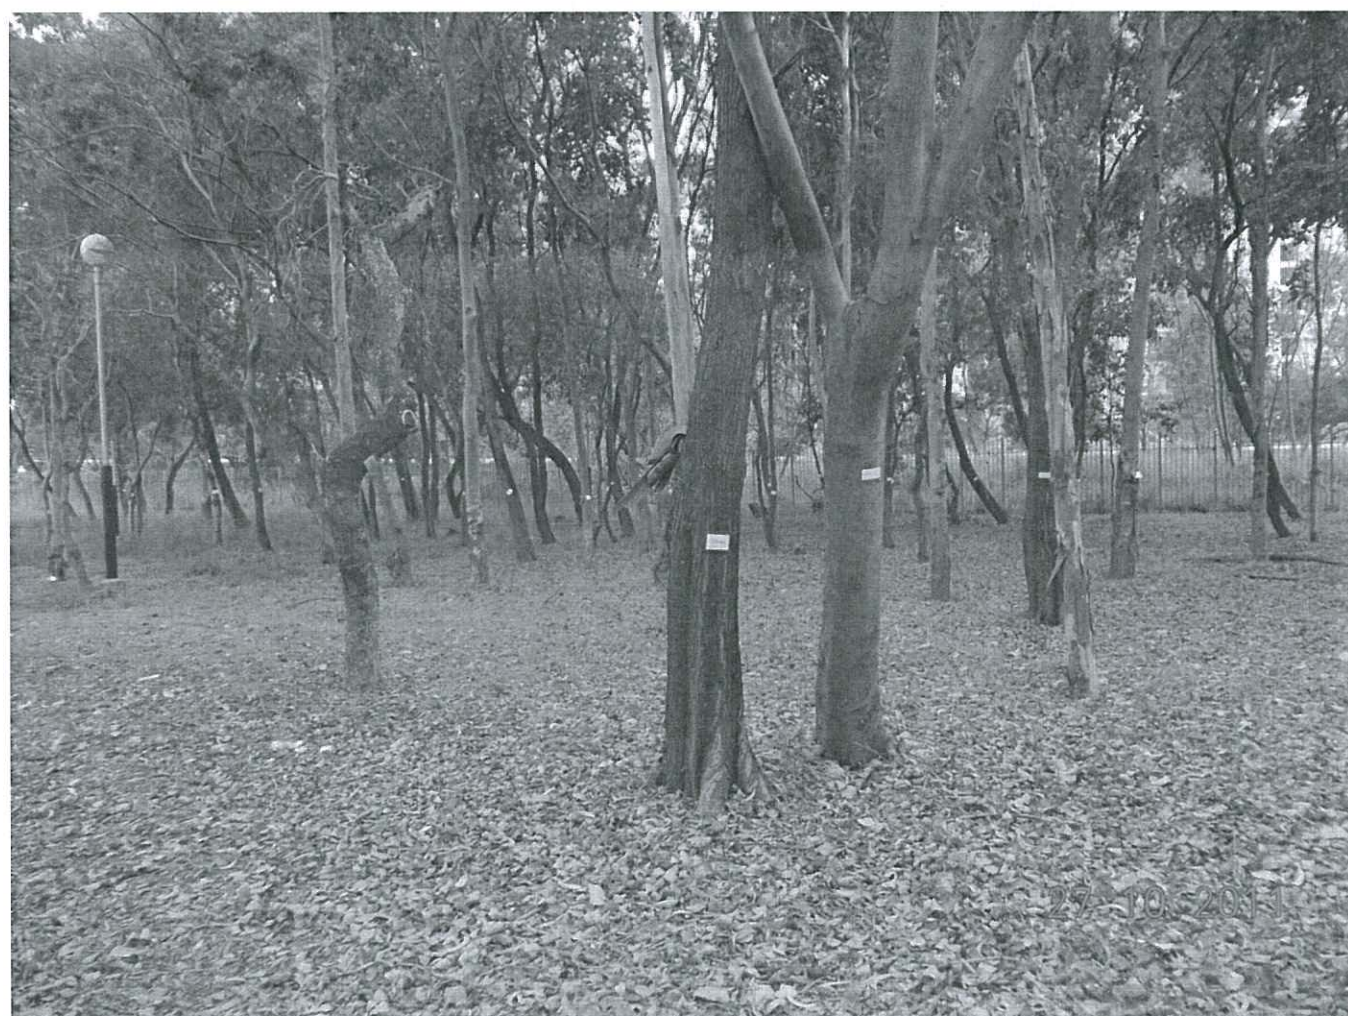
During inspection it is noted that some of the trees transplanted are of low survival rate. Some trees are now identified as dead trees on site they should be removed to prevent any safety hazard of falling within the works area or spreading pests & disease to other trees.

- 3.01 The trees at Ha Tsuen Pumping Station have been handed over to DSD since January 2011 for management and monitoring thereafter.
- 3.02 Dead trees were found during the Results Period. In order to alleviate land scape and visual impacts under the Project, the tree manager is recommended to remove and replace the dead trees as appropriate.
- 3.03 Trees in poor condition were also observed during the Result Period. More frequent watering or fertilizing and even further investigation on the tree conditions may need to be undertaken by the tree manager to improve living conditions of those poor trees.
