JOB No.: TCS00491/09

**CONSTRUCTION OF YUEN LONG SOUTH BRANCH  
SEWERS AND EXPANSION OF HA TSUEN SEWAGE  
PUMPING STATION**

**THE TWENTY-SECOND RESULTS OF  
LANDSCAPE AND VISUAL IMPACT MONITORING FOR  
NOVEMBER 2011 (No.22)**

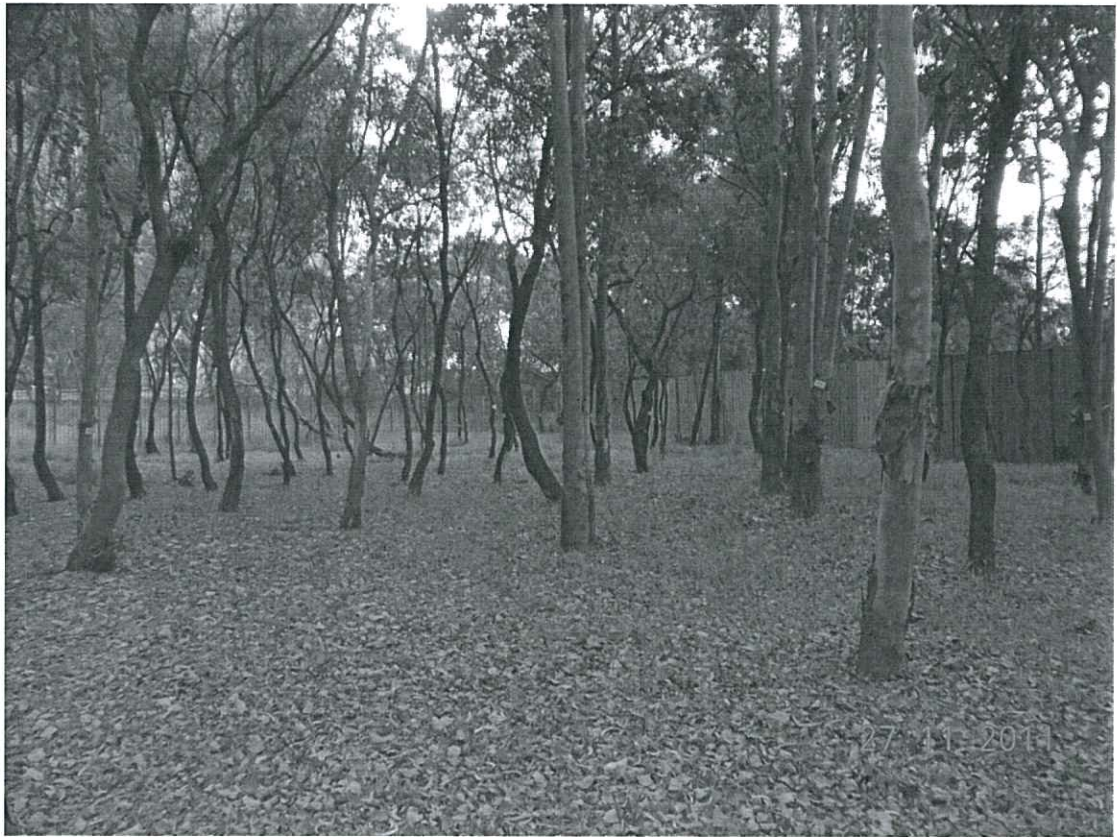
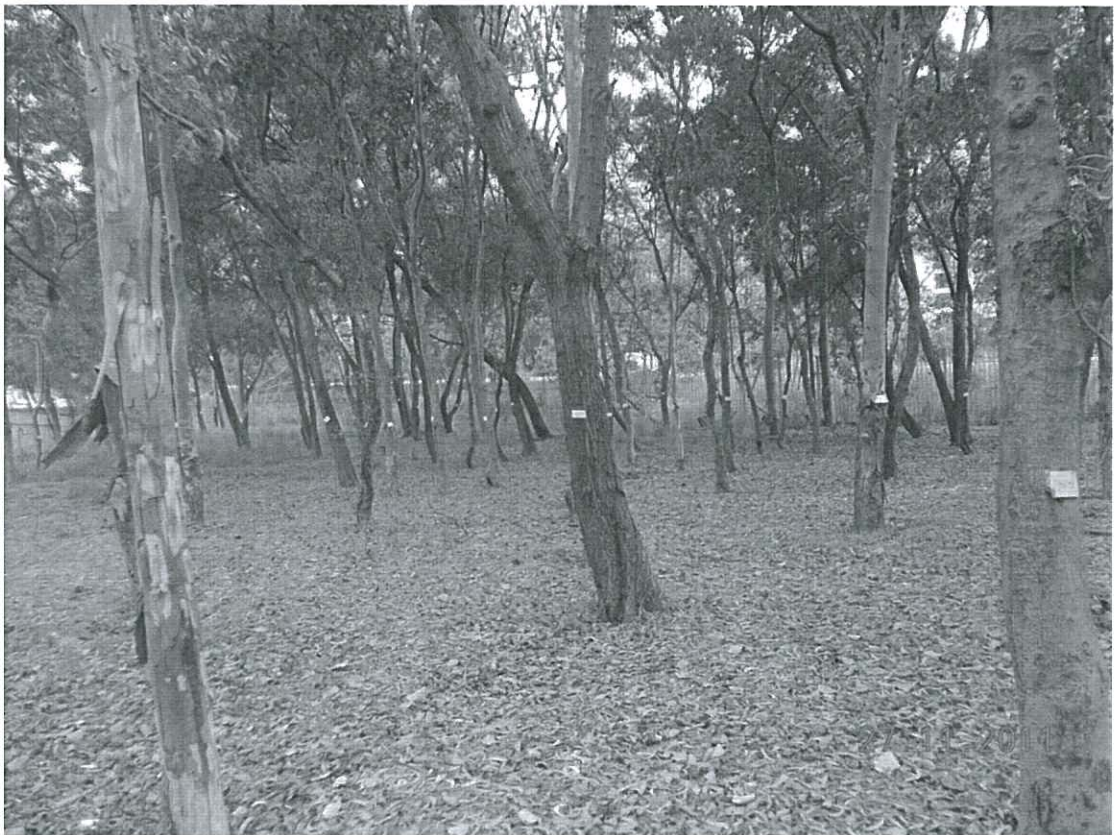
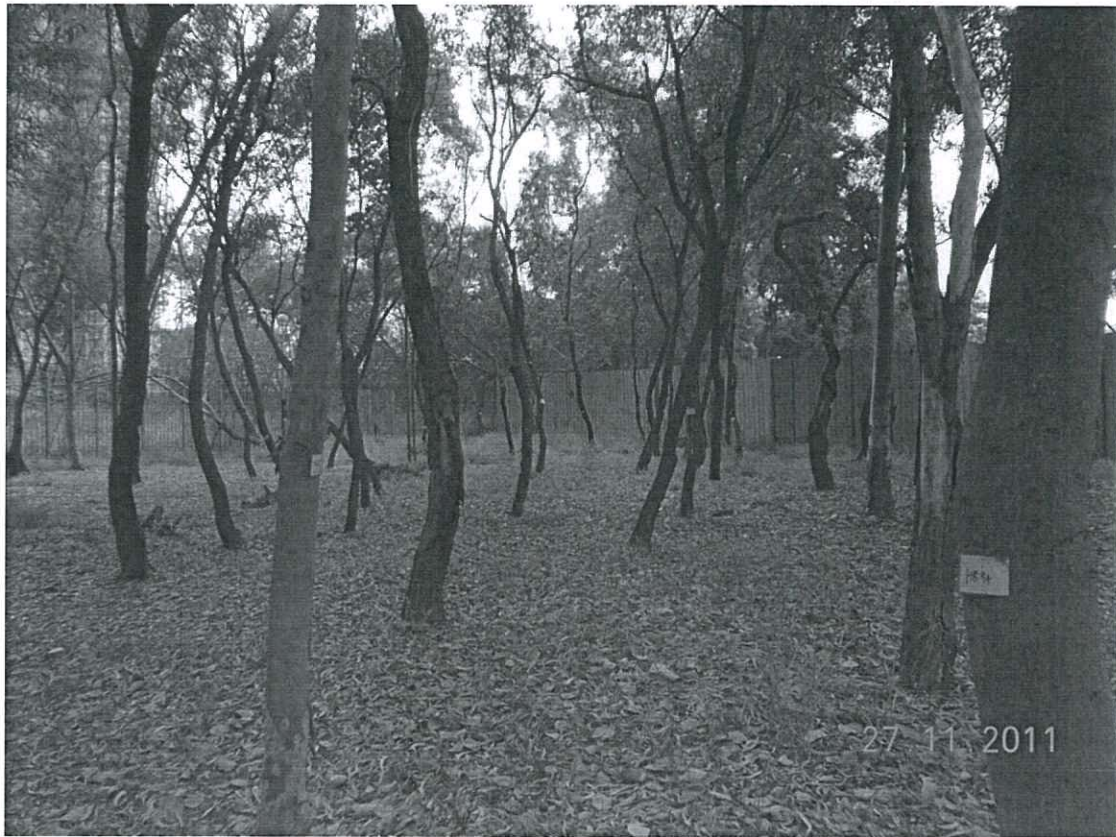
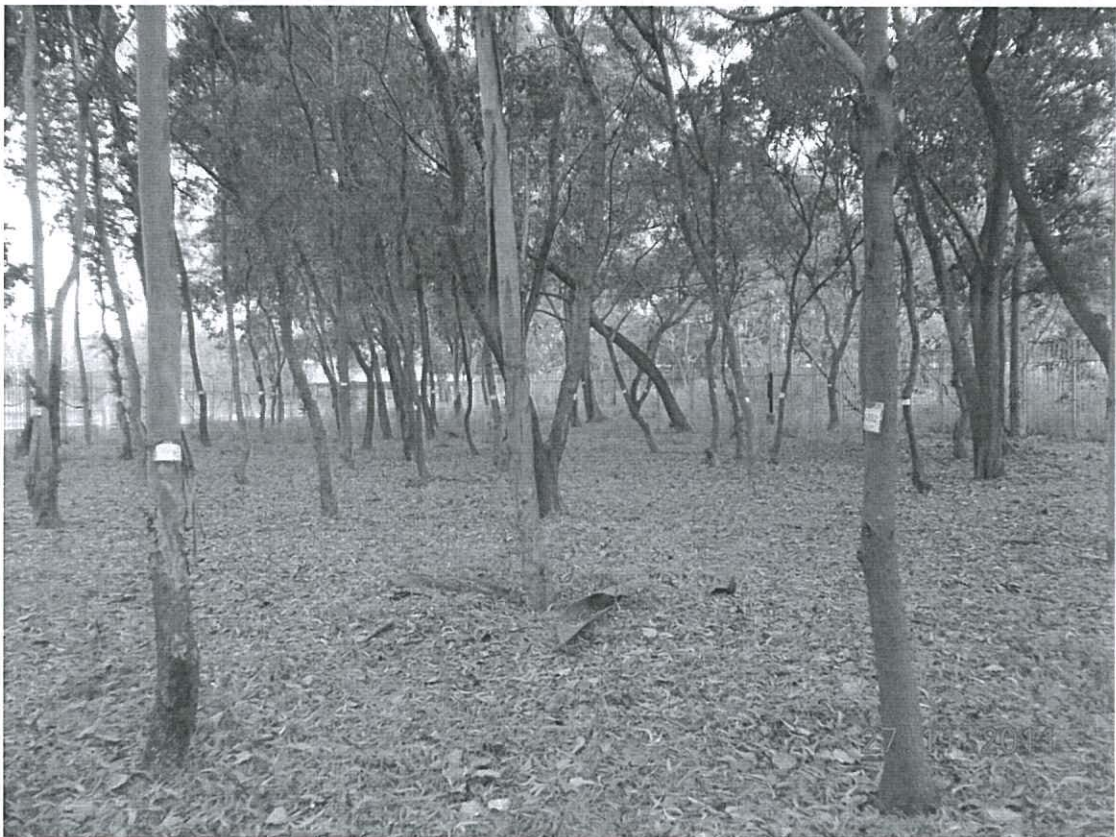
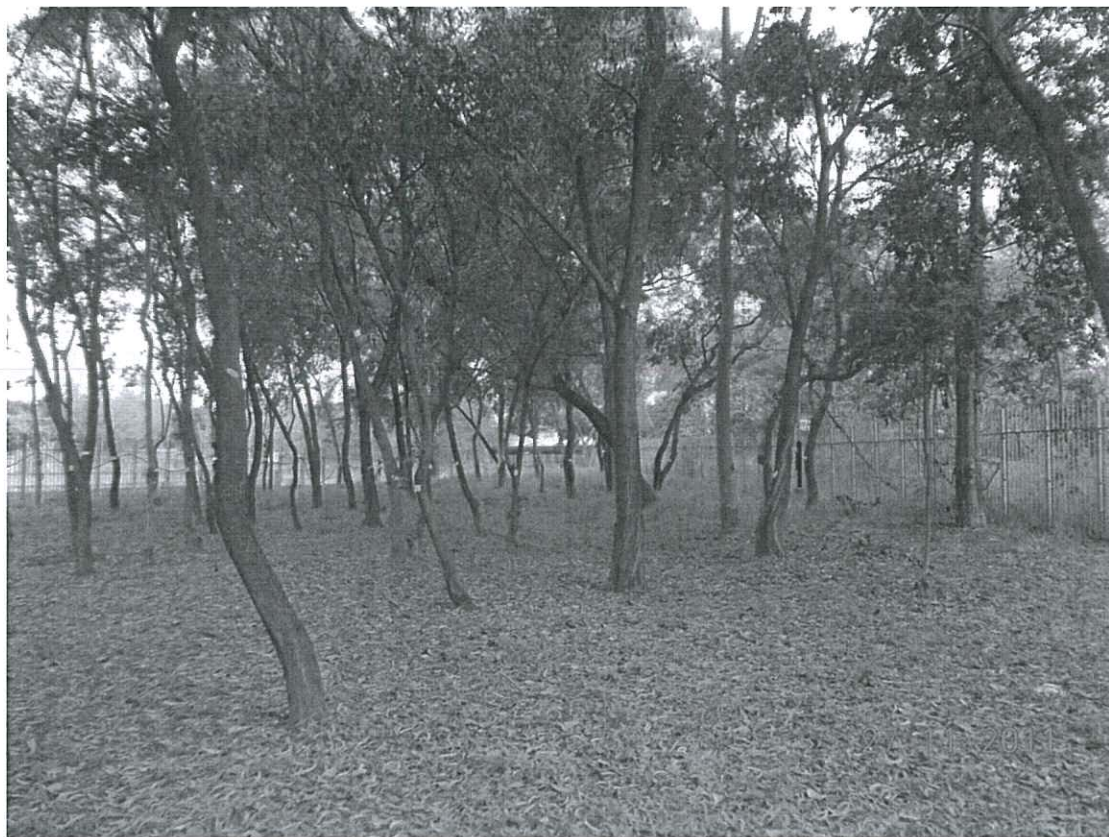
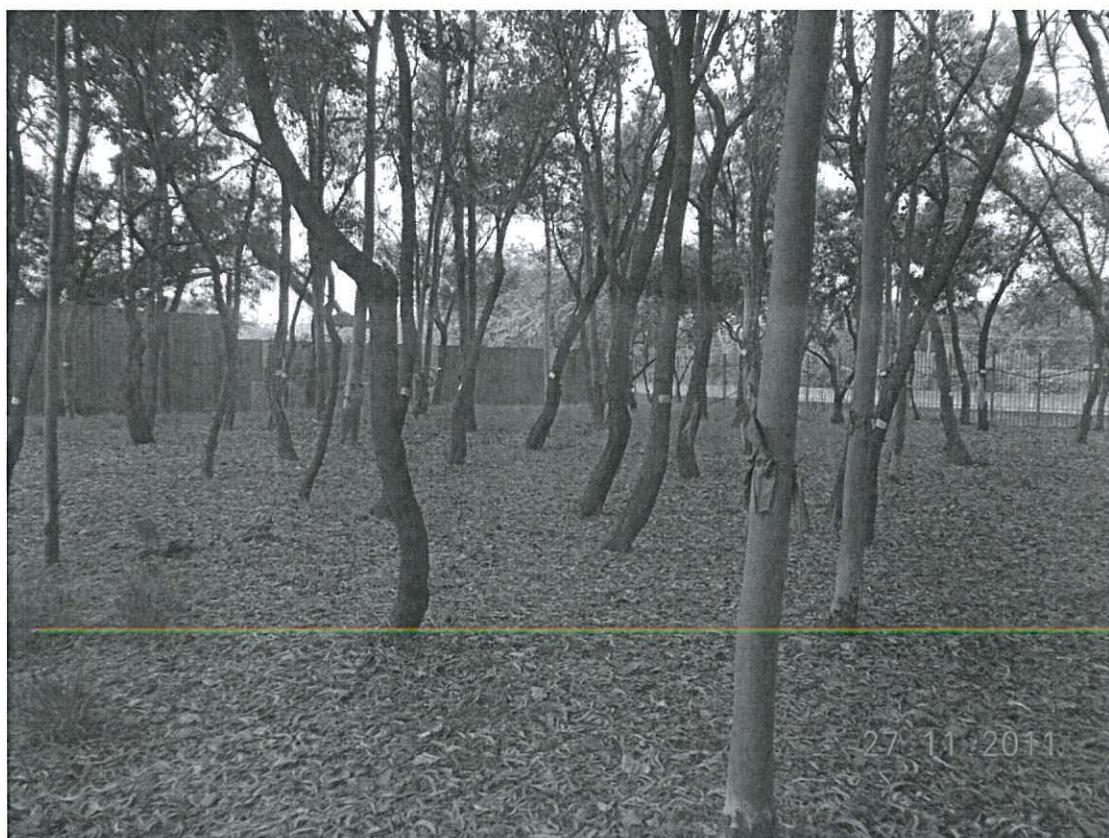
During inspection it is noted that some of the trees transplanted are of low survival rate. Some trees are now identified as dead trees on site they should be removed to prevent any safety hazard of falling within the works area or spreading pests & disease to other trees.

**Summary of Dead Transplanted Trees in Ha Tsuen Sewage Pumping Station**
