DSD CONTRACT No.: DC/2009/08

CONSTRUCTION OF YUEN LONG SOUTH BRANCH SEWERS AND EXPANSION OF HA TSUEN SEWAGE PUMPING STATION

THE TWENTY-THIRD RESULTS OF LANDSCAPE AND VISUAL IMPACT MONITORING FOR DECEMBER 2011 (No.23)

Site Inspection Checklist

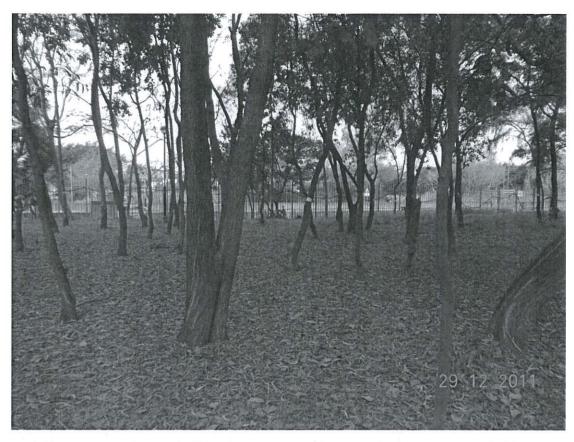
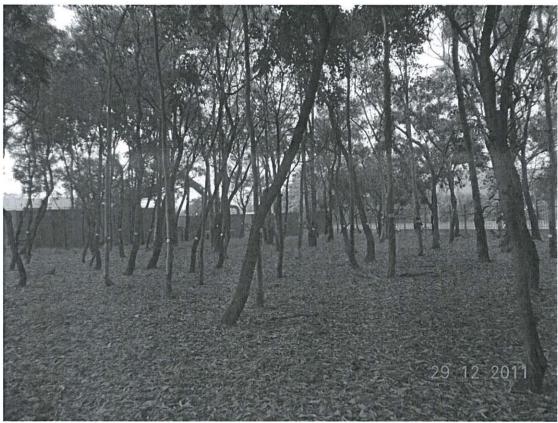
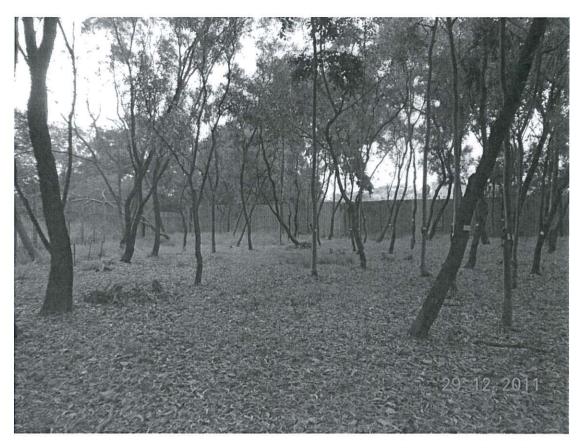
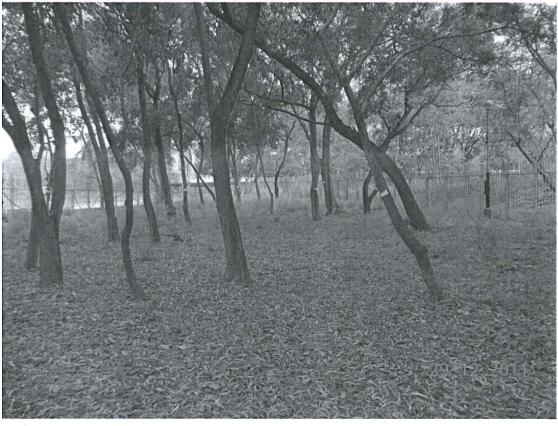
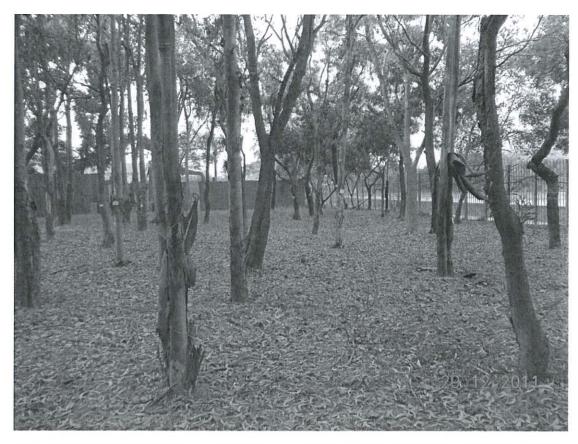
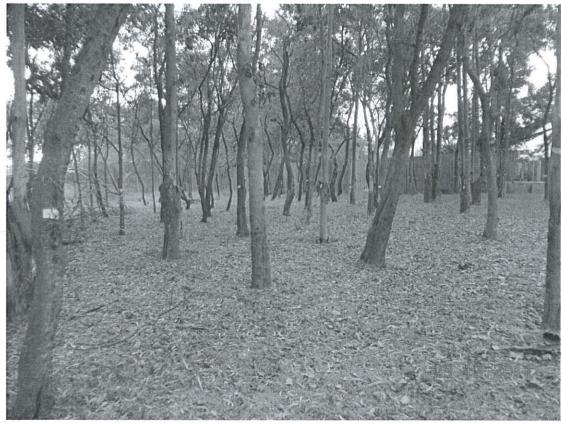
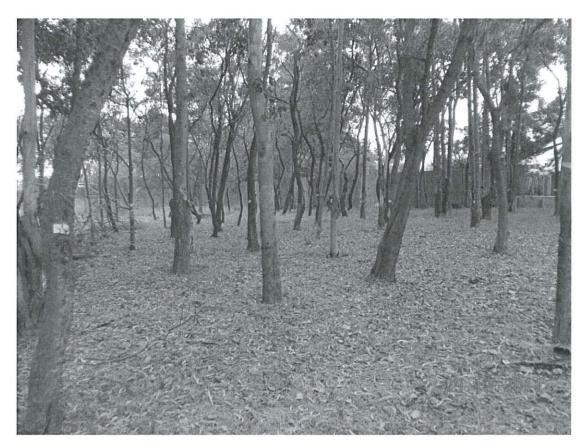
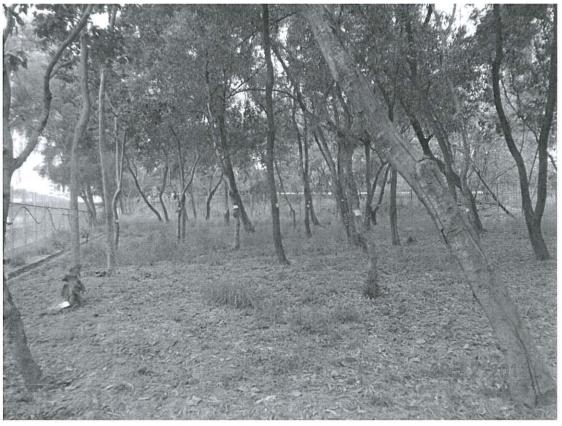
•						
Rer	narks	2 / /L HISKO					
Dur	ing inspection it is noted that some of the trees transplanted are of low su	rvival rat	e. Some t	rees are i	now ider	ntified a	s dead trees
on s	ite they should be removed to prevent any safety hazard of falling within	the work	s area or	spreading	g pests &	diseas	e to other trees.
	Signatures:				HE KY MIC		
	Senior Landscape Architect

Summary of Dead Transplanted Trees in Ha Tsuen Sewage Pumping Station

Size					
Tree No.	Tree Spec	Tree Species		Trunk Dia. (mm)	Spread (m)		
HA202	Melia azedarach	森樹	6	111	3		
HA203	Eucalyptus torelliana	毛葉桉	8	143	3		
HA216	Acacia auriculiformis	耳果相思	7	201	3		
HA226	Acacia auriculiformis	耳果相思	6	131	4		
HA227	Acacia auriculiformis	耳果相思	8	242	3		
HA245	Acacia confusa	台灣相思	7	137	3		
HA255	Acacia auriculiformis	耳果相思	8	201	3		
HA257	Acacia confusa	台灣相思	7	217	3		
HA265	Acacia auriculiformis	耳果相思	6	188	3		
HA273	Acacia auriculiformis	耳果相思	5	290	4

- 3.01 The trees at Ha Tsuen Pumping Station have been handed over to DSD since January 2011for management and monitoring thereafter.
- 3.02 Dead trees were found during the Results Period. In order to alleviate land scape and visual impacts under the Project, the tree manager is recommended to remove and replace the dead trees as appropriate.
- 3.03 Trees in poor condition were also observed during the Result Period. More frequent watering or fertilizing and even further investigation on the tree conditions may need to be undertaken by the tree manager to improve living conditions of those poor trees.

Proposed species to replace dead transplanted trees:

- (1) Melaleuca quinquenervia 白千層 Trunk diameter 60 ~ 70mm
- (2) Bauhinia variegata 宮粉羊蹄甲 Trunk diameter 60 ~ 70mm
