JOB No.: TCS00491/09

DSD CONTRACT No.: DC/2009/08

CONSTRUCTION OF YUEN LONG SOUTH BRANCH  
SEWERS AND EXPANSION OF HA TSUEN SEWAGE  
PUMPING STATION

THE TWENTY-SEVENTH RESULTS OF  
LANDSCAPE AND VISUAL IMPACT MONITORING  
FOR APRIL 2012 (NO.27)

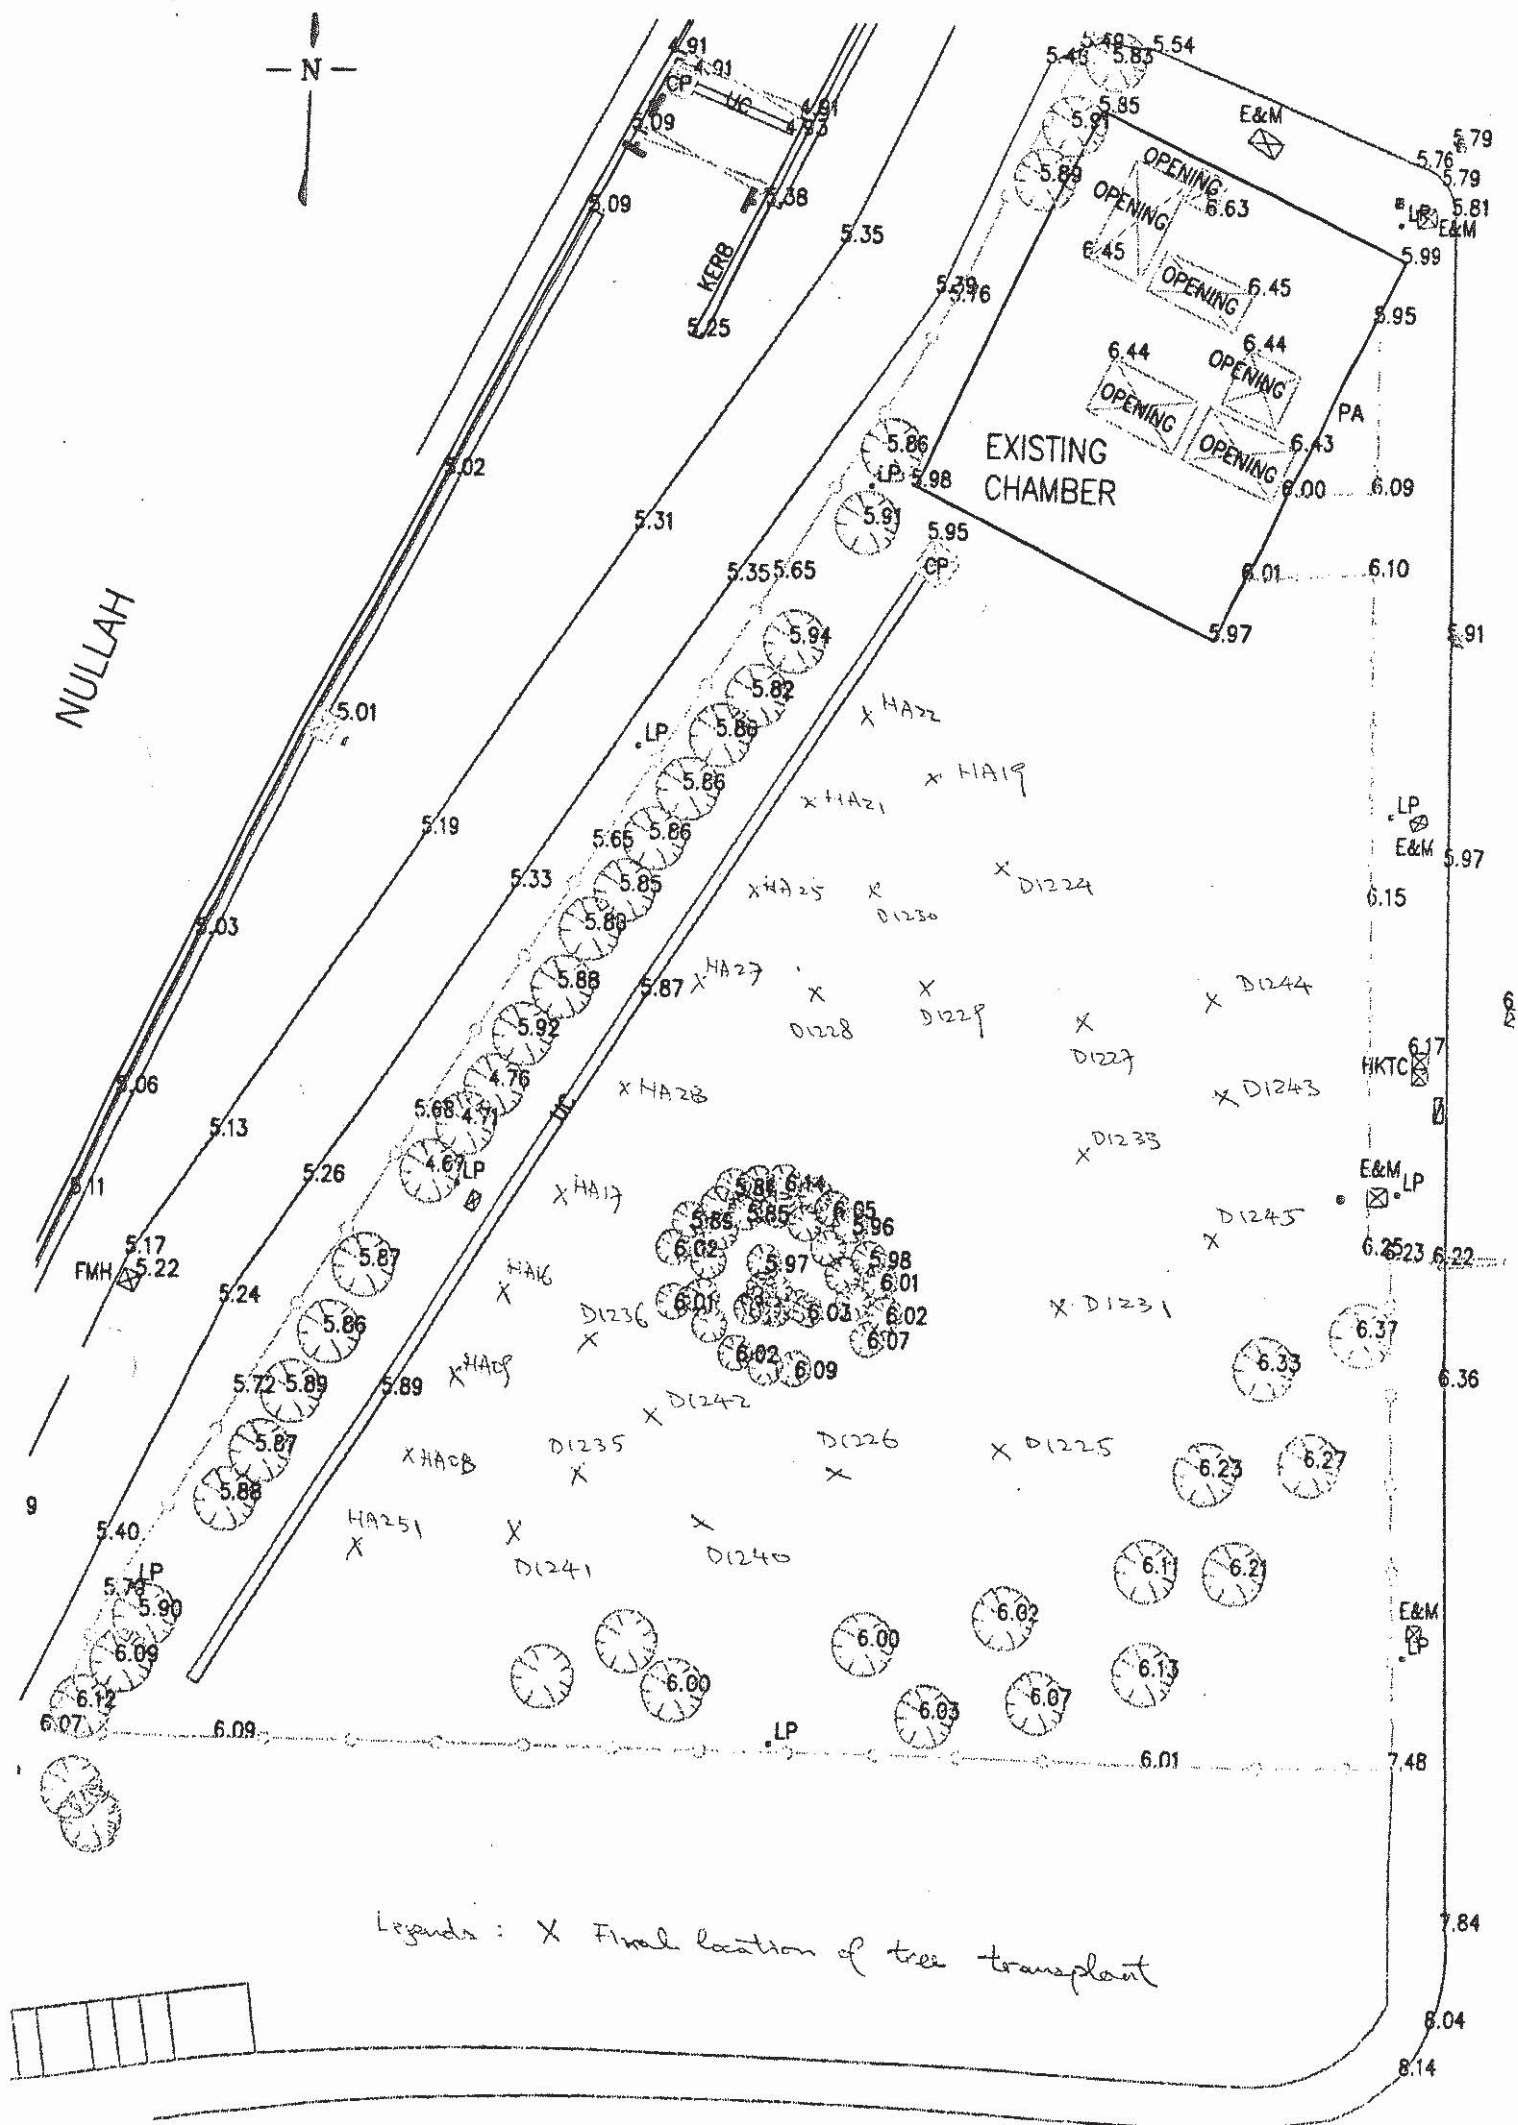
Legend: X Final location of tree transplant
