CONSTRUCTION OF YUEN LONG SOUTH BRANCH SEWERS AND EXPANSION OF HA TSUEN SEWAGE PUMPING STATION

THE THIRTY-THIRD RESULTS OF LANDSCAPE AND VISUAL IMPACT MONITORING FOR OCTOBER 2012 (No.33)

Site Inspection Checklist

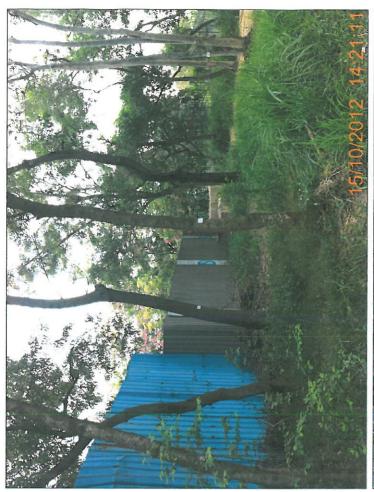
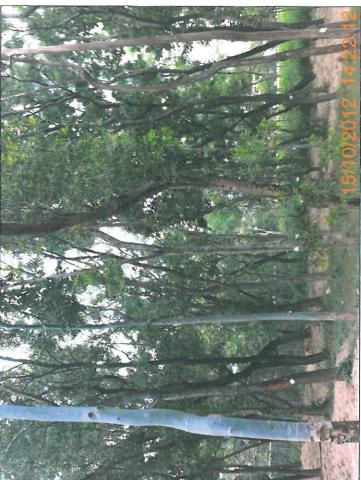
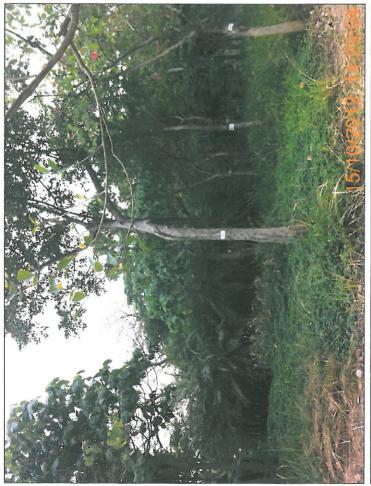
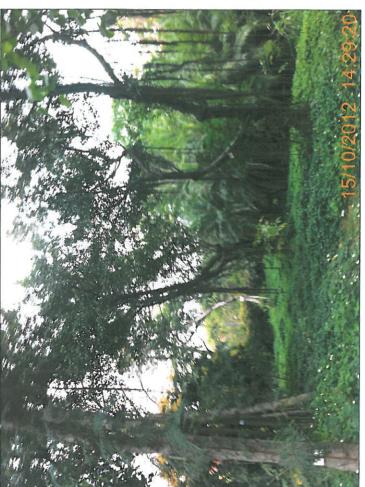
3.	All construction	on works are carried out within site boundary properly		\checkmark		\checkmark				
4	Carry out the	initial tree survey prior to construction		\checkmark		\checkmark				
5	Provide tree la	abels according to tree survey records		\checkmark		\checkmark				
Cor	mments:									
Sta	ndard hoarding	was erected and well maintained around the works area a	t Ha Tsue	n Sewage	e Pumpin	g Statio	n (HTSPS).			
The	contruction has	s no implication to protected tree.								
II.	Transplanting '	Works

(x) Replacement		\checkmark							
Cor	nments:									
The	ere had total 73 i	nos. of transpalnted trees in Ha Tsuen Sewage Pumping S	Station due	e to const	truction v	vorks un	der this cor	ntract.		
All	tree have been l	nandover back to DSD.								
III.	Landscaping V	Vorks

(x) Replacement		1		\checkmark		
Cor	nments:					4.5	
No	landscaping works were carried out in the reporting month						
IV.	Preservation and Protection of Trees

1.	All preserved trees are protected in accordance with the specifications	V					Market .
2.	All preserved trees are fenced off properly	V					
3.	No construction activities are carried out in the protection zone of the preserved trees	1					
Cor	nments:						
All	retained trees were fenced off and protected properly within the works ar	ea of the	site, DSE) is carry	ing out	he prese	ervation
and	protection.						
Cor	iclusion						
Ger	erally, the overall conditions are normal in the transplanting and visual in	npact at	Ha Tsuen	Sewage	Pumpin	g Statio	n. The conditions
of h	oarding was satisfactory. The trees which are at Ha Tsue Pumping Statio	n have be	een return	ed to Dra	ninage S	ervices	Department manageme
and	monitoring in January2011.						
	·						
Rer	narks						
	4						
	Signatures:						
	Sanior Landscana Architect

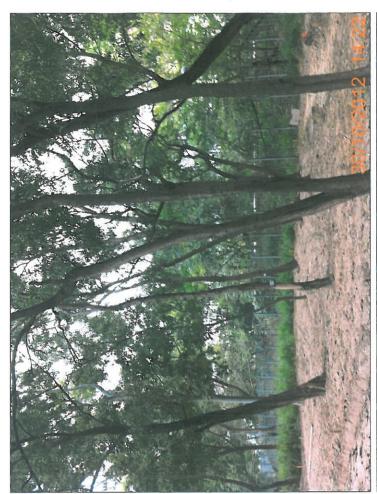
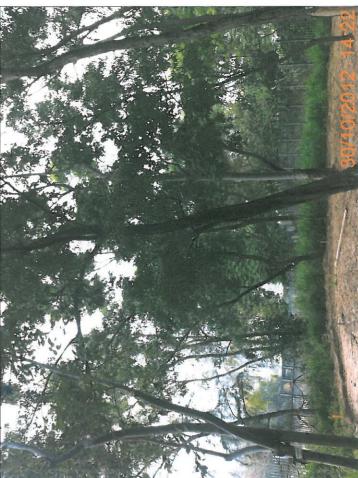
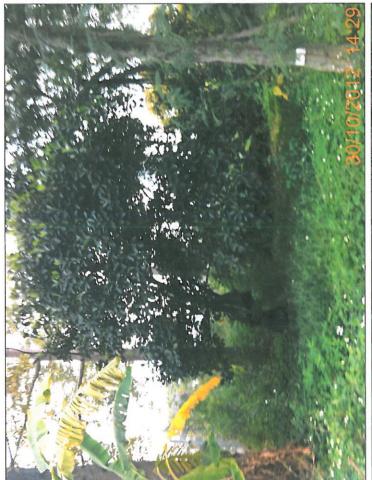
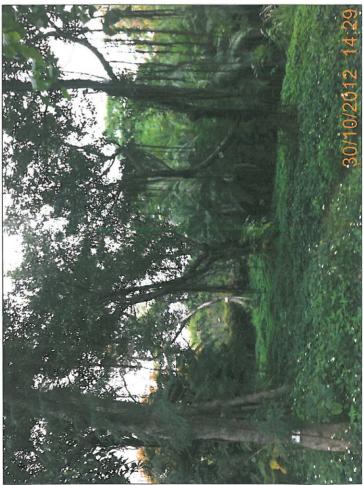
I. (General									
1.	Erect hoarding	g around site boundary properly		\checkmark						
2.	Keep well mai	intenance of hoarding		\checkmark		✓				
3.	All construction	on works are carried out within site boundary properly				/				
4	Carry out the	initial tree survey prior to construction		\checkmark		✓				
5	Provide tree la	abels according to tree survey records		\checkmark		✓				
Co	mments:									
Sta	ndard hoarding	was erected and well maintained around the works area a	t Ha Tsue	n Sewage	e Pumpin	g Station (HTSPS).			
The	e contruction has	s no implication to protected tree.					TWO STATES OF THE STATES OF TH			
II.	Transplanting '	Works					observed the second sec

(x) Replaceme	nt	\checkmark							
Cor	nments:									
The	ere had total 73 n	nos. of transpalnted trees in Ha Tsuen Sewage Pumping S	Station due	to const	ruction v	vorks under this co	ntract.			
All	tree have been h	andover back to DSD.								
III.	Landscaping V	Vorks		,

(x) Replacement		1		\checkmark		
Con	nments:						
No	landscaping works were carried out in the reporting month						water the second se
IV.	Preservation and Protection of Trees

1.	All preserved trees are protected in accordance with the specifications	V	-				
2.	All preserved trees are fenced off properly	V					
3.	No construction activities are carried out in the protection zone of the preserved trees	✓					
Cor	nments:						
All	retained trees were fenced off and protected properly within the works ar	ea of the	site. DSD	is carryi	ing out t	he prese	ervation
and	protection.						· · · · · · · · · · · · · · · · · · ·
Co	aclusion						
Gei	nerally, the overall conditions are normal in the transplanting and visual in	npact at	Ha Tsuen S	Sewage	Pumpin	g Statio	n. The conditions
of l	noarding was satisfactory. The trees which are at Ha Tsue Pumping Statio	n have be	een returne	d to Dra	inage S	ervices l	Department manageme
and	monitoring in January2011.						
Rei	narks			-

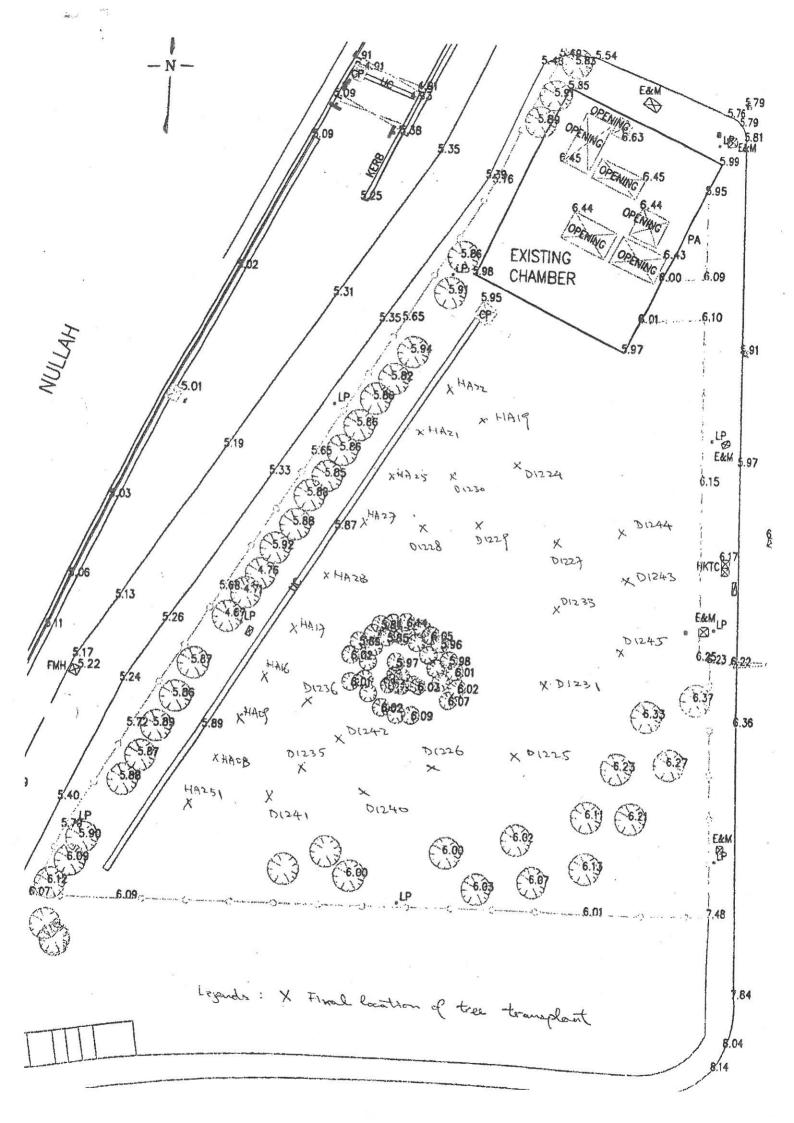
Summary of Dead Transplanted Trees in Ha Tsuen Sewage Pumping Station

Size	
Tree No.	Tree Species	5	Height	Trunk	Spread	Eallow vm action
		(m)	Dia. (mm)	(m)	Follow up action	
HA202	Melia azedarach	森樹	6	111	3	
HA203	Eucalyptus torelliana	毛葉桉	8	143	3	
HA207	Acacia confusa	台灣相思	6.5	120	2.5]
HA216	Acacia auriculiformis	耳果相思	7	201	3	1
HA226	Acacia auriculiformis	耳果相思	6	131	4	HA202,HA203,
HA227	Acacia auriculiformis	耳果相思	8	242	3	HA207,HA216,
HA245	Acacia confusa	台灣相思	7	137	3	HA226,HA227, HA245,HA250,
HA250	Acacia confusa	台灣相思	6.5	180	2.5	HA255,HA257,
HA255	Acacia auriculiformis	耳果相思	8	201	3	HA265,HA266,
HA257	Acacia confusa	台灣相思	7	217	3	HA272,HA273
HA265	Acacia auriculiformis	耳果相思	6	188	3	HB62,HB63,HB66
HA266	Acacia auriculiformis	耳果相思	5.5	180	3	,
HA272	Eucalyptus torelliana	毛葉桉	7	120	3	HB67,HB67,HB82
HA273	Acacia auriculiformis	耳果相思	5	290	4	,
HB62	Acacia confusa	台灣相思	6	200	3	HB83,HB93,HB10
HB63	Acacia auriculiformis	耳果相思	6	300	4.5	1, HB102. Those
HB66	Acacia confusa	台灣相思	6	210	3	trees were

HB67	Acacia confusa	台灣相思	6	205	3	removed by CSHK
HB82	Acacia auriculiformis	耳果相思	5.5	285	3	on 29th
HB83	Acacia auriculiformis	耳果相思	6	290	3.5	October2012.
HB93	Acacia auriculiformis	耳果相思	5	270	3	1
HB101	Acacia confusa	台灣相思	6.5	220	3.5	1
HB102	Acacia confusa	台灣相思	6	200	3	1

Proposed species to replace dead transplanted trees:

⁽¹⁾ Melaleuca quinquenervia 白千層 - Trunk diameter $60 \sim 70 mm$

⁽²⁾ Bauhinia variegata 宮粉羊蹄甲 - Trunk diameter $60 \sim 70 mm$
