CONSTRUCTION OF YUEN LONG SOUTH BRANCH SEWERS AND EXPANSION OF HA TSUEN SEWAGE PUMPING STATION

THE THIRTY-FOURTH RESULTS OF LANDSCAPE AND VISUAL IMPACT MONITORING FOR NOVEMBER 2012 (No.34)

Site Inspection Checklist

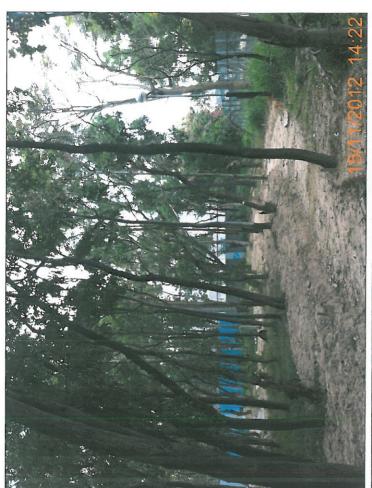
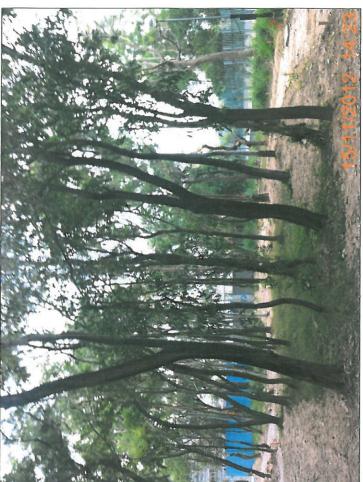
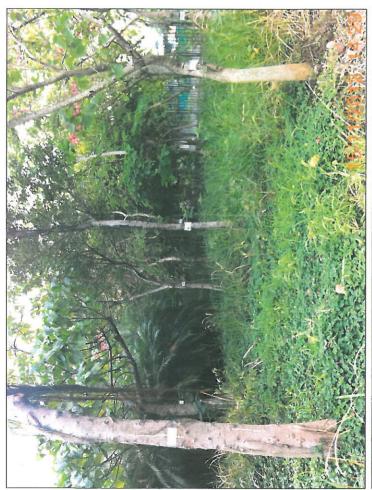
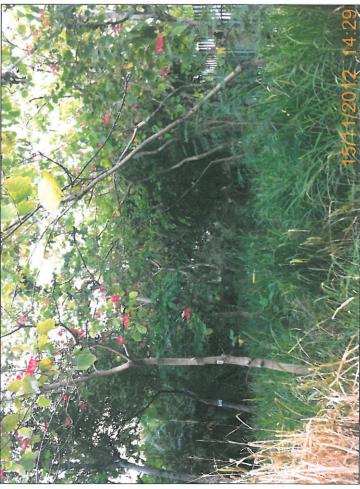
3.	No construction activities are carried out in the protection zone of the preserved trees	✓					
Co	nments:						
All	retained trees were fenced off and protected properly within the works a	irea of the	site. DSI) is carry	ing out t	he pres	ervation
and	protection.						
Co	nclusion					1.10	
Ge	erally, the overall conditions are normal in the transplanting and visual	impact at	Ha Tsuer	sewage	Pumpin	g Statio	m. The conditions
	oarding was satisfactory. The trees which are at Ha Tsue Pumping Stati						
and	monitoring in January2011.						
Re	narks	7,,,,,,,,,,,,,,,,,,,,,,,,,,,,,,,,,,,,,,

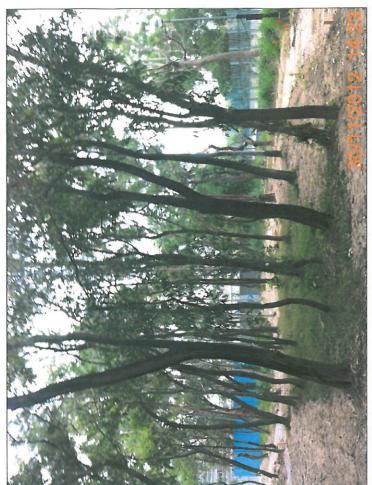
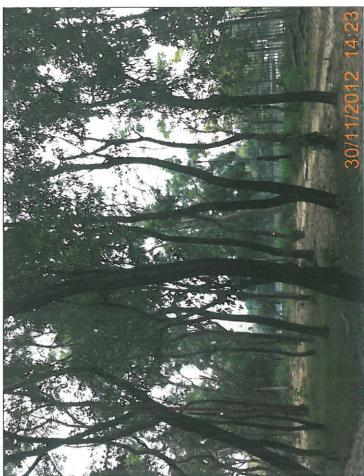
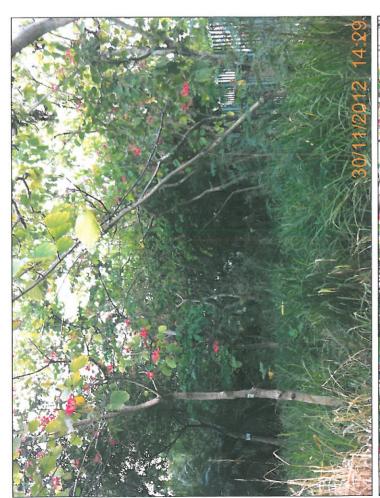
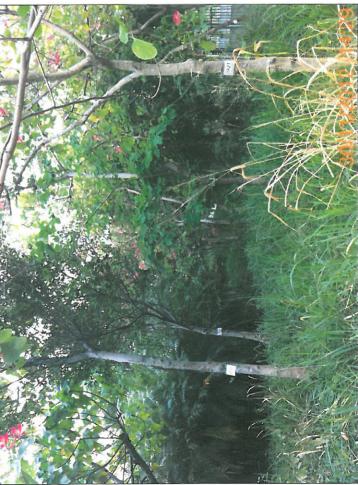
i.	All preserved trees are protected in accordance with the specifications	\checkmark					
2.	All preserved trees are fenced off properly	~					
3.	No construction activities are carried out in the protection zone of the preserved trees	V					
Co	nments:						
All	retained trees were fenced off and protected properly within the works are	ea of the	site. DSE	is carry	ing out t	he prese	ervation
and	protection.						
Co	nclusion						
Ge	nerally, the overall conditions are normal in the transplanting and visual in	npact at l	Ha Tsuen	Sewage	Pumpin	g Statio	n. The conditions
of l	noarding was satisfactory. The trees which are at Ha Tsue Pumping Station	n have be	een return	ed to Dra	inage S	ervices	Department managem
anc	monitoring in January2011.						
			,				
Re	narks						
Description of the Party of the	Signatures:

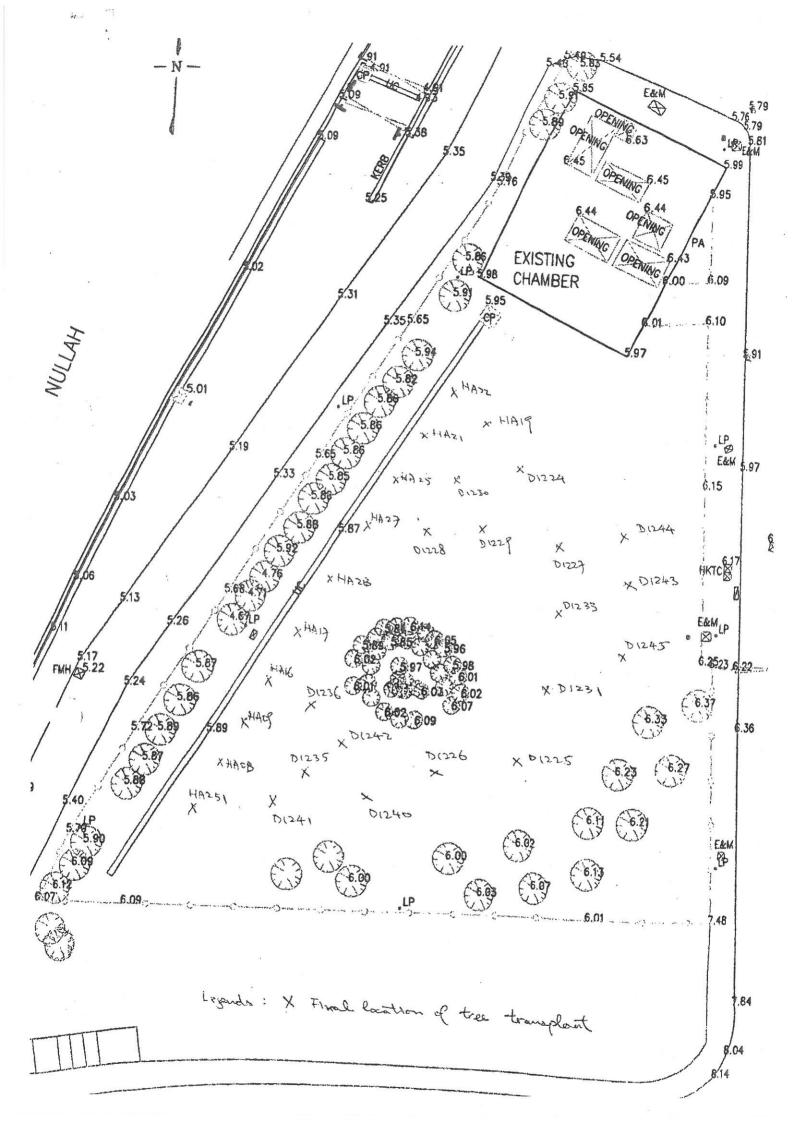
Summary of Dead Transplanted Trees in Ha Tsuen Sewage Pumping Station

*	Size	
Tree No.	Tree Species	S	Height	Trunk	Spread	Fellow ve setion
		(m)	Dia. (mm)	(m)	Follow up action	
HA202	Melia azedarach	森樹	6	111	3	
HA203	Eucalyptus torelliana	毛葉桉	8	143	3	
HA207	Acacia confusa	台灣相思	6.5	120	2.5	
HA216	Acacia auriculiformis	耳果相思	7	201	3	111,000,111,000
HA226	Acacia auriculiformis	耳果相思	6	131	4	HA202,HA203,
HA227	Acacia auriculiformis	耳果相思	8	242	3	HA207,HA216, HA226,HA227,
HA245	Acacia confusa	台灣相思	7	137	3	HA245,HA250,
HA250	Acacia confusa	台灣相思	6.5	180	2.5	HA255,HA257,
HA255	Acacia auriculiformis	耳果相思	8	201	3	HA265,HA266,
HA257	Acacia confusa	台灣相思	7	217	3	HA272,HA273
HA265	Acacia auriculiformis	耳果相思	6	188	3	HB62,HB63,HB66
HA266	Acacia auriculiformis	耳果相思	5.5	180	3] ,
HA272	Eucalyptus torelliana	毛葉桉	7	120	3	HB67,HB67,HB82
HA273	Acacia auriculiformis	耳果相思	5	290	4	,
HB62	Acacia confusa	台灣相思	6	200	3	HB83,HB93,HB10
HB63	Acacia auriculiformis	耳果相思	6	300	4.5	1, HB102. Those
HB66	Acacia confusa	台灣相思	6	210	3	trees were

HB67	Acacia confusa	台灣相思	6	205	3	removed by CSHK
HB82	Acacia auriculiformis	耳果相思	5.5	285	3	on 29th October2012.
HB83	Acacia auriculiformis	耳果相思	6	290	3.5	October2012.
HB93	Acacia auriculiformis	耳果相思	5	270	3	1
HB101	Acacia confusa	台灣相思	6.5	220	3.5	
HB102	Acacia confusa	台灣相思	6	200	3

Proposed species to replace dead transplanted trees:

- (1) Melaleuca quinquenervia 白千層 Trunk diameter $60 \sim 70 \text{mm}$
- (2) Bauhinia variegata 宮粉羊蹄甲 Trunk diameter $60 \sim 70 \text{mm}$
