JOB No.: TCS00491/09

DSD CONTRACT No.: DC/2009/08

CONSTRUCTION OF YUEN LONG SOUTH BRANCH  
SEWERS AND EXPANSION OF HA TSUEN SEWAGE  
PUMPING STATION

THE THIRTY-FIFTH RESULTS OF LANDSCAPE AND VISUAL IMPACT  
MONITORING  
FOR DECEMBER 2012 (No.35)

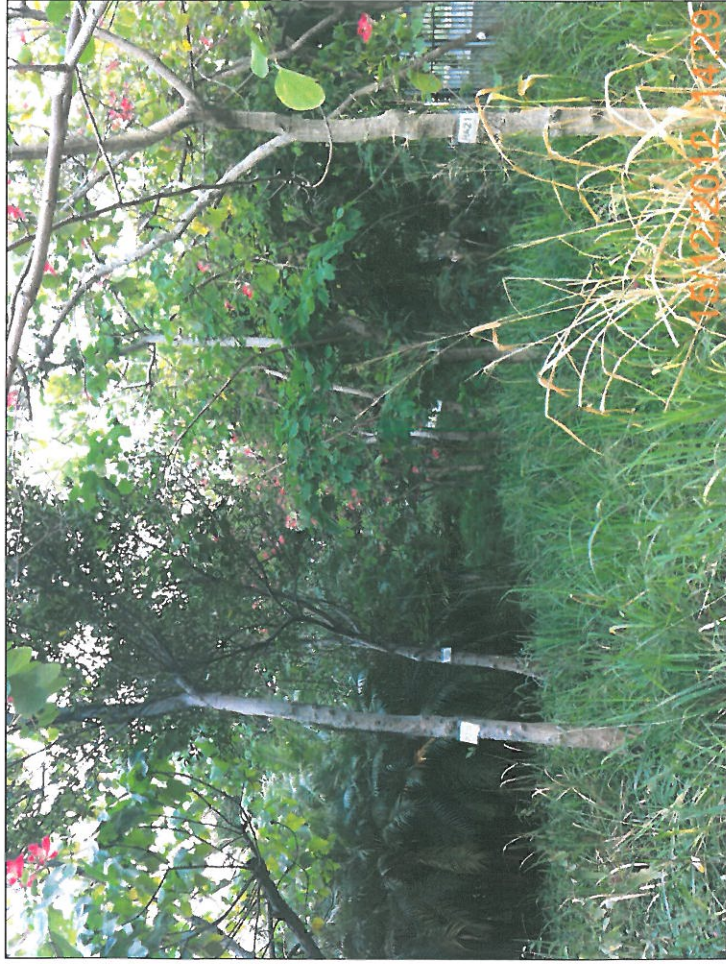
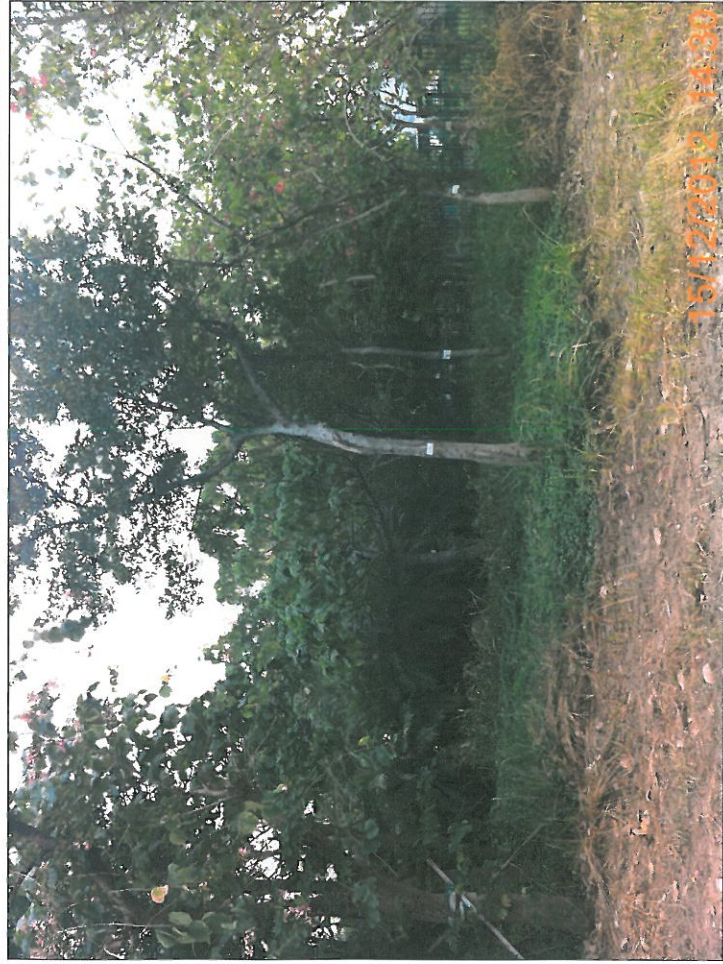
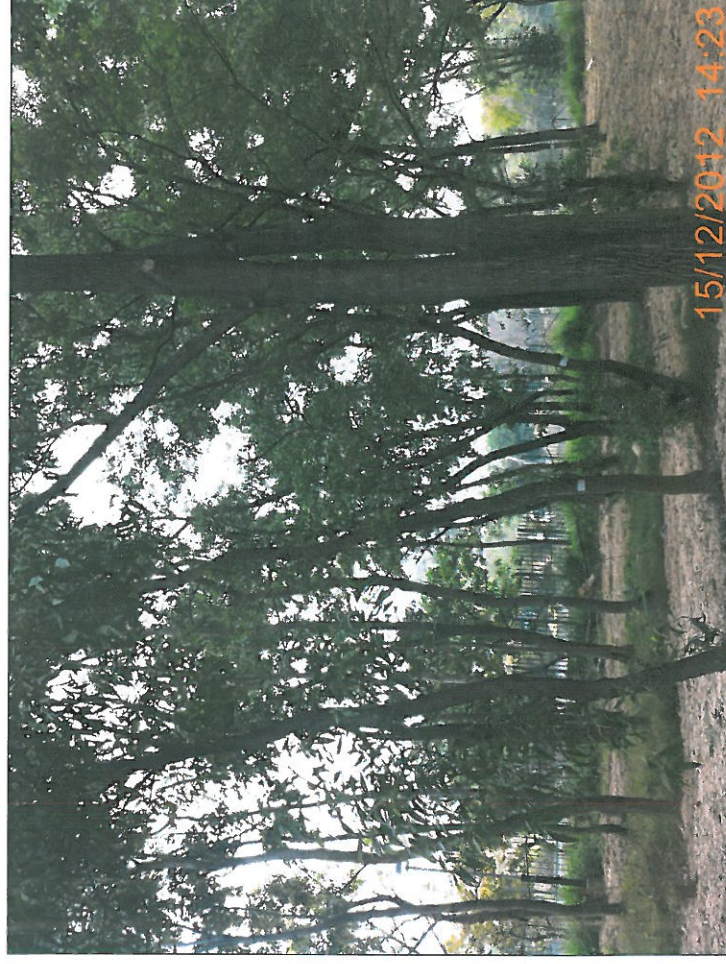
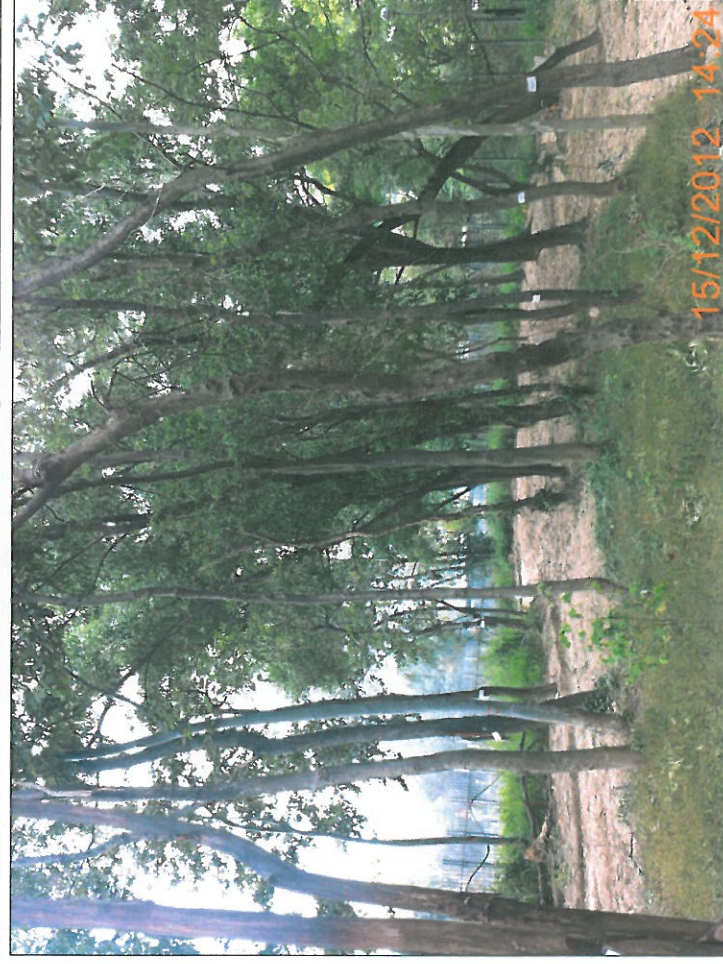
Standard hoarding was erected and well maintained around the works area at Ha Tsuen Sewage Pumping Station (HTSPS).

There had total 73 nos. of transplanted trees in Ha Tsuen Sewage Pumping Station due to construction works under this contract.

All retained trees were fenced off and protected properly within the works area of the site. DSD is carrying out the preservation and protection.

Generally, the overall conditions are normal in the transplanting and visual impact at Ha Tsuen Sewage Pumping Station. The conditions of hoarding was satisfactory. The trees which are at Ha Tsue Pumping Station have been returned to Drainage Services Department management and monitoring in January 2011.

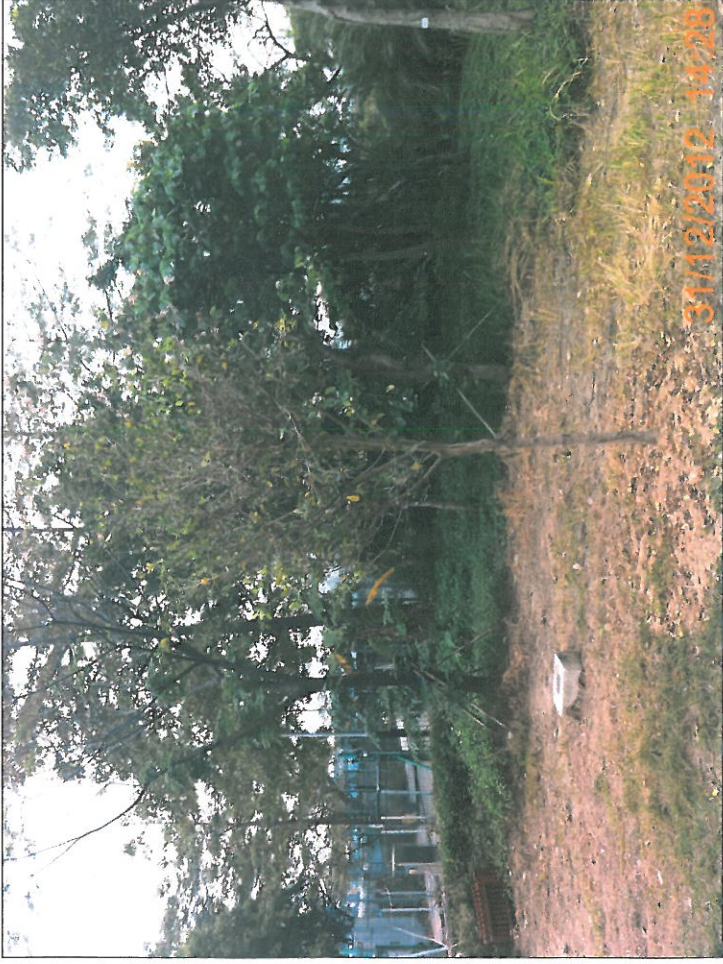
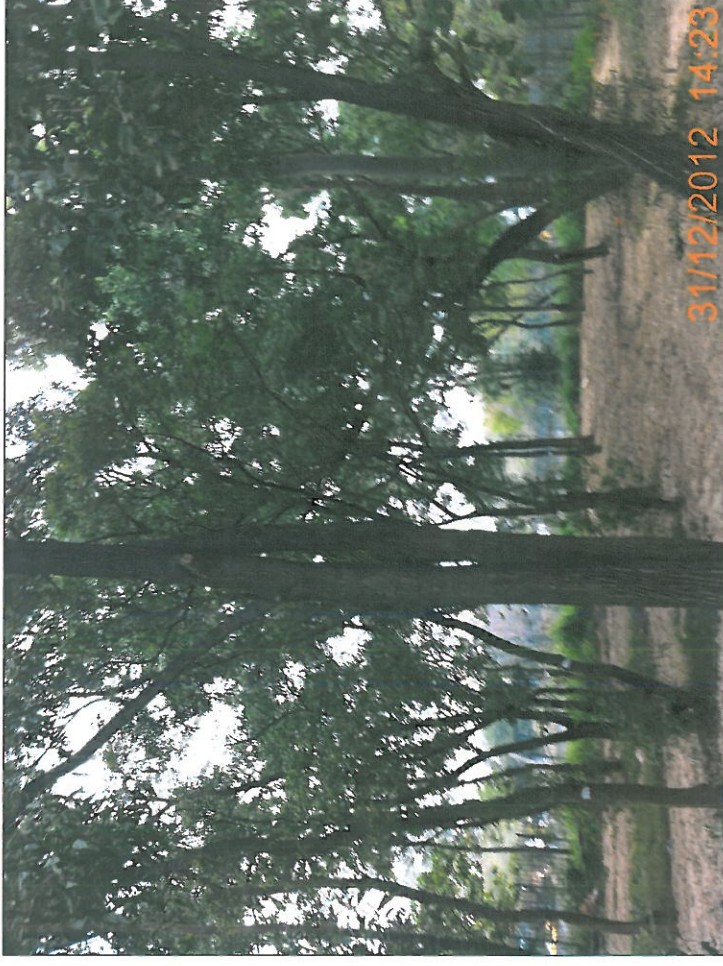
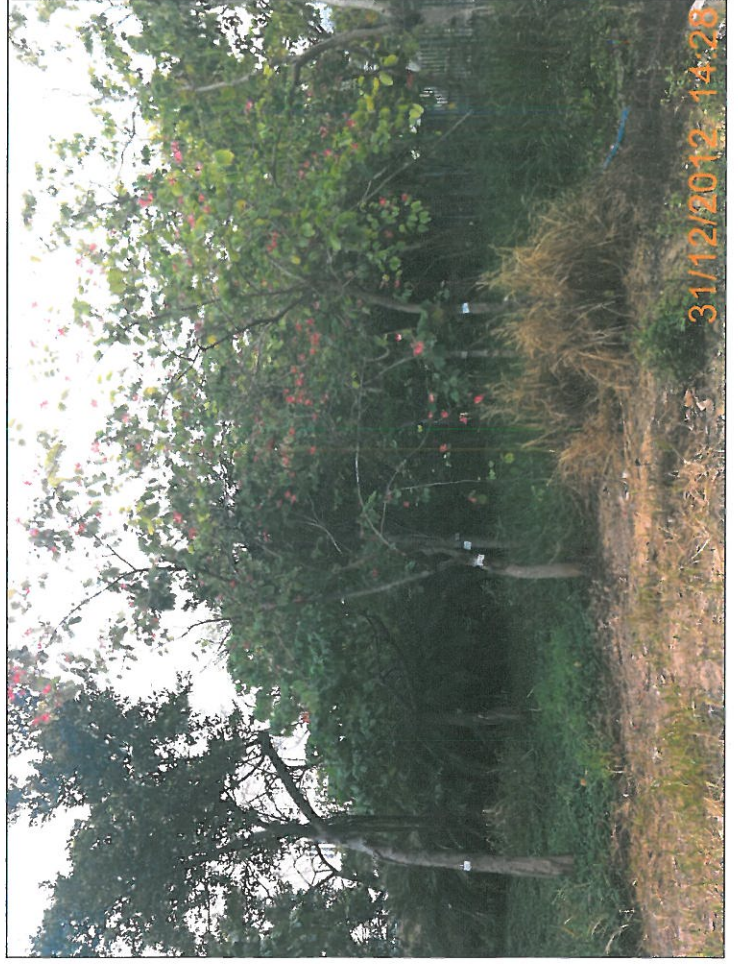
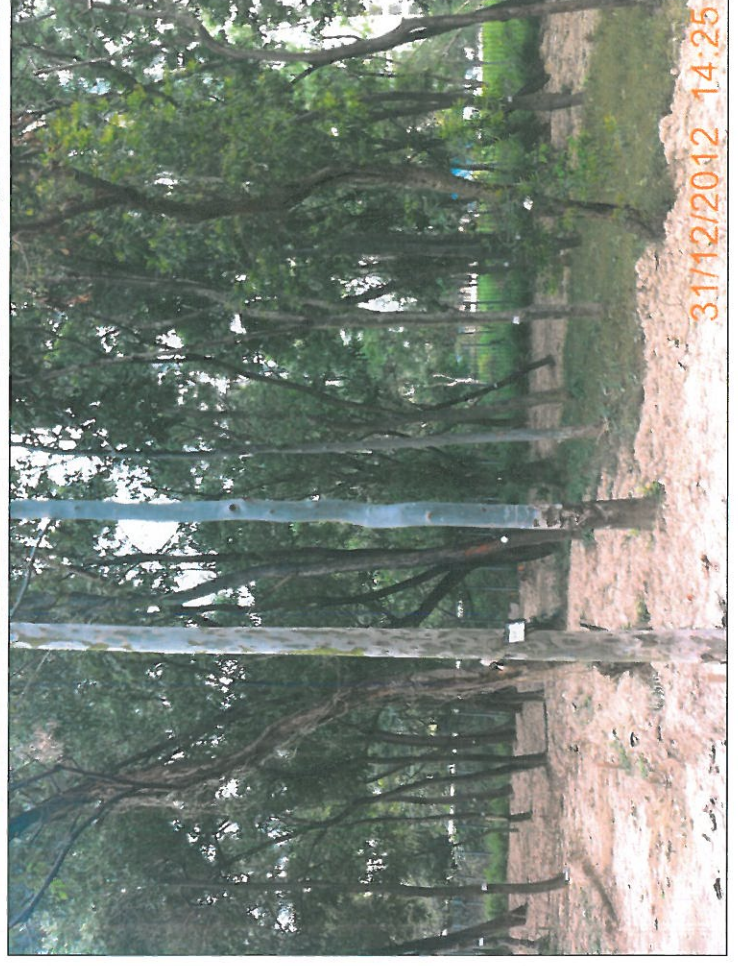
Standard hoarding was erected and well maintained around the works area at Ha Tsuen Sewage Pumping Station (HTSPS).

There had total 73 nos. of transpalnted trees in Ha Tsuen Sewage Pumping Station due to construction works under this contract.

All retained trees were fenced off and protected properly within the works area of the site. DSD is carrying out the preservation and protection.

Generally, the overall conditions are normal in the transplanting and visual impact at Ha Tsuen Sewage Pumping Station. The conditions of hoarding was satisfactory. The trees which are at Ha Tsue Pumping Station have been returned to Drainage Services Department management and monitoring in January 2011.

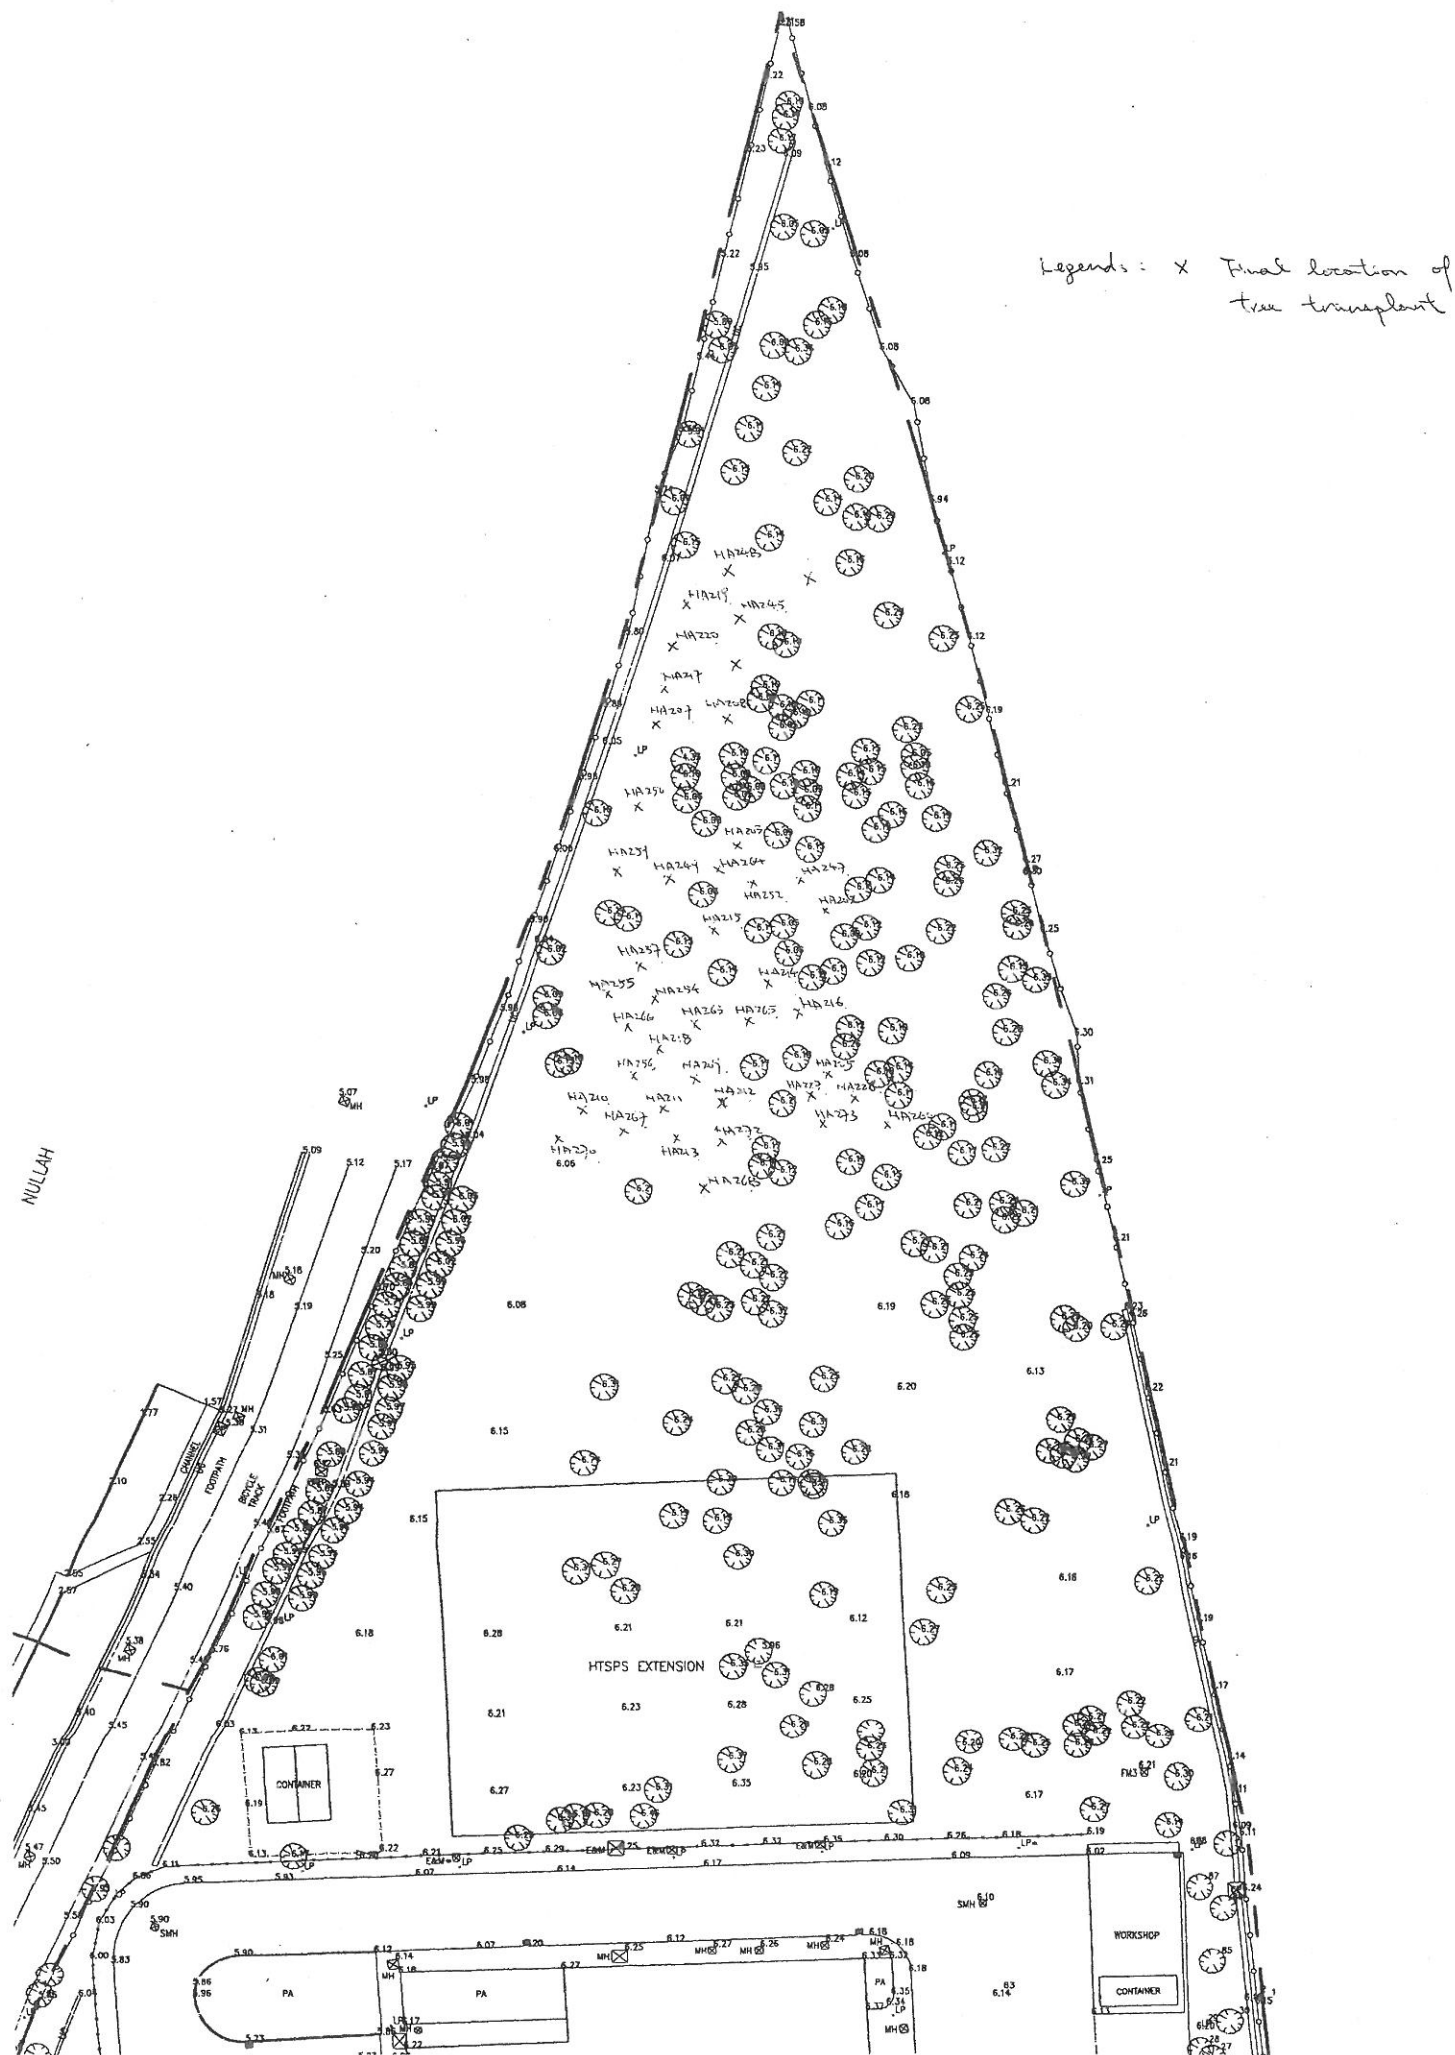
## Summary of Dead Transplanted Trees in Ha Tsuen Sewage Pumping Station

| Tree No. | Tree Species | | Size | | | Follow up action |
|---|---|---|---|---|---|---|
| HA202 | Melia azedarach | 森樹 | 6 | 111 | 3 | HA202,HA203, HA207,HA216, HA226,HA227, HA245,HA250, HA255,HA257, HA265,HA266, HA272,HA273 HB62,HB63,HB66 , HB67,HB67,HB82 , HB83,HB93,HB101, HB102. Those trees were removed by CSHK on 29th October2012. |

Proposed species to replace dead transplanted trees:

- (1) Melaleuca quinquenervia 白千層 - Trunk diameter 60 ~ 70mm
- (2) Bauhinia variegata 宮粉羊蹄甲 - Trunk diameter 60 ~ 70mm
