CONSTRUCTION OF YUEN LONG SOUTH BRANCH
SEWERS AND EXPANSION OF HA TSUEN SEWAGE
PUMPING STATION

THE THIRTY-NINTH RESULTS OF LANDSCAPE AND VISUAL IMPACT
MONITORING
FOR APRIL 2013 (No.39)

Contract No.: DC/2009/08
Contract title: Construction of Yuen Long South Sewer and Expansion of Ha Tsuen Sewage Pumping Station
Contractor: China State Construction Engrg. (HK) Ltd.
Location: Ha Tsuen Sewage Pumping Station
Inspection Date: 15-Apr-2013

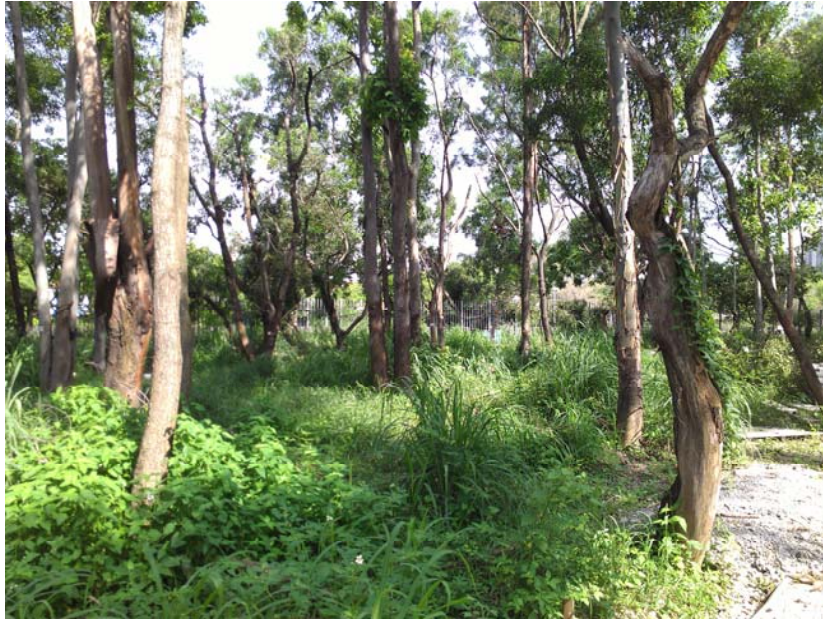
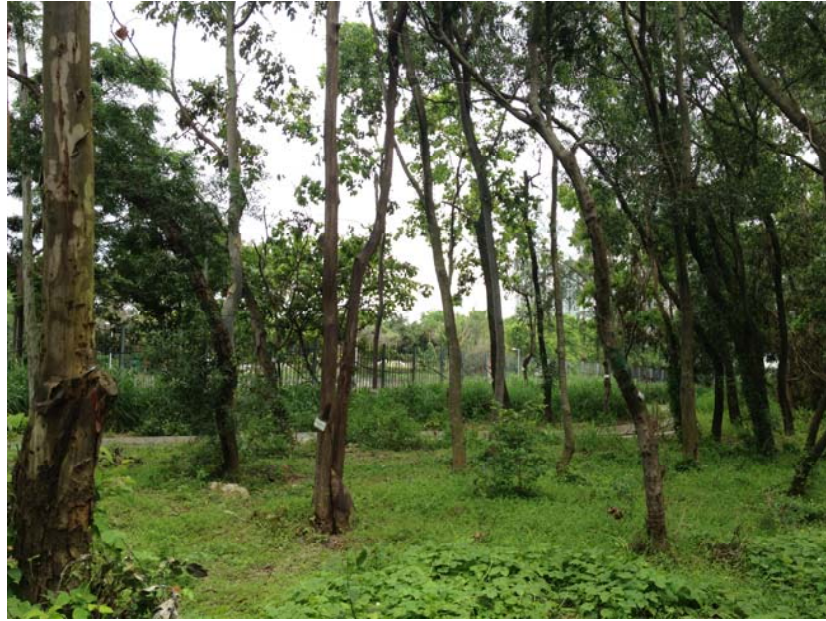
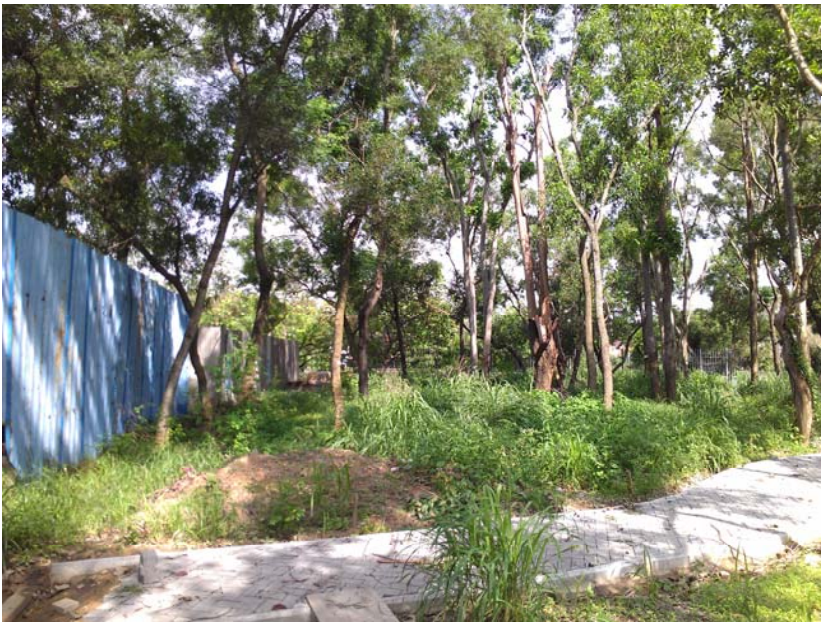
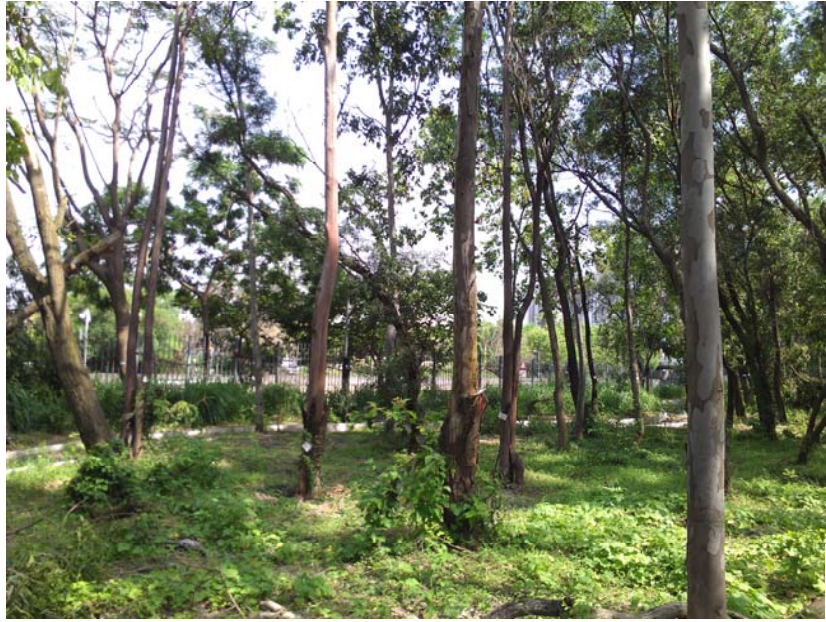
Standard hoarding was erected and well maintained around the works area at Ha Tsuen Sewage Pumping Station (HTSPS).

All retained trees were fenced off and protected properly within the works area of the site. DSD is carrying out the preservation and protection.

Generally, the overall conditions are normal in the transplanting and visual impact at Ha Tsuen Sewage Pumping Station. The conditions of hoarding was satisfactory. The trees which are at Ha Tsuen Pumping Station have been returned to Drainage Services Department management and monitoring in January 2011.

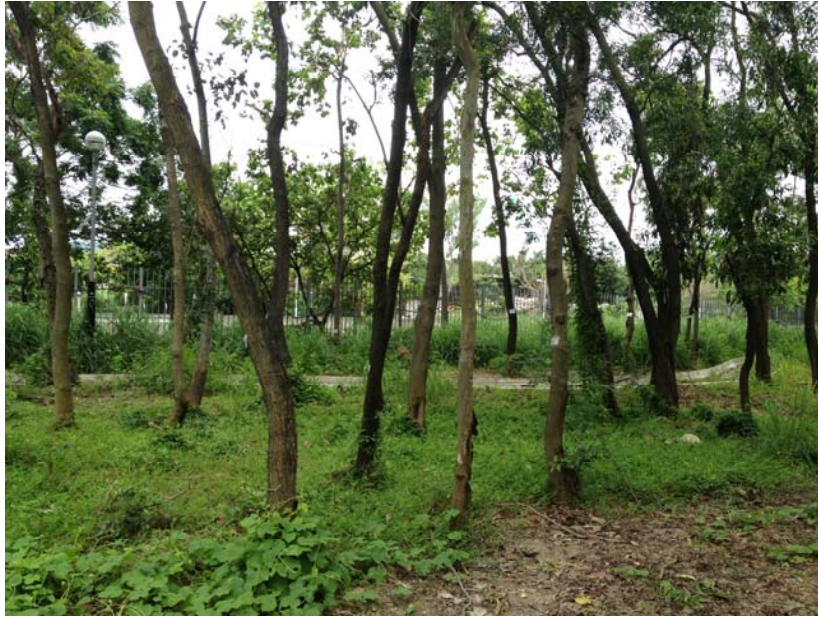
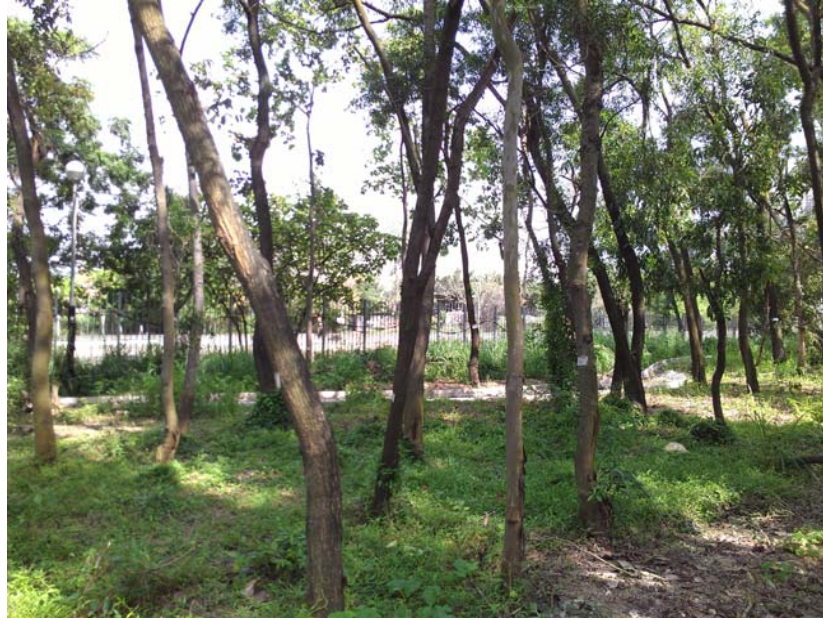
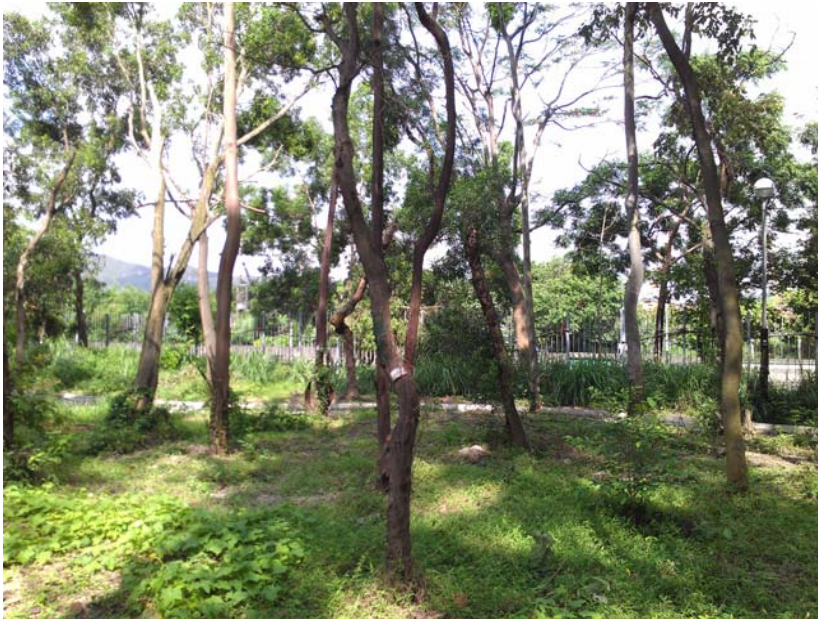
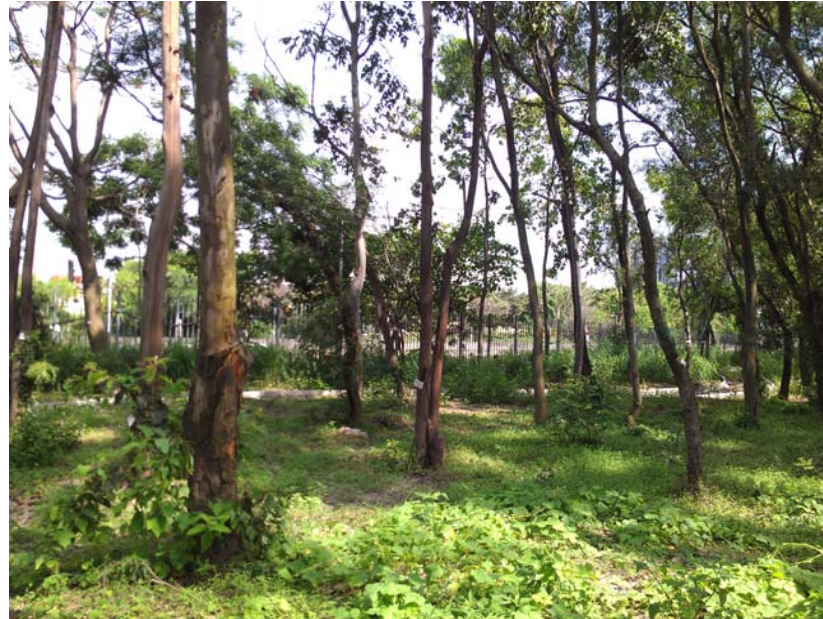
Standard hoarding was erected and well maintained around the works area at Ha Tsuen Sewage Pumping Station (HTSPS).

All retained trees were fenced off and protected properly within the works area of the site. DSD is carrying out the preservation and protection.

Generally, the overall conditions are normal in the transplanting and visual impact at Ha Tsuen Sewage Pumping Station. The conditions of hoarding was satisfactory. The trees which are at Ha Tsuen Pumping Station have been returned to Drainage Services Department management and monitoring in January 2011.
