**CONSTRUCTION OF YUEN LONG SOUTH BRANCH  
SEWERS AND EXPANSION OF HA TSUEN SEWAGE  
PUMPING STATION**

**THE FORTY-SECOND RESULTS OF LANDSCAPE AND VISUAL IMPACT  
MONITORING  
FOR JULY 2013 (No.42)**

**Location:** Ha Tsuen Sewage Pumping Station

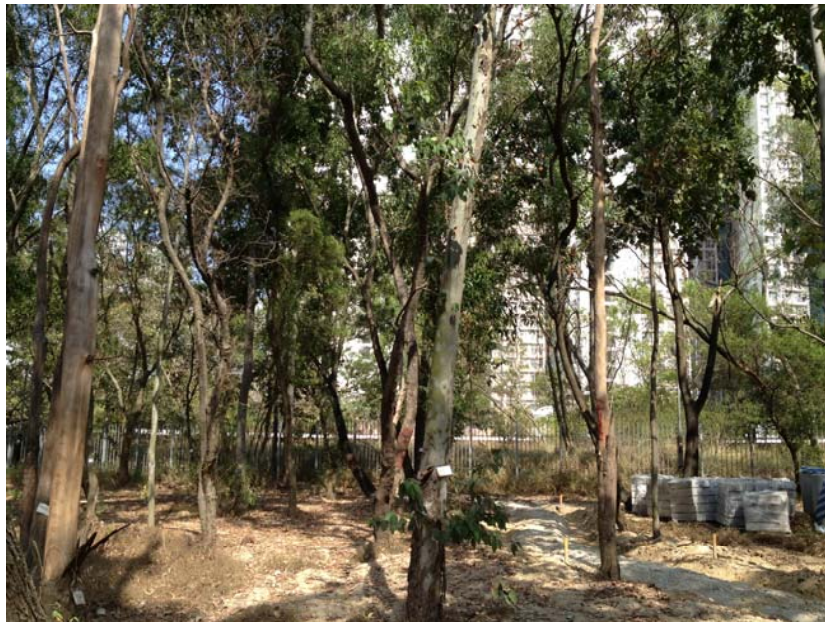
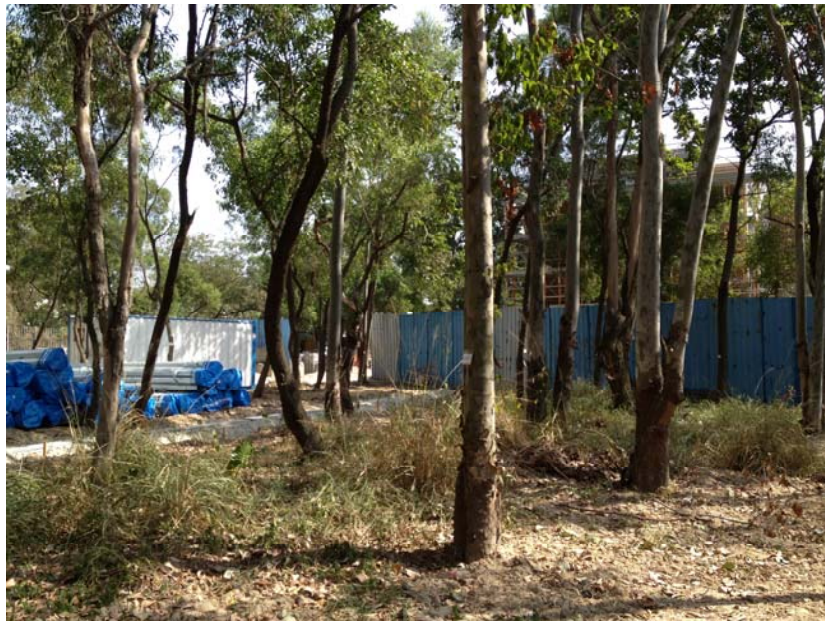
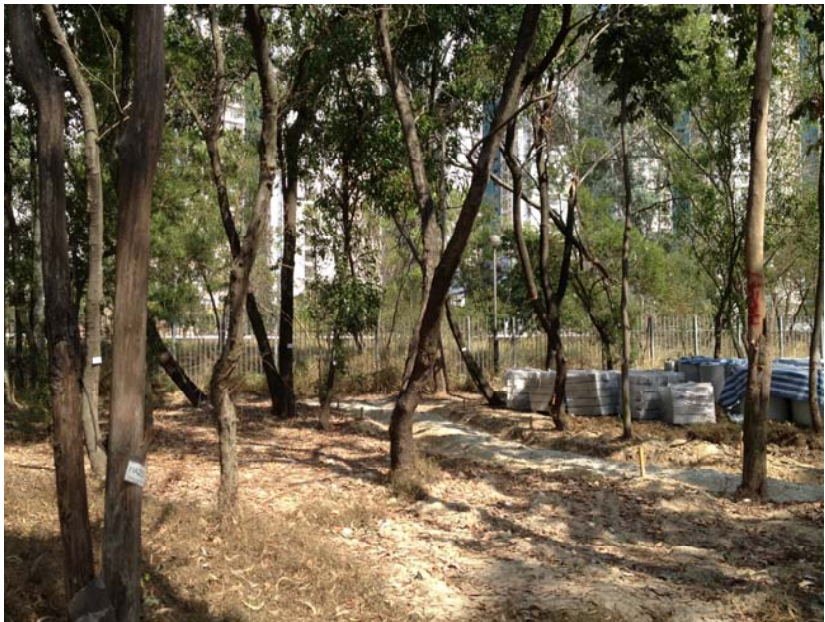
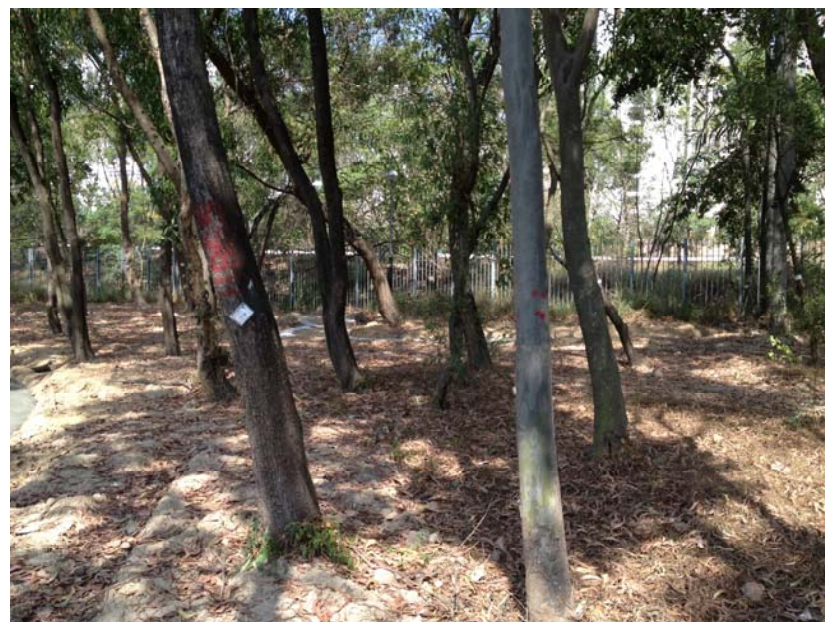
Generally, the overall conditions are normal in the transplanting and visual impact at Ha Tsuen Sewage Pumping Station. The conditions of hoarding was satisfactory. The trees which are at Ha Tsuen Pumping Station have been returned to Drainage Services Department management and monitoring in January 2011.

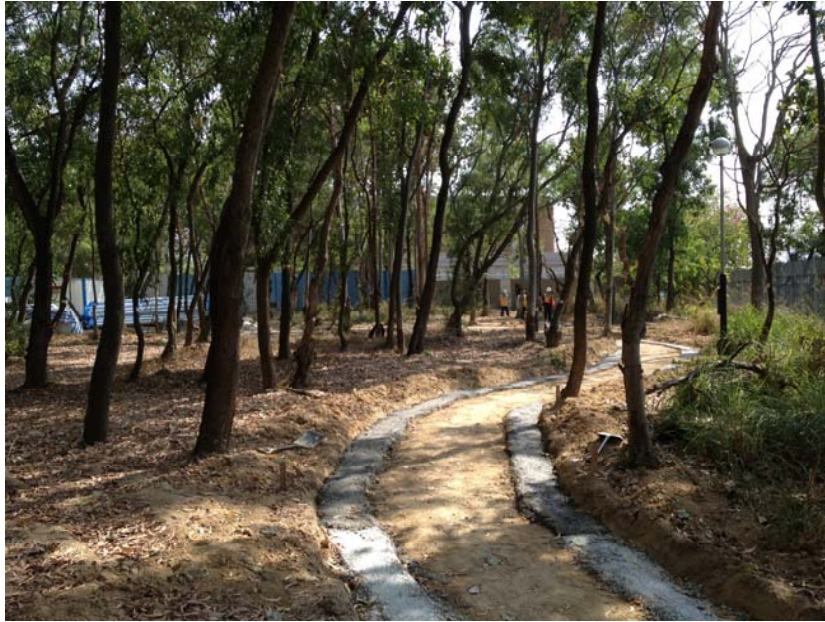
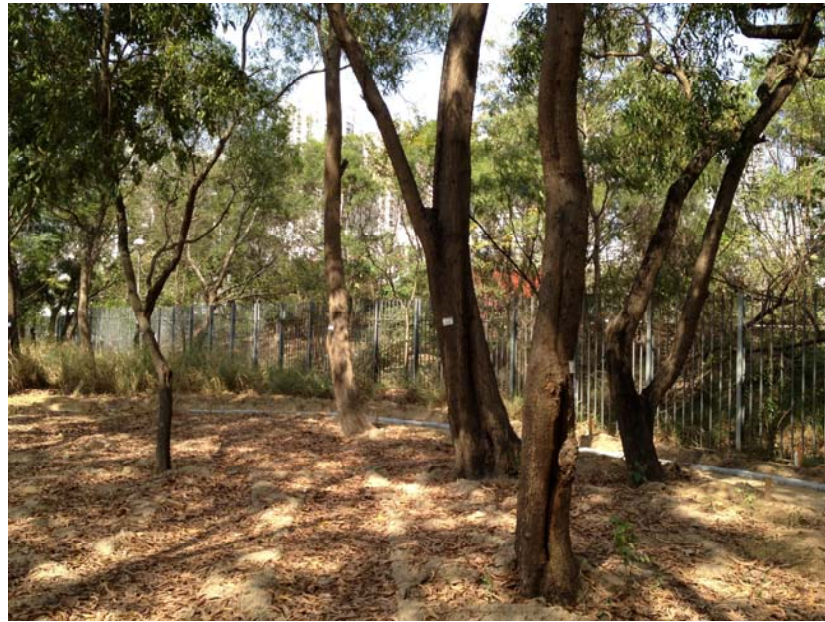
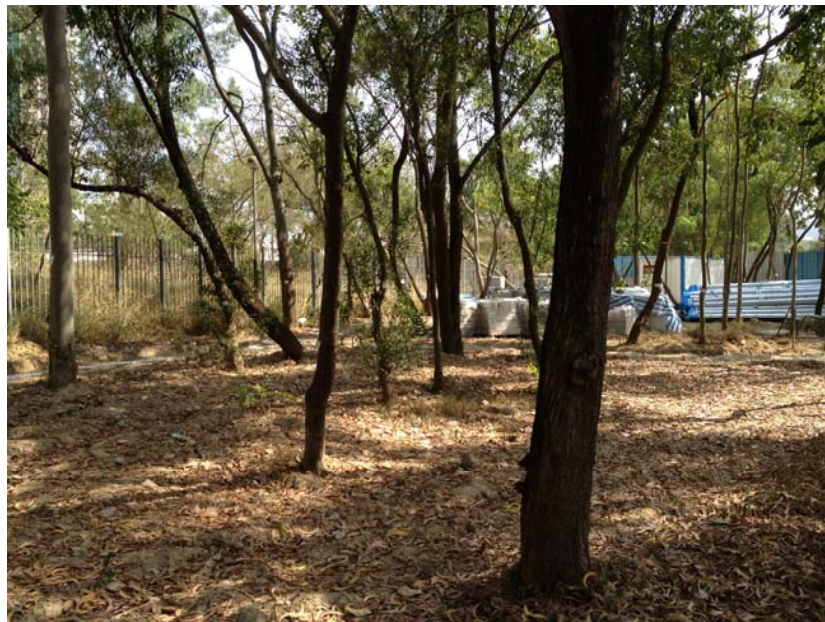
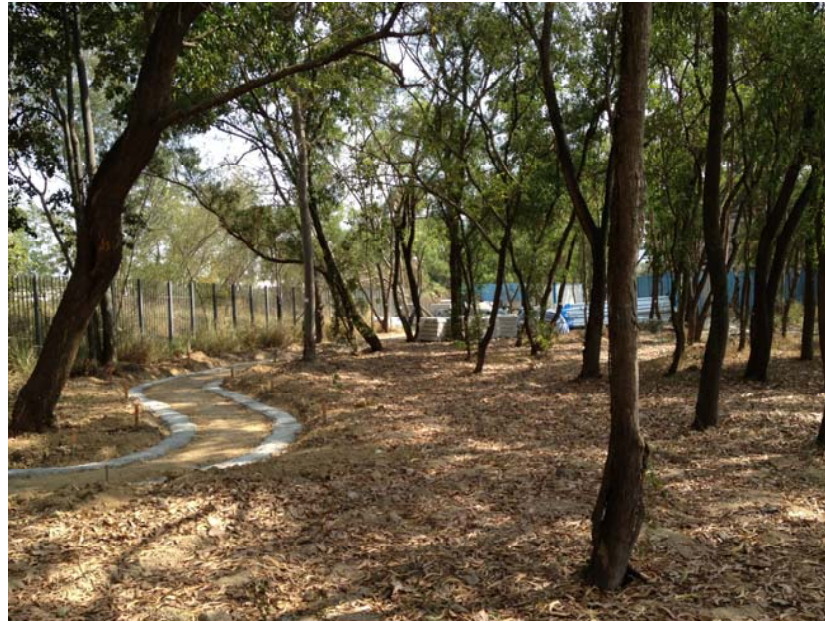
Generally, the overall conditions are normal in the transplanting and visual impact at Ha Tsuen Sewage Pumping Station. The conditions of hoarding was satisfactory. The trees which are at Ha Tsuen Pumping Station have been returned to Drainage Services Department management and monitoring in January 2011.
