**CONSTRUCTION OF YUEN LONG SOUTH BRANCH
SEWERS AND EXPANSION OF HA TSUEN SEWAGE
PUMPING STATION**

**THE FORTY-THIRD RESULTS OF LANDSCAPE AND VISUAL IMPACT
MONITORING
FOR AUGUST 2013 (No.43)**

**CHINA STATE CONSTRUCTION ENGINEERING
(HONG KONG) COMPANY LIMITED**

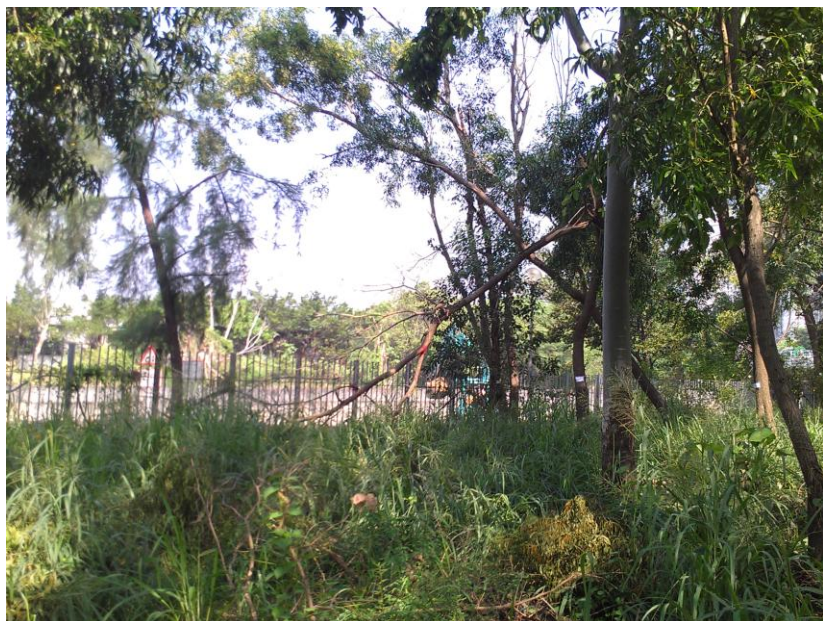
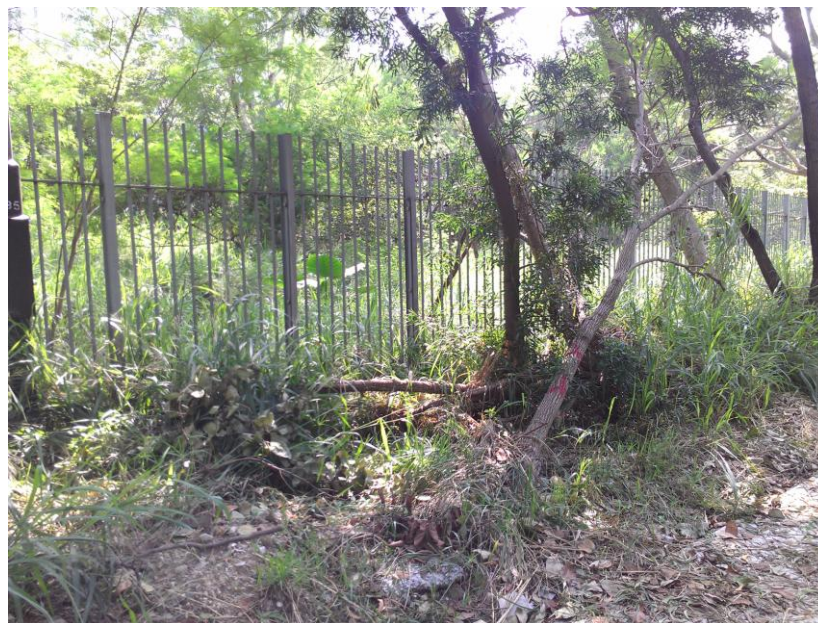
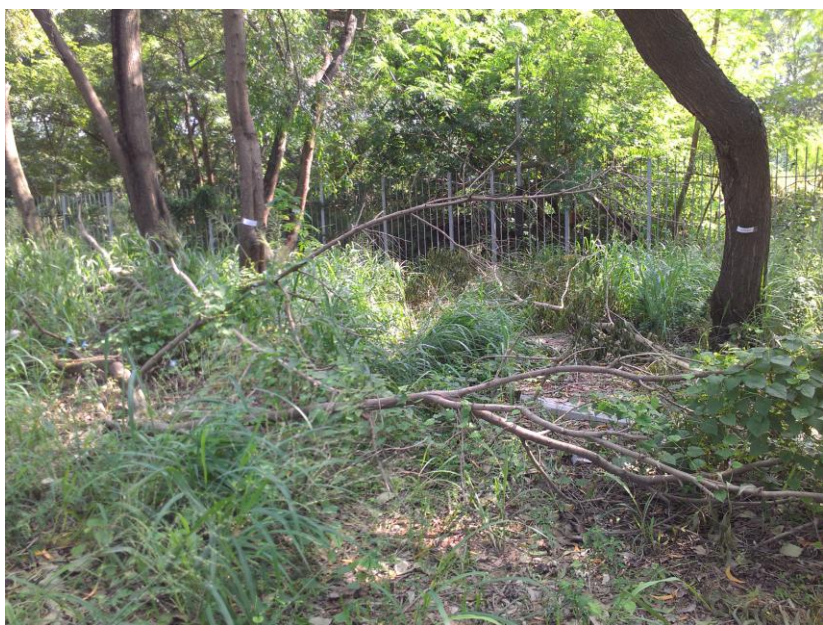
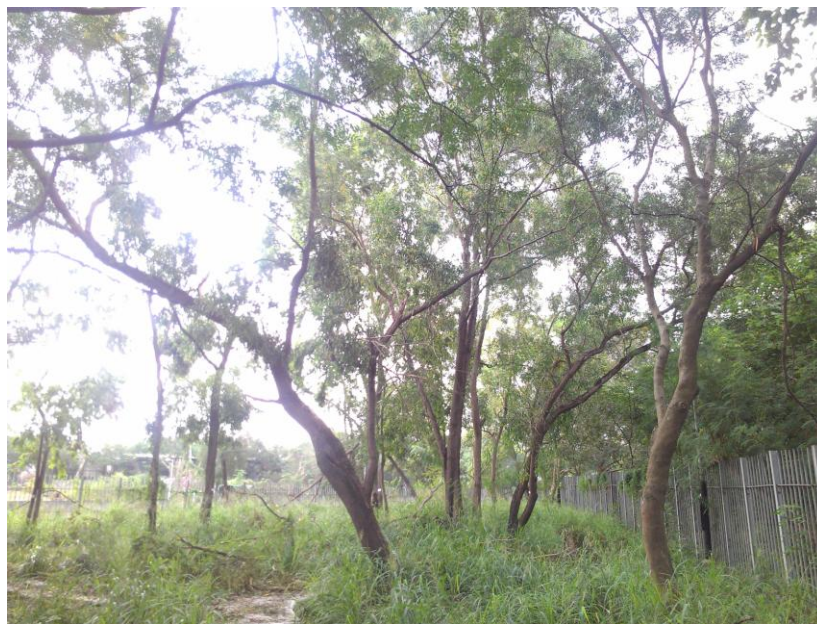
2. The transplanted trees are kept in regular inspection within the establishment period	<input type="checkbox"/>	<input type="checkbox"/>	<input checked="" type="checkbox"/>	<input type="checkbox"/>	<input checked="" type="checkbox"/>	Some trees were damaged by typhoon

The conditions of hoarding was satisfactory. Many trees were found to be damaged after typhoon signal no. 8 approached on 14/8/2013. Landscaping architect of Drainage Service Department will come to inspect the trees and decide any further action needed to be taken.

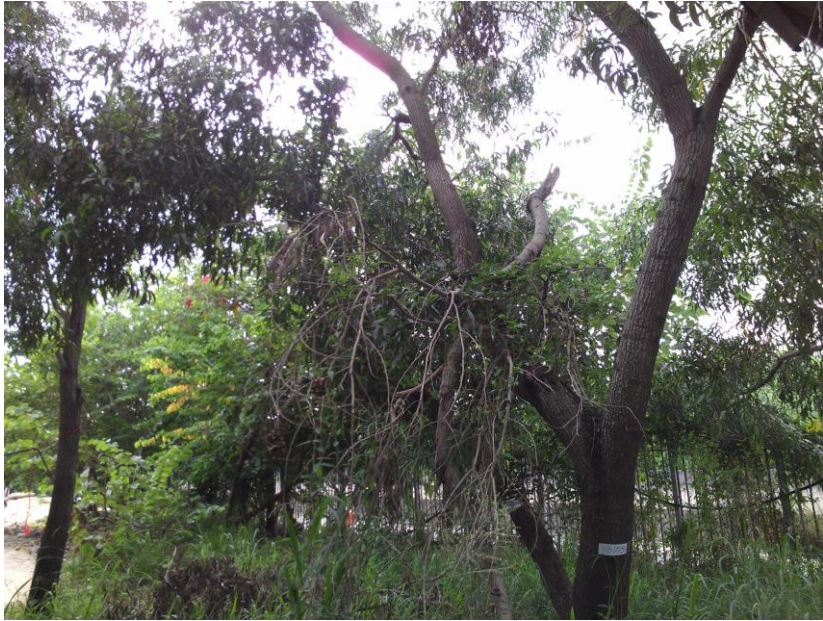
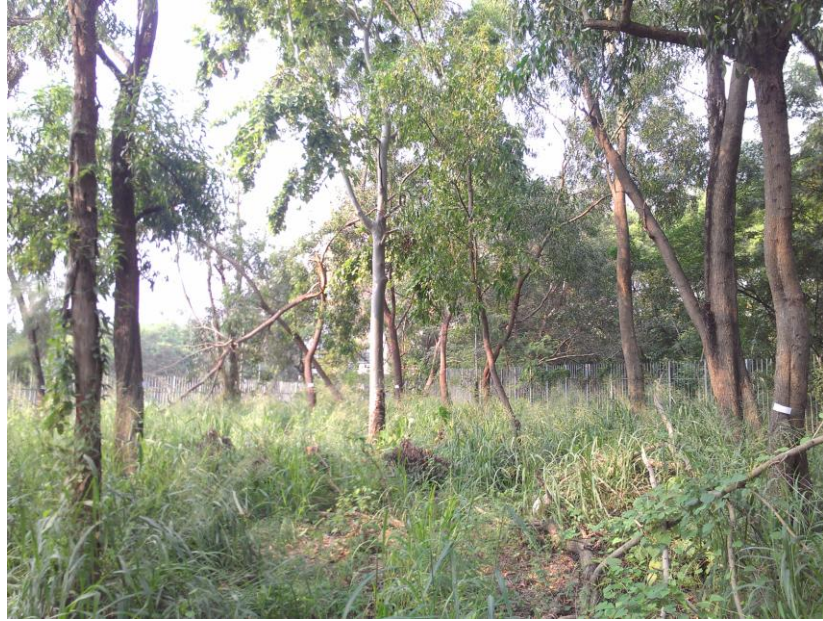
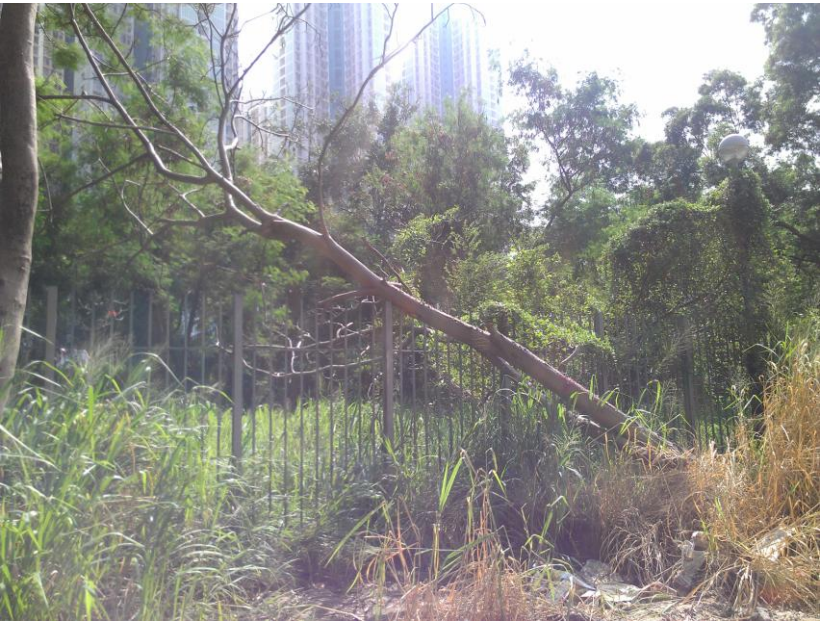
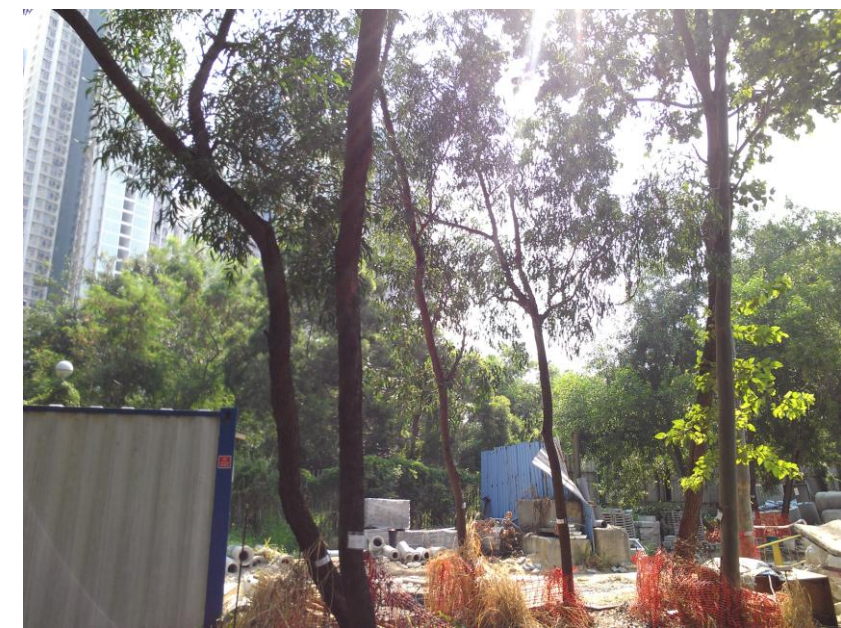
2. The transplanted trees are kept in regular inspection within the establishment period	<input type="checkbox"/>	<input type="checkbox"/>	<input checked="" type="checkbox"/>	<input type="checkbox"/>	<input checked="" type="checkbox"/>	Some trees were damaged by typhoon

Landscaping architect of Drainage Services Department visited the site and inspected the trees on 29/8/2013. It was decided to fell the damaged trees and total of 20 nos. of new trees will be planted after the those trees are felled.

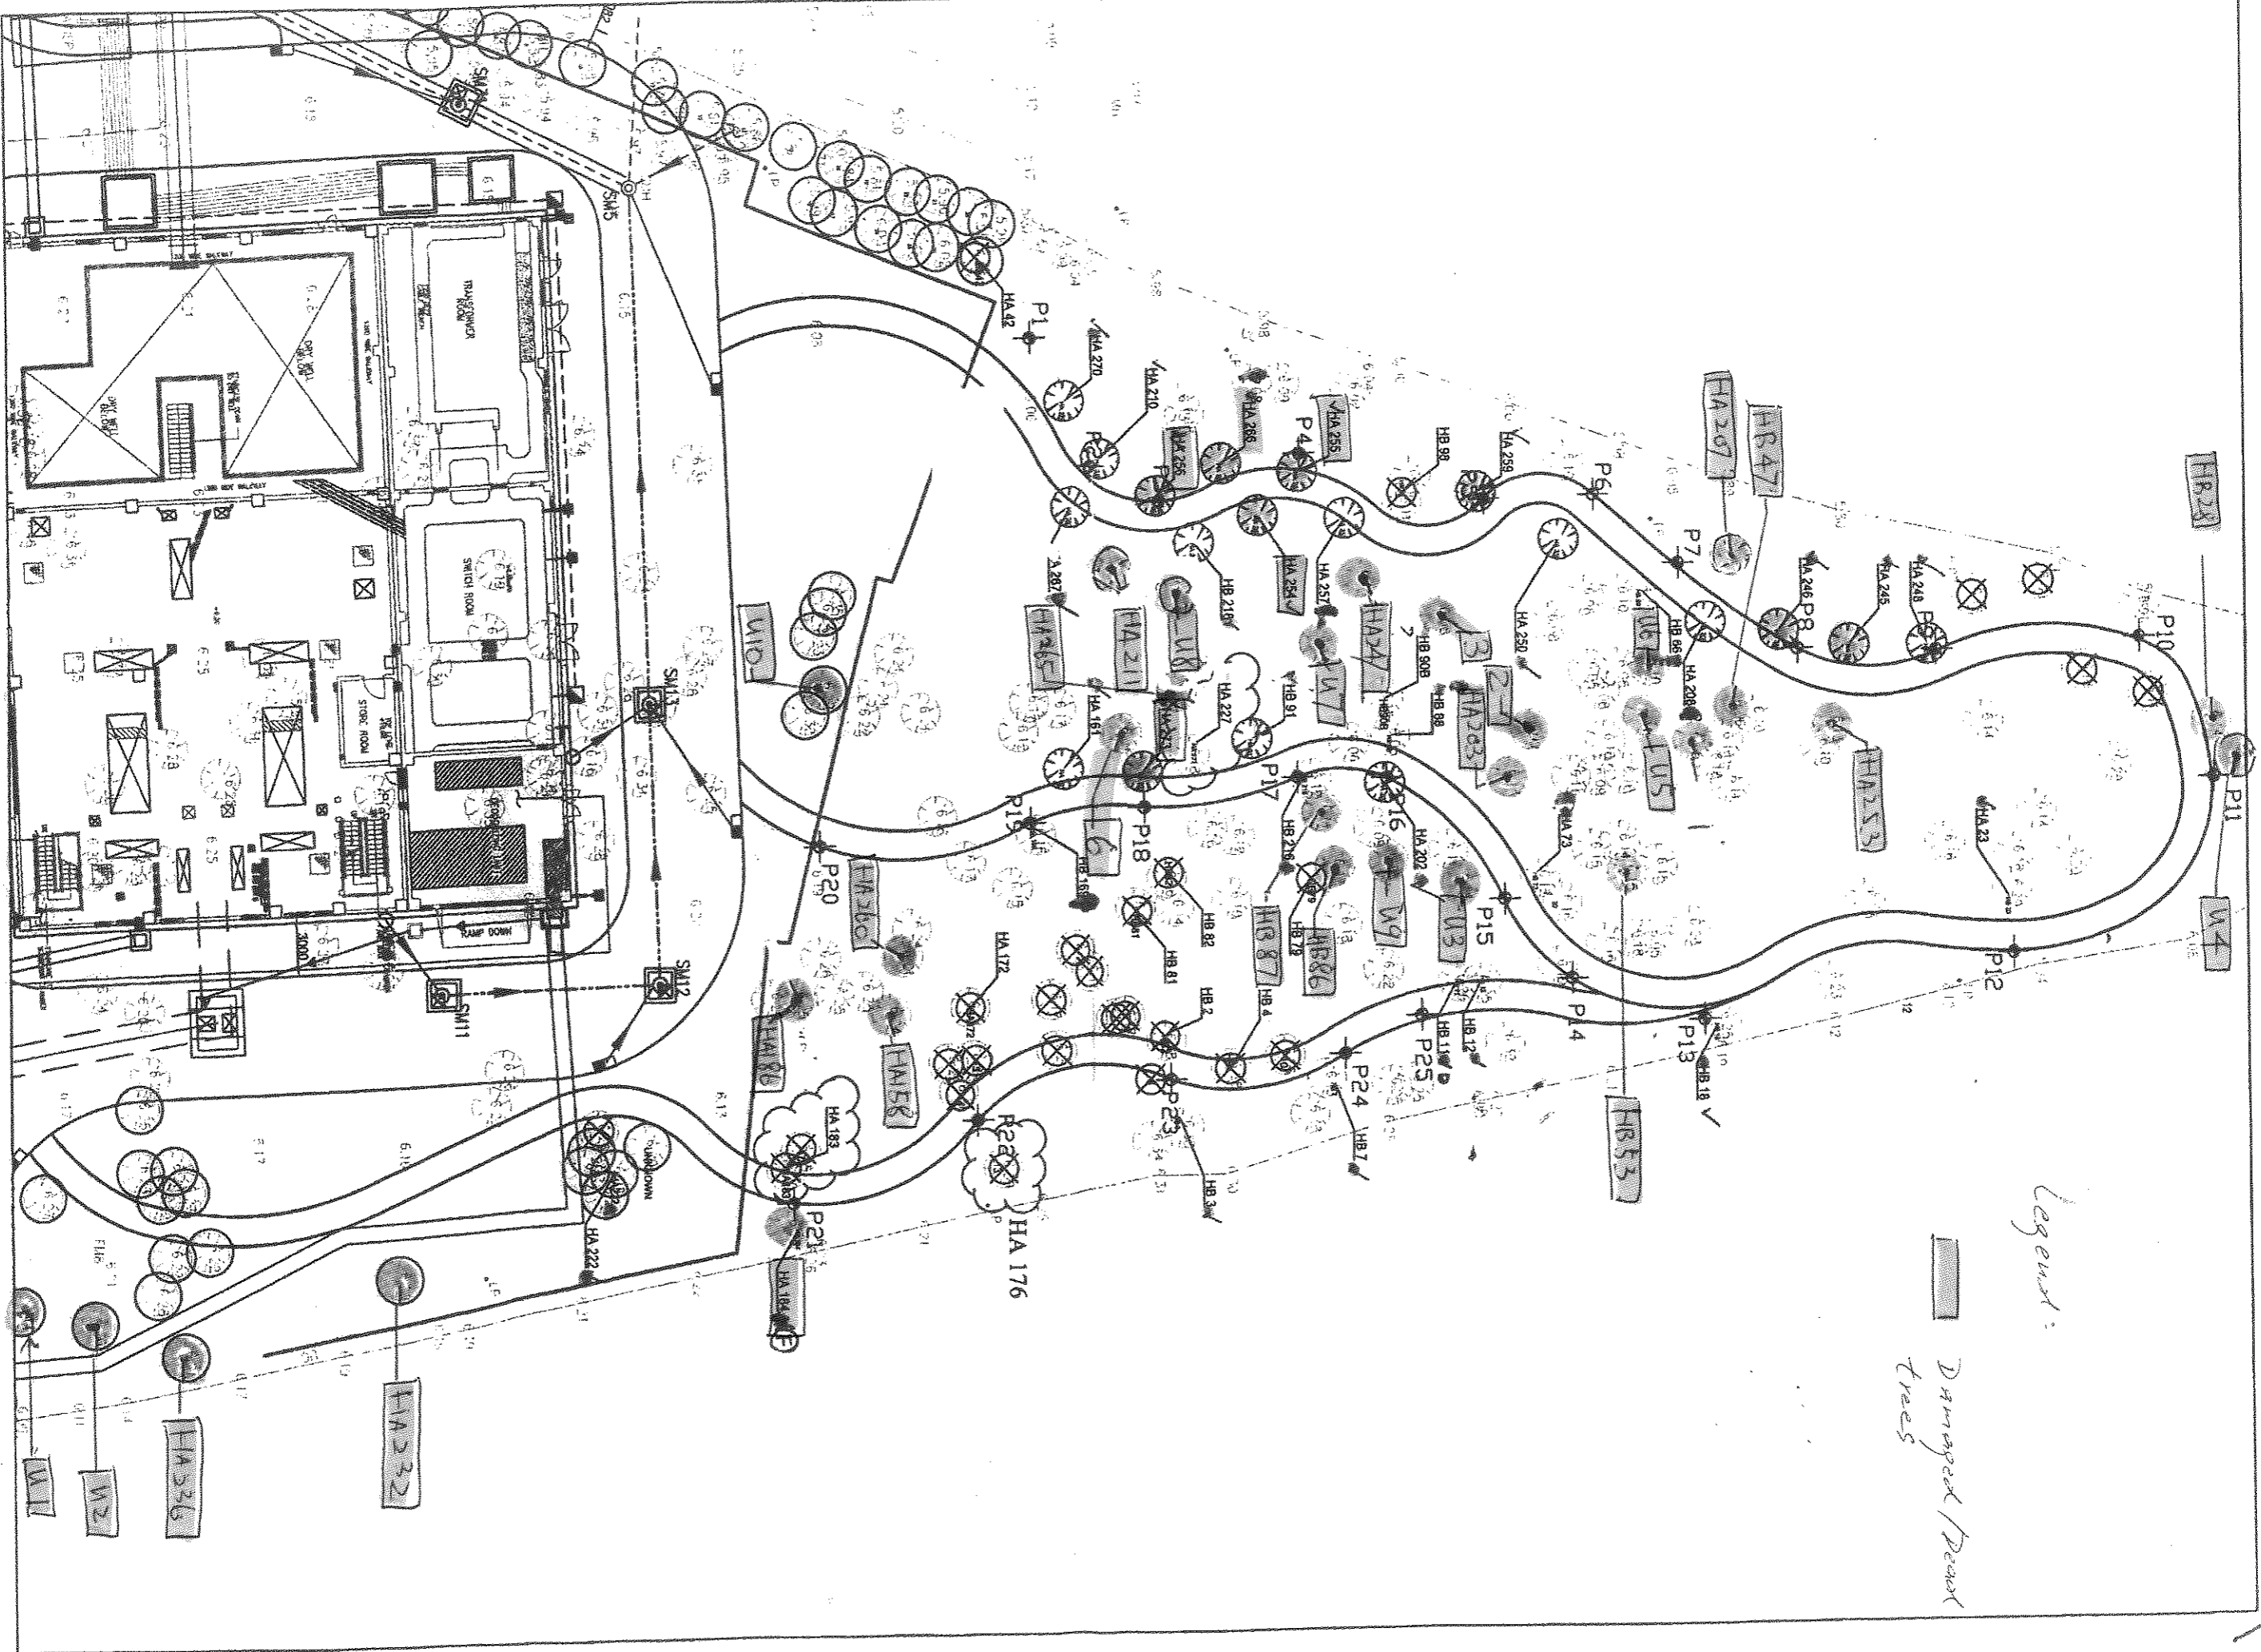
Location Plan of Damaged/Dead Trees

- 2.03 During the site inspection on 15th August 2013, a total of 20 trees were found to be damaged/dead after typhoon signal no.8 approached on 14/8/2013. The location plan and summary of damaged/dead trees are enclosed in Appendix B and C respectively. Landscaping architect of Drainage Services Department visited the site and inspected the trees on 29/8/2013. It was decided to fell the damaged trees and the programme is enclosed in Appendix D.

- 2.04 A total of 20 nos. of new trees will be planted after those trees are felled, however the species and approximate locations of new/transplanted trees are still pending, the relevant information will be attached in LVIM results in October 2013.
