JOB No.: TCS00491/09

DSD CONTRACT No.: DC/2009/08

**CONSTRUCTION OF YUEN LONG SOUTH BRANCH
SEWERS AND EXPANSION OF HA TSUEN SEWAGE
PUMPING STATION**

**THE FORTH-FOURTH RESULTS OF LANDSCAPE AND VISUAL IMPACT
MONITORING
FOR SEPTEMBER 2013 (No.44)**

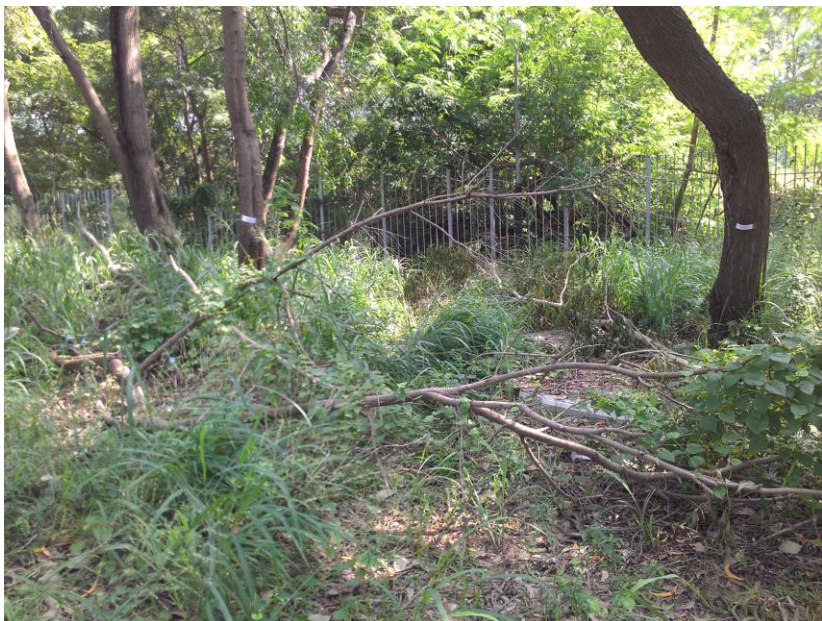
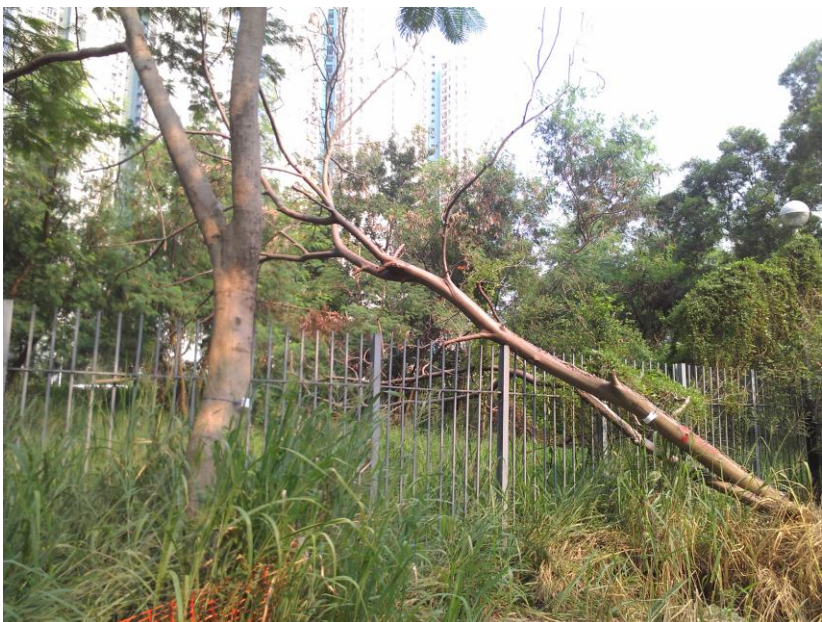
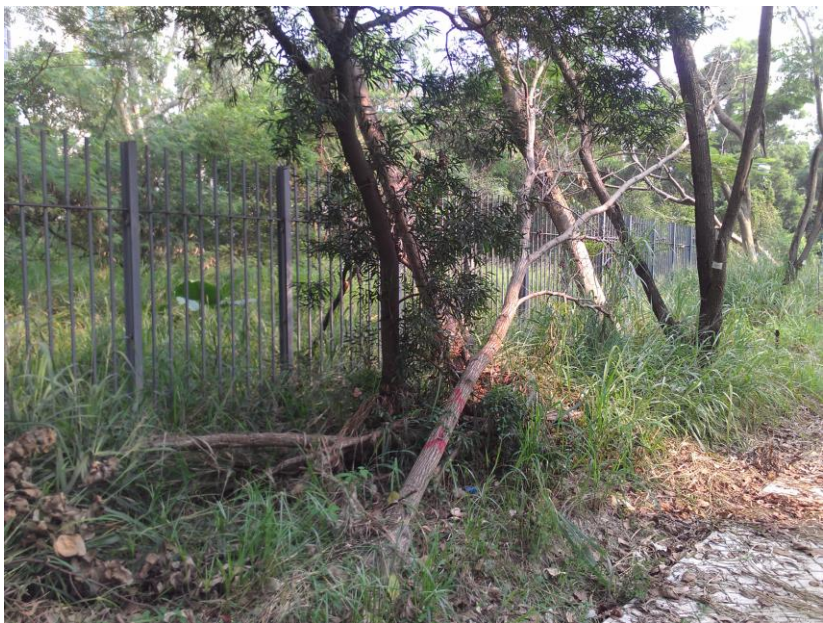
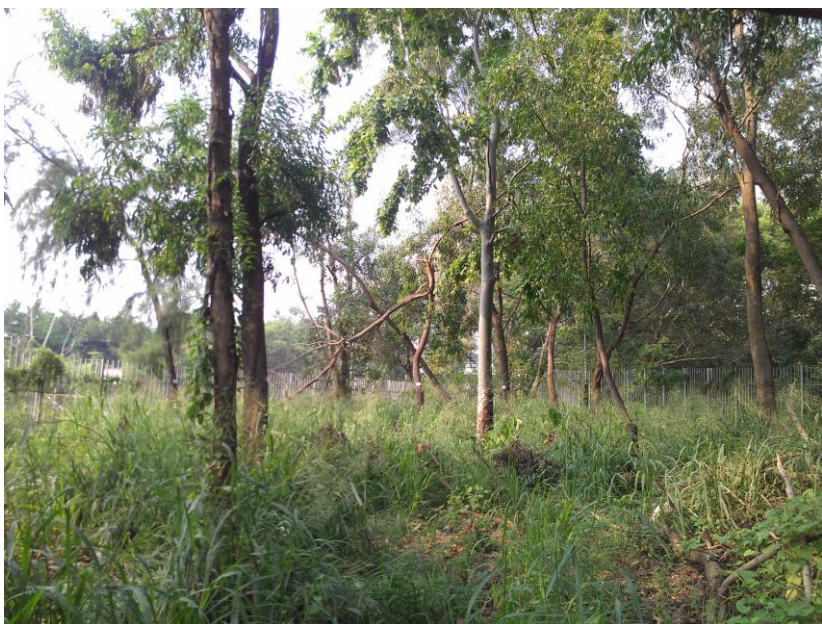
2. The transplanted trees are kept in regular inspection within the establishment period	<input type="checkbox"/>	<input type="checkbox"/>	<input checked="" type="checkbox"/>	<input type="checkbox"/>	<input checked="" type="checkbox"/>	Some trees were damaged by typhoon

Landscaping architect of Drainage Services Department visited the site and inspected the trees on 29/8/2013. It was decided to fell the damaged trees and total of 20 nos. of new trees will be planted after the those trees are felled.

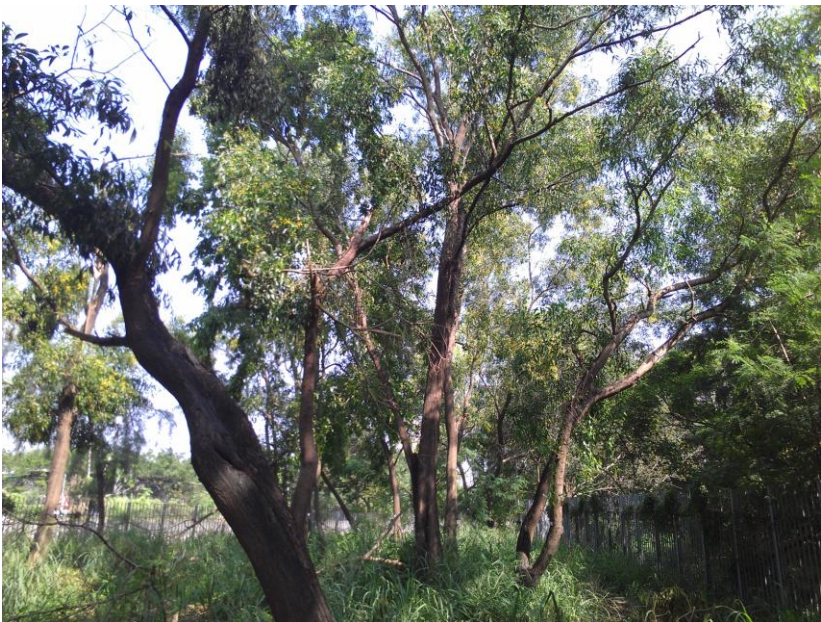
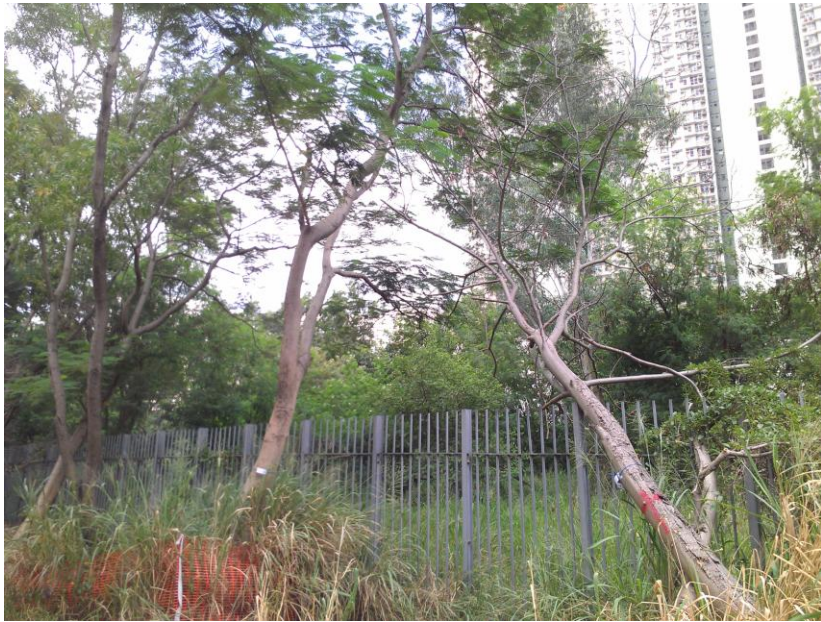
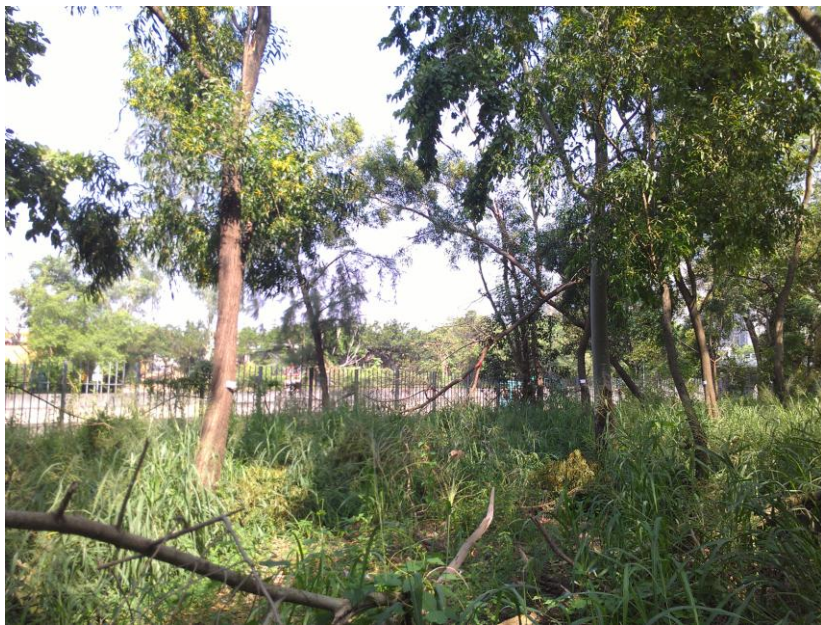
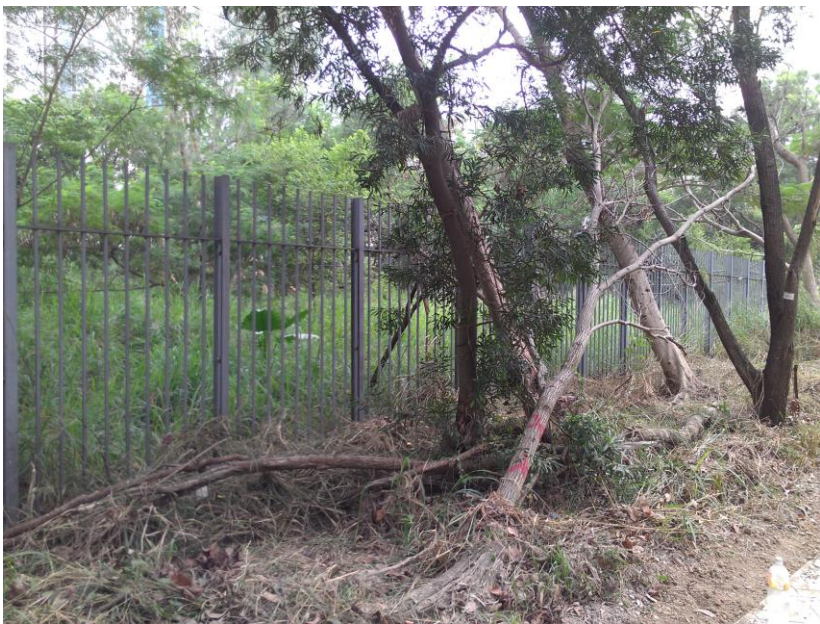
2. The transplanted trees are kept in regular inspection within the establishment period	<input type="checkbox"/>	<input type="checkbox"/>	<input checked="" type="checkbox"/>	<input type="checkbox"/>	<input checked="" type="checkbox"/>	Some trees were damaged by typhoon

Landscaping architect of Drainage Services Department visited the site and inspected the trees on 29/8/2013. It was decided to fell the damaged trees and total of 20 nos. of new trees will be planted after the those trees are felled. The typhoon signal no. 8 approached on 22/9/2013 further damaged the trees. Landscaping sub-contractor was arranged to fell the damaged trees shortly.

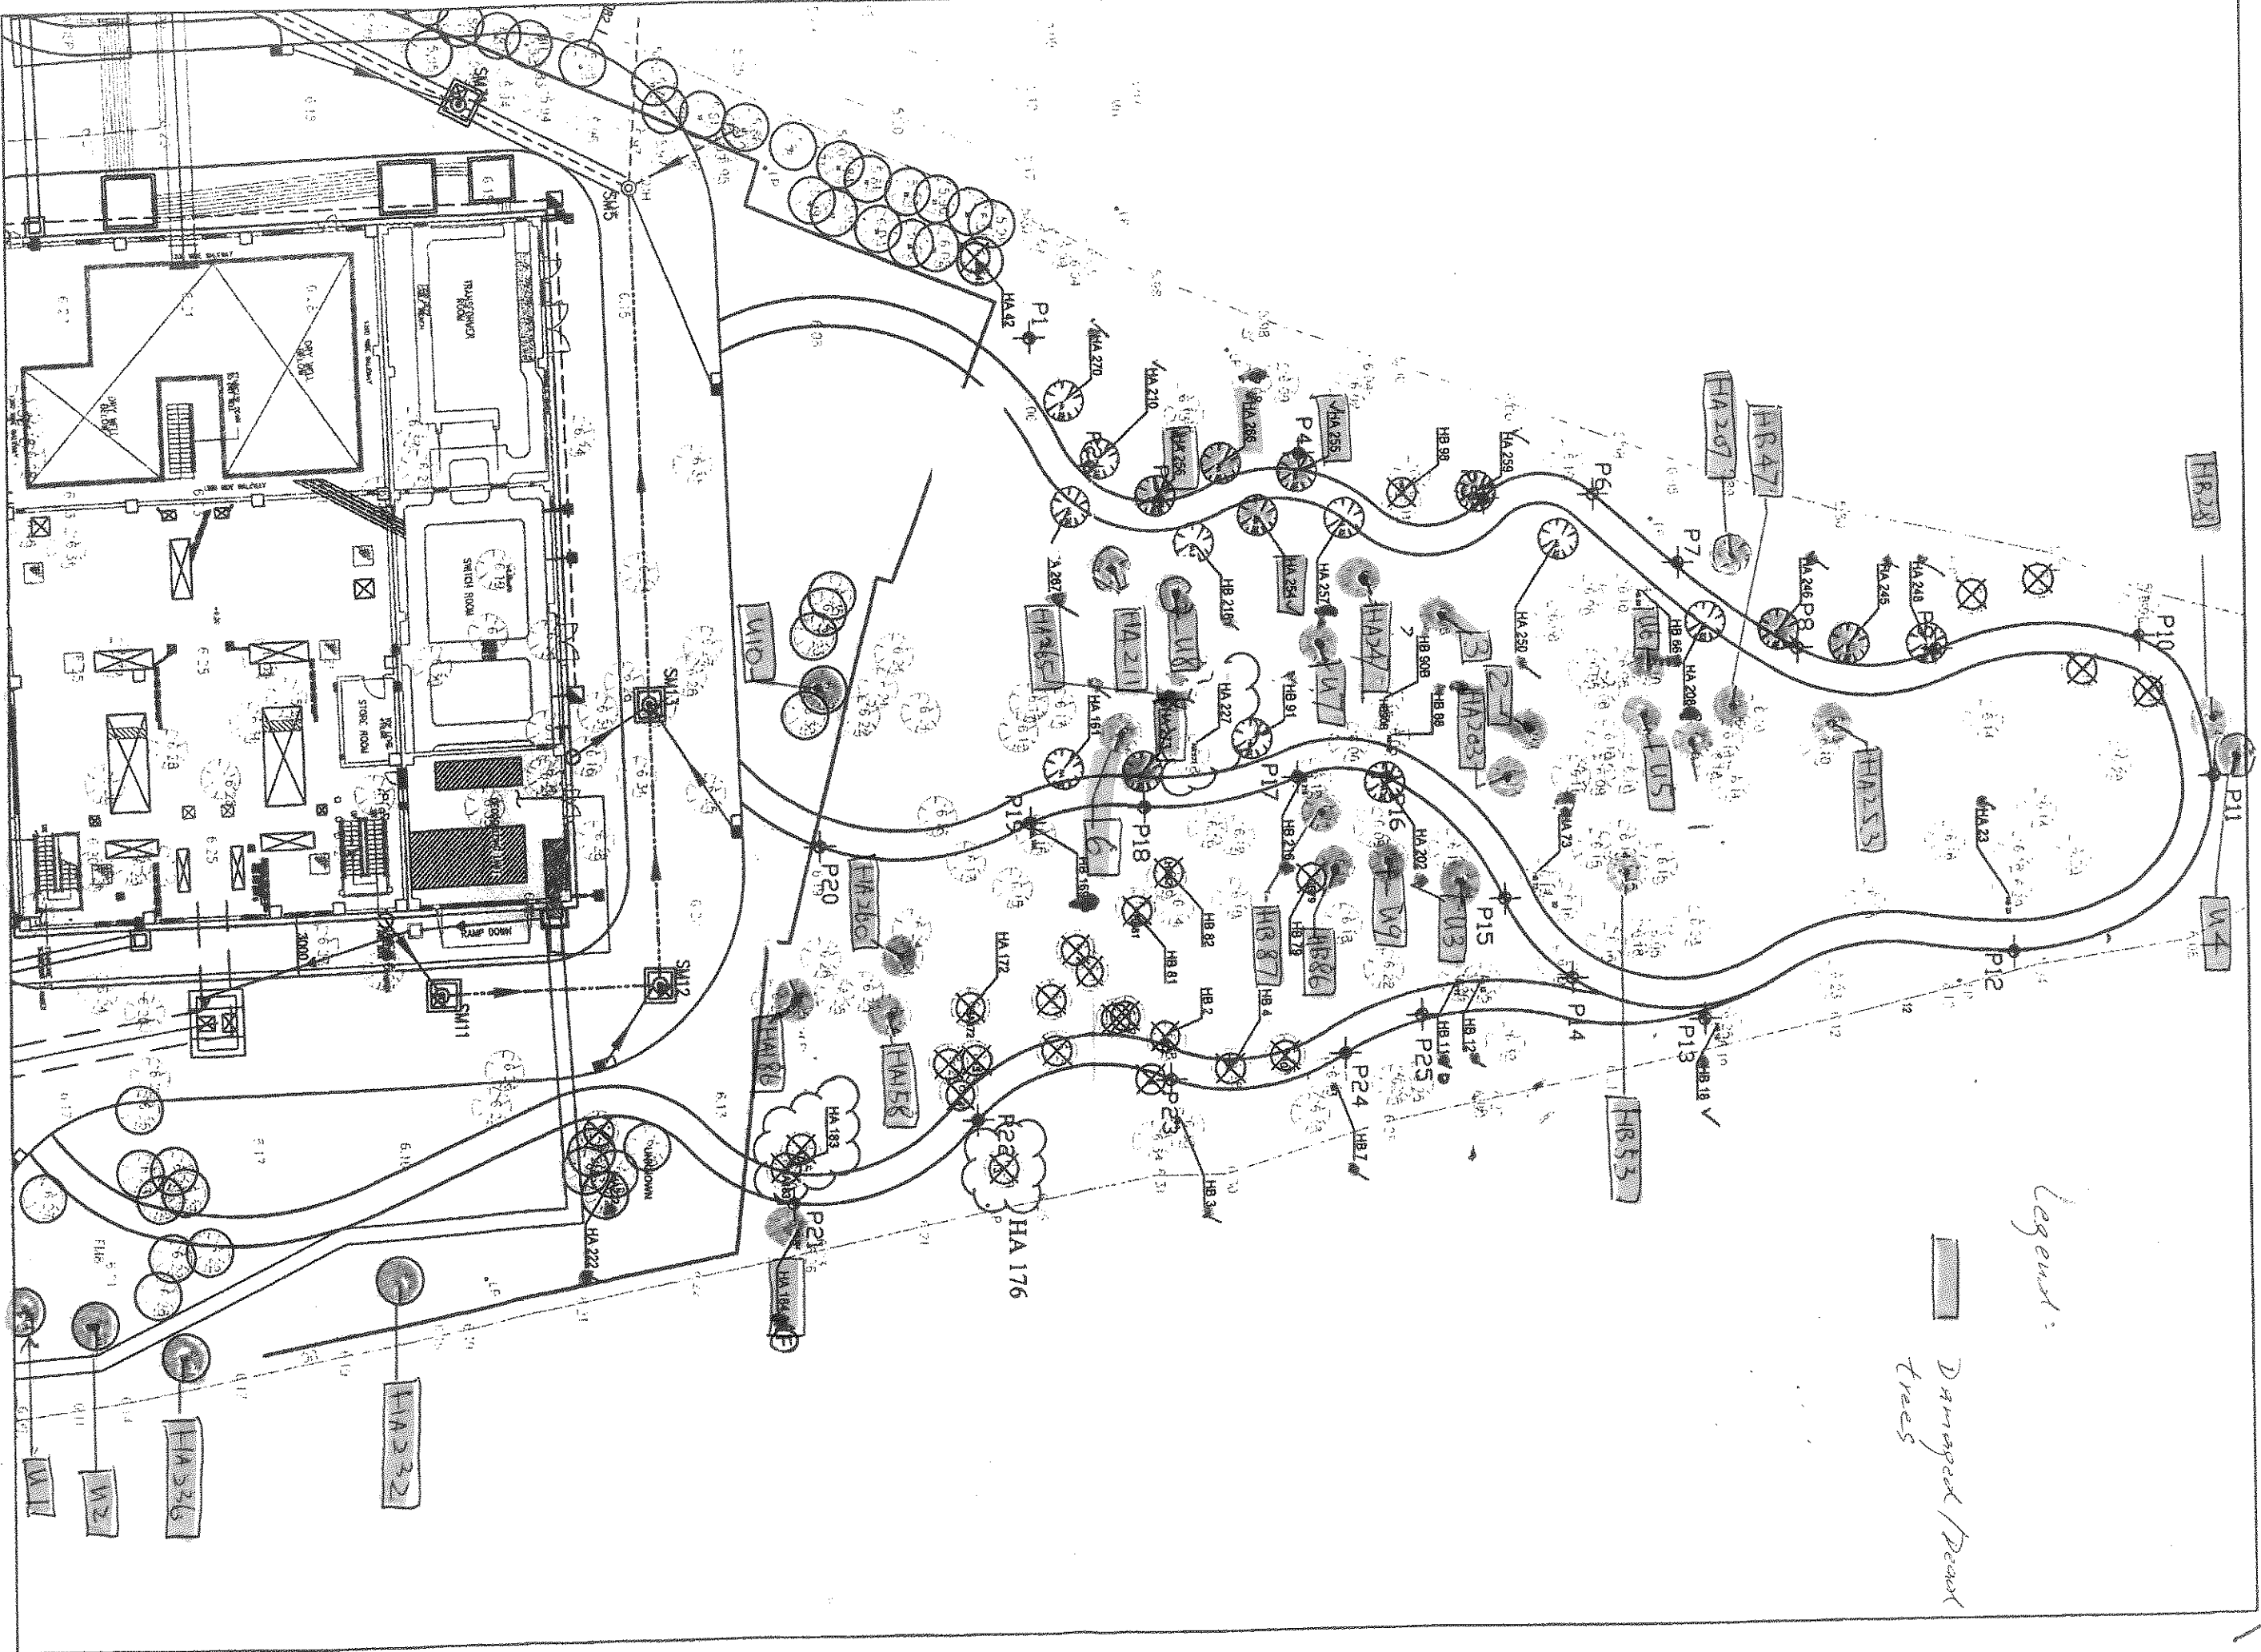
Location Plan of Damaged/Dead Trees

- 2.03 The typhoon signal no.8 approached on 22/9/2013 further damaged the trees and 15 trees were found to be damaged/dead after this typhoon, the location plan and summary of damaged/dead trees are enclosed in Appendix B and C respectively. After the site inspections by Landscaping architect of Drainage Services Department, total of 35 nos. of damaged trees were decided to be felled and the programme is enclosed in Appendix D. The summary of tree number, species and condition damage for those trees were attached with the site inspection checklist.

- 2.04 A total of 20 nos. of new trees will be planted after those trees are felled, however the species and approximate locations of new/transplanted trees are still pending, the relevant information will be attached in LVIM results in October 2013.
