DSD CONTRACT No.: DC/2009/08

CONSTRUCTION OF YUEN LONG SOUTH BRANCH SEWERS AND EXPANSION OF HA TSUEN SEWAGE PUMPING STATION

THE FORTH-SIXTH RESULTS OF LANDSCAPE AND VISUAL IMPACT MONITORING FOR NOVEMBER 2013 (NO.46)

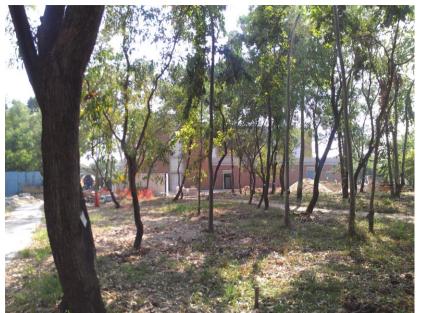
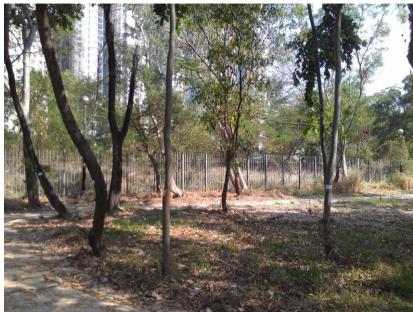
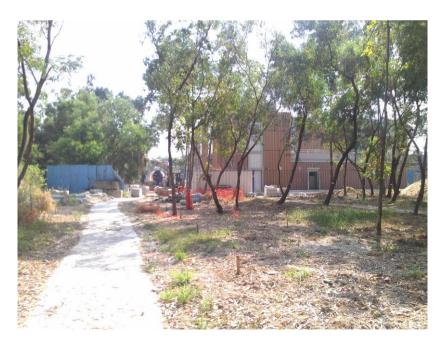
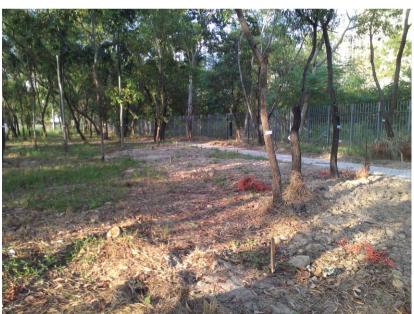
3.	No construction activities are carried out in the protection zone of the preserved trees	<b>✓</b>					
Cor	nments:						
All	retained trees were fenced off and protected properly within the works ar	ea of the	site. DSI	) is carry	ing out t	he pres	ervation
and	protection.	iii-					
Cor	clusion						
Lan	dscaping sub-contractor fell and removed total of 35 nos. damaged trees	on 12/10	/2013. Di	rainage S	ervice D	epartme	ent confirmed to plant to
	os. new trees with the following species:						
10 r	os. of Litsea glutlnosa (潺槁樹)						
10 n	os. of Schlma superba (木荷)						
12 n	os. of Bichofla polycarpa (重陽木)						
10 n	os. Cinnamomum burmanil (陰香)						
Ren	narks						
	Signatures:						
	Senior landscape Architect  (Name: David Bloxham)

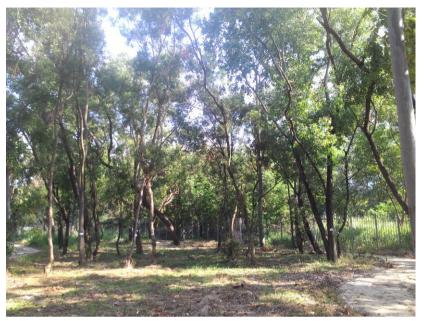
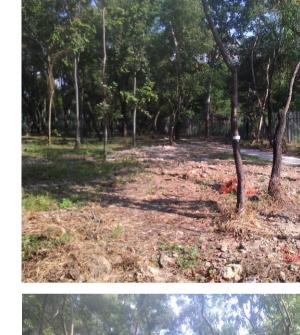
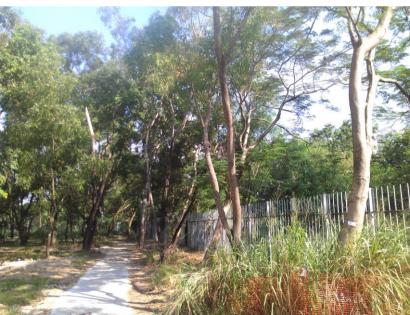
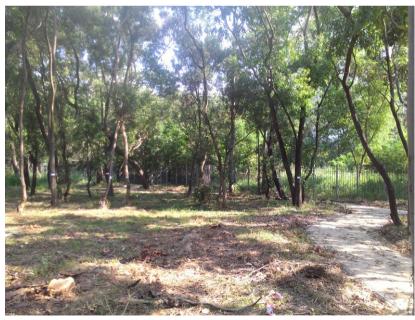
1. All preserved trees are protected in accordance with the specification	ons 🗸				-
2. All preserved trees are fenced off properly	$\checkmark$				
<ol> <li>No construction activities are carried out in the protection zone of the preserved trees</li> </ol>	he 🗸				
Comments:					
All retained trees were fenced off and protected properly within the work	s area of the	site. DSD	is carry	ing out the pres	ervation
and protection.					
Conclusion					
Landscaping sub-contractor fell and removed total of 35 nos. damaged tr	rees on 12/10/	/2013. Dr	ainage Se	ervice Departme	ent confirmed to plant
42 nos. new trees with the following species:			Ü		· ·
10 nos. of Litsea glutlnosa (潺槁樹)					
10 nos. of Schlma superba (木荷)					
12 nos. of Bichofla polycarpa (重陽木)					
10 nos. of Cinnamomum burmanil (陰香)					
26 nos. of trees were felled and removed on 18 November 2013 under ins	struction of D	rainage S	ervice D	epartment.
